# BAR BC DUDE RANCH

## CONDITION ASSESSMENT AND REPORT

University of Pennsylvania  
Architectural Conservation Laboratory

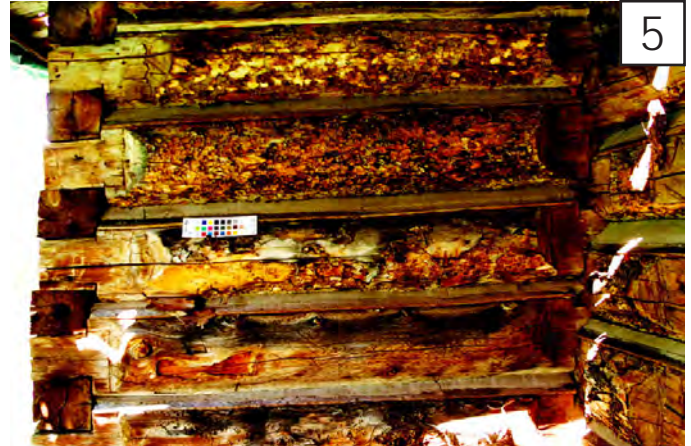
5 logs are tight and sound with minimal checking and no signs of rot.

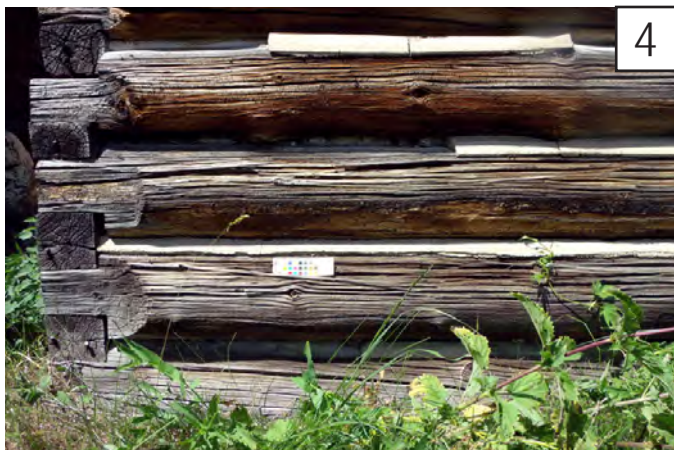
4 logs may have more checking and some minimal signs of deterioration.

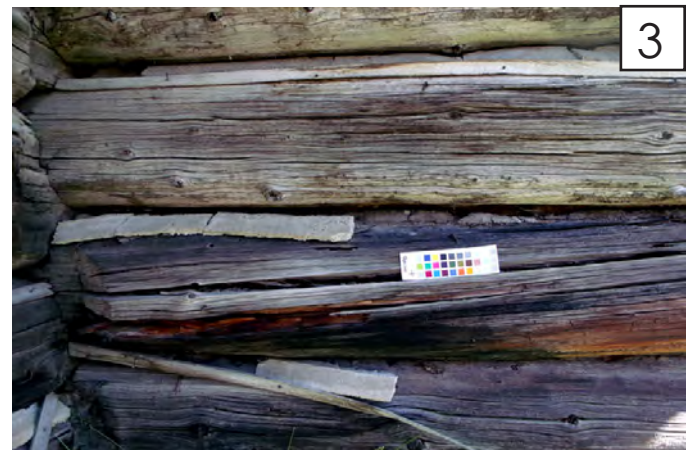
3 logs have more advanced checking, splitting and signs of loss.

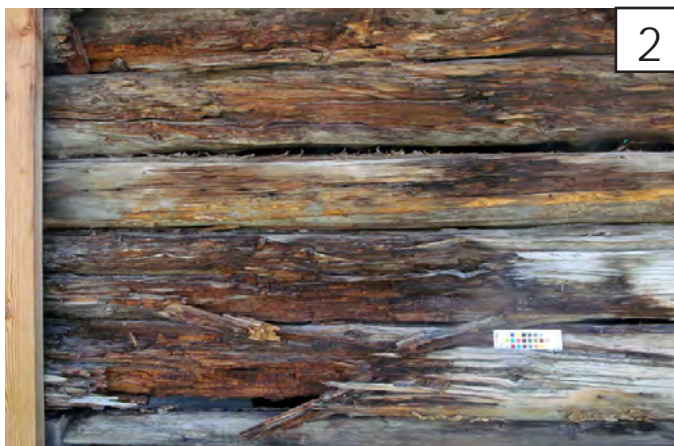
2 logs are beginning to show rot and more severe deterioration.

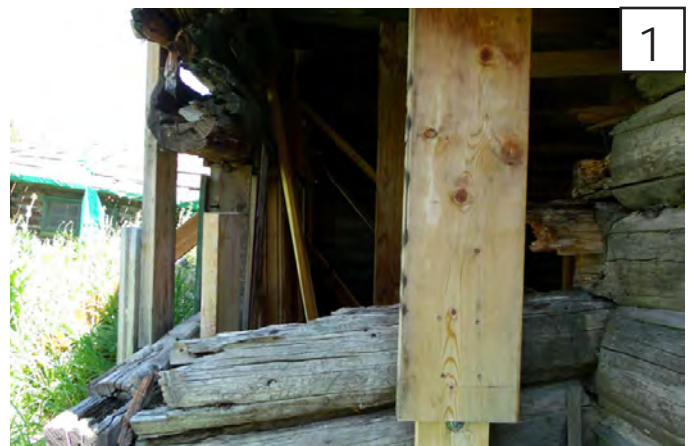
1 all logs rotted, deteriorated or missing, and are in danger of failure or are failing.

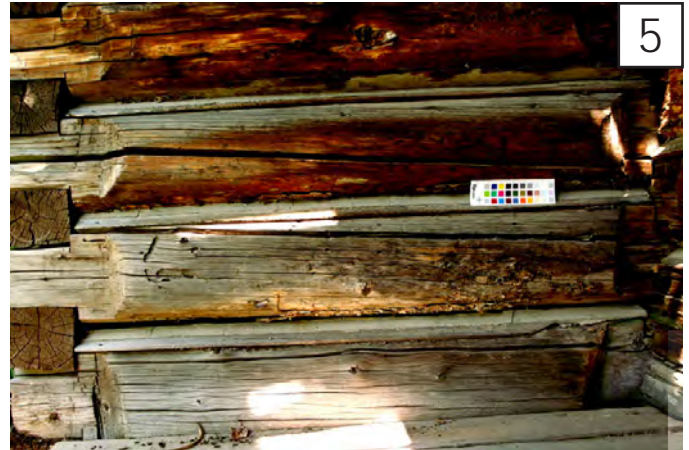
A 5 log is tight and sound with minimal checking and no signs of rot.

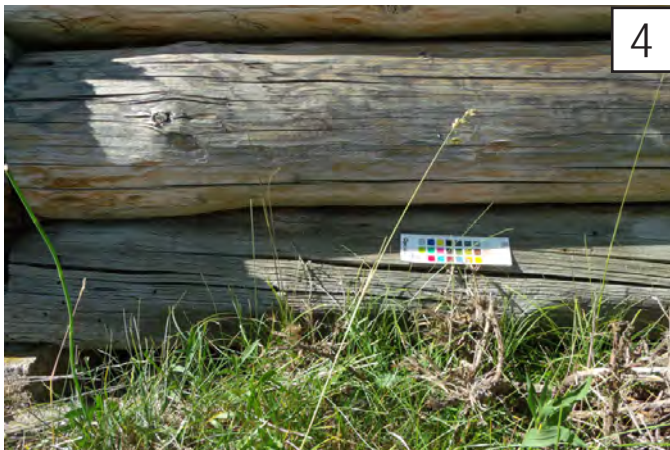
A 4 log may have more checking and some minimal signs of deterioration.

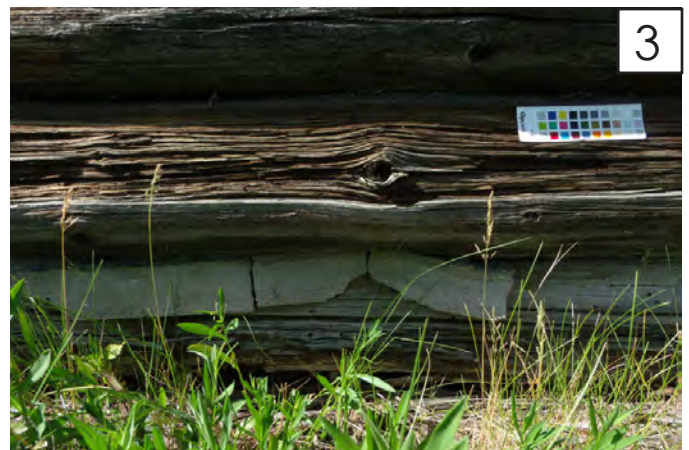
A 3 log has more advanced checking, splitting and signs of loss.

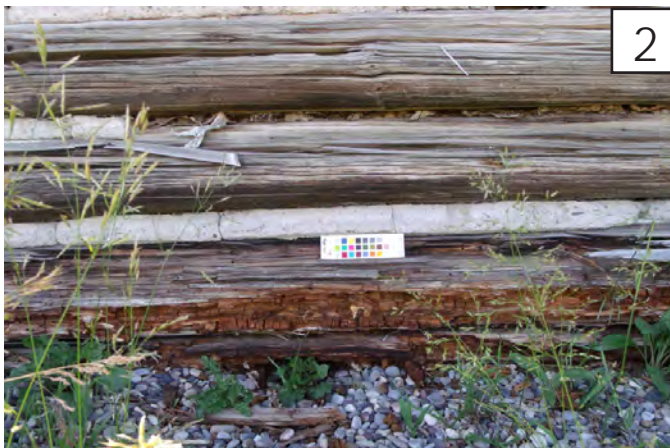
A 2 log is beginning to show rot and more severe deterioration.

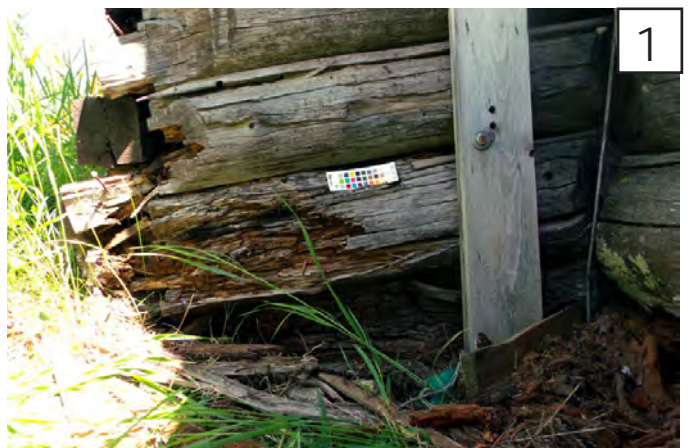
A 1 log is rotted, deteriorated or missing, and in danger of failure or are failing.

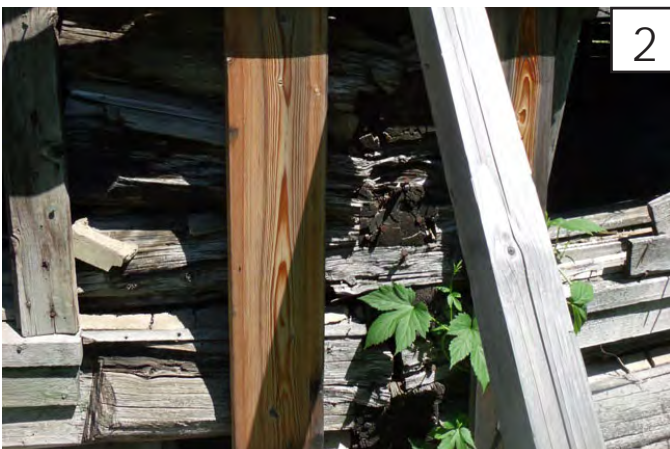
2 corners usually require stabilization and exhibit extreme separation and deterioration.

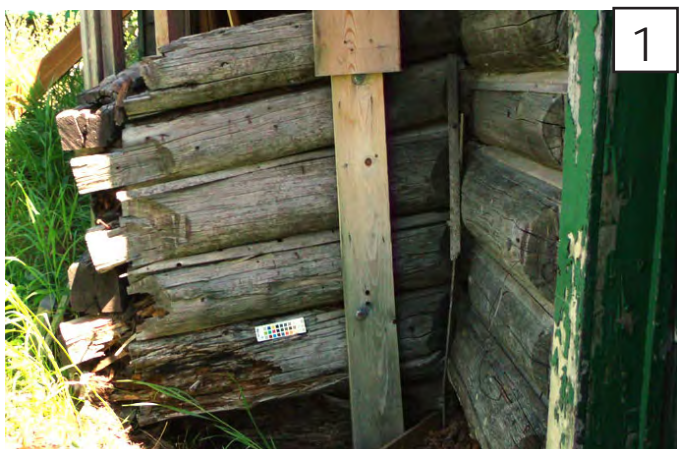
1 corners exhibit deterioration to the point of failure.

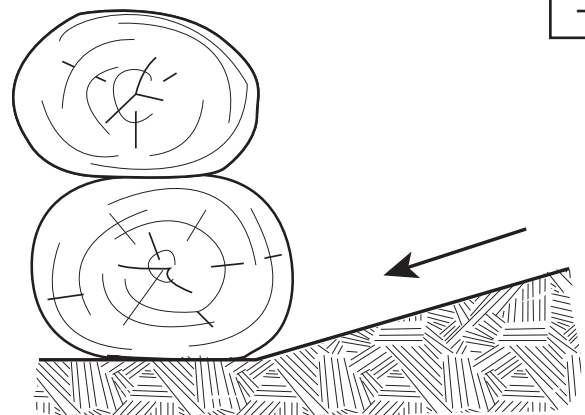
Negative drainage is the condition in which run-off is directed toward the wall sill.

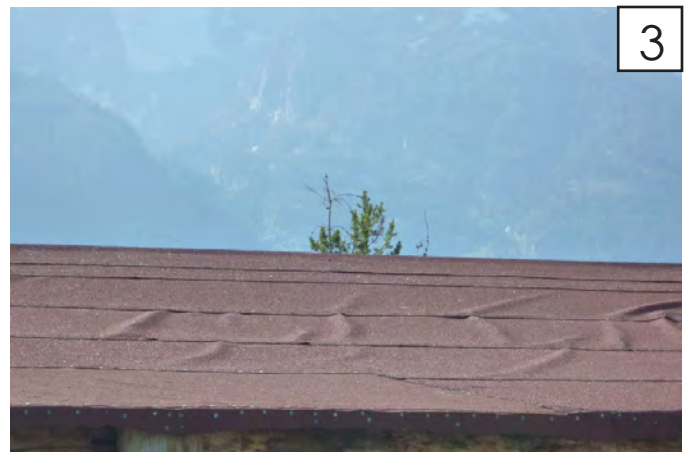
3 condition may be puckered, incorrectly installed, or beginning to show wear.

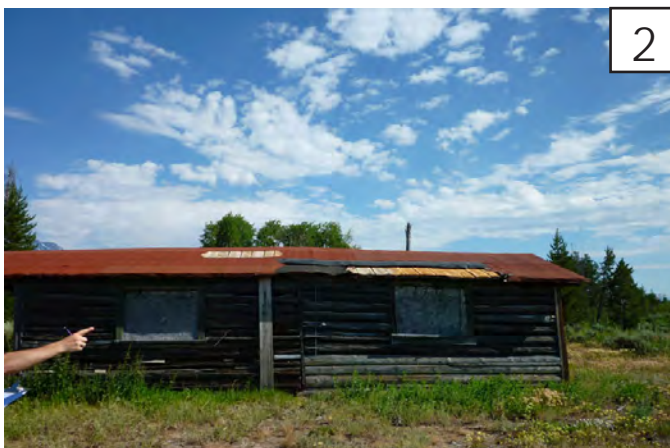
2 condition exhibits a small to moderate degree of failure and deterioration.

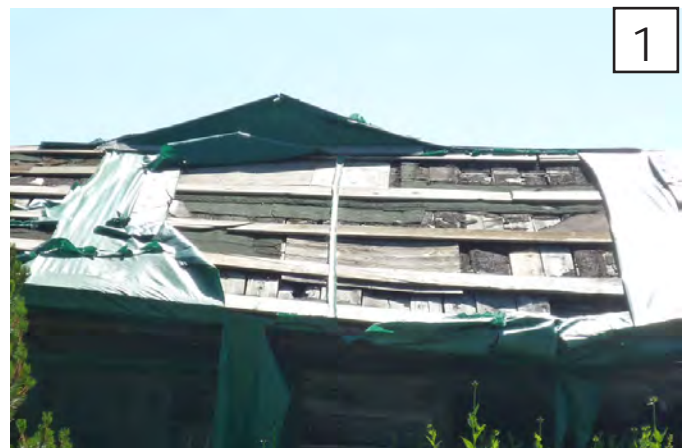
1 condition is damaged, failed, or severely deteriorated.

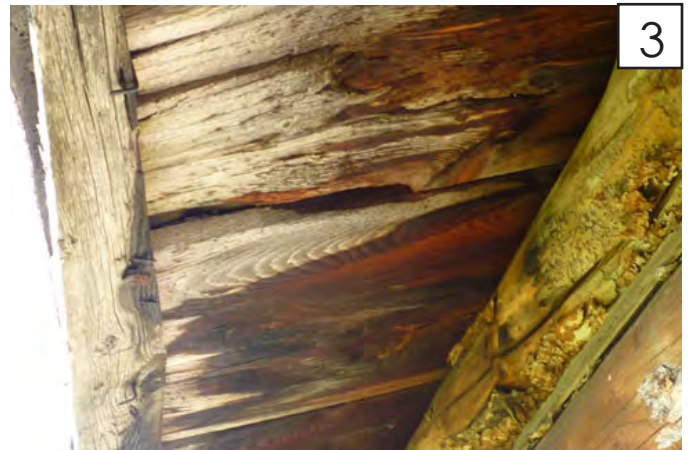
3 sheathing shows signs of water infiltration, minor rot and some splitting.

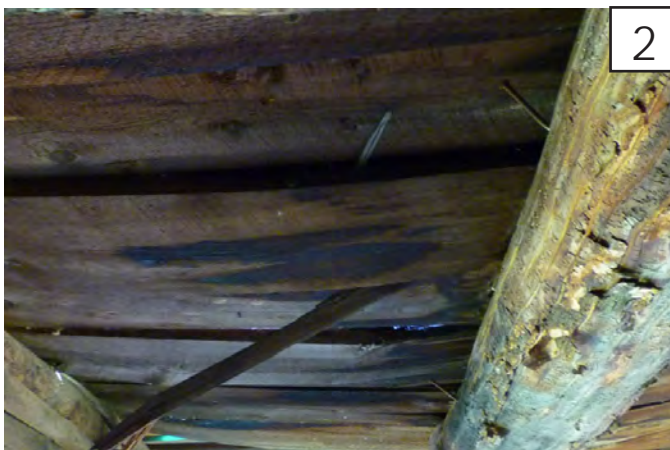
2 sheathing is more severely deteriorated, with evidence of rot and other decay.

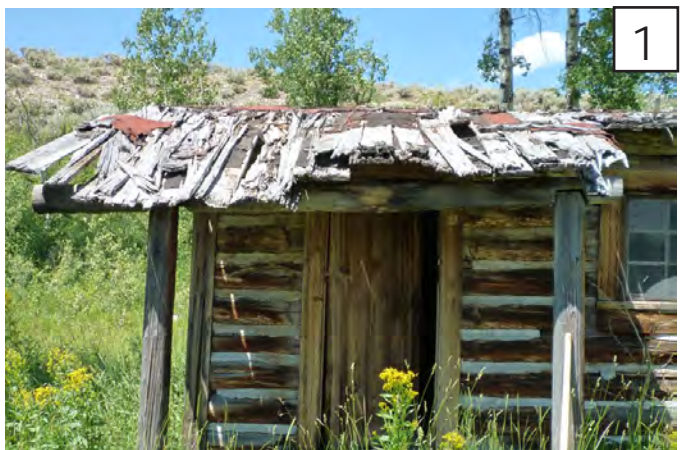
1 sheathing has reached the point of failure, material loss and extensive deterioration.

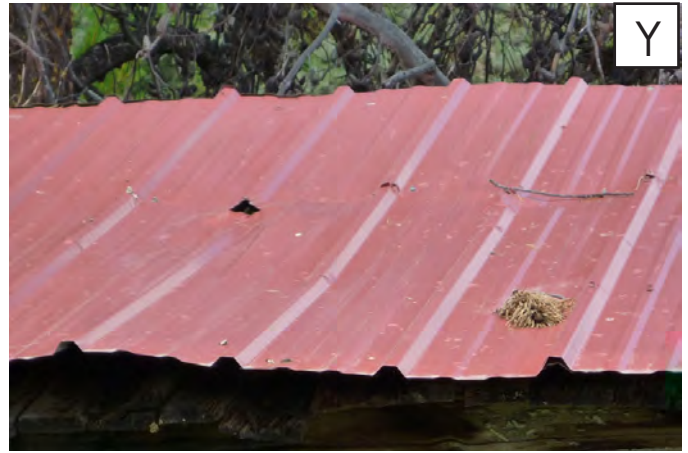
Roof deterioration evident.

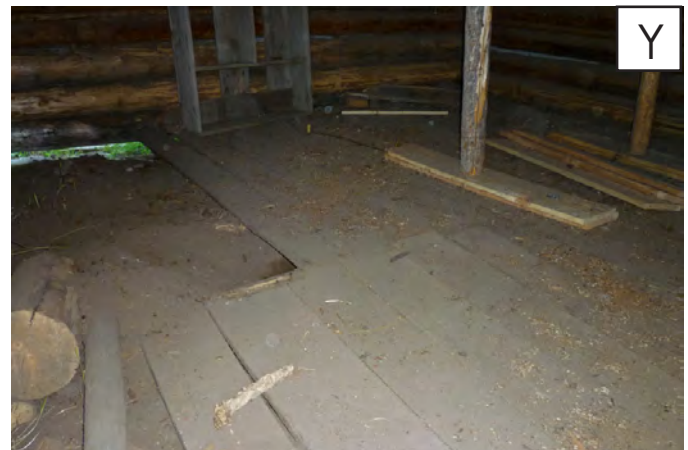
Floor deformation present.

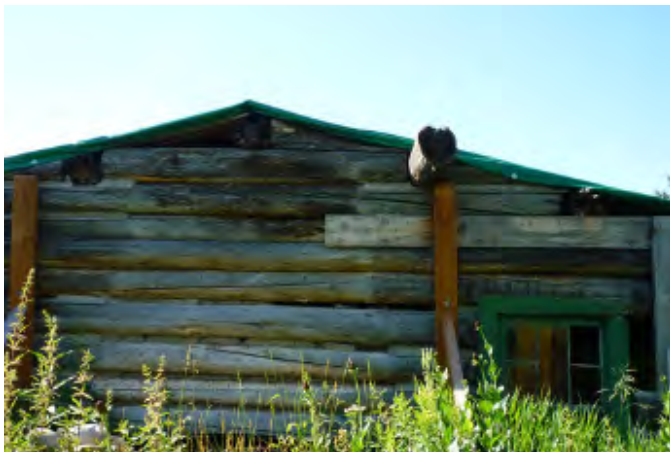
Three rotten purlin ends and one intact.

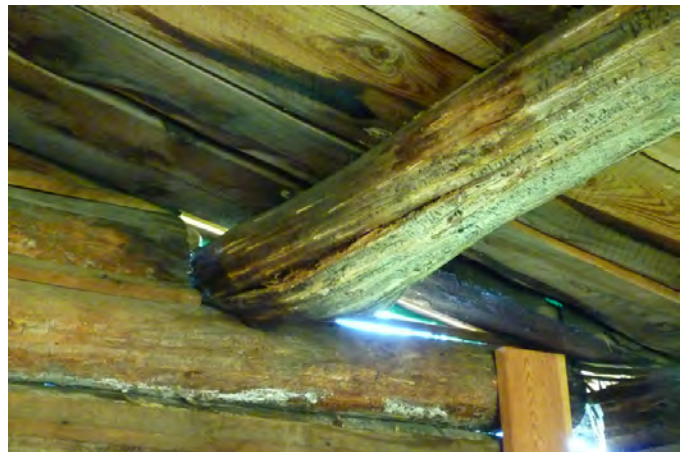
A purlin in poor, failing condition.

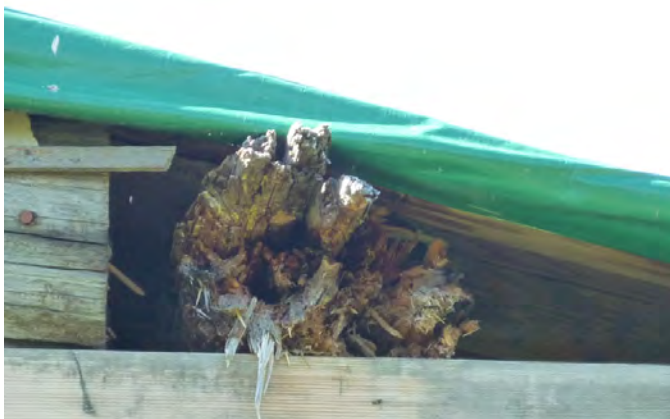
A rotten purlin end.

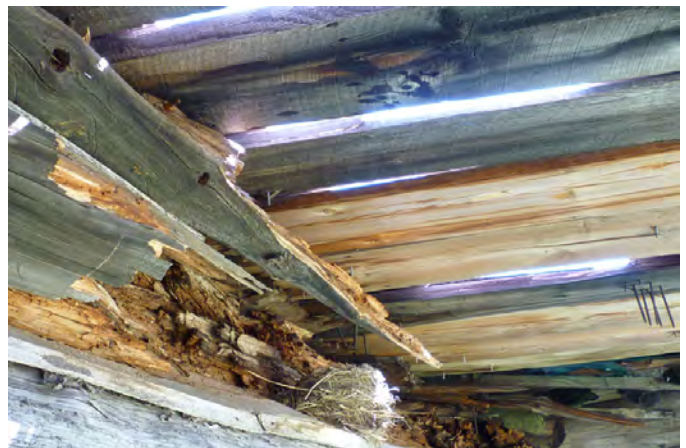
A failed purlin end.

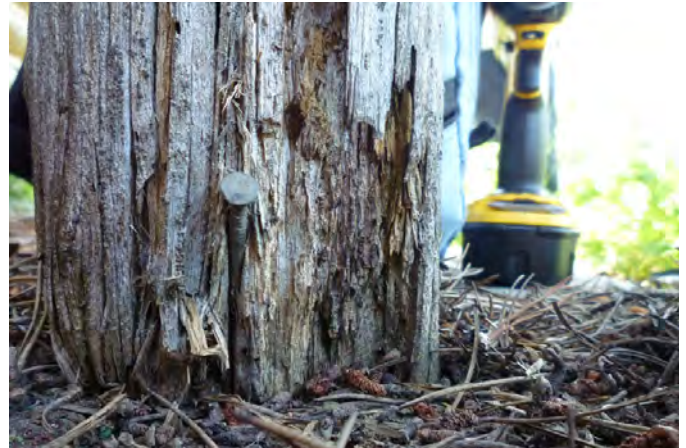
Basal rot evident.

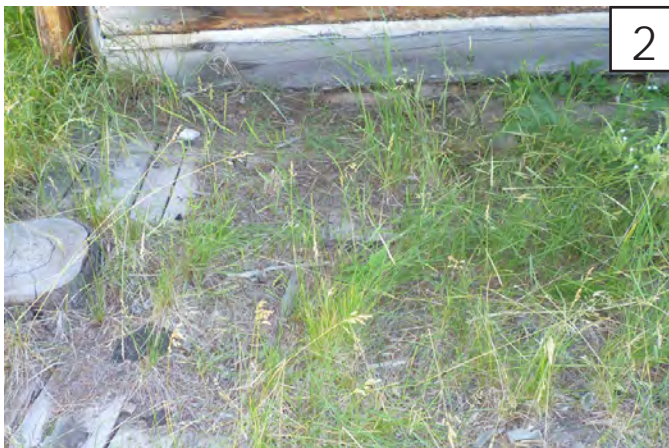
2 porch floor boards are warped and decayed.

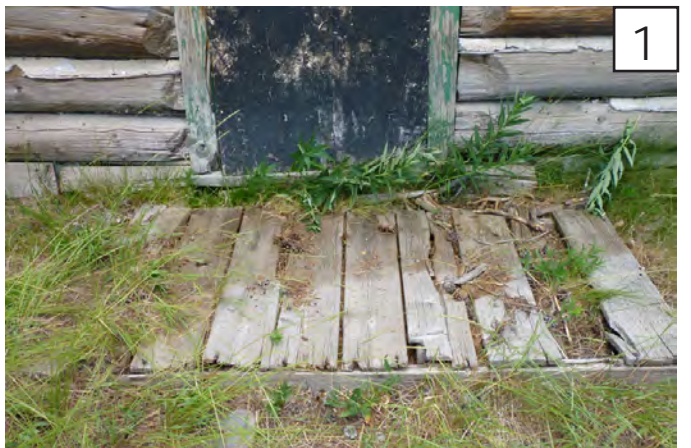
1 porch floor boards are warped, deteriorated, and have substantial material loss.

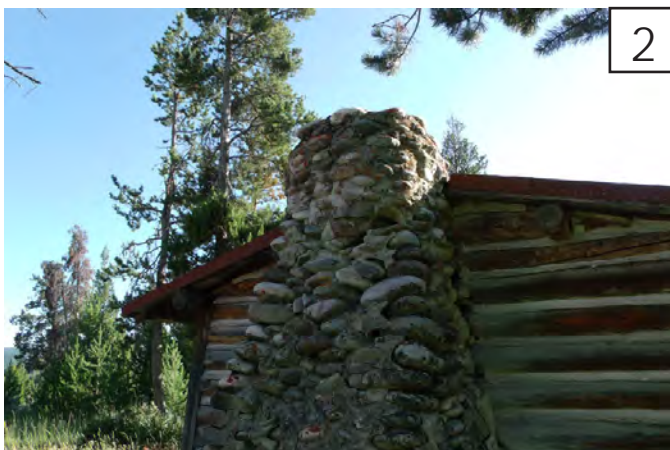
2 chimney condition exhibits major loss which penetrates to the interior of the structure.

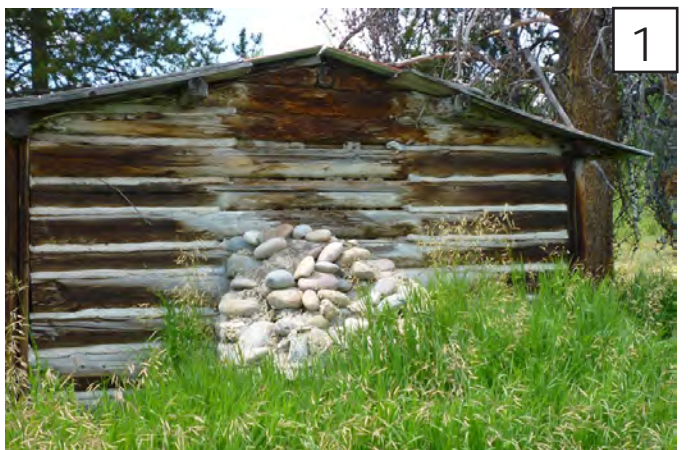
1 chimney condition denotes total failure and loss.

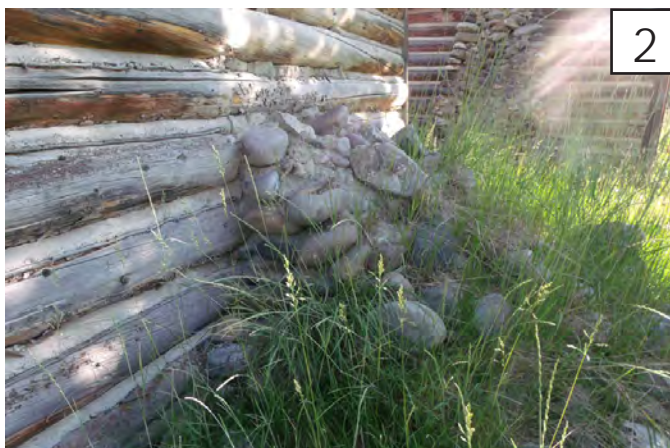
2 chimney condition exhibits major loss which penetrates to the interior of the structure.

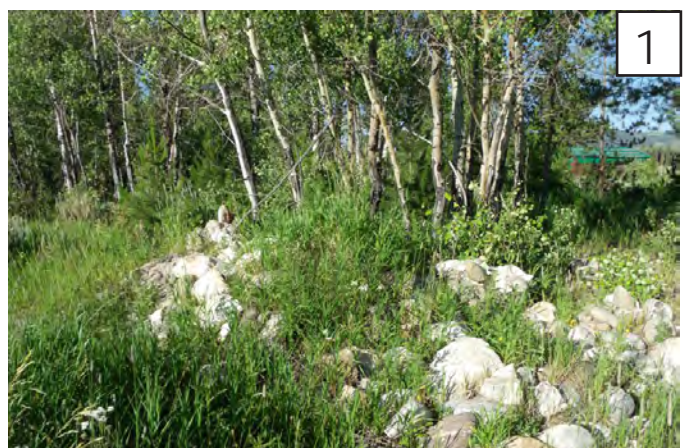
1 chimney condition denotes total failure and loss.

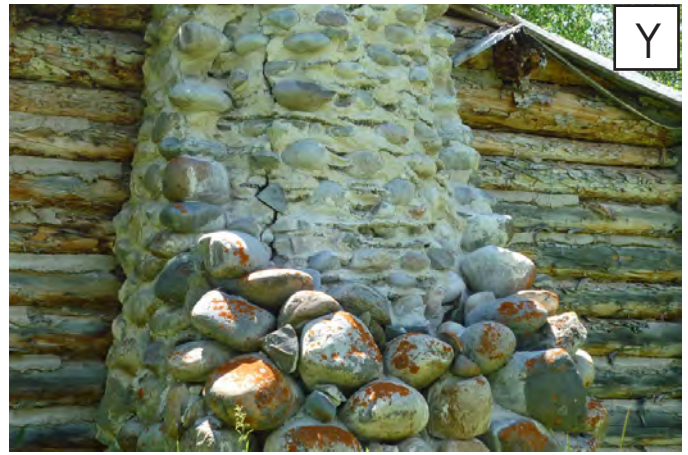
Cracking present.

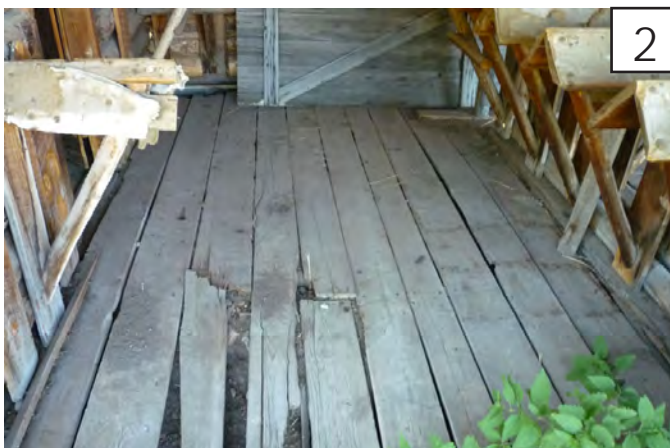
2 floor boards have areas of loss, broken boards, warping and are severely deteriorated.

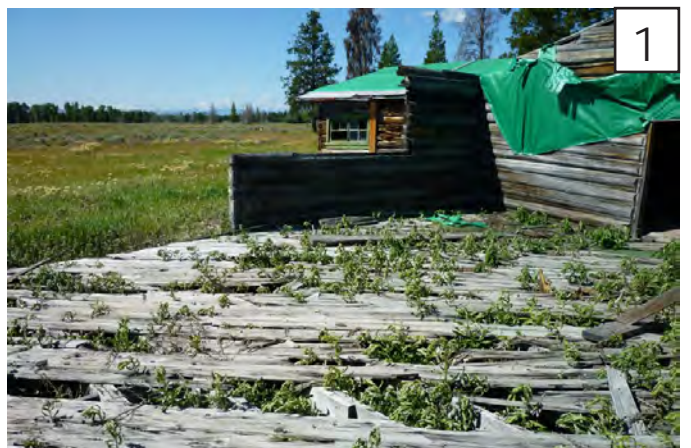
1 floor boards are extremely deteriorated, with material loss and failure.
