DRAYTON HALL

Charleston South Carolina

A CONSERVATION ASSESSMENT AND TREATMENT PROJECT

June 27, 2003

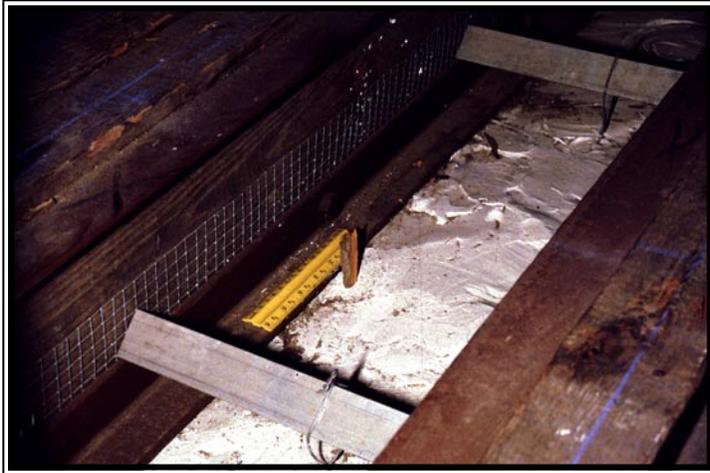
Steel and aluminum angle introduced to the joist system of the ceiling added approximately 4500 additional pounds the the dead load of the ceiling. (UPenn 1991)

suggested that, while ultimate strength was improved, vibrational stiffness was not. Moreover, the steel reinforcement had added approximately 4500 pounds of additional dead load to the existing ceiling system. This had certainly increased the deflections of the joists through creep since their installation and had probably enlarged the existing cracks. This alone may be the source of the observed “worsening” of the ceiling reported after the repairs.

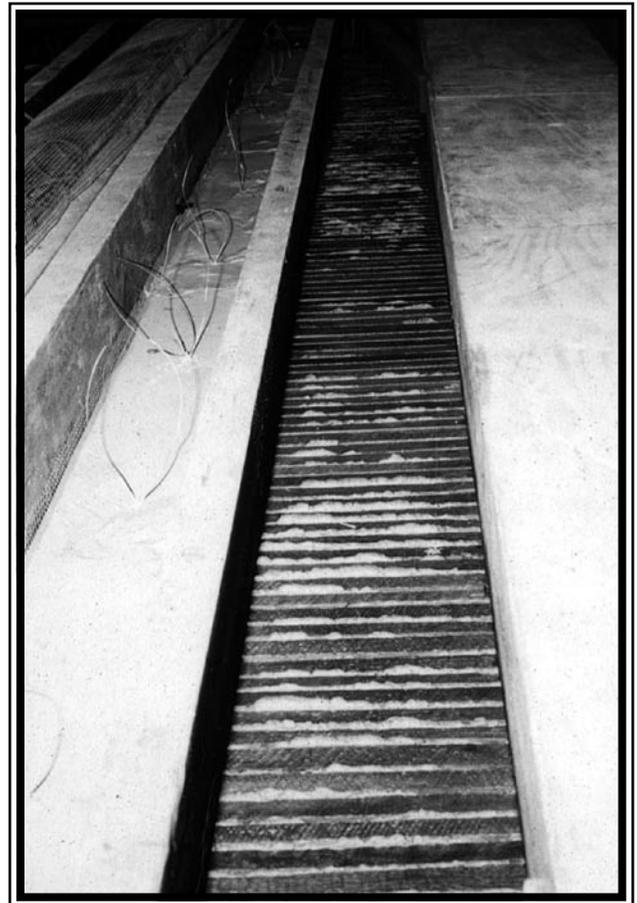
A view of the damaged keying as seen before the plaster was poured between the joists. (J.M. Garrison 1978)

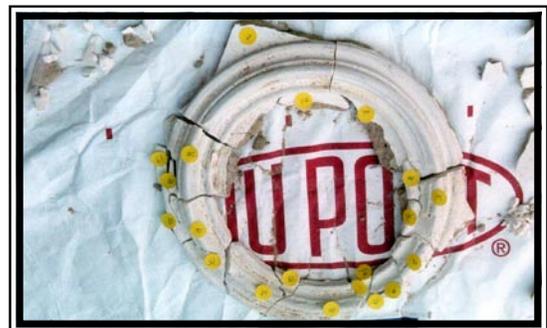
A broken medallion fitted back together. (UPenn 2002)

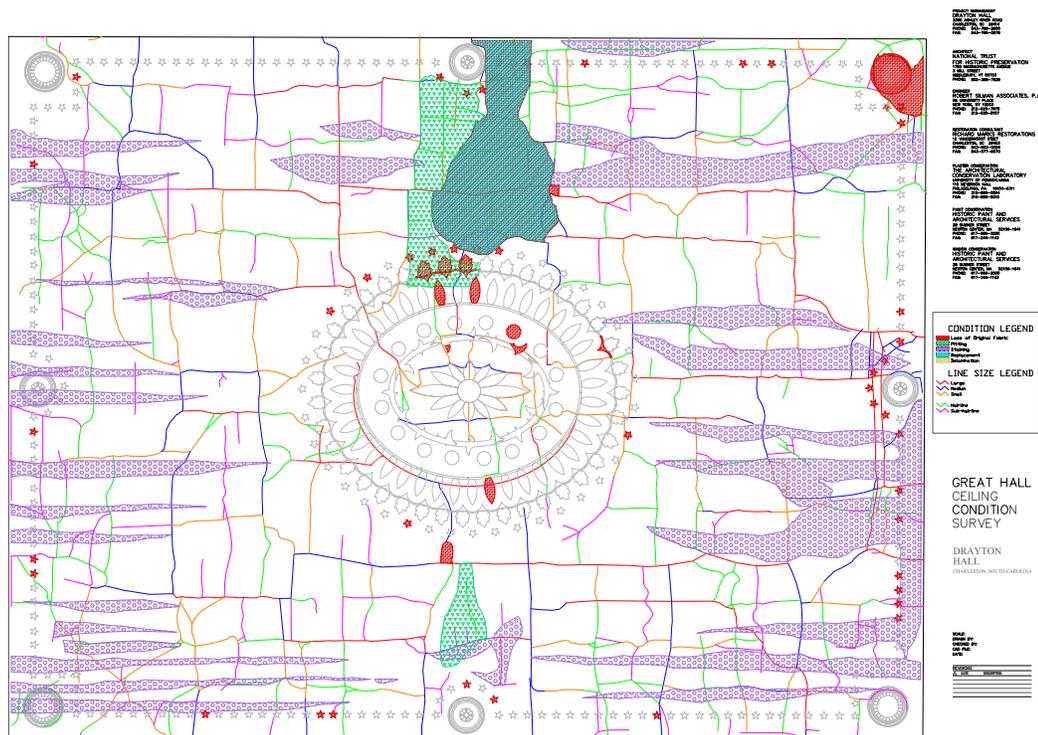
The completed condition survey from 2002. (UPenn 2002)

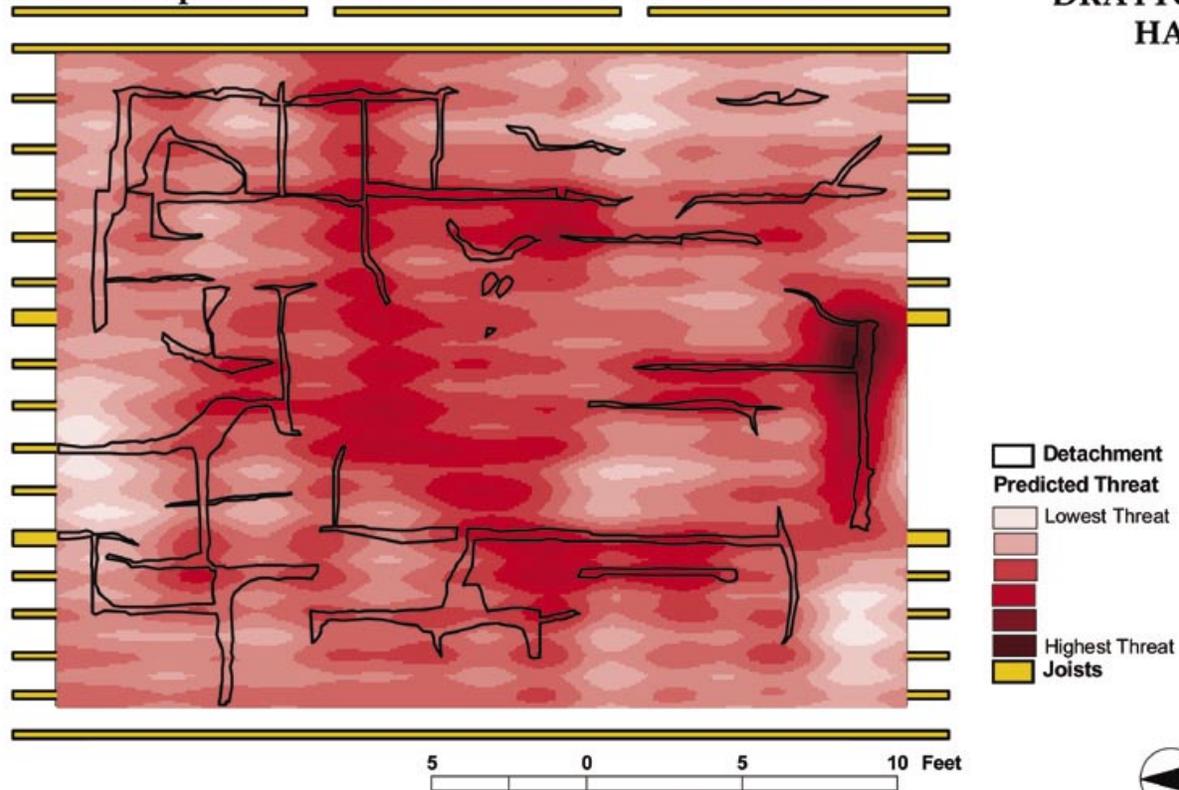
Relationship of 1991 Delamination and Predicted Threat

A color scaled representation of threatened areas executed in ArcView 3.2. (UPenn 2002)

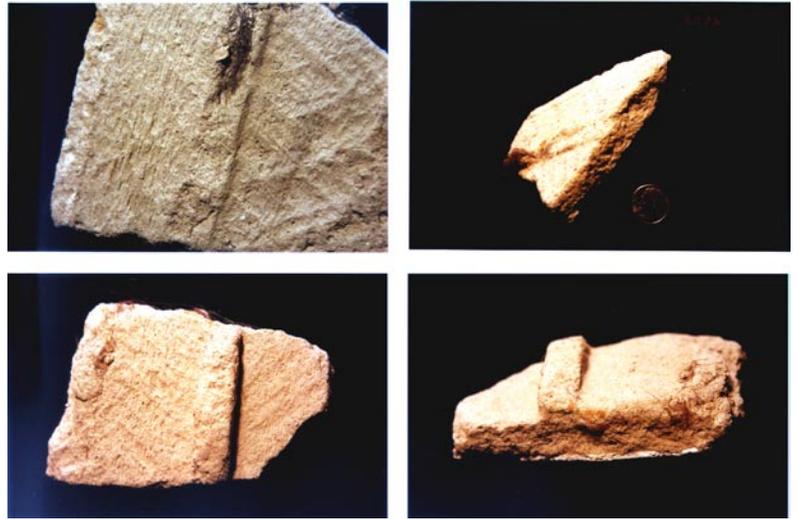
Samples of the original material showing the remains of the broken keying. (UPenn 2002)
