# TREATMENT REPORT

## Analysis and Conservation of the Great Hall Ceiling

DRAYTON HALL  
CHARLESTON, SOUTH CAROLINA

Prepared by:  
The Architectural Conservation Laboratory and Research Center  
University of Pennsylvania

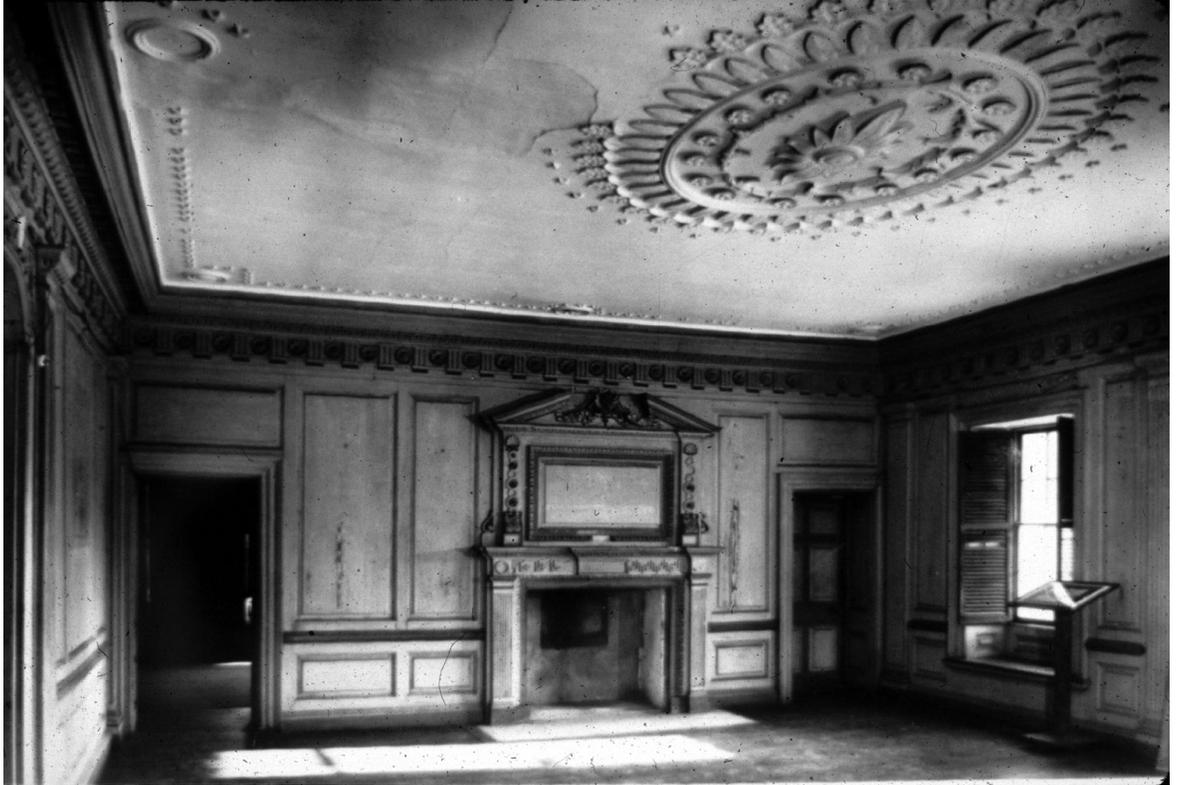
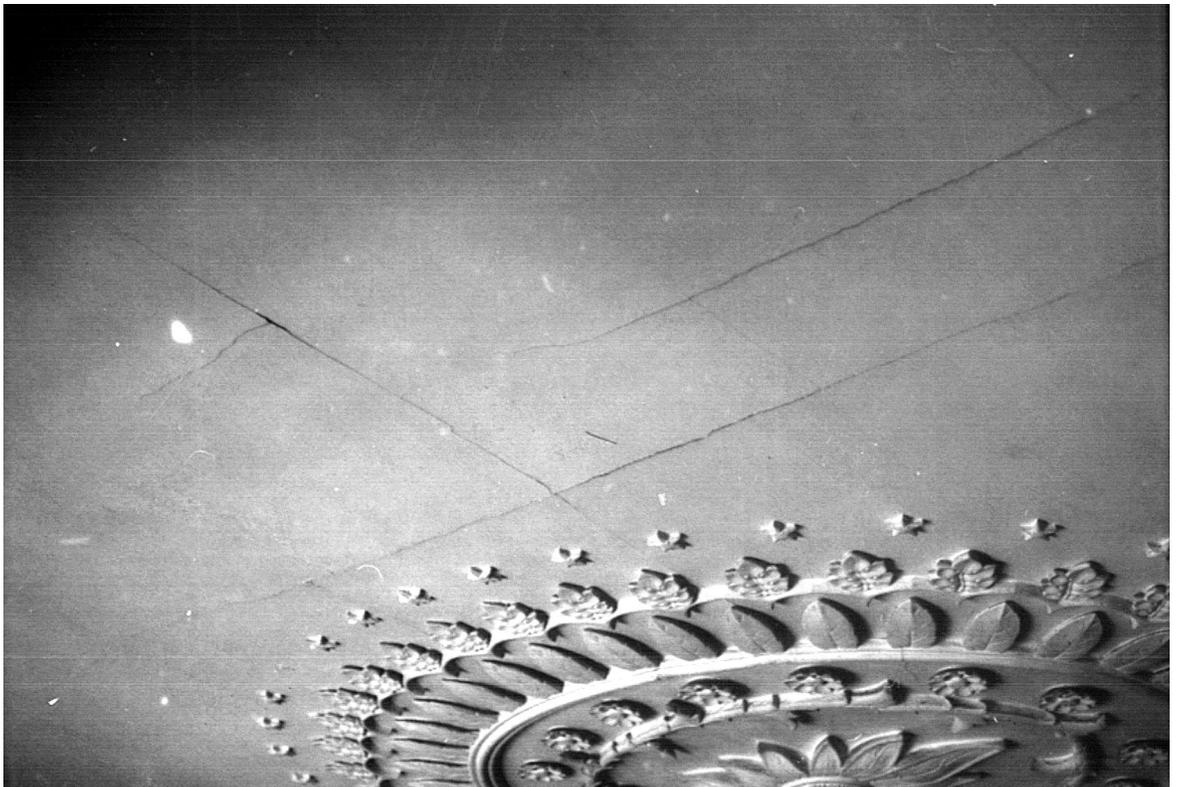
During the same year, a study of the ceilings also identified several problem areas including the Great Hall, where cracking and plaster to lath detachment were especially severe (Fig. 2).<sup>2</sup> As a result, the second floor was closed to visitor traffic until the ceiling of the Great Hall could be structurally improved and a series of measures were outlined for the total reattachment of the ceiling. Beginning in the spring of 1978, the following sequence of procedures for the stabilization of the Great Hall ceiling was performed (Fig.3)<sup>3</sup>:

Figure 2A: Great Hall, view looking southwest. (photographer: J.Schwartz, 1978)

Figure 2B: Great Hall detail before stabilization. (photographer: J.M. Garrison, January 15, 1978)

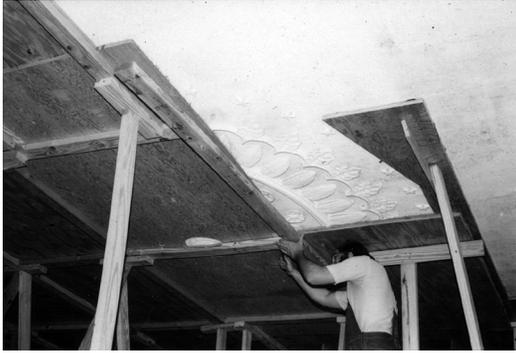
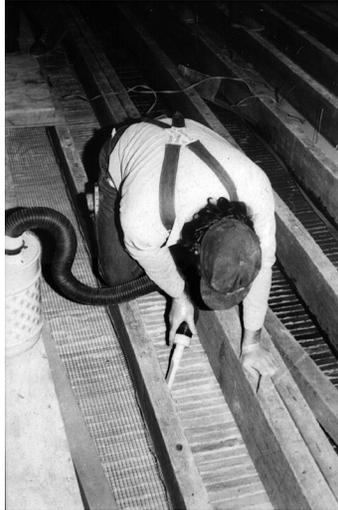
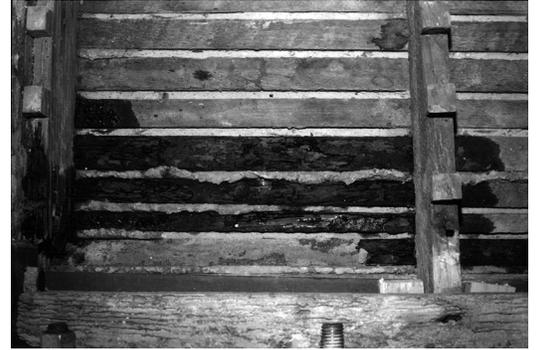
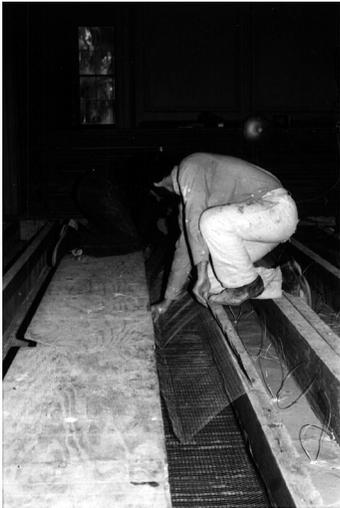
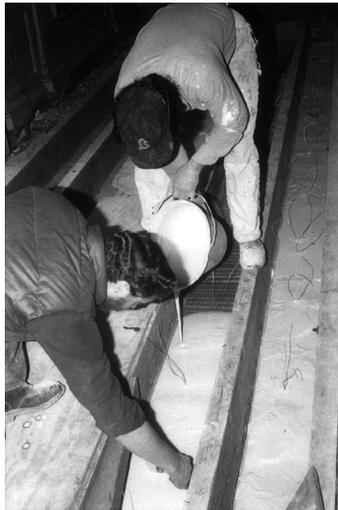
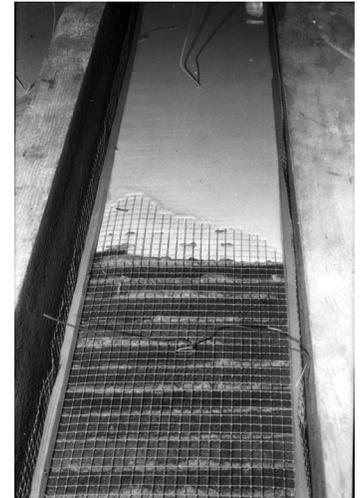
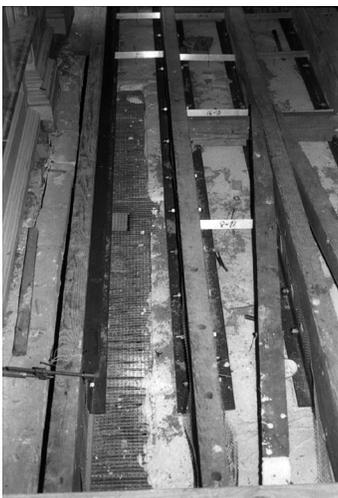
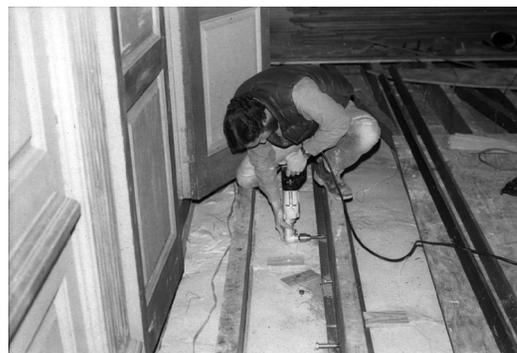
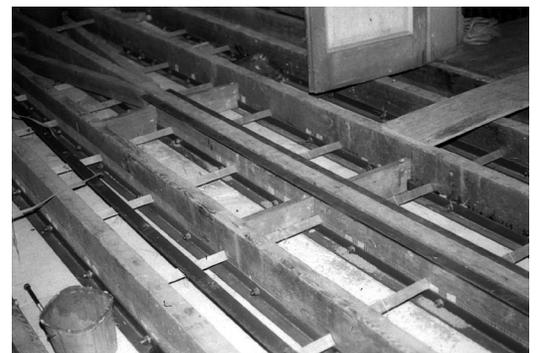
Figure 3: 1978 ceiling stabilization sequence. (photographer: J. M. Garrison)

- Installation of temporary shoring (a)
- Removal of floorboards (b)
- Removal of damaged plaster and damaged keying (b)
- Cleaning of debris from joists and lath (b,c)
- Application of acrylic bonding agent to joists, lath, and plaster (c)
- Insertion of U-shaped channels of galvanized steel wire mesh into joist spaces (d)
- Attachment of suspension wires to mesh (d)
- A continuous pour of plaster of Paris in each joist bay intended to set to a depth of  $\frac{3}{4}$  - 1" (e,f)
- Installation of steel angles to the sides of the joists (the bolts used to attach them also fastening the mesh to the sides of the joists) (g,h)
- Installation of aluminum angles across each joist space to rest on the lower steel angles (i)
- Attachment of the suspension wires to the aluminum angles (g)
- Replacement of the existing flooring

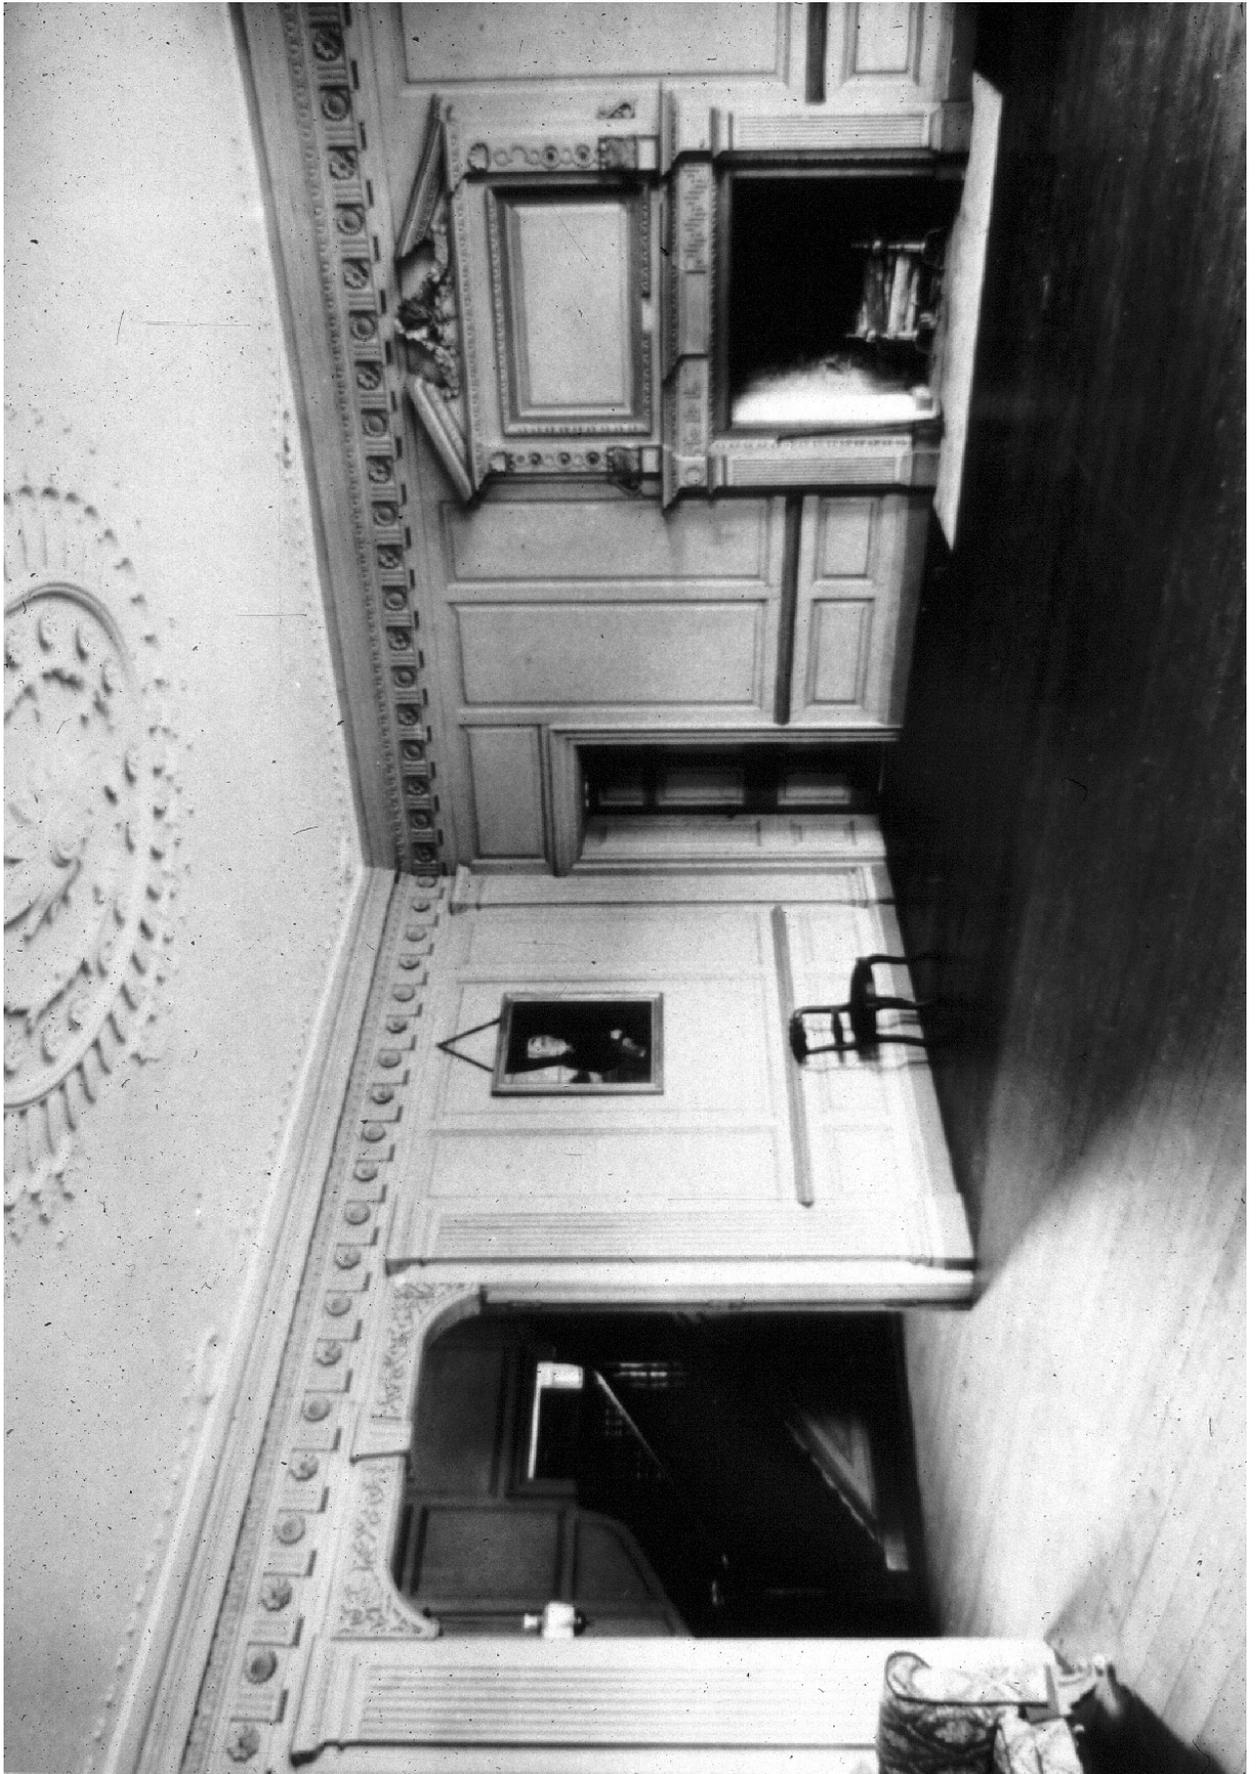
- These overall conditions predate the opening of the house to the public as evidenced in the 1938 Frances Benjamin Johnston photographs of the Great Hall (Fig. 4). Worsening of the plaster cracking and detachment would have occurred as a result of increased live load from visitation.

Figure 4: Great Hall, view looking southeast. (photographer: Frances Benjamin Johnston ca.1938)

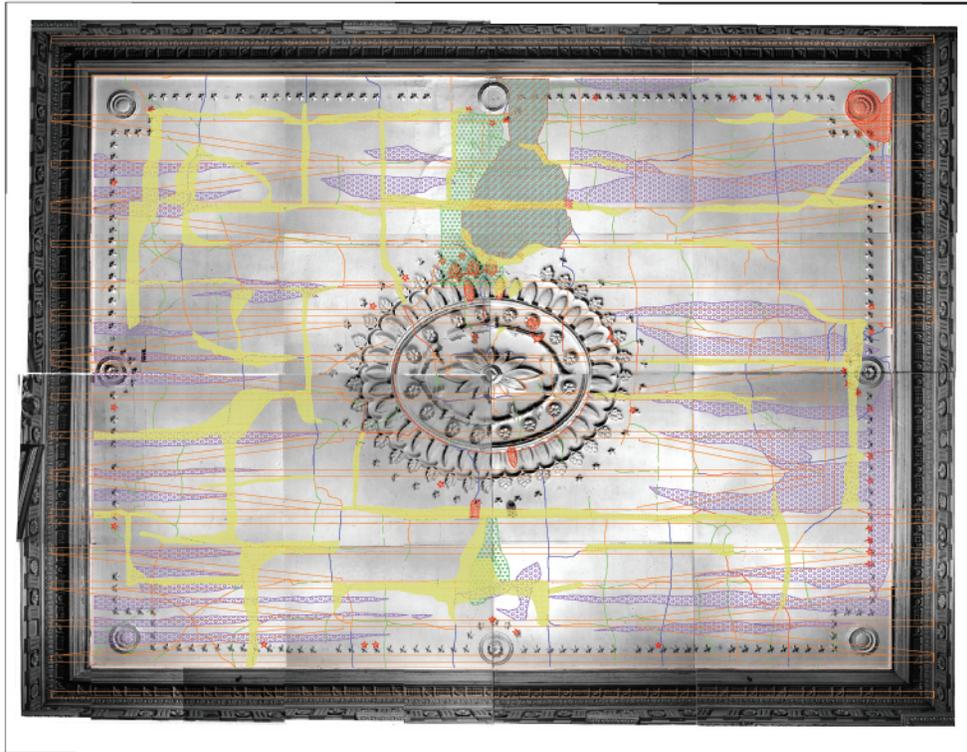
The 1991 and 2001-02 studies of the plaster ceiling and its framing were executed using non-destructive techniques. The architectural fabric was thoroughly examined in order to determine whether specific elements might exhibit evidence indicative of alteration. This was also done to correlate the structural behavior and failure of the various materials and assemblies in association with each other (e.g., framing, plaster, and previous stabilization systems). A conditions assessment of the plaster ceiling was conducted primarily through visual examination. The following conditions were identified and graphically recorded on a rectified photomontage: cracking, detachment, patching, adhesive repair, pitting, staining, missing ornaments, and plaster loss. In 1991 areas of blind detachment were also identified through percussive sounding. Annotated drawings of existing conditions of the framing system, joist by joist, and the plaster ceiling were prepared as well (see Fig. 6).

Figure 6: 1991 ceiling conditions with framing plan.

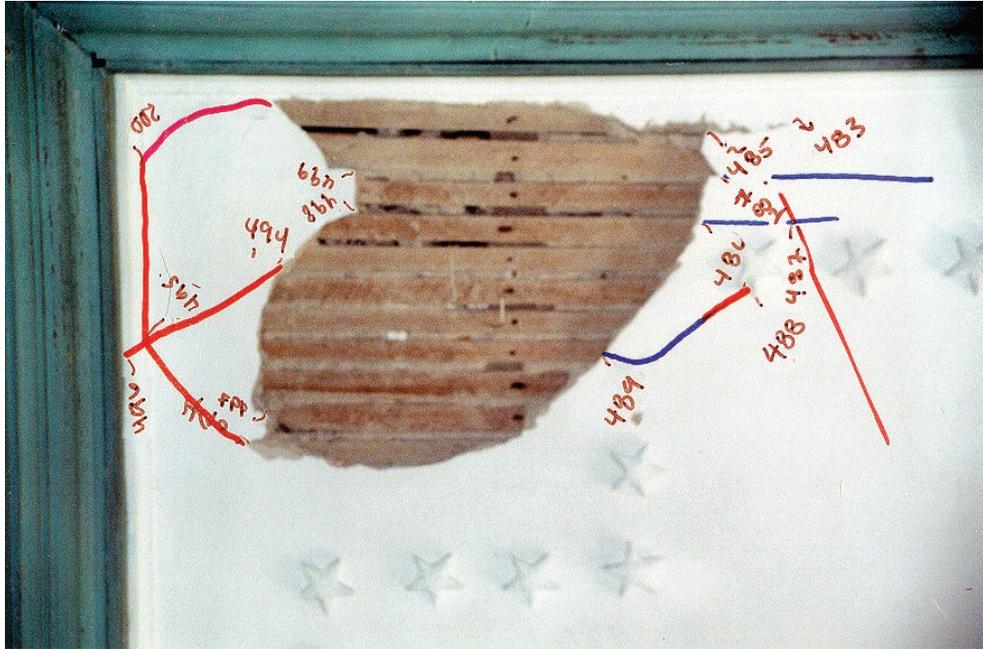
Figure 10: Impact damage from Hurricane Hugo preparation, 1989.

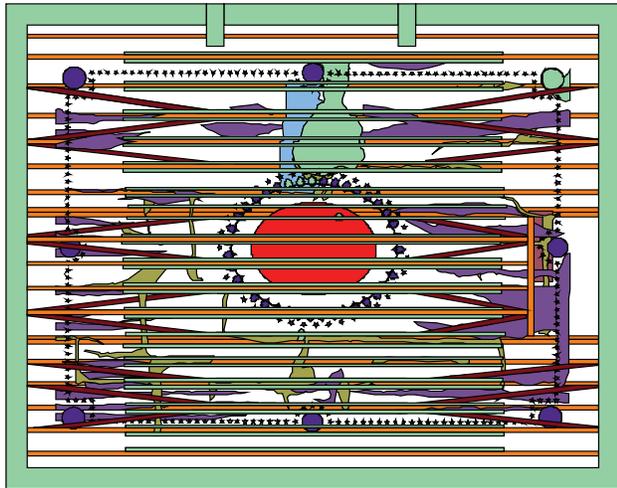
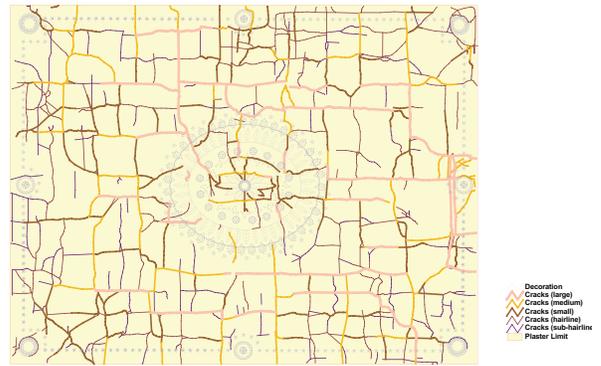
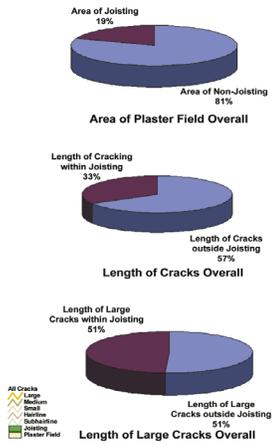
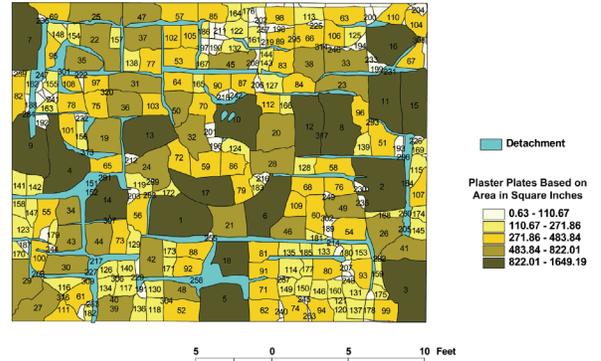
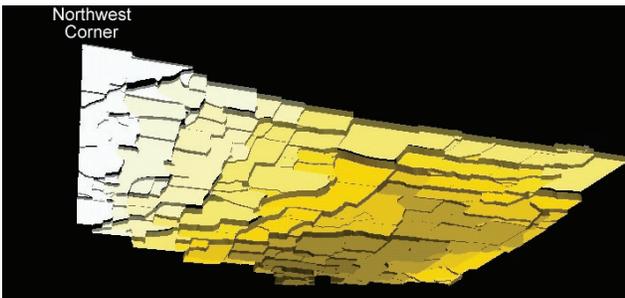
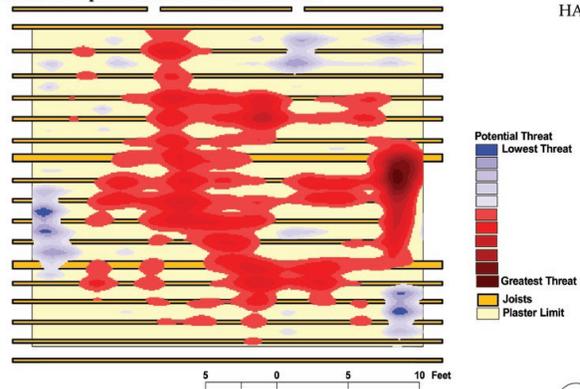
Figure 12: GIS assessment sequence of the ceiling.

was collected using a plumb bob and two known datum points located at the northeast and southeast corners of the plaster field. Each of the intersections were plumbed to the floor where the distances from each of the two datum points were measured. The intersection of each crack was identified and mapped in AutoCAD® using X, Y coordinates based on the measurements taken from the datum points (Fig. 11). Additionally the Z coordinate or vertical shift out of the theoretical horizontal plane of the ceiling was mapped from these points using a laser level which created a level datum line around the room. Once all of the data was collected and digitally drawn in AutoCAD®, each condition was then imported into ArcView 3.2®. From this point Arcview was used to create regression modeling to identify the correlation between the crack patterns and their variables. Spatial analysis was conducted using three extensions including Spatial Analyst®, 3-D Analyst®, and Geostatistical Analyst® in order to find the spatial structure of the cracks such as density, as well as to create predictive maps to identify the location of potential threats to the surface (Fig. 12).

- Under force, an existing crack will continue to extend outward until it reaches a limiting edge.
- Under a constant load including gravity, an existing crack will more likely continue to grow before new cracks appear.
- Concentrations of existing cracks are directly linked to the sizes of the cracks, with smaller cracks being closer together, each taking up some of the flex. Larger cracks may be taking the same amount of flex requiring fewer cracks to distribute the force over the same amount of area.
- Areas of the ceiling, which have been compromised and repaired can directly impact the direction of smaller cracking but do not seem to have an impact on the larger cracks.
- The patterns of the vertical deflection of these cracks also show areas where the ceiling has deflected the greatest under its own weight.

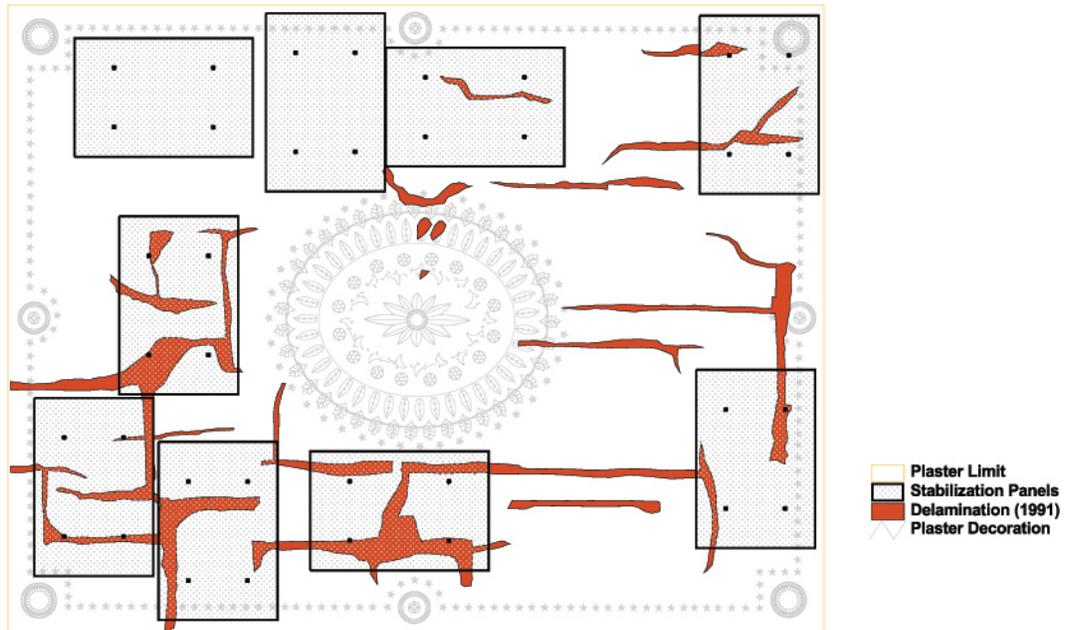
Figure 15: Identified areas for temporary stabilization, 2002.

While the conditions of the ceiling ranged from complete loss to structurally sound plaster, it was decided that identifying areas for stabilization should be based on the degree and extent of detachment. The first and most severe condition was plaster which had fully detached but was still in place. This condition was observed around the edges of complete loss and in isolated areas of total detachment. It was understood that in the latter situation, the failed plaster would most likely need to be removed in order to properly reattach it, however reinstalling these sections of plaster was far more desirable than replacing them with new plaster. This occurred in two sections of the ceiling, beneath the second floor hearth and in the southeast corner. The second plaster condition was those areas of plaster where blind detachment had been identified from sounding.

### Stabilization panels located based on existing delamination

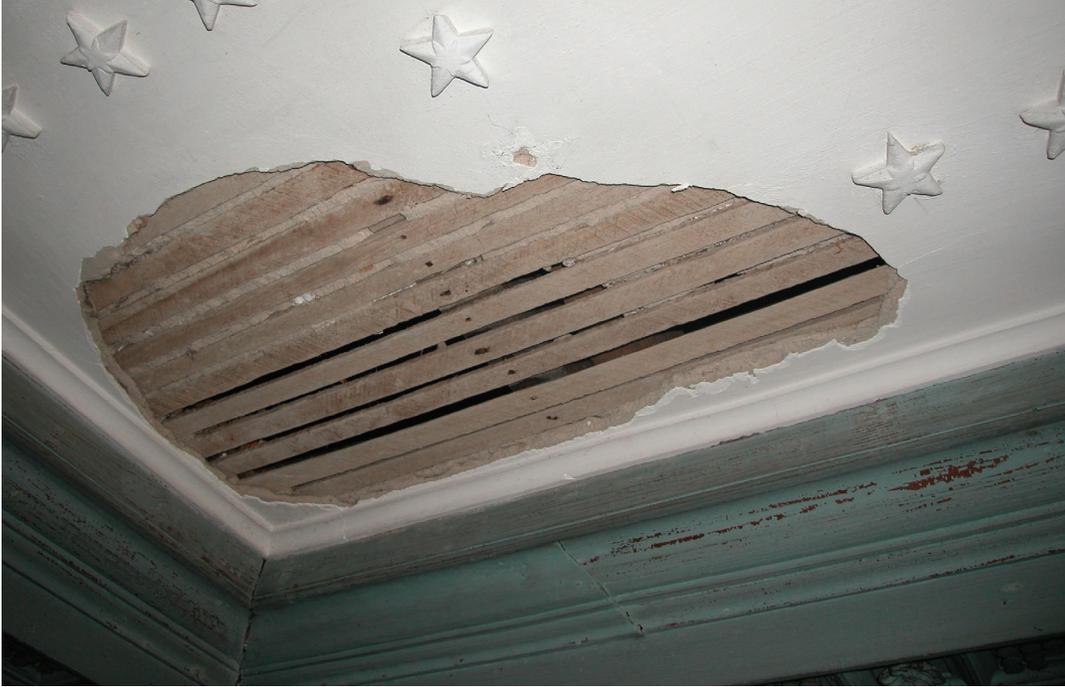
Figure 21A: Southeast corner before repair.

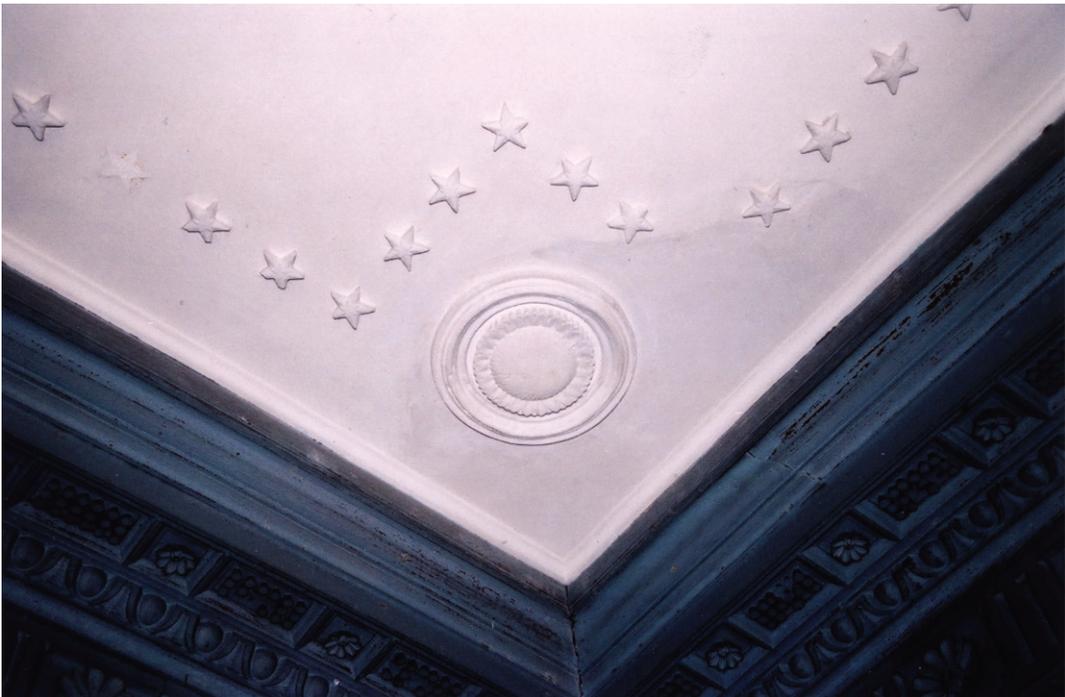
Figure 21B: Southeast corner after repair.

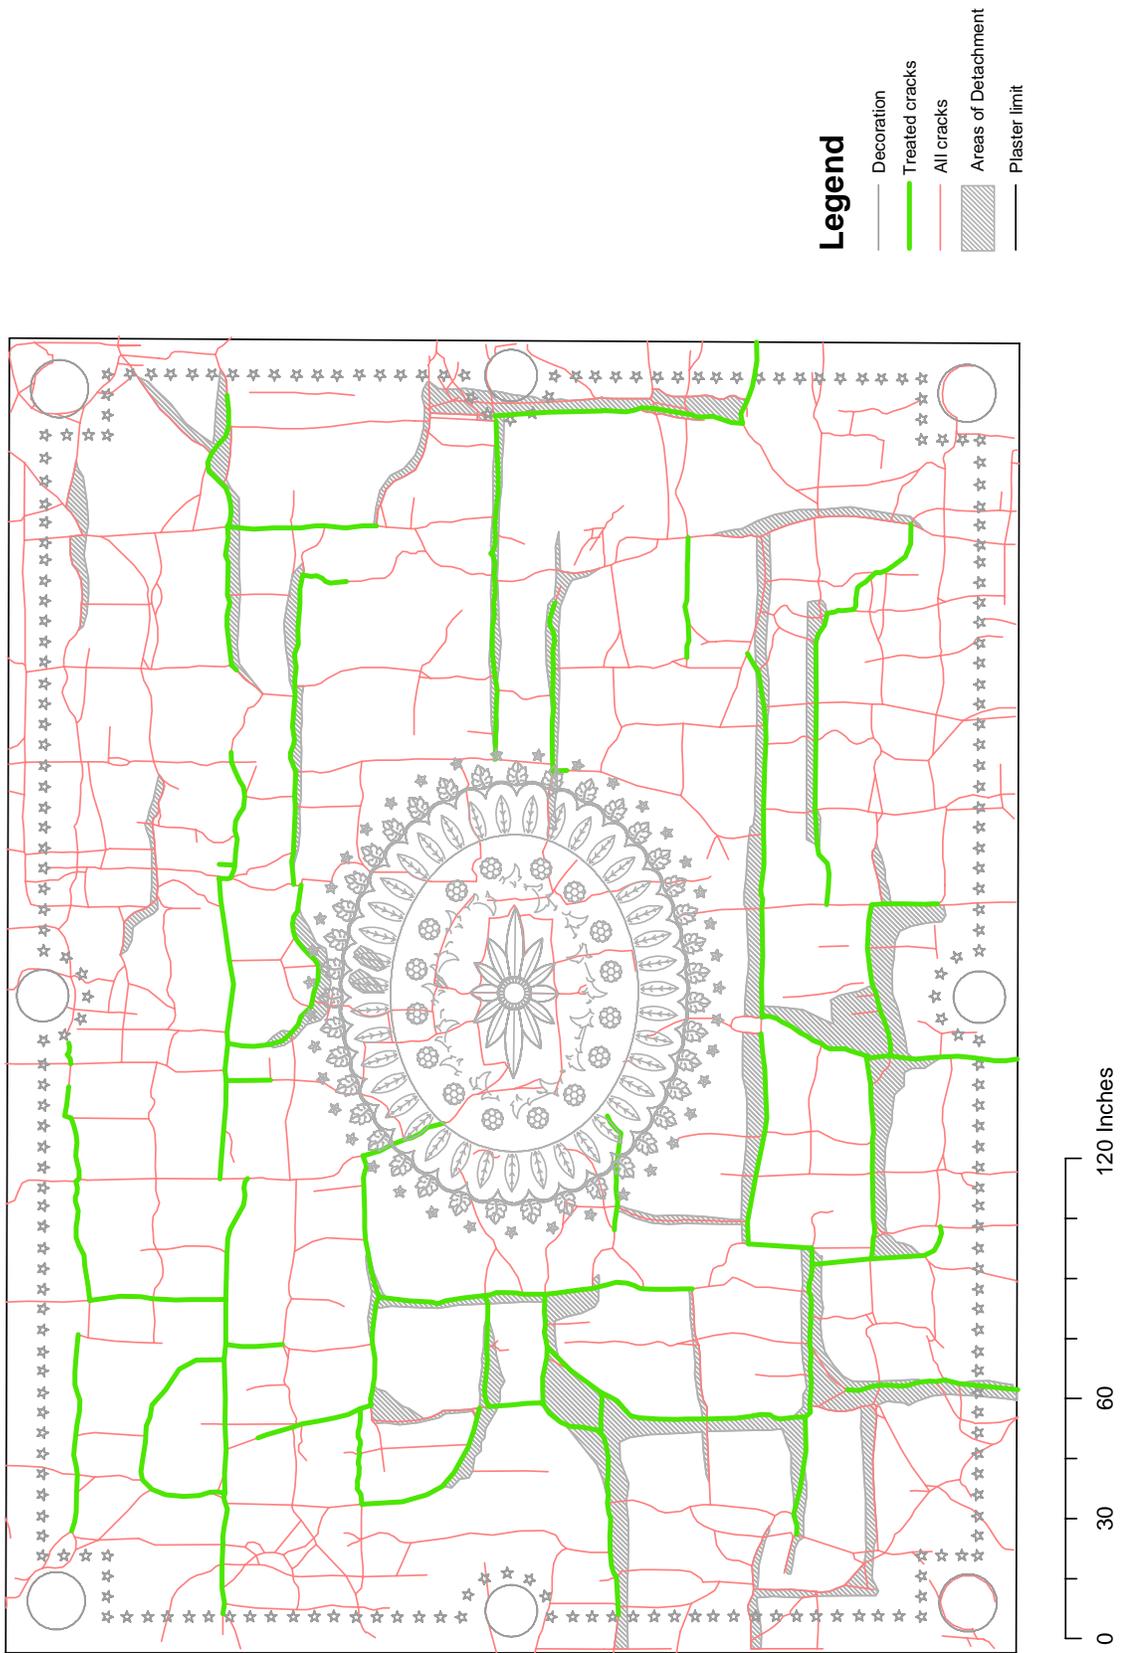
Fig. 23 Mapping of treated cracks, 2002.
