THE EARLY PHRYGIAN GATE AT GORDION, TURKEY: 2012 INVESTIGATION AND RECOMMENDATIONS FOR STRUCTURAL STRENGTHENING AND STABILIZATION

Prepared for:
Mr. Frank Matero
University of Pennsylvania
115 Meyerson Hall
210 South 34th Street
University of Pennsylvania
Philadelphia, PA 19104

Prepared by:
David T. Biggs, P.E., S.E.
Biggs Consulting Engineering PLLC
740 Hoosick Road, Suite 4305
Troy, New York 12180
(518) 495-5739

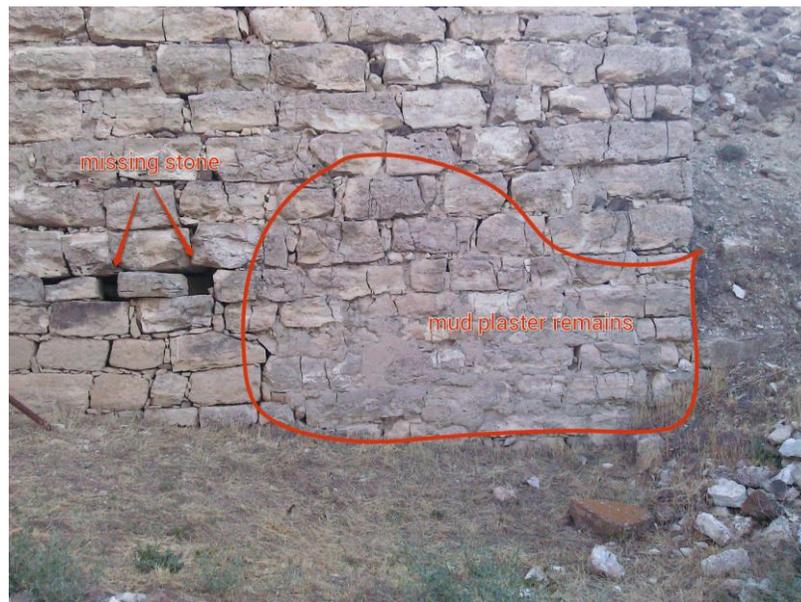
Figure 4 - South east elevation of North Court wall (2012)

In Figure 2, the plaster on the south face of the North Court walls is visible. Almost none of the plaster or the earthen mortar exists in Figure 3. Figure 4 shows a close up of the lower right corner of Figure 2 where the plaster and earthen mortar still exist. The majority of the mortar in the facing stones has been eroded.

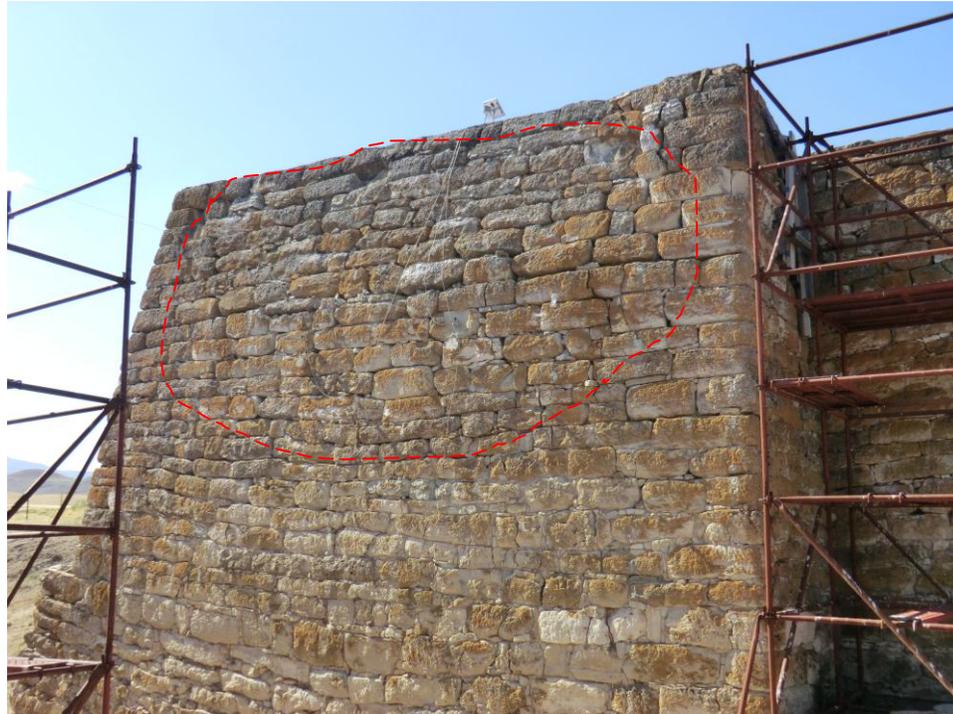
Figure 5 - Bulge in north wall of South court wall

2. There is a significant bulge on the north wall as seen in Figure 5. Recordings of the bulge were begun in 1989. As previously noted, the bulge increased by 30 to 40 mm in 1999. Previously annual movements were less than 15 mm. During the earthquake, some stones came loose on the north wall (Goodman 2002). The stones are marked and being stored at the archeology depot for future reuse.

The bulge occurs above the grouted area of the wall. The joints are open (Figure 8); only chinking stones are visible in some joints. The literature has stated that this bulge has been a safety concern for many years. There is evidence the bulge increased following the 1999 earthquake. Given the open joints and the growing size of the bulge, the wall is a safety concern.

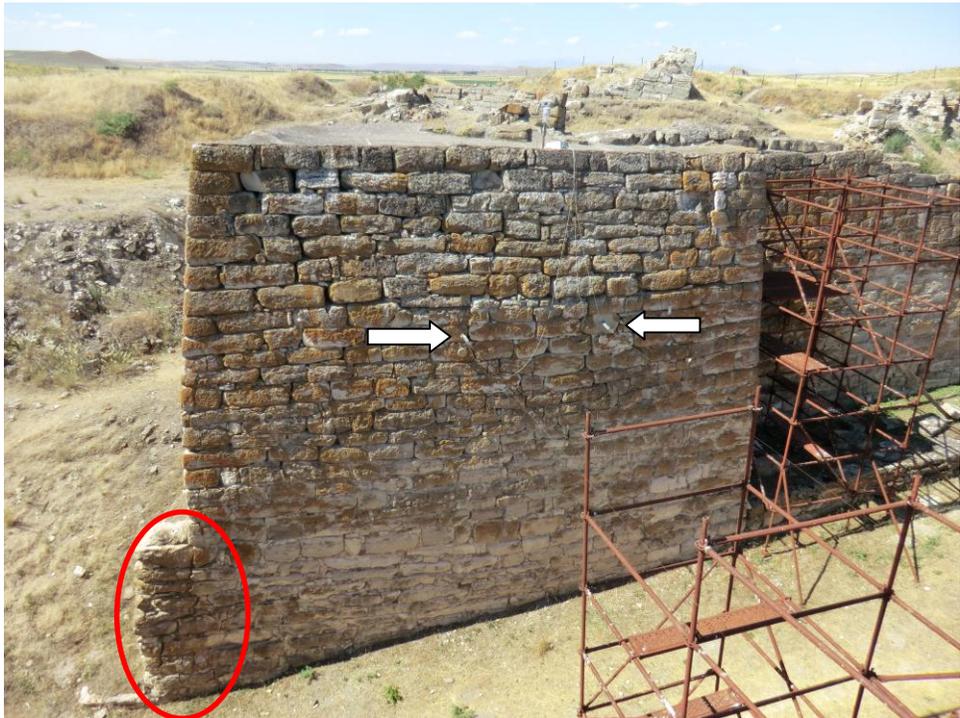
Figure 9 - Monitoring devices

3. Two monitoring devices are attached to the wall (arrows, Figure 9). Reportedly, they are no longer functioning. The devices are attached to individual stones; the stones are not mortared to adjacent stones. Any recordings might only indicate the movement of the individual stones.

4. The lower left of Figure 9 (oval) also shows a crack at the lower east corner below a ledge. This crack is in an area of wall that has been grout injected. A second ledge is lower and partially exposed.

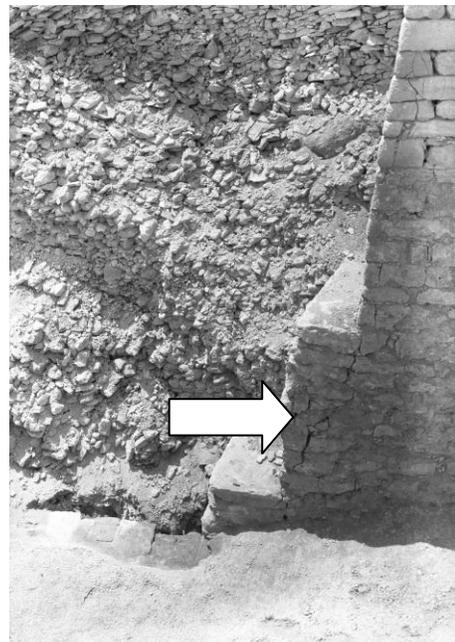
Figure 11 - 1955 Photograph

Figures 10 and 11 show the crack following the 1955 excavation. Both ledges are exposed. The crack is essentially unchanged between 1955 and 2012.

This crack has been discussed in previous literature. Rogers 1989 mentions that a repair method was proposed in 1987 by William C.S. Remsen that would pin the broken stones together. Figure 12 shows the current condition of the crack. While the corner was grout injected, apparently no pins were used to stitch the stones together as proposed by Remsen. However, no cracking of the grouted joints was observed in 2012.

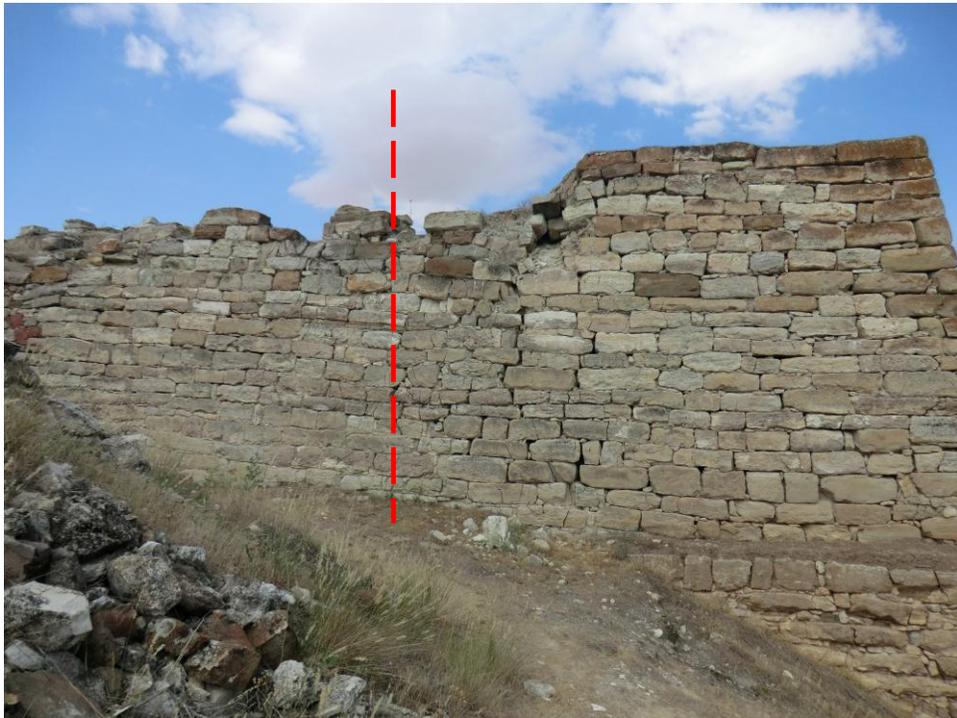
Figure 13 - East wall of South Court

5. The east wall has cracks also. Figure 13 shows the crack locations compared to the interior wall as shown by the red line on Figure 14. There is no direct correlation based upon the known information. The east wall shows no signs of global displacement due to the backfill. Cracking could be due to settlement, overload from upper walls, lateral pressure, or rubble fill settlement within the core.

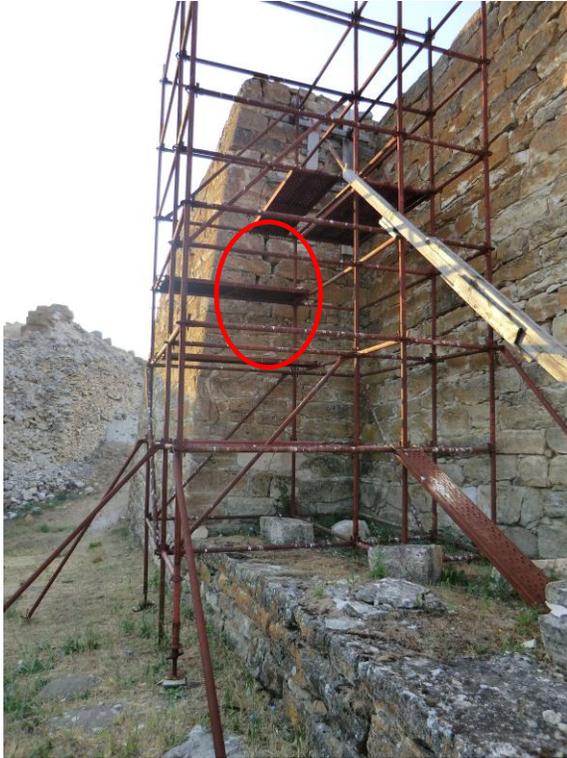
Figure 16- West return wall

6. The west end return wall of the north wall has large cracks and the stones are displaced. Scaffolding and temporary bracing have been installed to retain loose stones (Figure 16). While some stones have already fallen, Figure 17 shows the temporary bracing that was installed to retain the remaining loose stones at the top; the bracing extends down approximately 8 feet from the top (arrow). There are more loose stones below the level of the bracing (oval, Figure 16). These loose stones can lead to partial collapse of the wall.

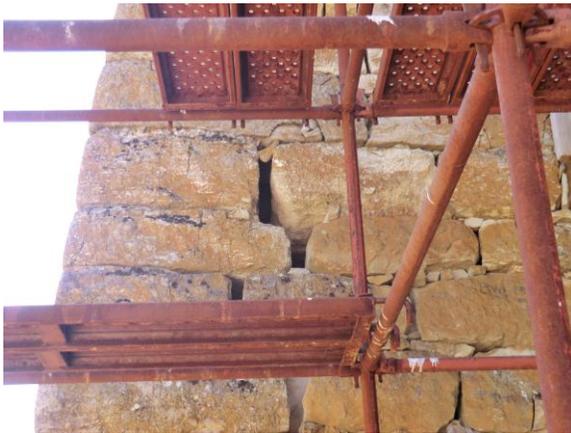
Figure 18 - Crack at west return wall

There are large voids within the wall at the cracks. No earthen material is visible within the wall, only stones. Figure 18 shows a close up of the crack. Figure 19 is a photograph taken looking into the crack. Loose stone is visible but there is no earthen mortar; the mortar and plaster have been eroded.

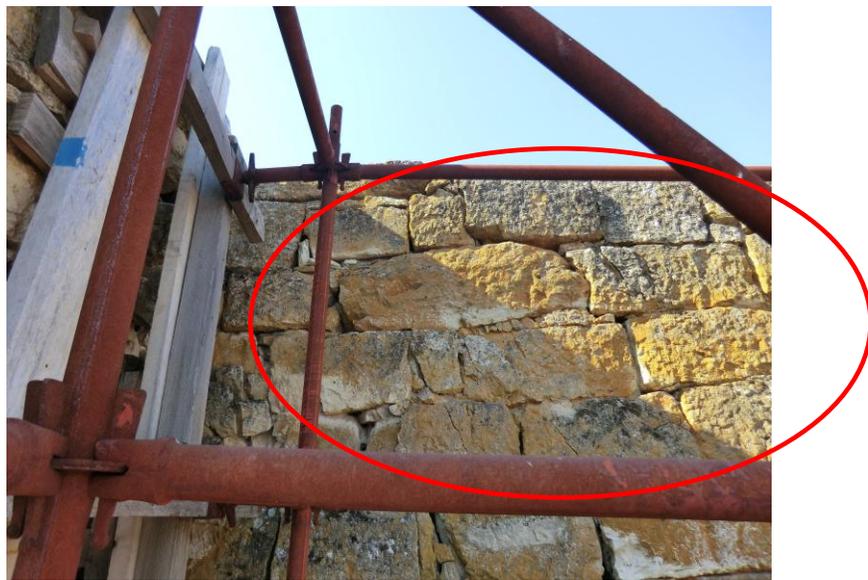
Figure 21 - North Wall

7. Another bulge is developing at top of west end of the north wall (oval, Figure 21). Figure 21 is taken adjacent to the inside corner of Figure 17.

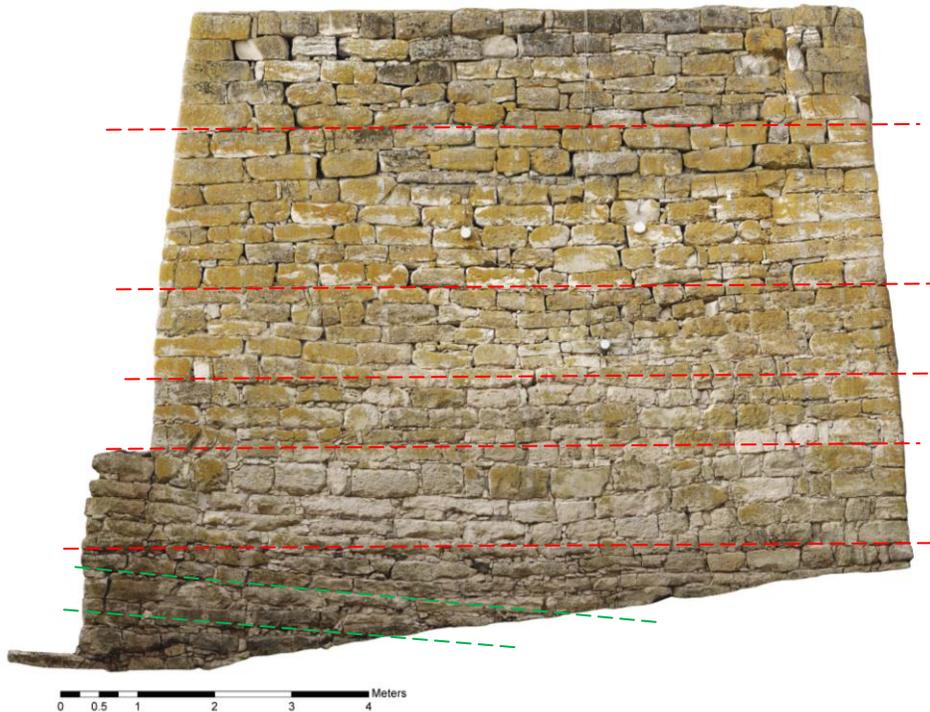
Figure 22 - Rectified photograph of North wall of South Court

8. Figure 22 shows the north wall. Several horizontal red lines and sloping green lines have been added for reference to follow the stone coursing.

At first glance, the lower portion of the wall appears to have settled in the center (see the coursing relative to the green lines on Figure 22). However in the upper portion of the wall, the coursing appears nearly horizontal again. Thus, it appears that the sloped coursing at the bottom may be the way the wall was built.

It is also assumed the foundations for the walls are not level but step up with the grade. If logs were used in the foundation construction, the walls would have settled from the wood rotting. Based upon the horizontal joints in Figure 22, either there were no logs or the walls settled uniformly. Uniform settlement would be surprising for stepped foundations. More information is needed.

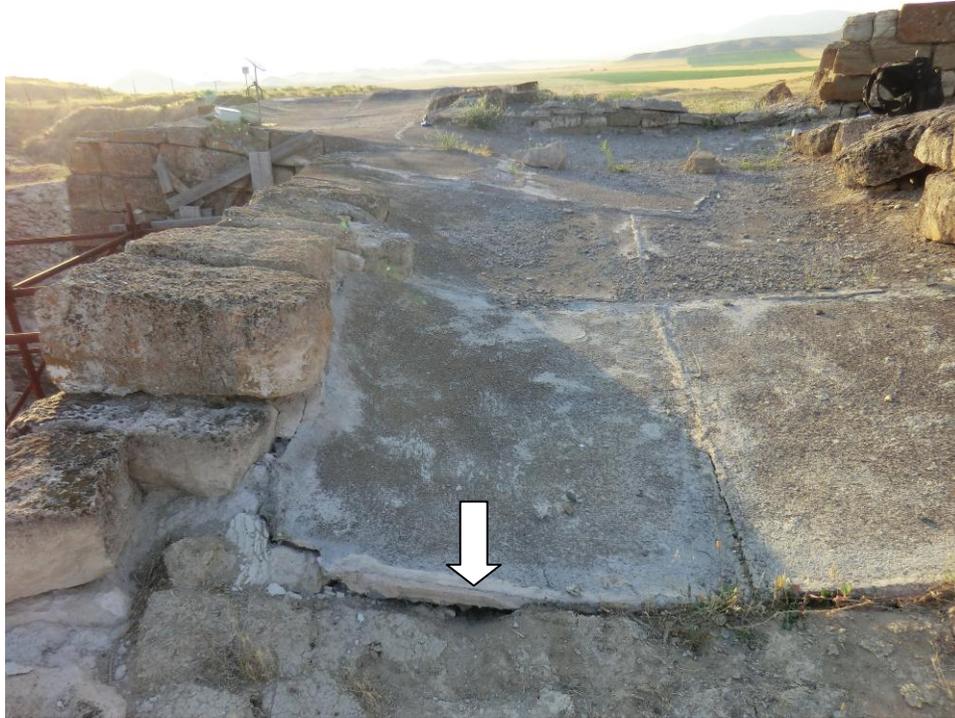
Figure 23 - Cap above north wall of South Court.

10. There is a concrete cap on the majority of the north wall of the South Court (Figure 23). The cap was sectioned into panels and the joints have a sealant between them. The sealant is deteriorated in locations.

The cap slopes toward the west. At the end of the cap, there is a channel that has been created by erosion (arrow, Figure 23). Water entry causes erosion of the earthen mortar within the rubble core.

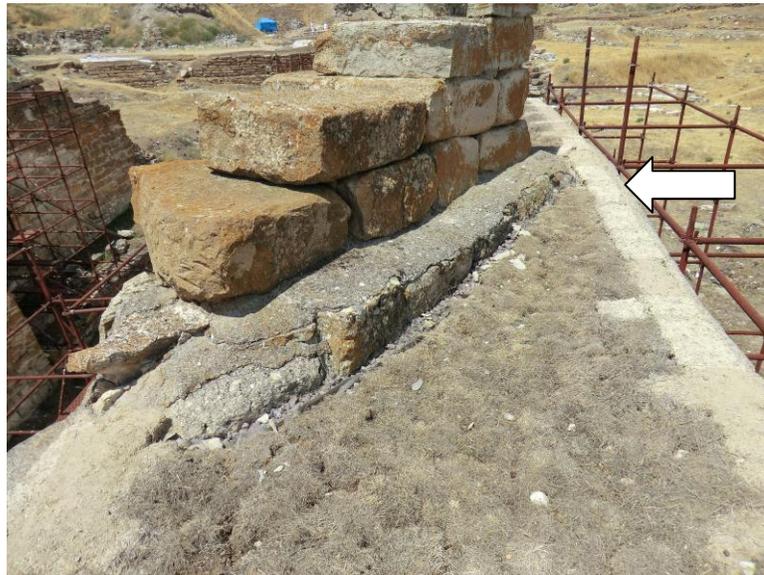
Figure 26 - Top of wall

Figure 26 shows the area of the bulge from the top (arrow). Based upon Figure 15, there was a Middle Phrygian wall that extended to the right in this figure that may have caused a high point loading.

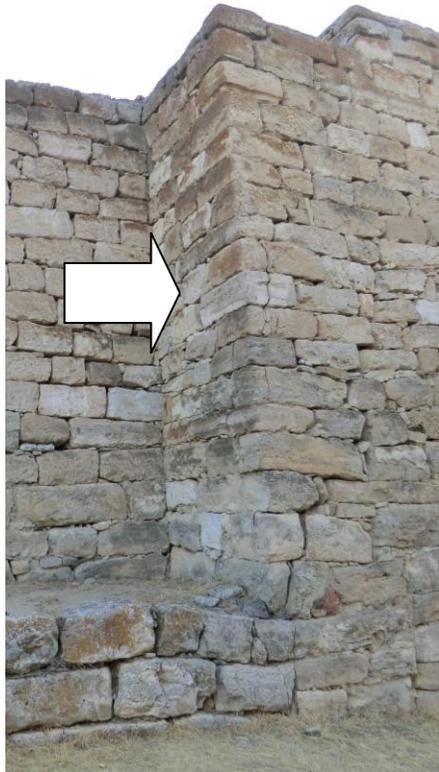
Figure 27 - Return wall and crack

5. Figure 24 shows a diagonal crack at the left end of the wall. Figure 27 shows this crack and the return wall (arrow). The joints of the return wall indicate some displacement has occurred.

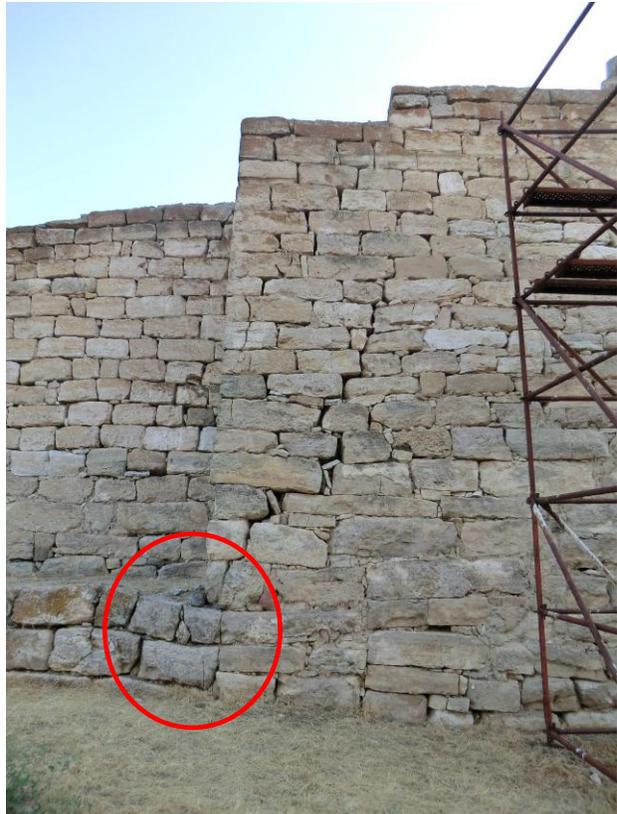
Figure 28 - Wall crack

Figure 28 shows the diagonal crack more clearly. There has been both lateral and outward displacement of the facing stones. The crack has weakened the corner and could collapse during a seismic event. The crack is not seen on the 1955 photograph of Figure 25.

The bottom of the crack (oval, Figure 28) indicates settlement has occurred. Figure 29 is a close-up of the bottom of the crack. The settlement is likely due to overload, compression due to loss of earthen mortar, or foundation settlement. This settlement is also visible in the 1955 photograph of Figure 25.

The angle of the crack is approximately 60 degrees from horizontal. The corner crack at the South Court in Figure 11 has the same angle. Both imply compression cracking.

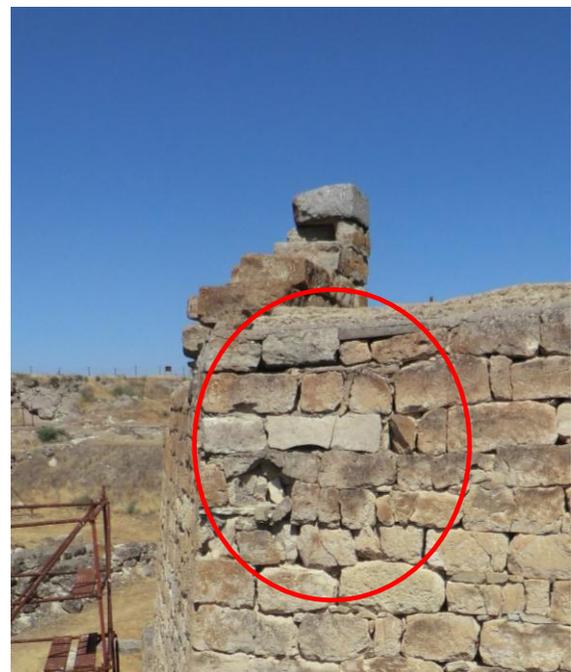
Figure 33 - Upper corner

6. The east wall is partially exposed (arrow, Figure 32). One ledge is visible. The upper corner has a small bulge and some displaced stones (oval, Figure 33). From Figure 15, there was a Middle Phrygian wall above this corner. From Figure 25, the bulge and displaced stones were evident in 1955.

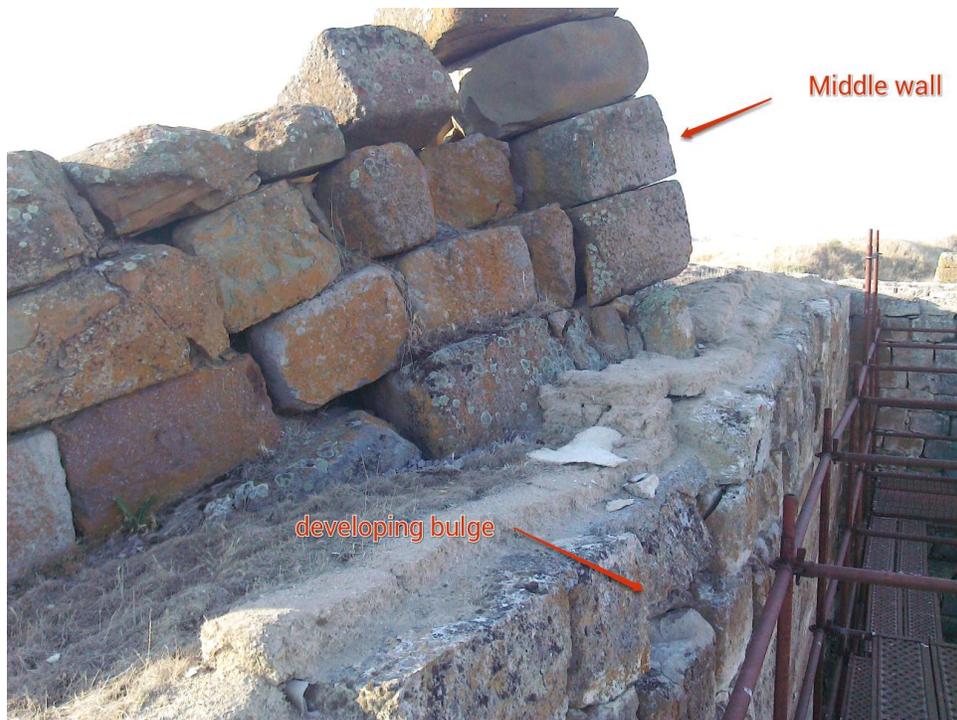
Figure 36 - Bulge developing in west face

8. The east wall shows no signs of global displacement due to the backfill. There are isolated bulges from facing stone movement. The bulges are primarily noticeable at the north end (Figure 36) adjacent to the upper walls.

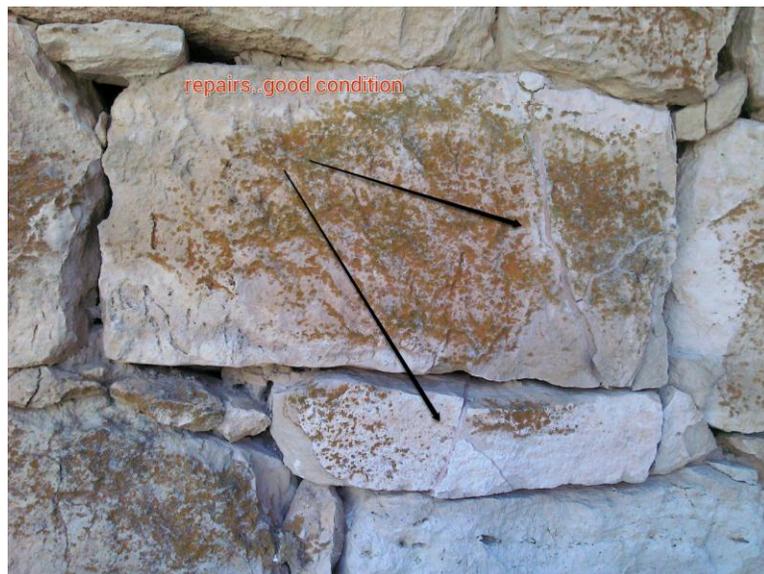
Figure 37 - Repaired stone

Previous efforts to repair stones were observed. Figure 37 (arrows) show stones that were repaired in situ. The repairs appear to be well bonded with no new cracks evident. These were representative of the repaired stones observed.

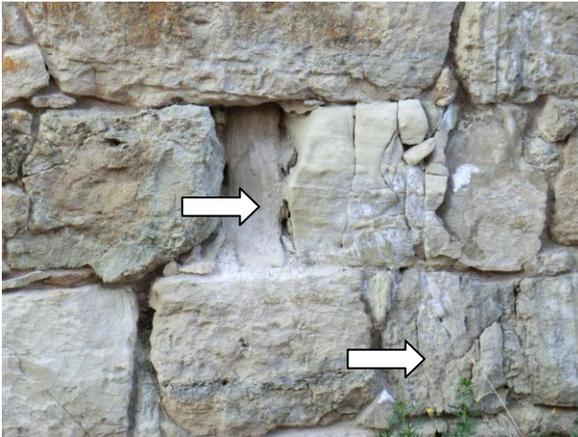
1. Many of the stones are cracked. Keller 2009 describes the stone types and bonding, the possible inclusion of timber ties within the walls and as foundation support, the lime wash that was observed by Young, and the use of batter to stabilize the taller walls. None of the timber ties were visible.
2. Some stones have deteriorated faster than others. Figure 38 shows a stone that has dissolved from environmental effects and erosion (upper arrow). The lower arrow points to a fractured stone. Figure 39 shows additional deteriorated stones.

Figure 38 - Deteriorated stones

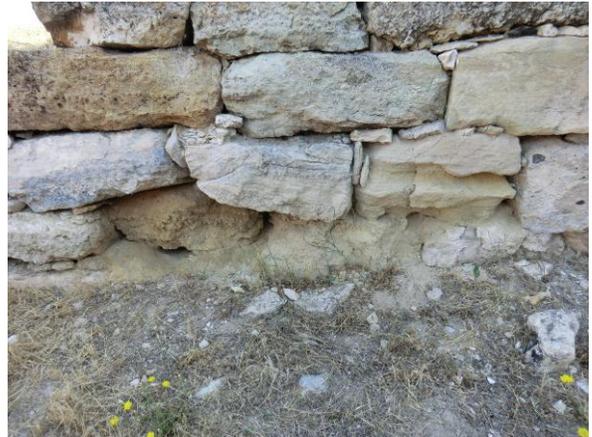
Figure 39 - Deteriorated stones

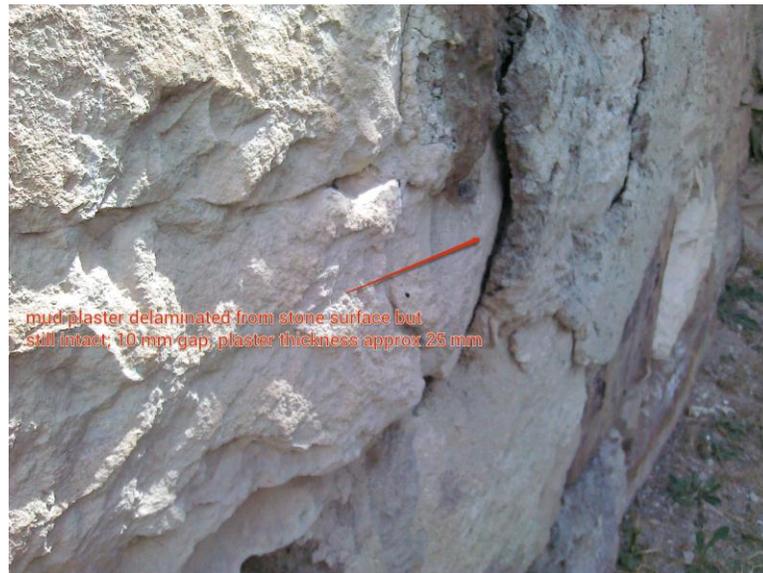
Figure 47 shows another wall area where the plaster is delaminating; there is a 10mm gap between the stone and the plaster. However, the surface strength of the plaster and the keying of the plaster with the mortar is still keeping the plaster on the wall. Future moisture and freeze-thaw effects will result in full delamination.

Figure 47 - Delaminated plaster
