Jackson Lake Lodge
Grand Teton National Park
Moran, WY

Historic Structure Report

Part 3

Prepared by:
The Architectural Conservation Laboratory
School of Design
University of Pennsylvania

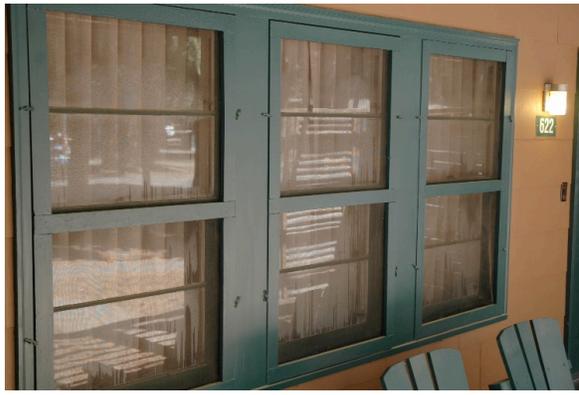
Left: Example of window with condensation on the interior face of the glass.

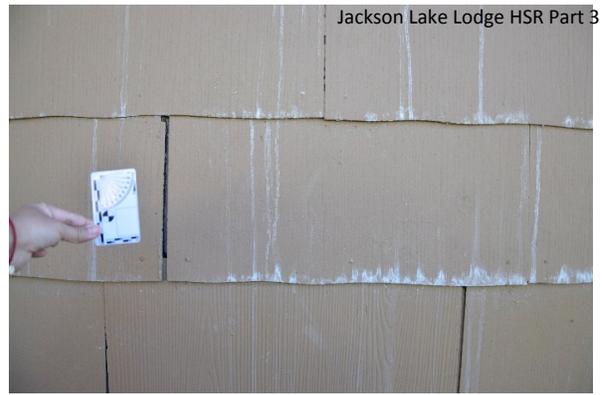
It was also noted that white leaching stains were found on the exterior cladding of the guest cabins. The exact cause of this phenomenon is unknown, but it could be a sign that moisture is collecting somewhere behind the shingles. This water may be eroding components behind the shingle, resulting in white deposits on the shingle surface. If there is a perforation in the composite insulation board behind the shingles, it could lead to mold growth and the deterioration of the various components within the wall assembly. It is important that this condition be assessed by a qualified specialist. Using infrared thermography is a nondestructive means of determining if moisture is collecting within the wall. Additionally, it is recommended that the components of the wall assembly be verified against the digitized original construction drawings (see next page). It may also be beneficial to have the R-value of the wall assembly calculated.

Right: Example of the white leaching stains found on the surface of shingles See the *Conditions Glossary* in Part 2 of the historic structures report for more details on this condition

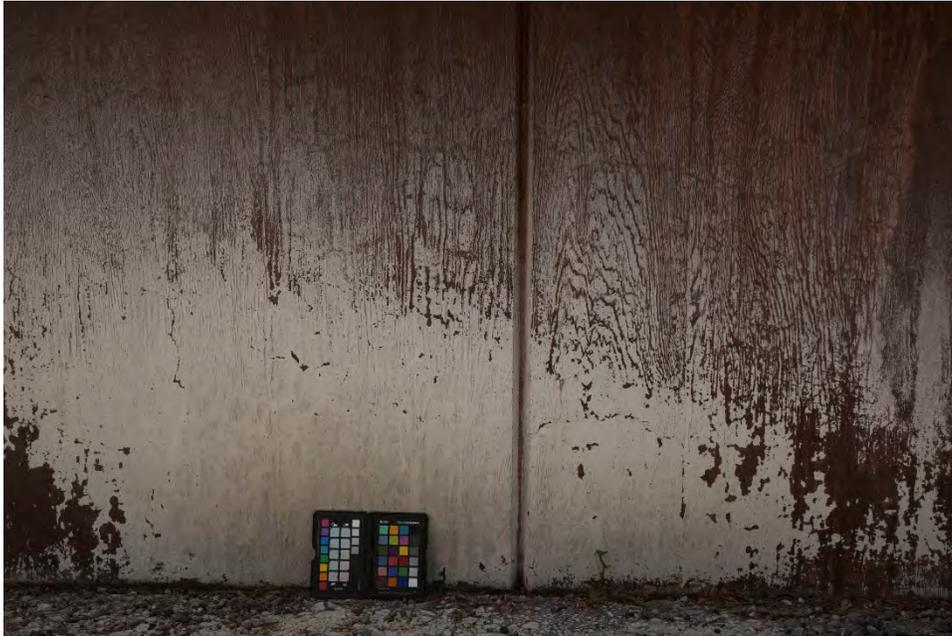
Fig. 23. Area prior to paint removal.

In addition, taking into account the possible health and safety risks to the applicator and to the environment, it is recommended the use of alternative methods such as the Sponge-Jet removal technique.

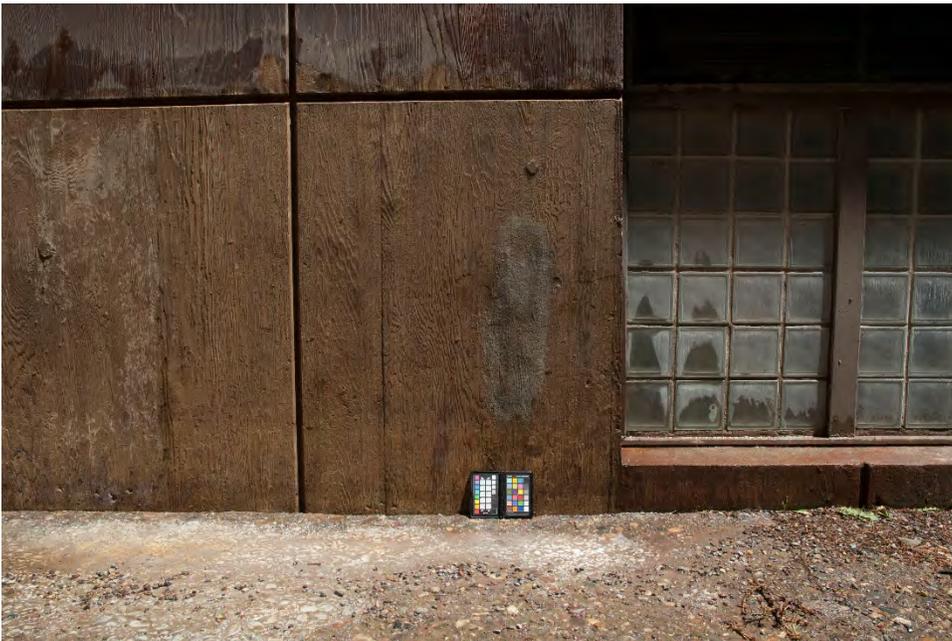
Fig. 24. Area after paint removal. Note the cementitious repair on the right.

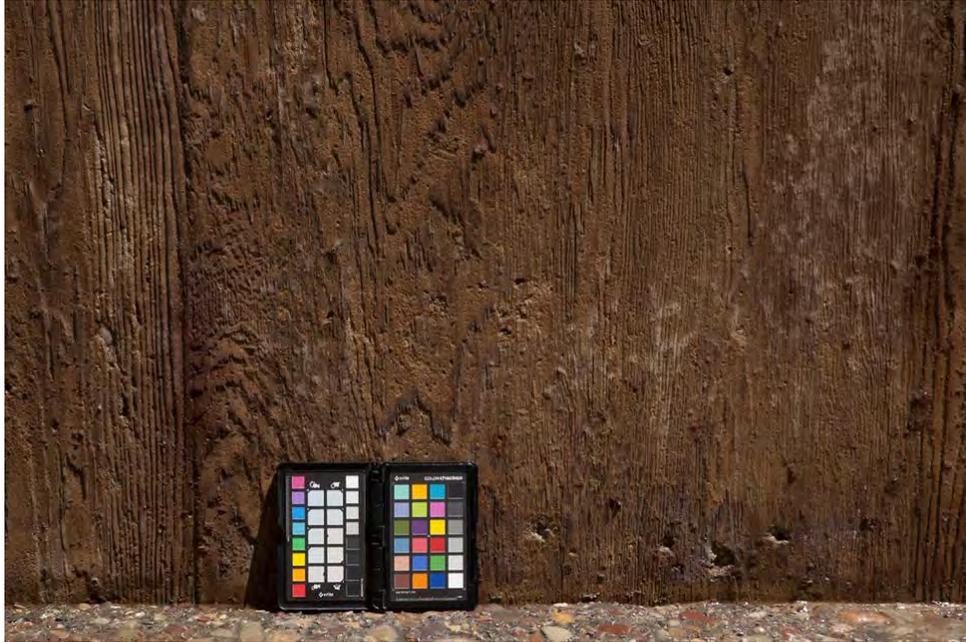
Fig. 25. Close up view of the surface after paint removal.

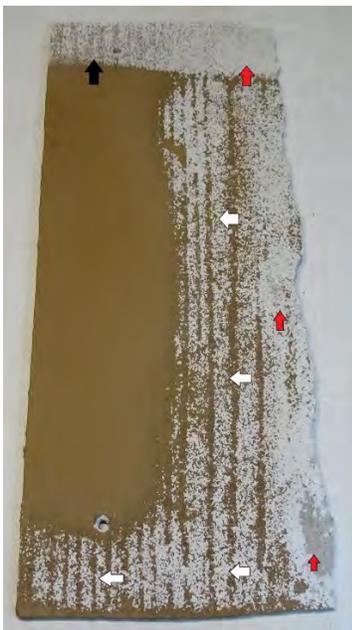
After a visual assessment, it appears that the sodium bicarbonate is gentler with the substrate. However, although it would seem to be a possible solution, the volume of soda required and the amount of time needed to accomplish the results you may desire are more than likely cost prohibitive. Also, this material is hazardous for the vegetation. Total fallout asbestos residue as a result of using microblasting techniques was not assessed. Total, negative air containment would be required initially to perform a mock up for blasting at least until a negative exposure assessment is obtained, if possible. Further testing to assess the potential hazards and fine-tune the methodology needs to be done.

Fig. 63. The photo on the right shows the blast areas by garnet (red arrows) and soda (white arrows). The black arrow shows the original finish of the shingle protected from paint by the overlapping of the upper shingle.
