**GEORGE NAKASHIMA
ARTS BUILDING AND CLOISTER
CONSERVATION & MANAGEMENT PLAN**

Project Director
Frank G. Matero

Prepared by
Cesar Bargues Ballester

Penn Praxis/The Architectural Conservation Laboratory
School of Design
University of Pennsylvania
January 30, 2017

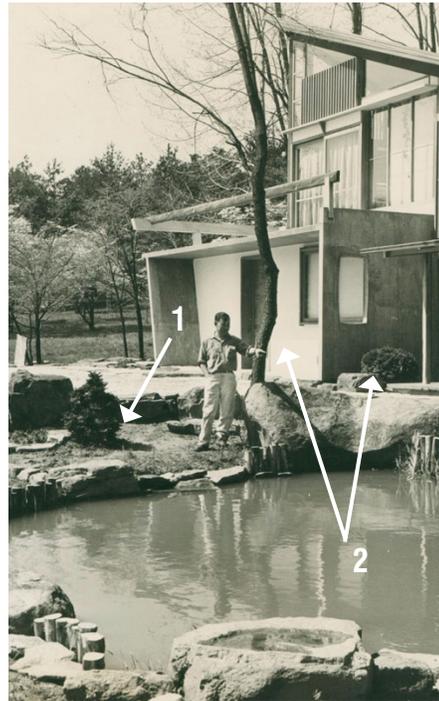
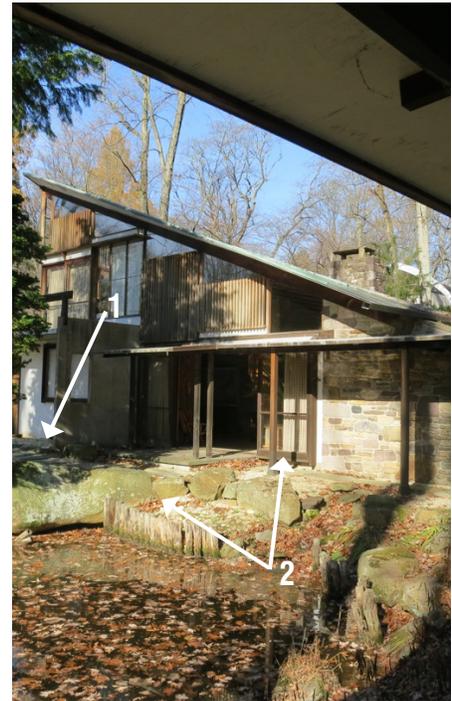
South Patio and Pond Planting, Historic (1967) and Current Conditions (2016):

1. Planned vegetation that conveys original design intent, now mature.
2. Formerly planted vegetation that conveys design intent that is currently missing.

On the other hand, the missing deciduous tree and small evergreen shrub constitute voids that violate the design intent of the Pond garden. The dominance of the Eastern red cedar and the absence of the formerly larger and more dominant deciduous tree has altered the design intent.

While it would not be advisable to remove or otherwise damage the Eastern red cedar at present (and indeed all attempts should be made to maintain its health), if in the future the red cedar were to die, original design intent through the planting of a large deciduous tree and a small red cedar in their historic relationship could be restored.

The small evergreen shrub by the sliding glass door Arts Building entrance could be replaced at any time.

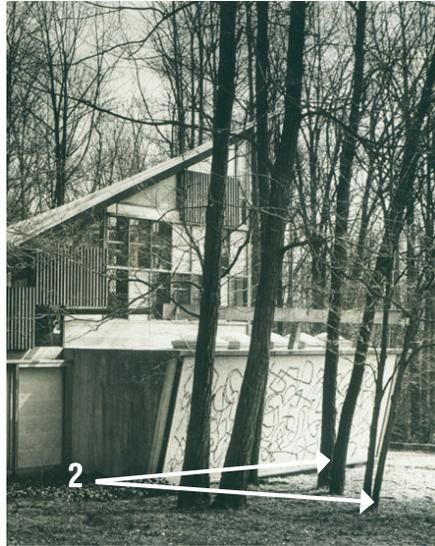
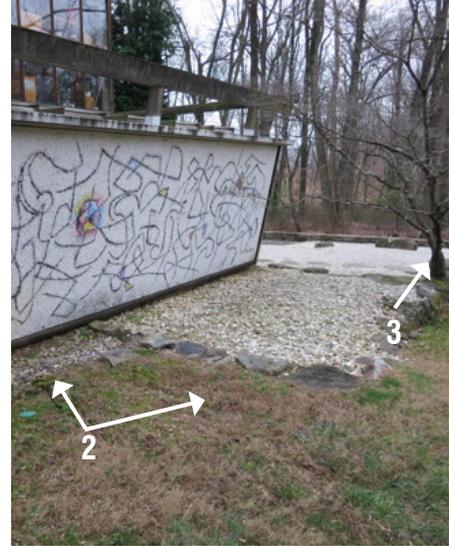
West Gravel and West-side Planting, Historic (1967) and Current Conditions (2016):

Formerly existing trees that are currently missing, adversely impacting the design intent, which should be replanted (2); Self-seeded trees that were not part of the original design intent but which should be allowed to remain (3).

Along Ben Shahn's mosaic mural wall, is another prime example of the second category: formerly planted vegetation that has since been removed, upsetting the design intent. The rectangular geometry of the West Gravel formerly responded to the presence of a deciduous tree, which is now missing.

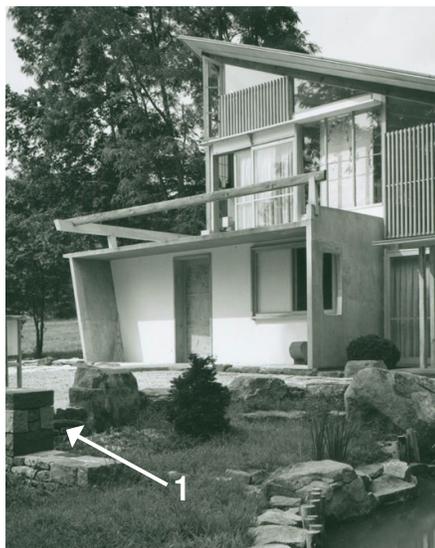
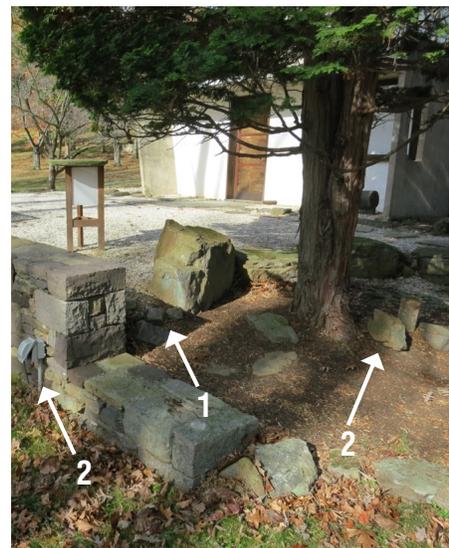
West Gravel and West-side Planting, Historic (1967) and Current Conditions (2016):

Missing retaining stone(s) at edge of Pond Planting (1). Stone that has moved or been added to the Pond Planting garden, resulting in an unintentional arrangement. Note also the electrical outlet at the base of the South Patio Stone Wall, which is non-contributing and which alters the design intent (2).

There are also new stones present in the Pond Planting which do not appear in historic photographs, suggesting that they are indeed the missing elements of the stone border, having moved or been displaced.

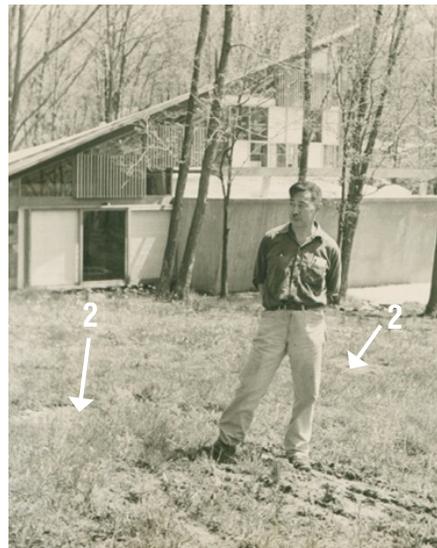
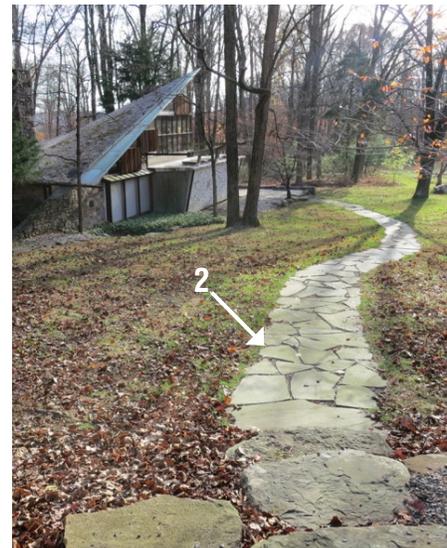
West-side paving stone approach path as designed, 1967 (20; current condition showing overly dominant stone paving, 2016.

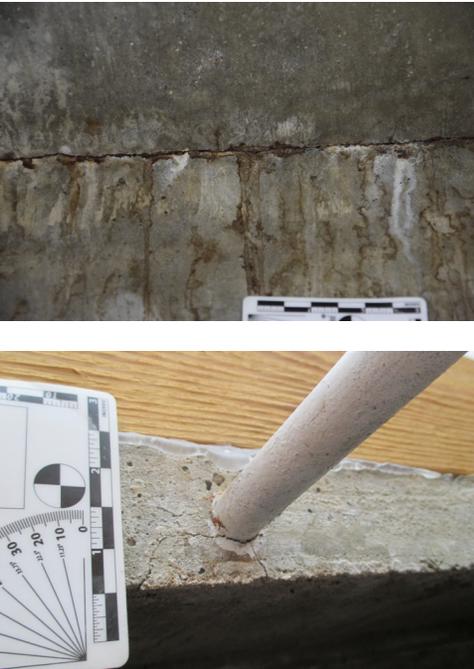
Above: Corrosion products and leaching caused by moisture infiltration in the past.
Below: Hairline cracks visible at the intersection between an electrical conduit and the concrete.

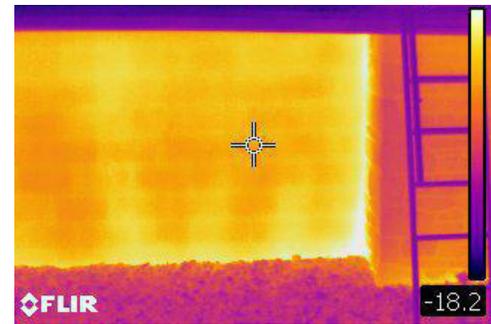
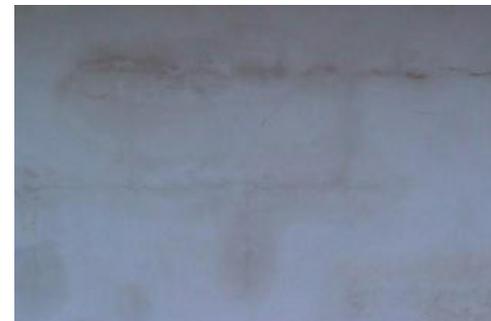
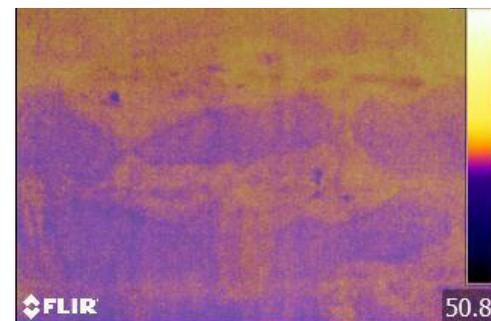
From top to bottom:
A. Infrared image showing the presence of a thermal bridge in the interface between the CMU wall and the stone masonry on the north elevation. The photograph was taken at 7:32 am on February 4th, 2016. The building was heated during the night.
B. Close up to the darker areas and hairline crack occurring at the concrete block perimeter.
C. Overlaid infrared image on the previous photograph. Note how the darker wet areas are warmer. The photograph was taken at 6:04 am on November 4th, 2016. The building was heated during the night.

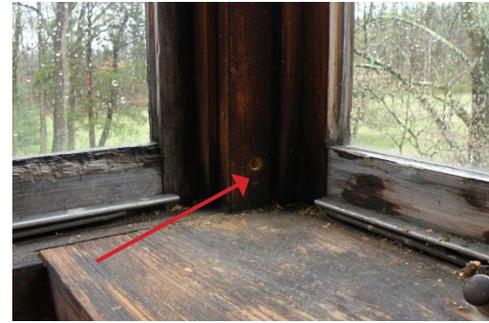
From top to bottom:
Figure 1. Sample removal location from the southwest corner post.
Figure 2. Fungal growth on the underside of the north railing.
Figure 3. Probing with an awl to determine the extent of deterioration in the plywood soffit on the Cloister.
Figure 4. Resistance drilling to identify the condition of an original porch post.

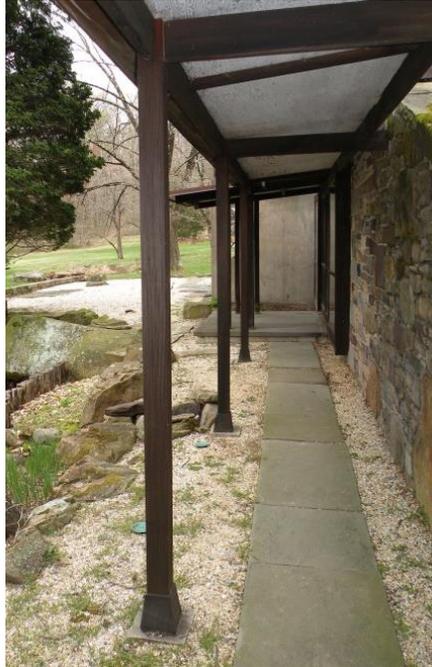
Right, above: Figure 30. Base of an original post at the landing outside the sliding doors on the south elevation. This post is in good condition.

One original post has more extensive deterioration at the base and is suitable for a hidden repair to prevent further deterioration of the wood (Figure 32). The post does not need to be replaced. The deterioration at the base of this post is likely similar to the deterioration that was present in the walkway posts that led to their replacement. The posts (at least the southeast landing post) are attached to the

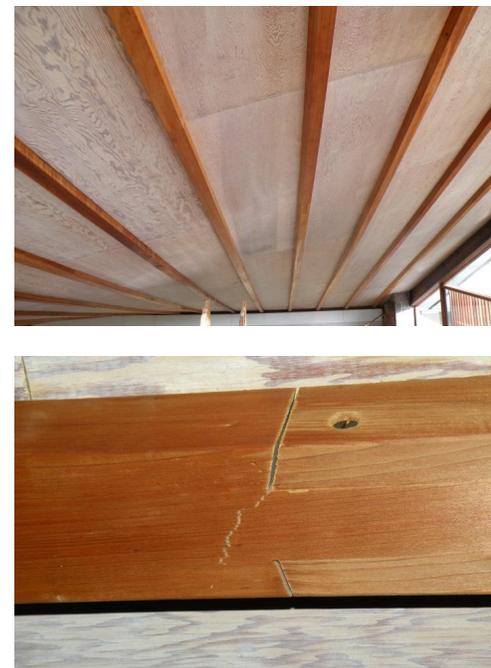
Above: Figure 42. Baldcypress ribs extending between the east and west walls. Below: Figure 43. Failure at the joist in the rib along grid line 6.

secured with a single screw. Very minor moisture stains are visible, mostly at the perimeter of the interior space; however, moisture content readings indicated that the wood has a moisture content of approximately 10 percent. The rib along grid line 6 has a split at one splice (Figure 43). The split, or failure, appears to be cosmetic and so would not affect the structural integrity of the ceiling and roof.

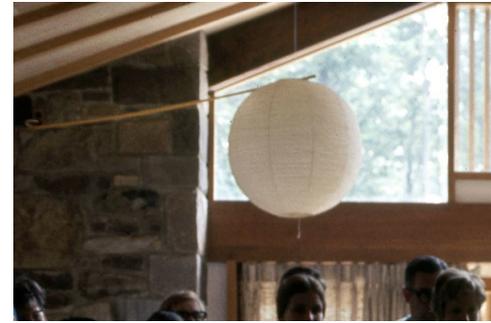
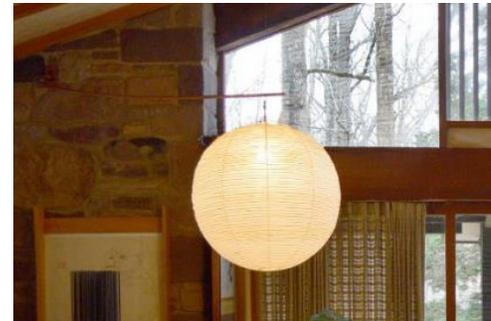
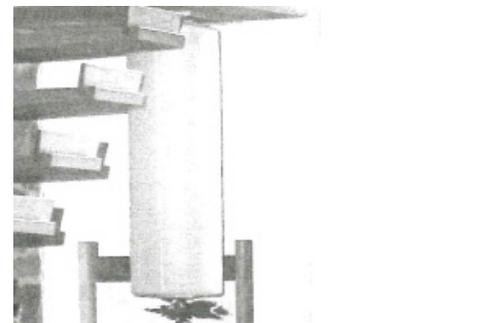
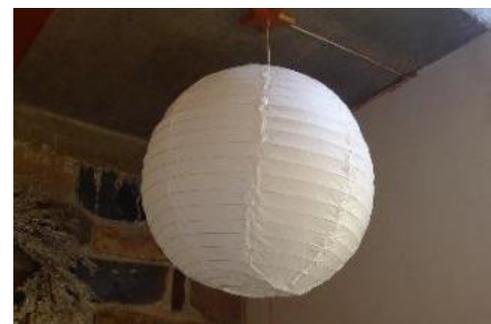
From top to bottom:
 Platform lamp, August 1969
 Current condition, January 2017. Note sagging in position of light, down over 18 inches.
 Detail of lamp under stair, May 1973.
 Existing condition, January 2017.
