**PENN PRAXIS/THE ARCHITECTURAL CONSERVATION LABORATORY**

**GEORGE NAKASHIMA  
ARTS BUILDING AND CLOISTER  
CONSERVATION & MANAGEMENT PLAN**

**INTERIM REPORT**

January 30, 2016

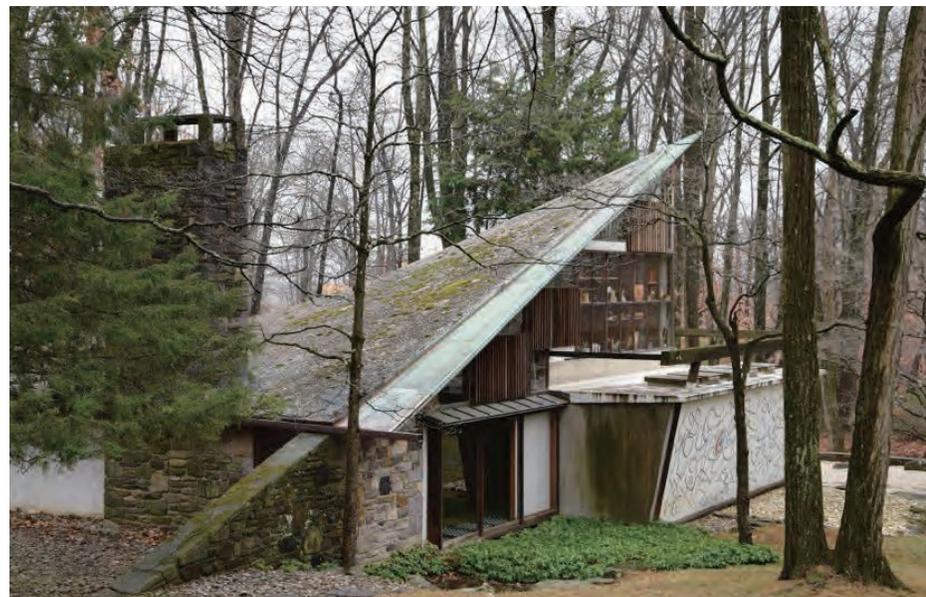
Fig. 5.2. Northwest elevation view. Date: December 2104. Notice the new gutter system, the copper canopy, and the new flat skylights. The copper patina is indicative of new and old flashing campaigns. The concrete floor of the terrace exhibits a waterproofing coating painted in white, which disrupts the original aesthetics. Landscape features have been changed over time. Source: Architectural Conservation Research Center

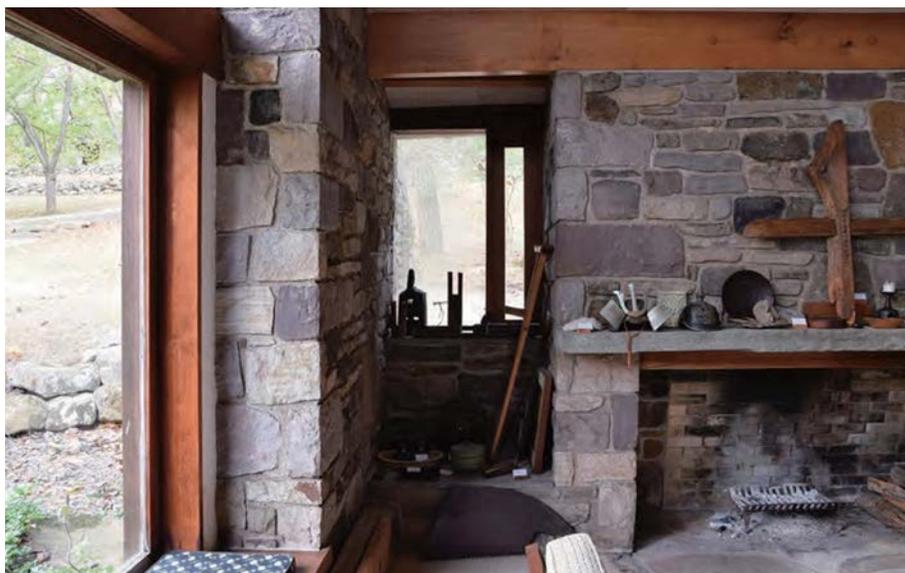
Fig. 5.6. Current state of the fireplace corner. Date: November 2014.

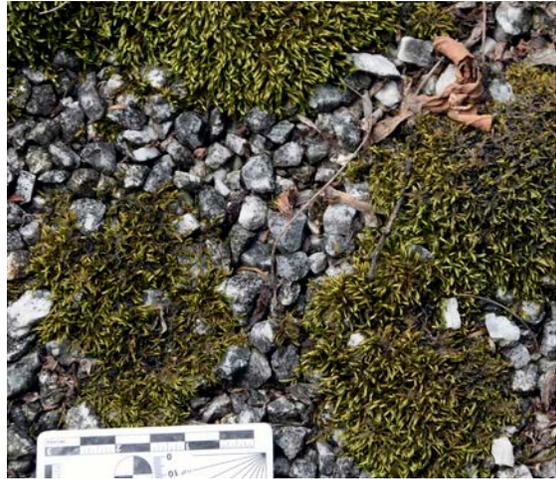
Presence of mosses, lichens, and related plants on the roof slope contributing to moisture retention.

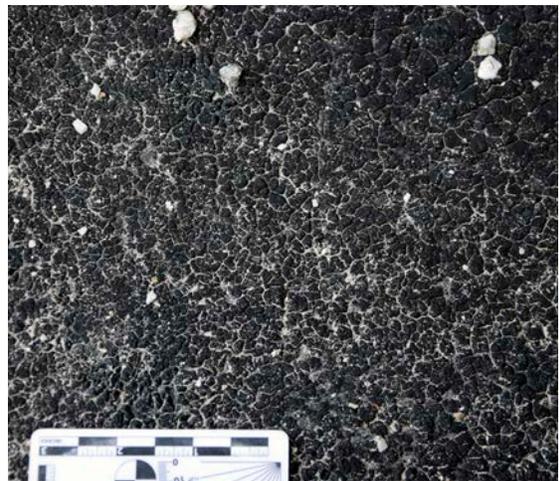
#### *Asphalt Cracking*

Asphalt exposed layer is cracked due to brittle because weathering which results in loss of elasticity.

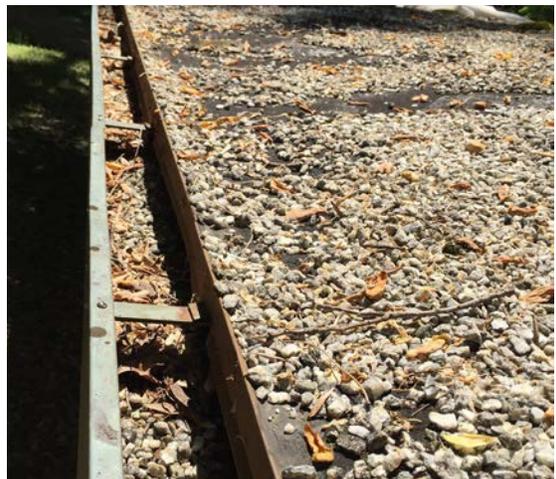
#### *Clogged gutters*

Presence of marble chips and leaves accumulated in the base of gutters contributing to poor drainage and water overflow.

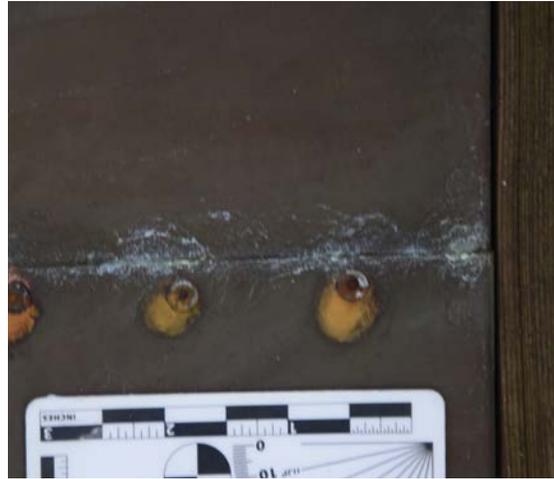
Greenish-blue corrosion occurs in the flashing joints due to water retention and redox reactions.

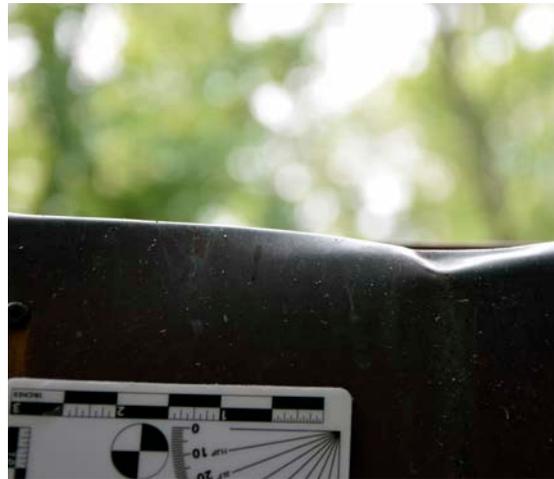
#### *Impact Damage*

Bent sections of copper due to mechanical impact of fallen branches.

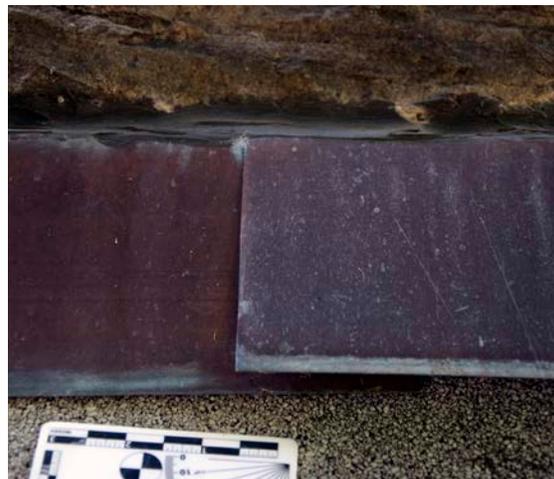
#### *Open Flashing*

Sections of copper sheets are out of plane because of lack of adhesion or insufficient adhesion.

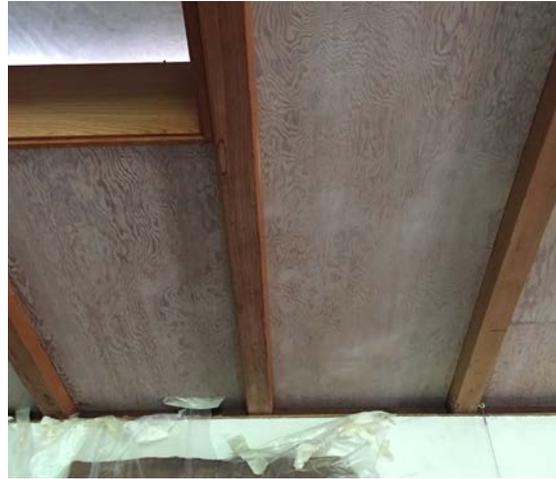
Moisture stains and wet surface from water seepage through the roofing system.

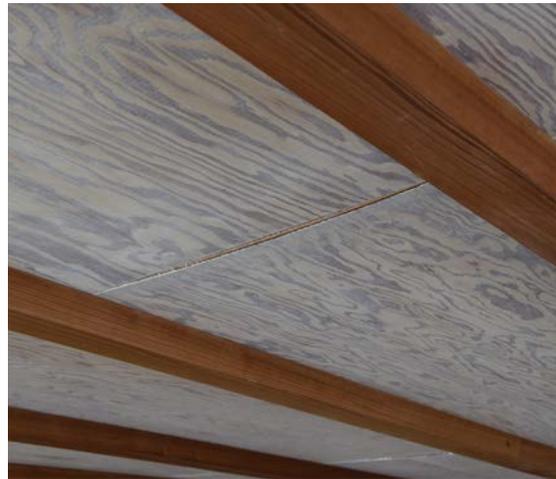
#### *Plywood Deformation*

Plywood board is bent and not flush with the contiguous boards.

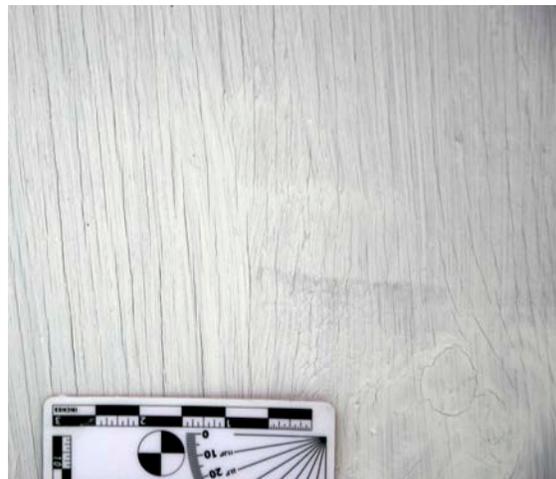
#### *Plywood Checking*

Multiple hairline cracks or slightly open parallel splits of different length.

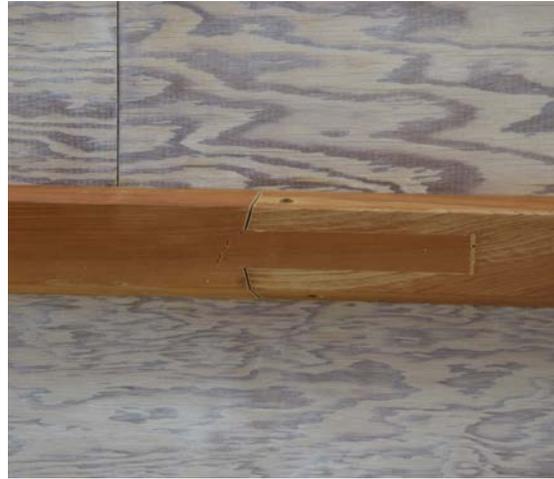
Single crack visible in rib joint.

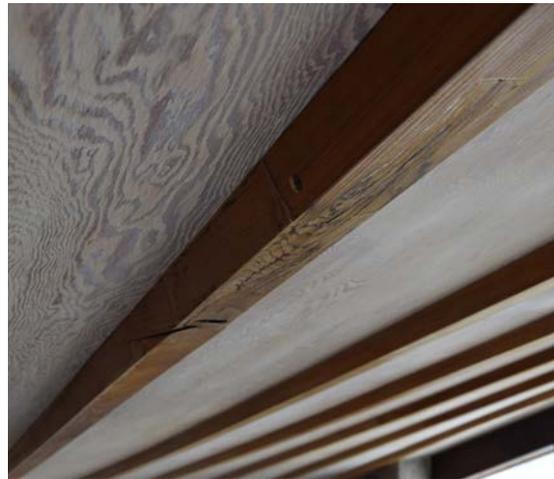
#### *Rib checks*

Checks limited to the lower middle section of the rib.

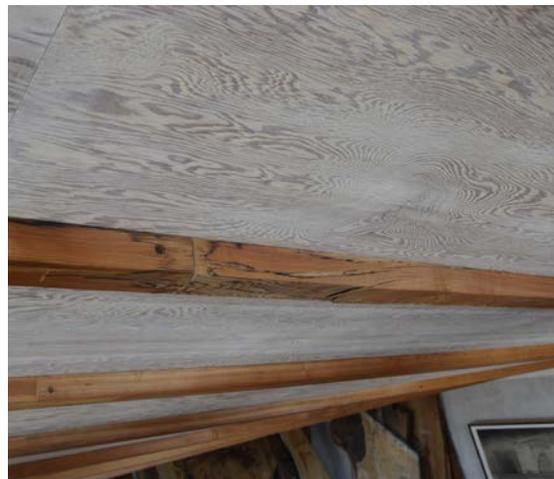
#### *Moisture Stain*

Color alteration in the ribs because of historic exposure to moisture.

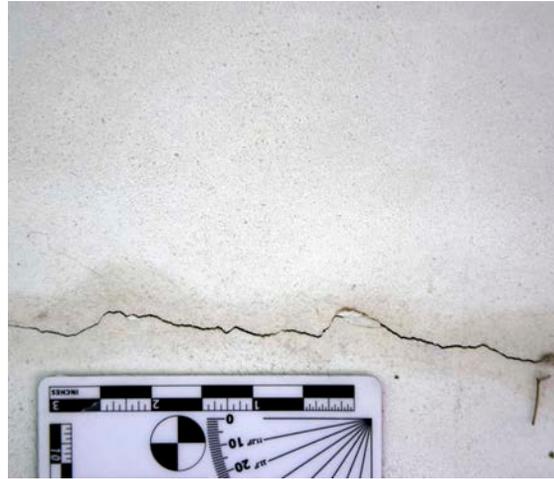
Cracks of variable length with a width between 1/32 and 1/16 inch, primarily longitudinal along the bedding joint.

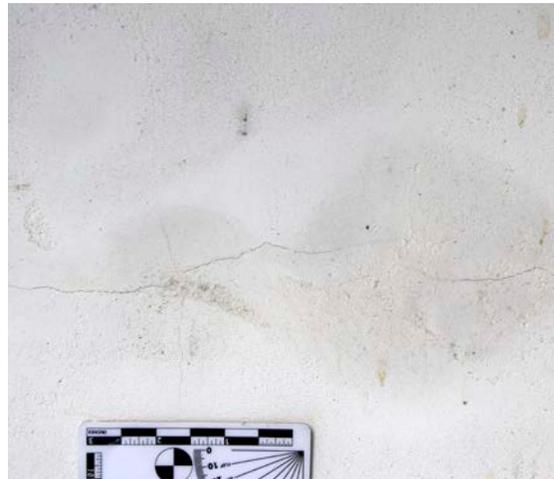
#### *Hairline Crack*

Cracks in the stucco surface having widths so small as to be barely perceptible. Orientation may vary and they can intersect other cracks forming a pattern.

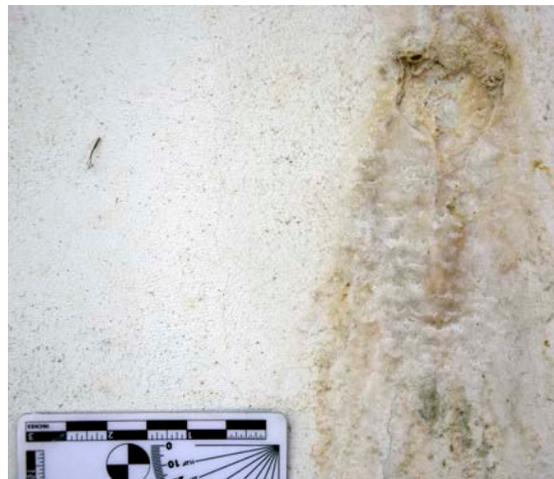
#### *Mineral Accretion*

Salts transported by water has evaporate and crystallized on the stucco surfaces forming mineral deposits in association with a reddish brown stain.

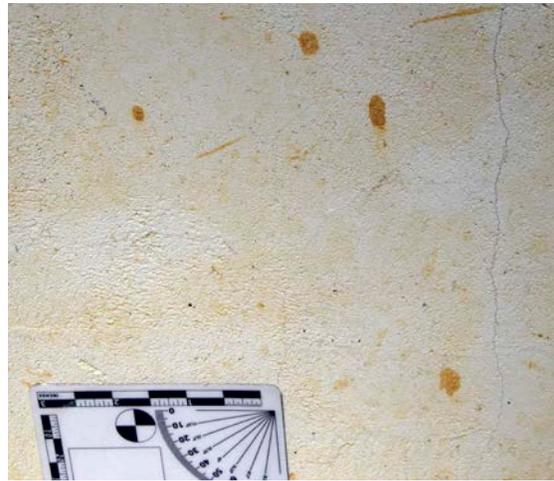
Water splash deposited soil particles upon the rendered surfaces creating a thin brown film disrupting the aesthetics qualities of the white stucco.

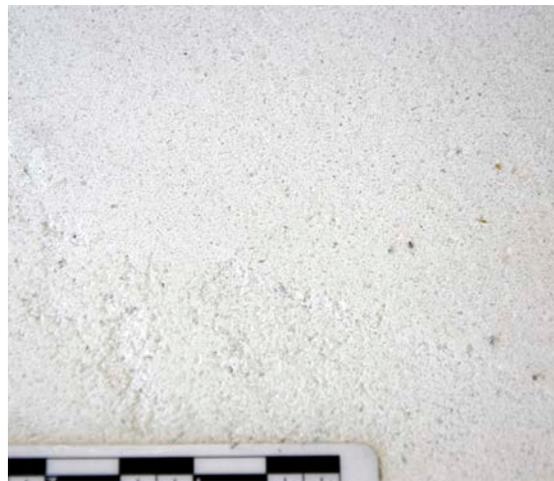
#### *Superficial Erosion*

Increased surface roughness due to moisture infiltration and salt crystallization. Surfaces contrast with the smoother surrounding surfaces.

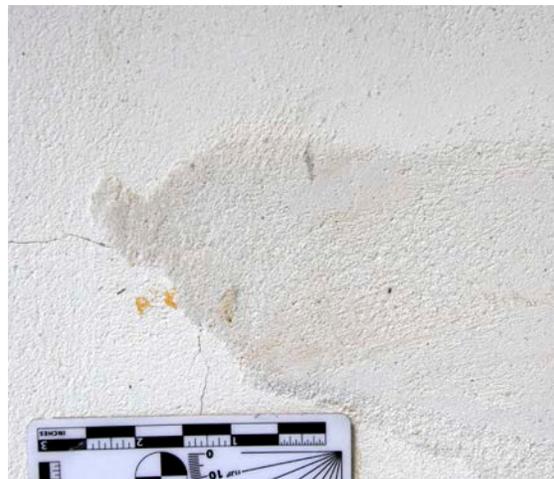
#### *Previous Repair*

Repair of eroded and cracked surfaces with a white cementitious material that shows a coarse-grain texture.

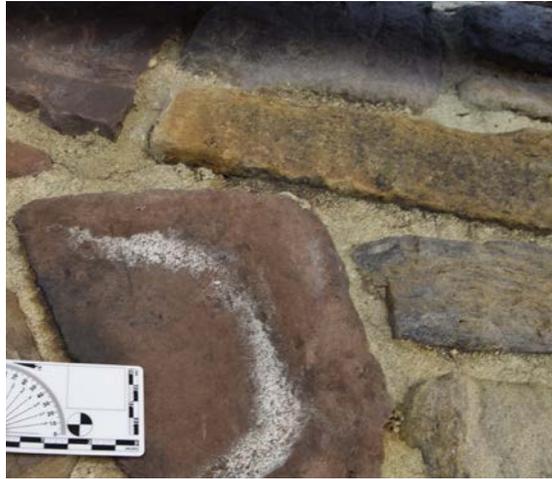
Generally whitish, powdery salts crystallized on the surface. Efflorescences are generally poorly cohesive and commonly soluble salt. This condition has been observed in the exterior and interior walls.

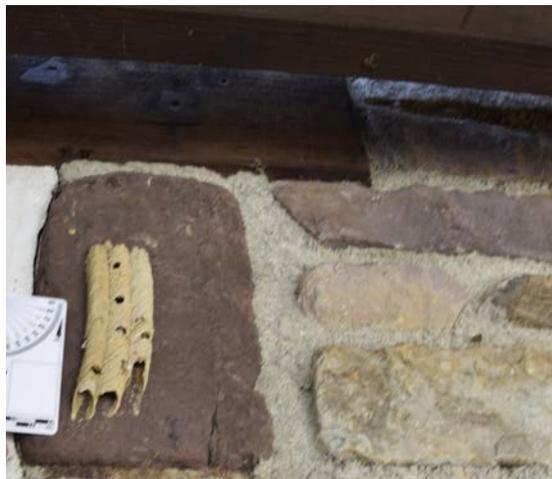
Mud dauber wasps have constructed their nest on the stone surface. Nests are also localized on other substrates in the other areas of the building.

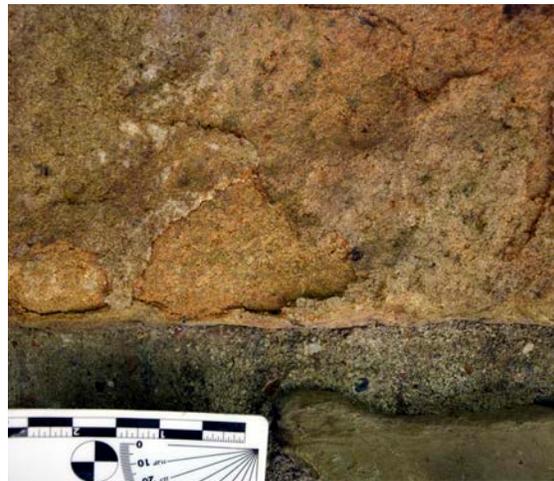
Surface erupts into blisters and crumbles away leading to a loss of stone surface.

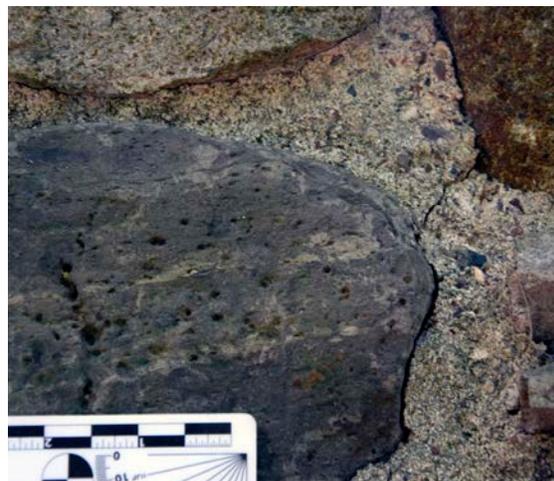
#### *Hairline cracks*

Thin cracks between mortar joints and stone units.

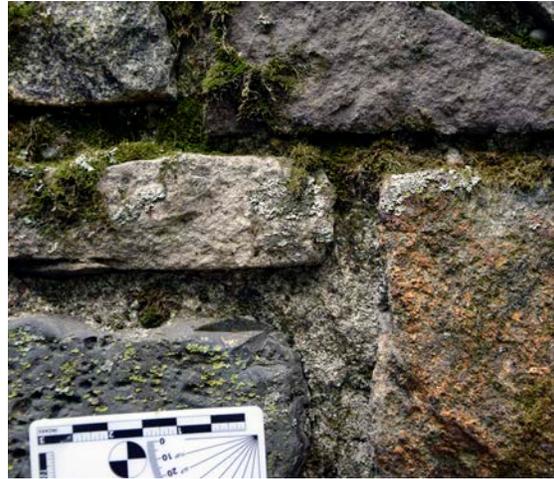
Presence of mosses, lichens, and related plants on stone masonry.

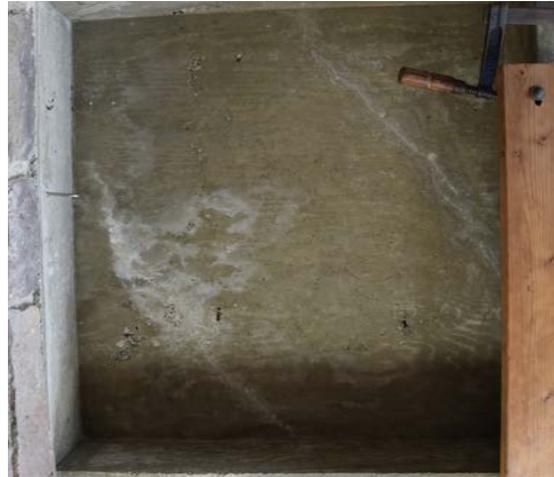
Cracks in the concrete elements having widths so small as to be barely perceptible. Hairline cracks show a variety of direction and can be accompanied by efflorescence or rust staining.

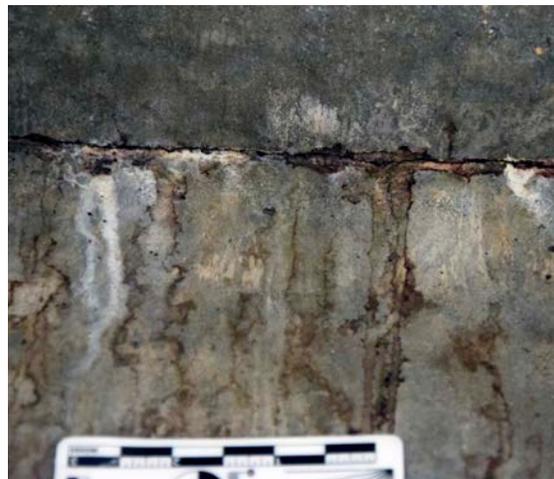
#### *Rust Staining*

Rust brownish red stains in a limited area of the concrete surface as a consequence of moisture intrusion and rebar corrosion.

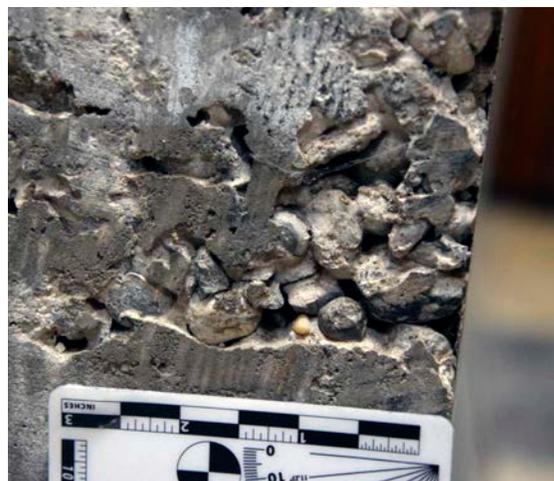
#### *Honeycombing*

Voids left in concrete due to poor mixing of the aggregate and vibration during the placing process.

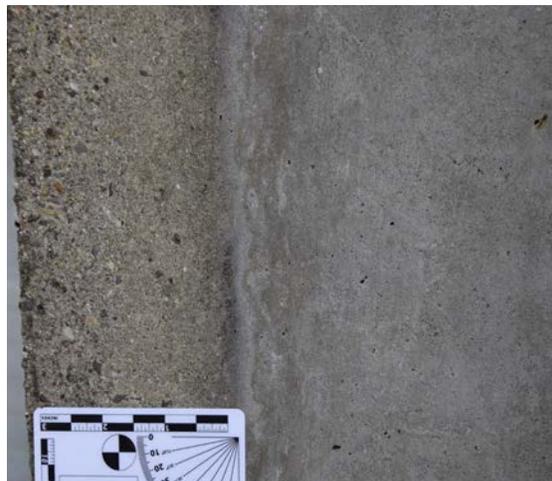
Overall rough surfaces due to exposure to rainwater, which has dissolved the outer layer of the cement paste leaving the aggregate particles exposed.

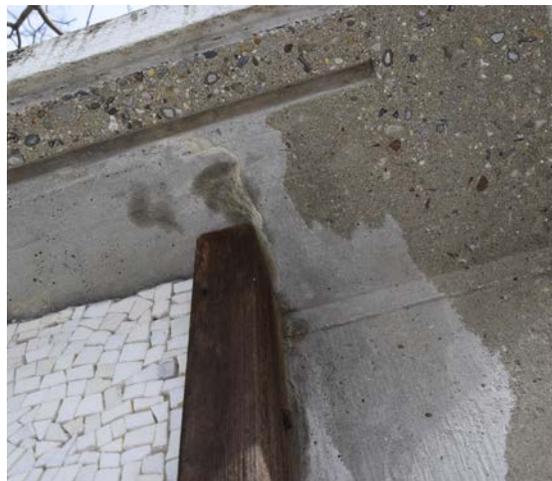
*Moisture Stains*

Discoloration of the concrete surface as a consequence of temporary wetting episodes.

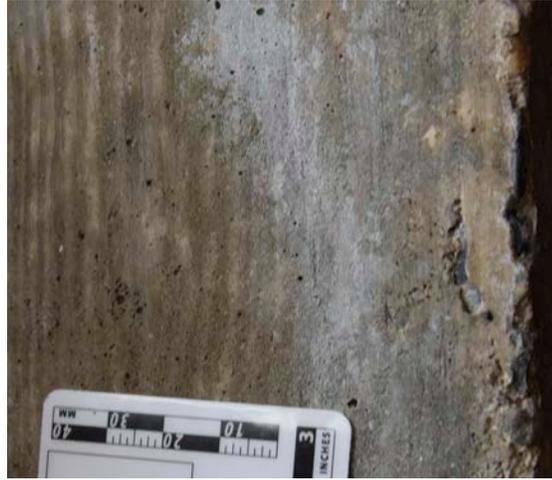
A whitish deposit of salts crystallized on the concrete surface precipitated by carbonation or evaporation.

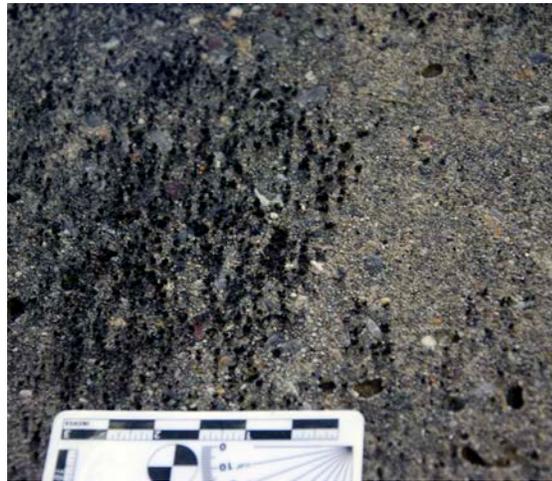
#### *Biological Colonization*

Presence of algae covering surfaces exposed to permanent moisture or regular wetting episodes.

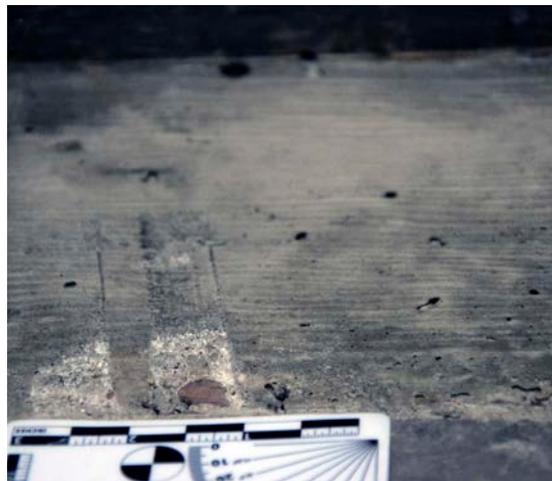
#### *Impact Damage*

Mechanical damage on the outer surface of the concrete.

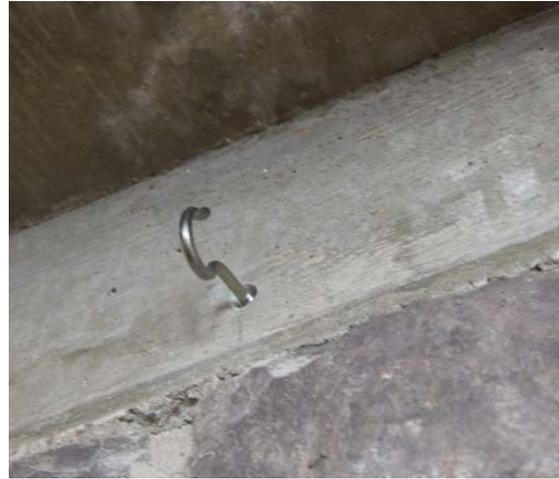
Installation of metallic elements by insertion in a concrete element.

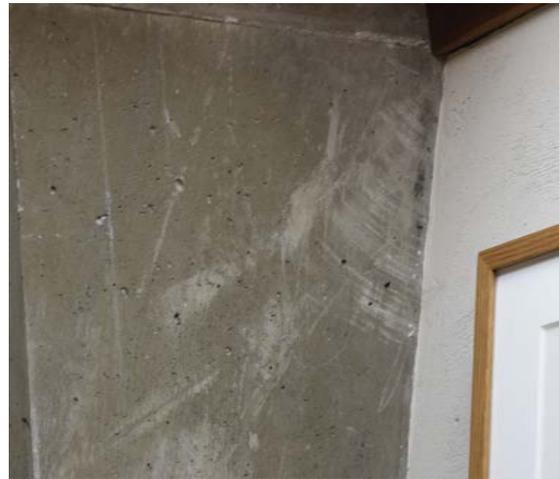
#### *Scratches*

Mechanical damage to the outer surfaces of the concrete thus damaging the fragile woodprint pattern.

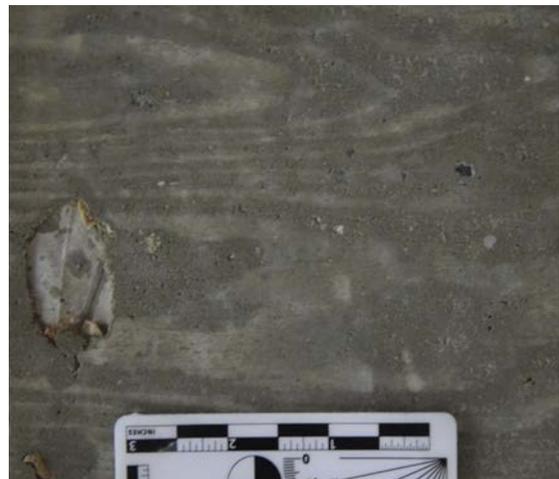
#### *Entrapped Elements*

Leaves and formwork wood chips entrapped in the concrete during the placing process.

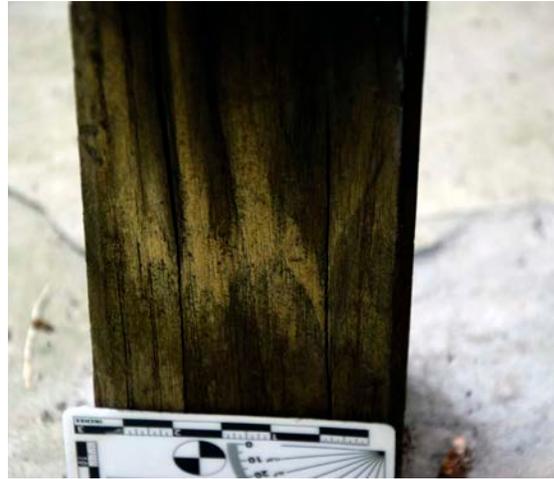
Areas of wood, showing color alteration, that have been attacked by fungus. These areas are soft and easily penetrable with an awl.

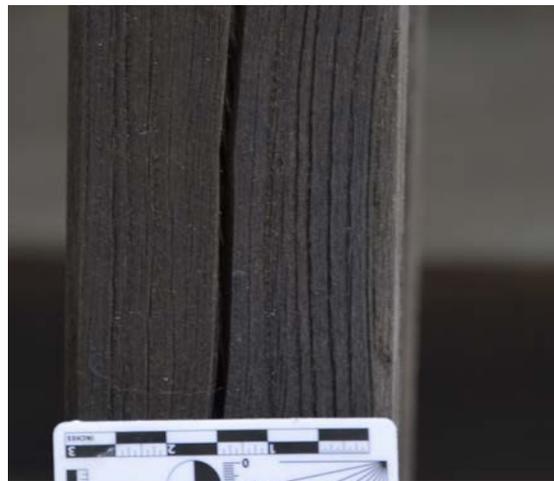
#### *Checking*

Longitudinal openings extending along the length of the wood member facilitating moisture infiltration. Structural stability appears not to be compromised though.

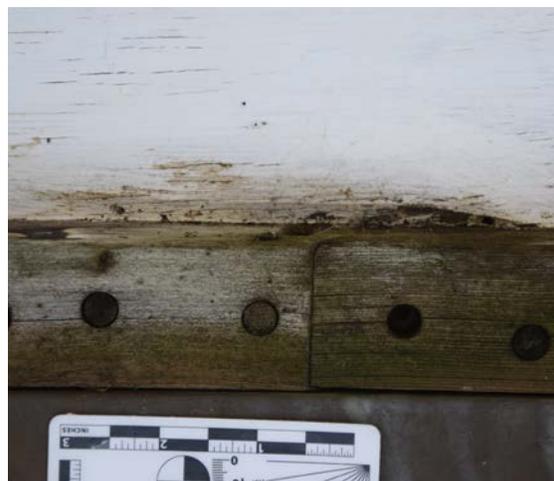
#### *Moisture Stains*

Uneven color alteration because of wetting episodes. Wood may be wet or dry.

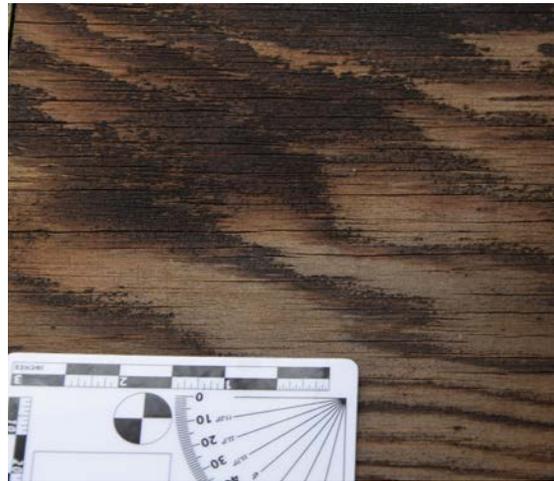
Wood surfaces showing the symptoms of slow degradation from a combination of natural factors: sunlight, moisture, temperature, chemicals, suspended particles carried by wind, and biological agents.

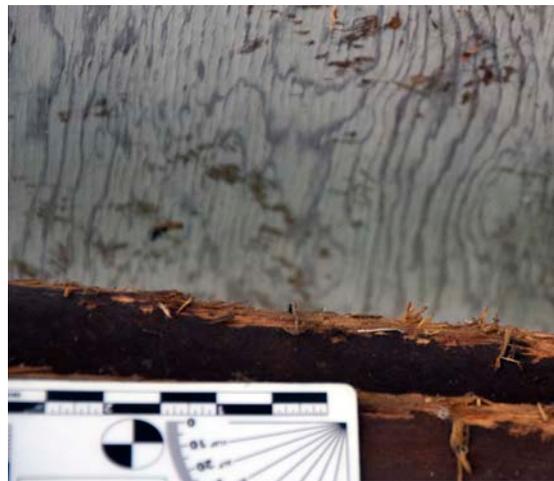
#### *Animal Abrasion*

Damages from animal activity, probably squirrels.

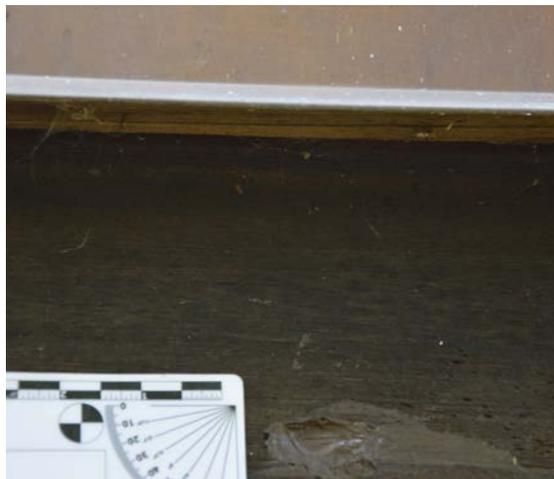
#### *Previous repair*

Holes perforated by woodpeckers repaired with the use of a brown epoxy resin.

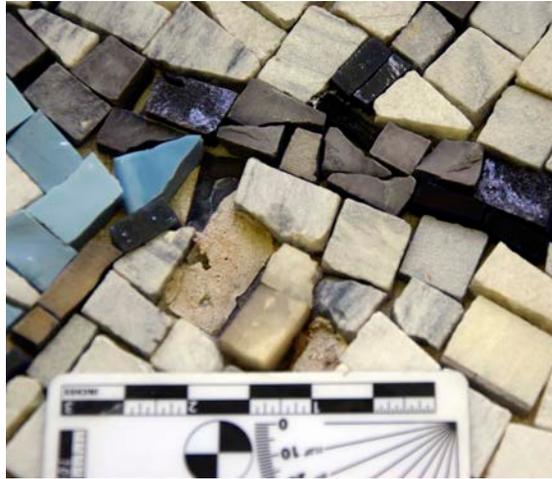
Single or multiple tesserae have detached because of lack of adhesion between the tesserae and the substrate.

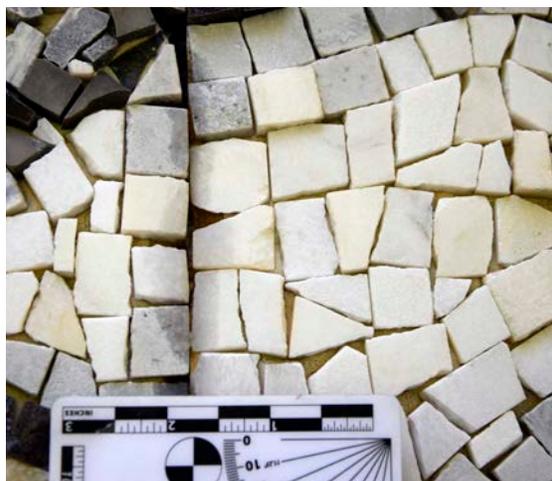
Discoloration due to the use of epoxy resin to adhere the tesserae and hide the screw heads fastening the mosaic to a wood substructure.

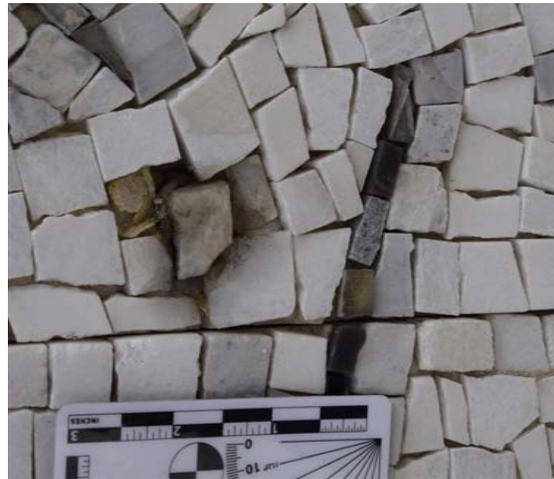
Adhesion failure causing individual tessera loss.

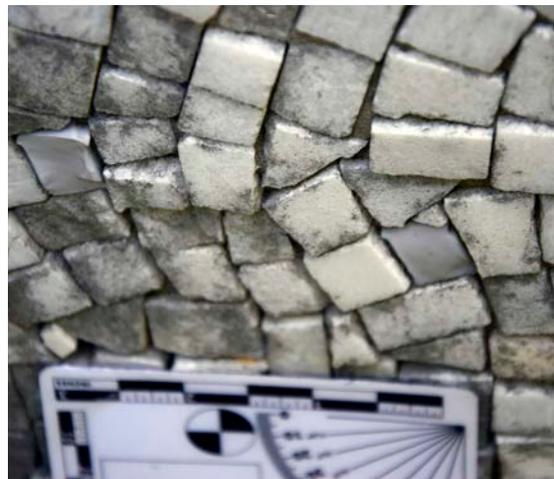
#### *Biological Colonization*

Microflora and soiling covering the lower section of the mosaic panels.

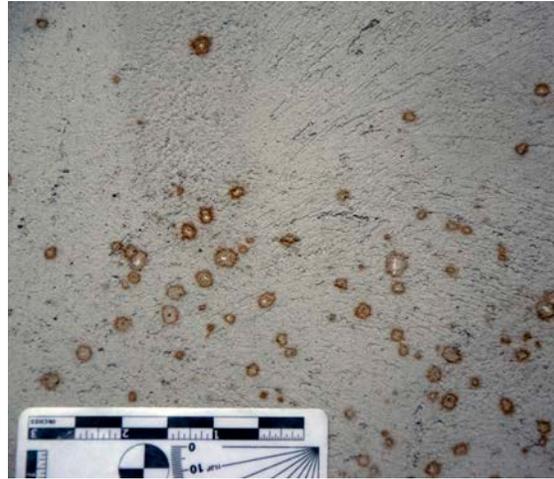
Circular staining that might be related to the oxidation of metallic components in the Structolite™ or to an unknown chemical reaction between constituents.

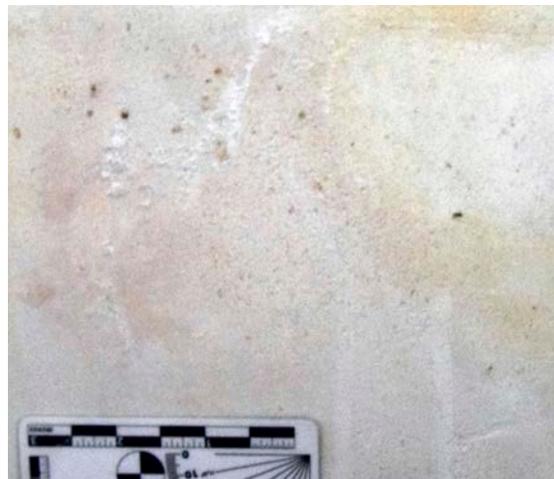
#### *Efflorescence*

Chiefly whitish powdery deposit of salts crystallized on the plaster surface.

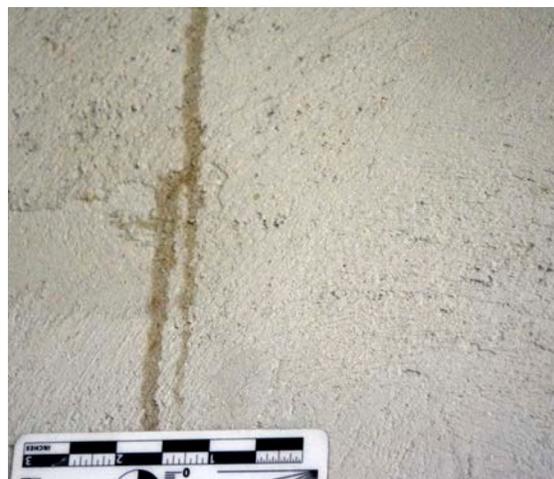
#### *Moisture Stains*

Color alterations of the surfaces caused by active leakage or past moisture infiltration.

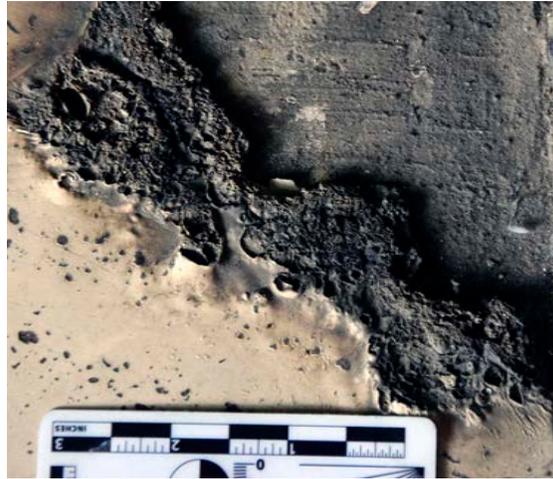
Flooring has been damaged by fire in the proximity to the fireplace hearth.

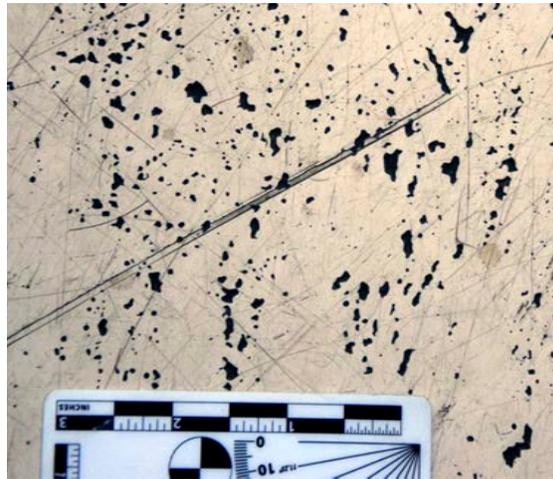
#### *Wear*

Scratches and superficial damage from visitation and use.
