Historic Structure Report: Architectural Data
Pipe Spring National Monument
Fredonia, AZ

Prepared for the National Park Service
January, 2014

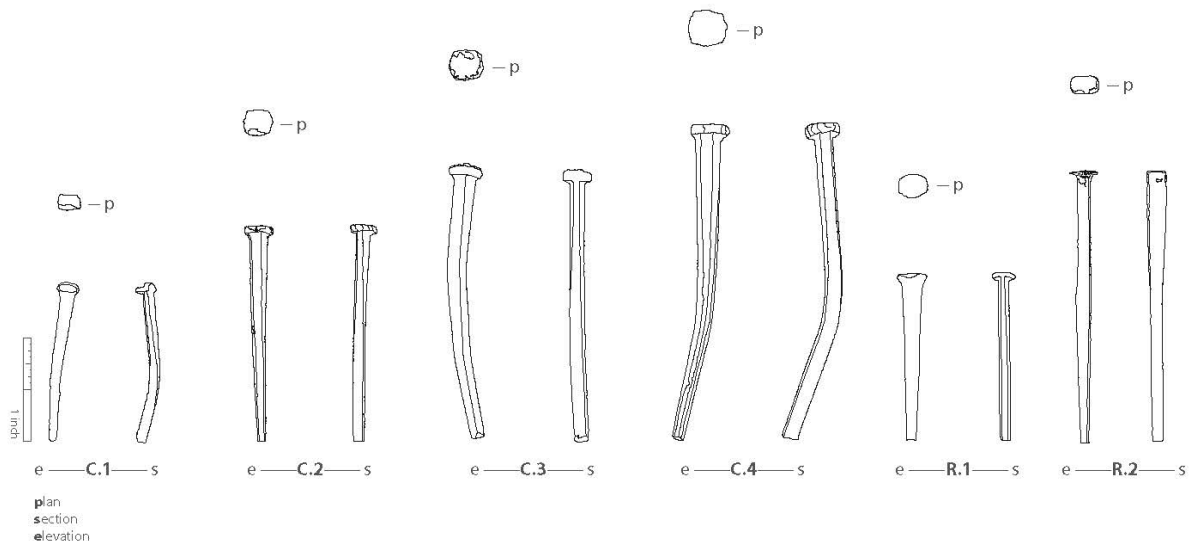
CUT NAILS			
Type	Length (inches)	Period	Use
C.1	1.5	Original	103: fireplace molding, beveled backband on door casings
C.2	2	Early Installation (pre-1900)	102: stair risers; 202: baseboards
C.3	2.5-2.63	Early Installation (pre-1900)	102: stair treads; 104: door casings
C.4	3	Early Installation (pre-1900)	104: door casings; 202: altered floorboard; 204: baseboards
R.1	1.5	Unknown	102: beadboard door; 103: Dutchman repair
R.2	2.5	Unknown	204: baseboards

An examination of the nail locations supports the installation dates of various features and suggests that certain alterations were likely contemporary. Type C.1 nails are found within the parlor fireplace surround and applied beveled backband to the door casing on the partition wall—both believed to be original features with no alterations (although these moldings may have been removed for repair with the original nails used in the reattachment). More sampling would be necessary to confirm whether this specific type was used exclusively in original moldings. It is possible that they were not used in any of the early alterations, since their use is generally limited to more delicate or ornamental moldings. No cut finishing nails were observed in the lower building.

The remaining sampled nails—types C.2, C.3, and C.4—were found in features altered at the end of the nineteenth century. These nails, all similar in their characteristics but of variable overall size, were used extensively in the meeting room stair risers, treads, and surrounding baseboards and adjacent floorboard. The doorway between the spring and cheese rooms—probably installed at the same period as the upper building staircase—contains door casings fastened with the larger nail types. These historic cut nails were not identified in any known restoration elements.

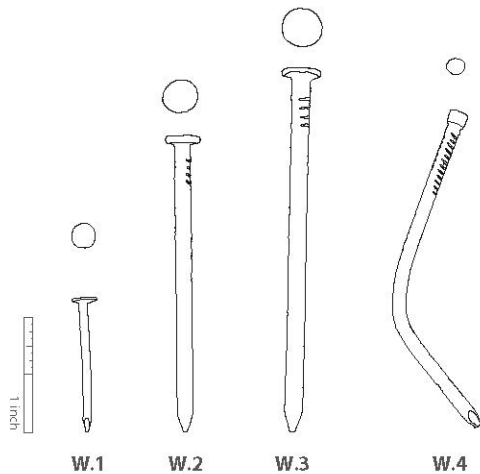
WIRE NAILS			
Type	Length (inches)	Period	Use
W.1	1	Early Restoration (1930)	204: lath
W.2	2.5	Early Restoration (1929/1930)	204: floor; 205: baseboards, floor
W.3	3	Early Restoration (1929/1930)	204: baseboards; 205: floor
W.4	3	Early Restoration (Post-1923)	204: baseboard

Wire nails, found in both the upper and lower buildings, were used in restoration campaigns and localized repair work of historic and replacement material. The change from cut
