# APPENDIX A

## FIGURES

- 1.0 Figures: Executive Summary
- 2.0 Figures: Description of Structures
- 5.0 Figures: Description and Investigations of the Fort Exterior
- 6.0 Figures: Description and Investigations of the Upper Building
- 7.0 Figures: Description and Investigations of the Lower Building

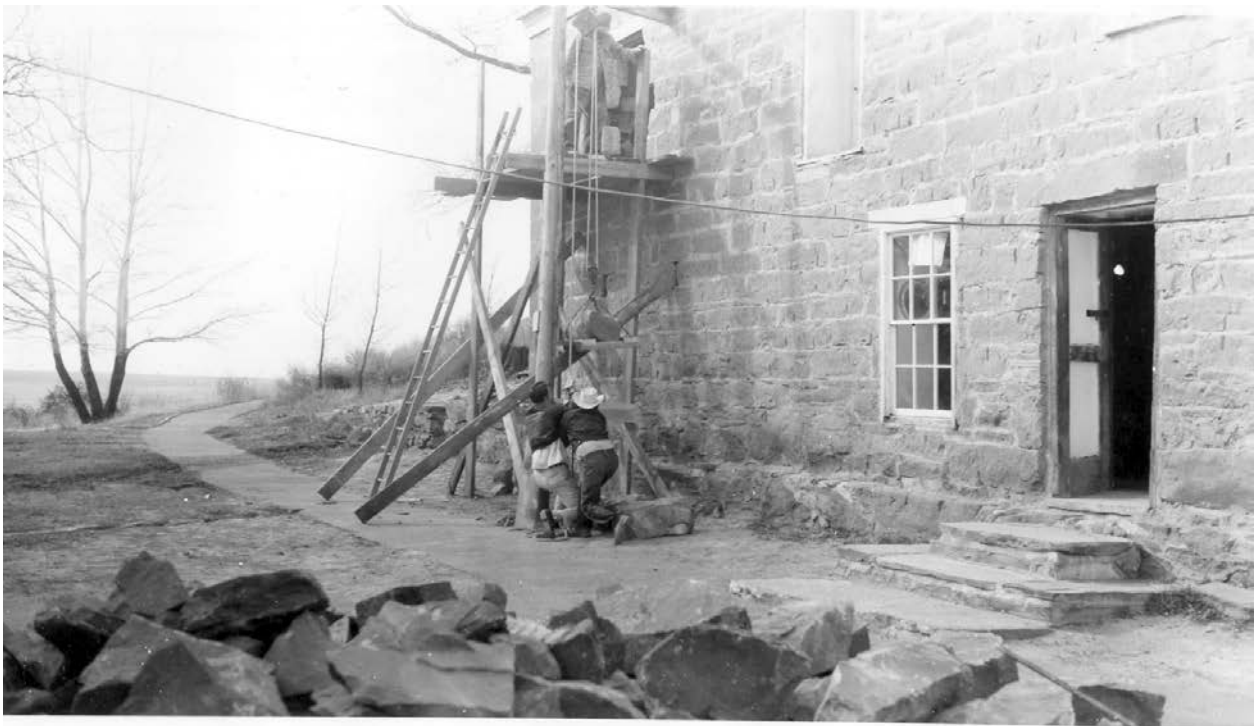
Figure 5.6. Leonard Heaton, "Showing work being done to remove windows put in the fort by Edwin Woolley in 1886 or 1887. Workmen: Clair Ford, Sherwin Heaton, Ray Mose" (January 19, 1959).

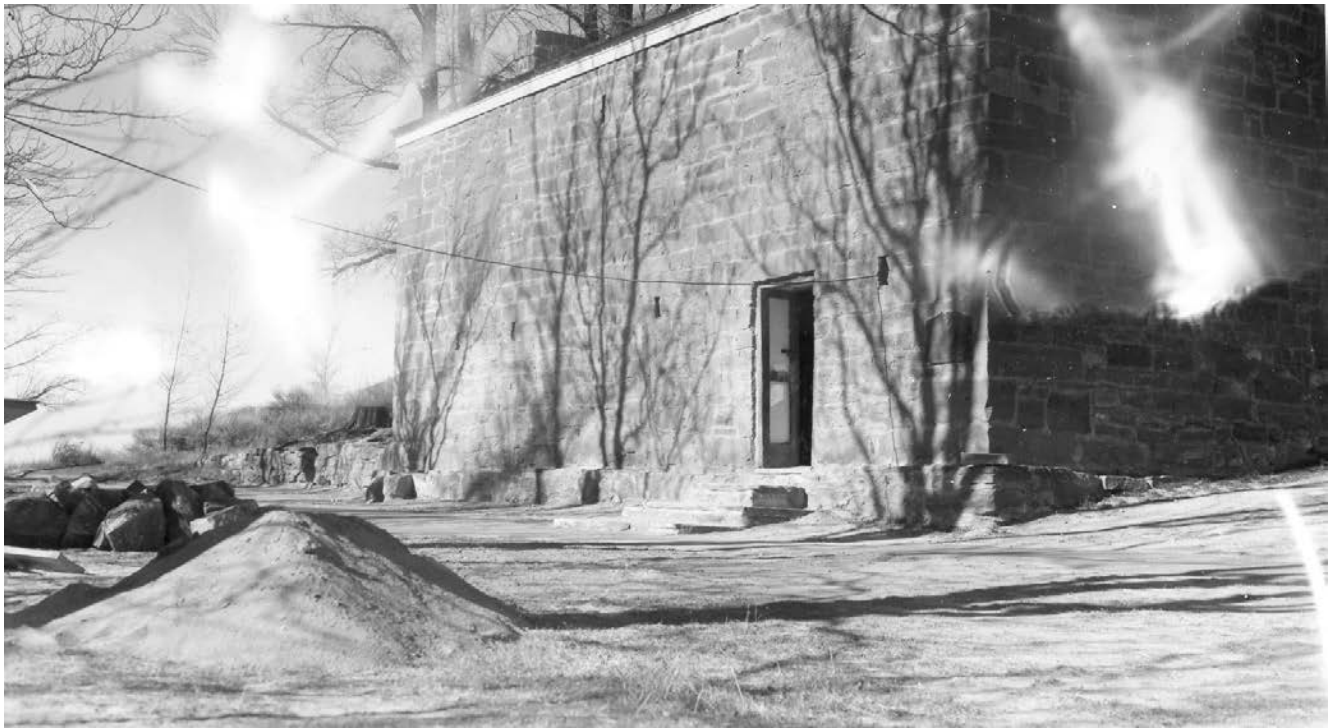
Figure 5.7. Leonard Heaton, "Showing completed job of removal of windows on south wall of fort" (February 5, 1959).

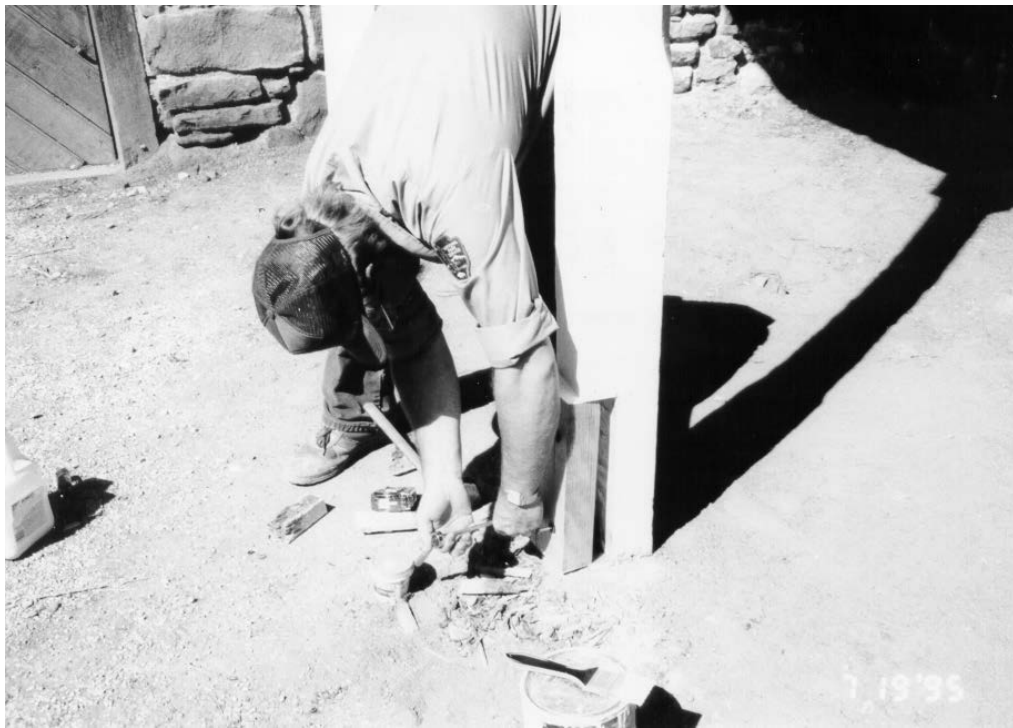
Figure 5.16. “Making a Dutchman repair to base of balcony post” (1995).

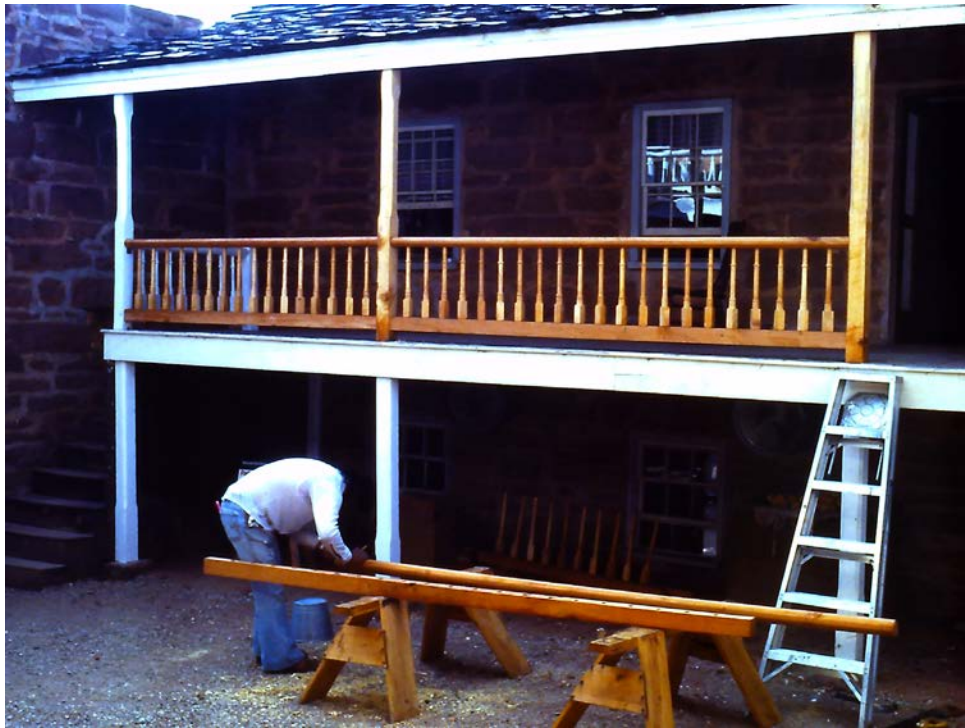
Figure 5.17. Fred Banks, “Rebuilding fort railing” (September 1982). Pipe Spring slide archive, fig. SL1327.

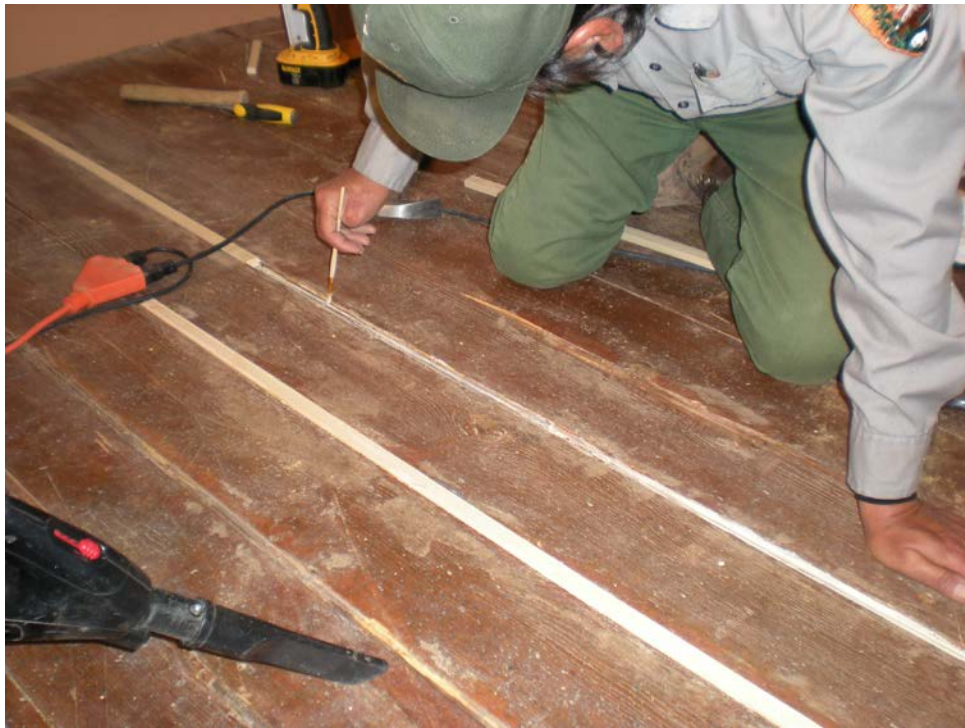
Figure 6.25. "Making repairs to floor" (March 04, 2009).

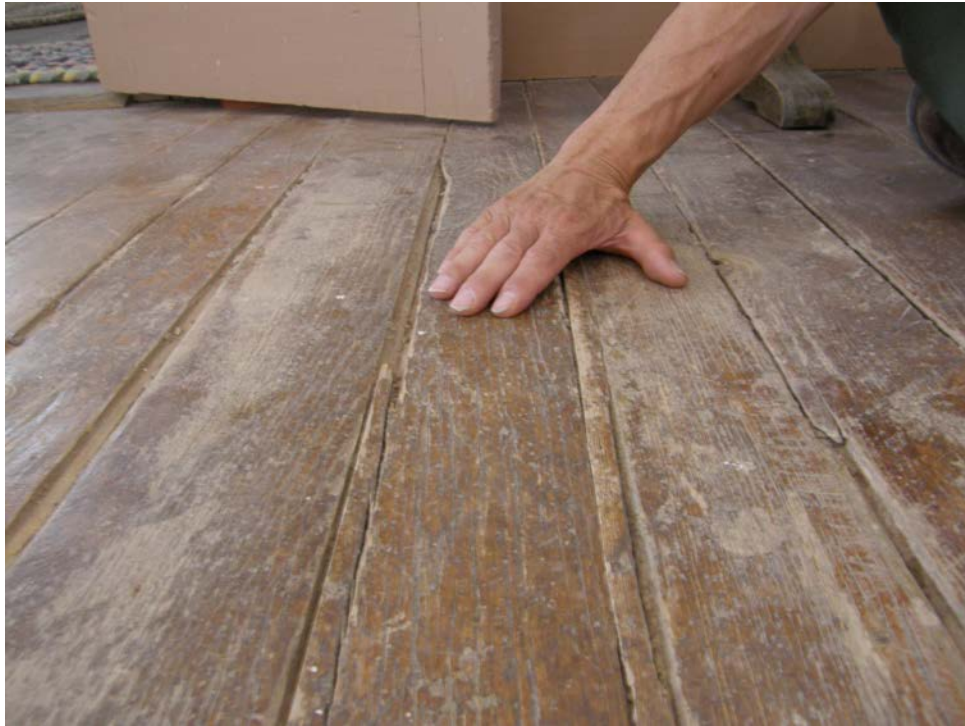
Figure 6.27. "Deteriorating floor" (July 05, 2007).

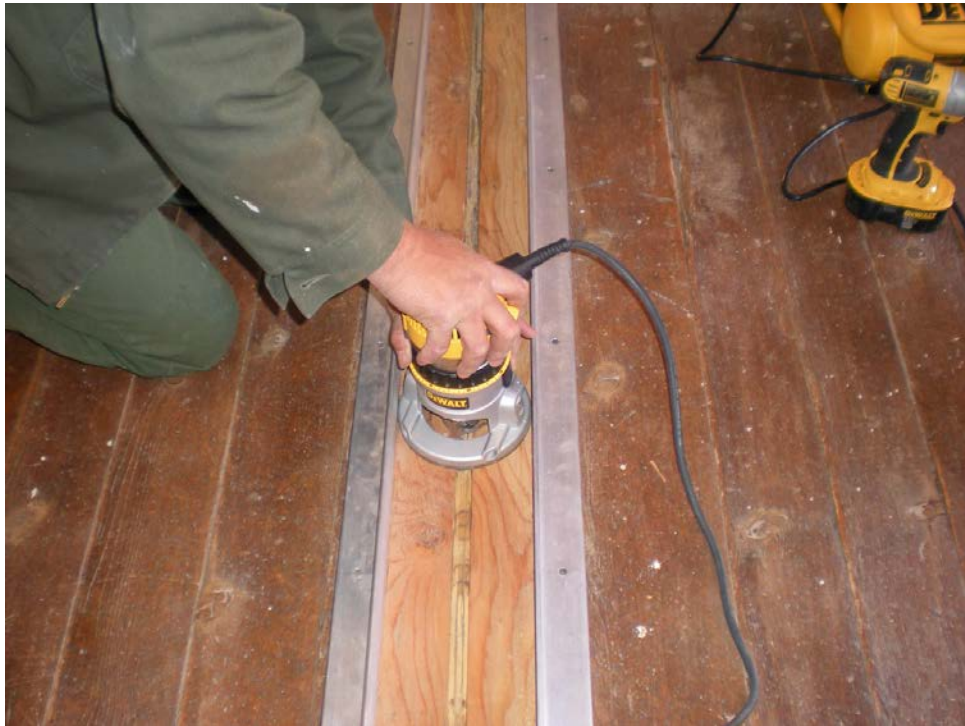
Figure 6.28. "Making repairs to floor" (March 06, 2009).

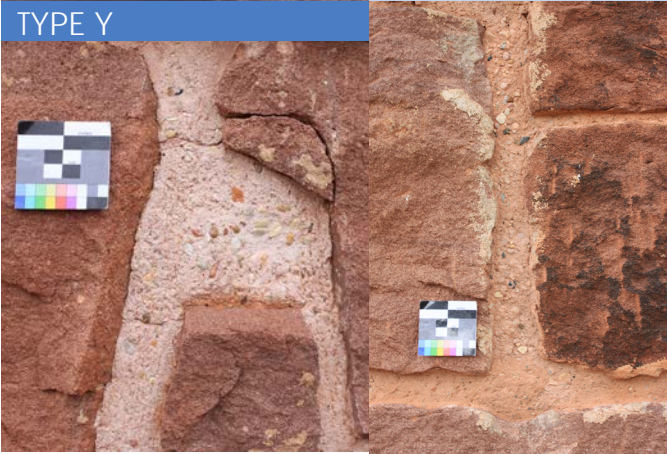
## TYPE Y

NOTE: Onsite, it was believed that this mortar was a separate "type", but upon further investigation, it appears that this mortar is a badly deteriorated form of Mortar Type C (left) and Mortar Type B (right).

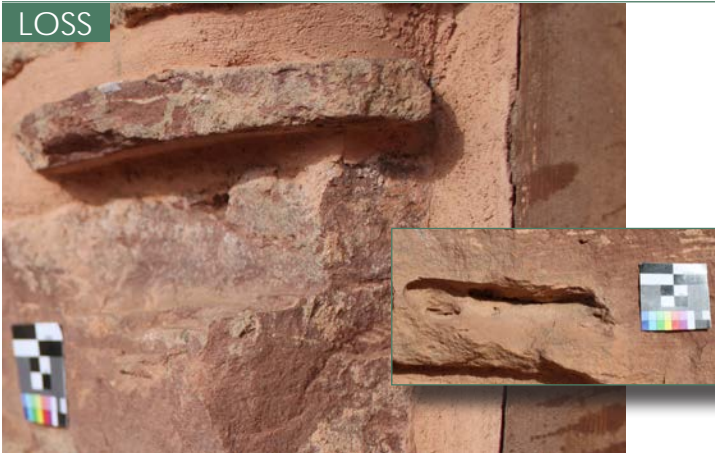
## LOSS

Voids in the stone surface, resulting from erosion, alveolization or mechanical damage.

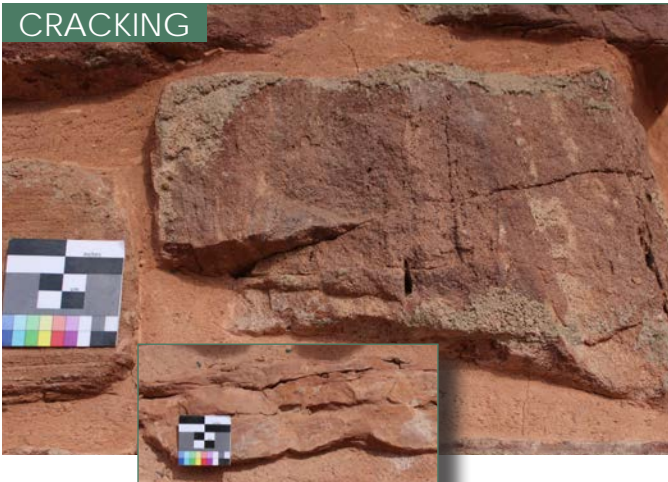
## CRACKING

Individual fissures, over 1/4 inch in width parallel to or across the bedding, result in the fragmentation of the stone.

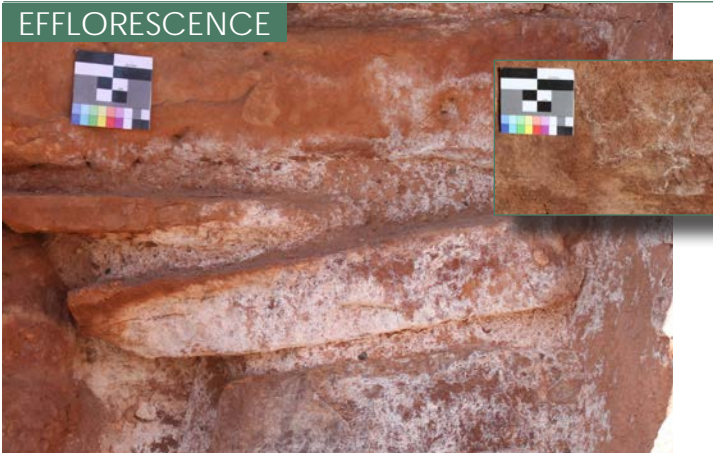
## EFFLORESCENCE

Generally whitish, powdery or whisker-like crystals of water-soluble salts.

This is particularly prevalent on the exterior of the East Cabin, on areas that closely abut the animal stables, as well as interior regions in both cabins that are frequently dampened by ground moisture penetration and rising damp.

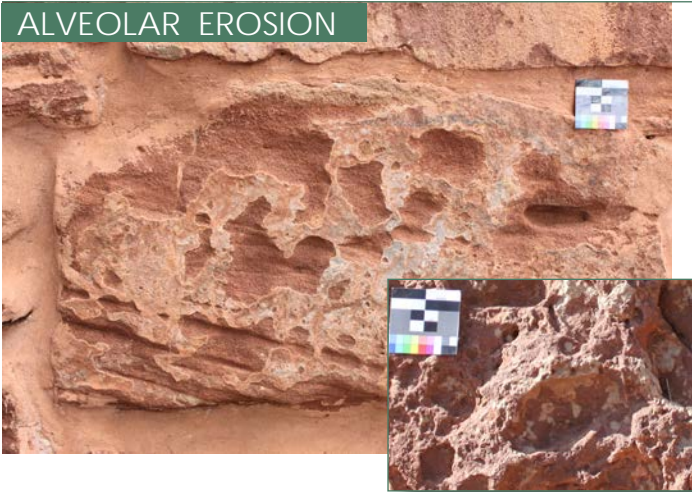
## ALVEOLAR EROSION

Also known as honeycomb weathering, tafoni, stone lattice and cavernous weathering, this condition is the formation of cavities of variable shapes and sizes on the stone surface.

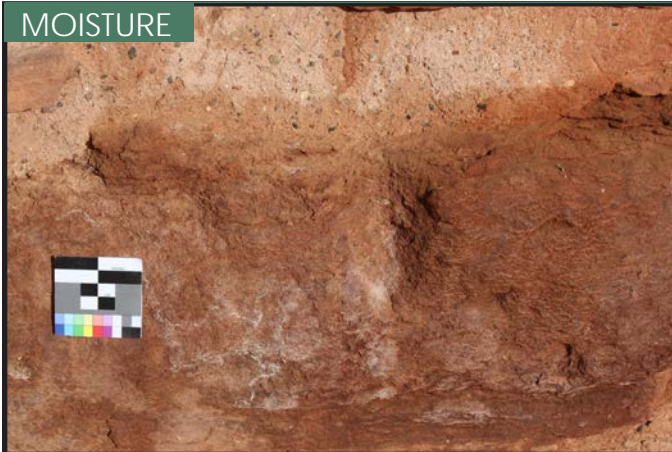
## MOISTURE

Areas of stone and mortar that are both visibly and physically wet.

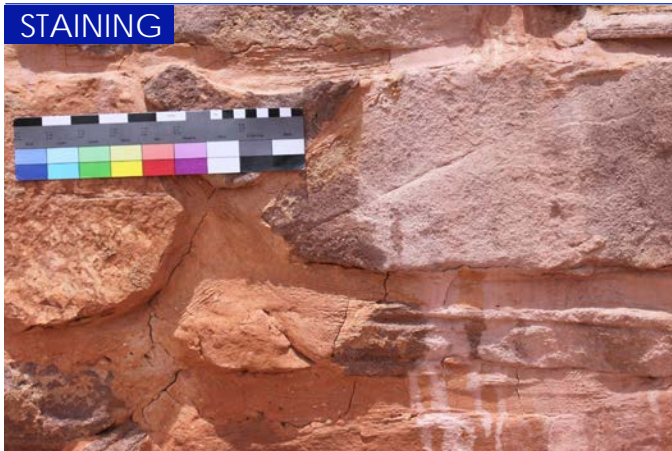
### STAINING

Whitish staining from water flow. These areas are most prevalent in portions of walls that have been recently repointed.

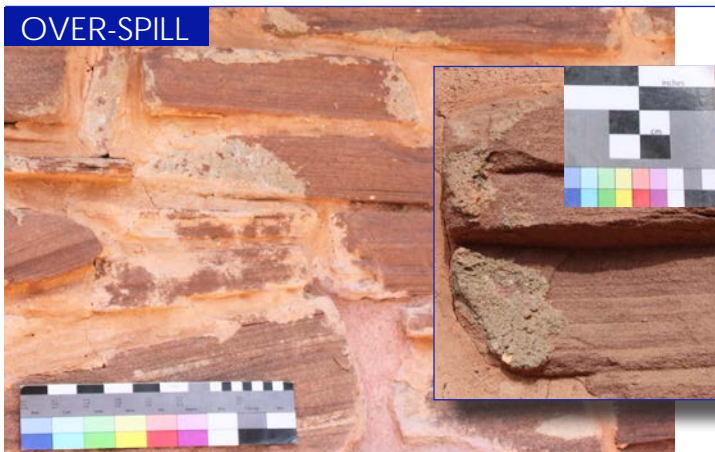
### OVER-SPILL

Whitish gray staining on stone edges from cementitious mortar repointing. This condition is most often a result of careless repointing that has later been replaced, so the mortar is only visible on the stone.

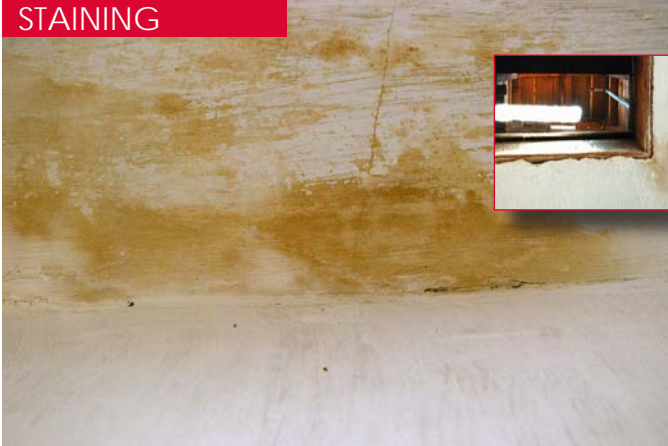
## STAINING

Discoloration of a surface, generally affecting plaster walls and ceilings.

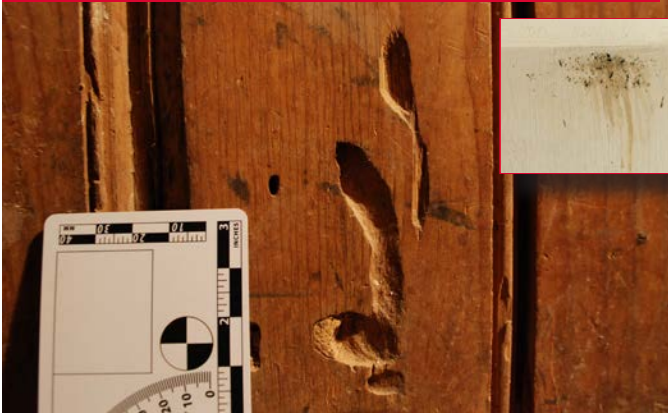
## INSECT DAMAGE AND ANIMAL DEPOSITS

Burrowing or tunneling in wood caused by termites and other insects. Guano or deposits due to bats and small animals.

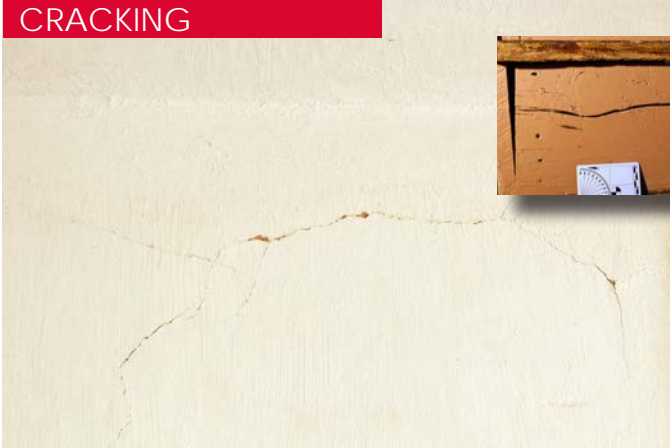
## CRACKING

Cracks caused by shrinking and swelling of wood due to changes in moisture content, and hairline and network cracking found within the plaster.

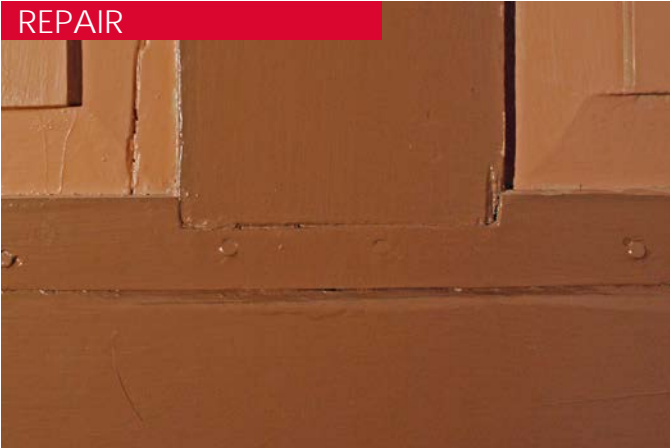
## REPAIR

In-kind replacement or fill of wood features due to displacement, moisture damage, or mechanical damage.
