**Re: Second National Bank
Philadelphia, PA
Ryan-Biggs Project 9644**

At your request, Ryan-Biggs has performed a study of the Second National Bank in Philadelphia at the Independence National Historical Park. Our study included nondestructive testing and structural analysis of selected marble columns. This report documents the results of our study.

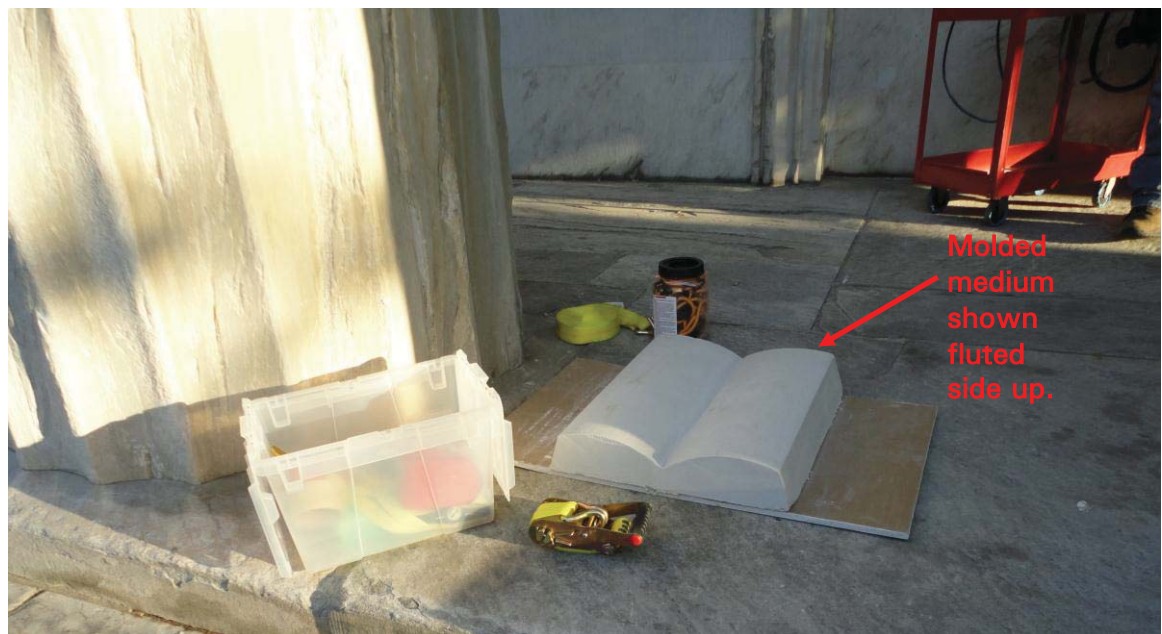
Photograph 1 - Molded medium for SPR.

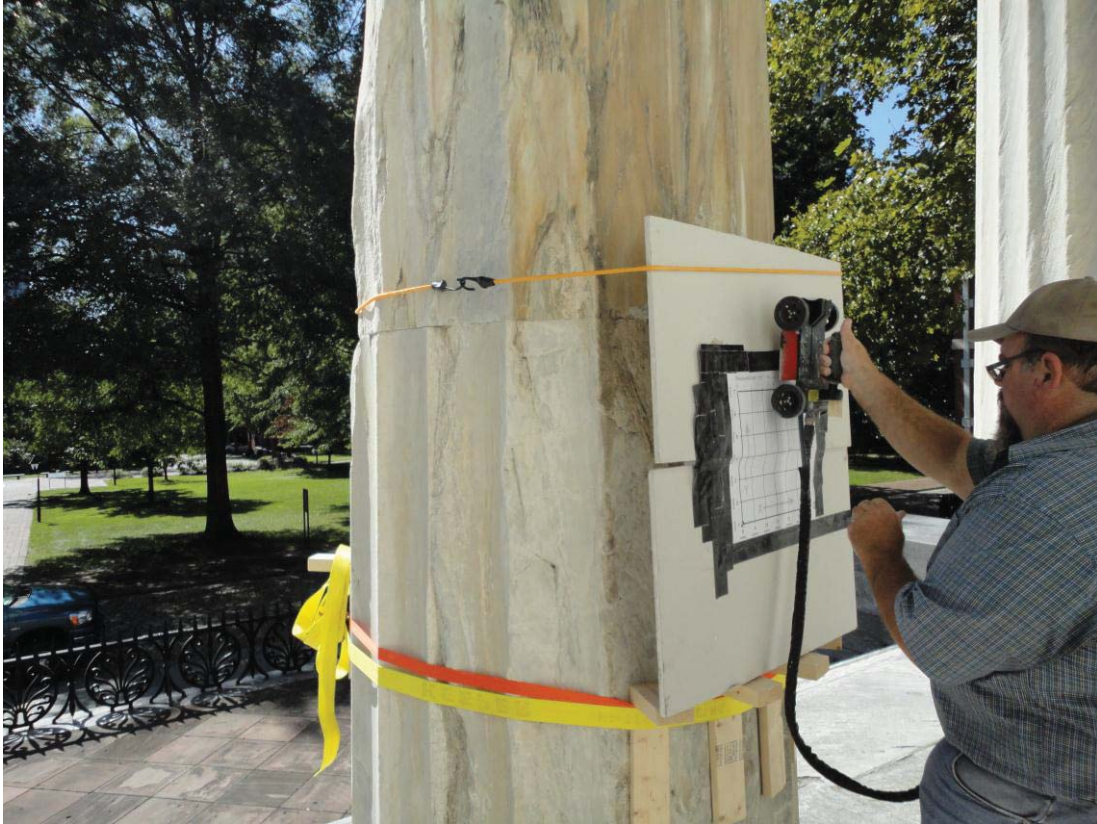
Photograph 2 - SPR scanning.

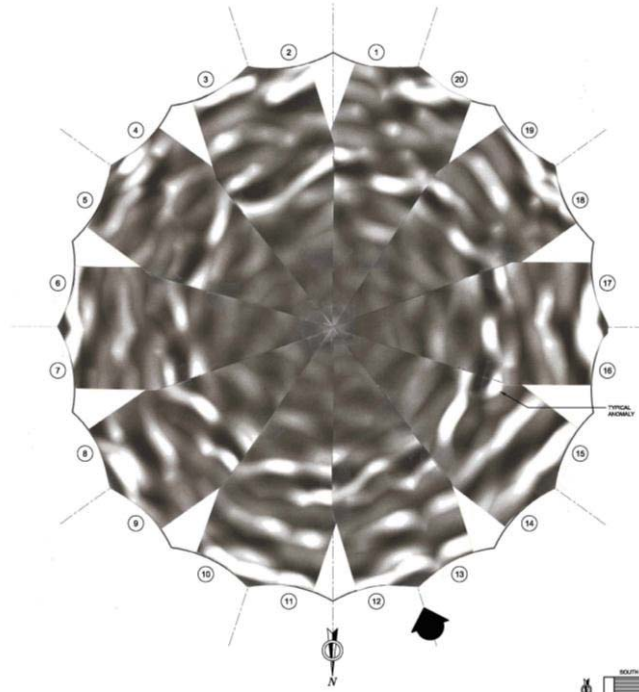
The software does not digitally join individual scans together. Figure 1 shows 10 individual scans from Column 7 that were printed and manually pasted together to represent a horizontal slice of the column. Photograph 2 was taken at Column 3 on the south elevation. Drawing S-1 is attached with this information.

Figure 1 - SPR scan slice.

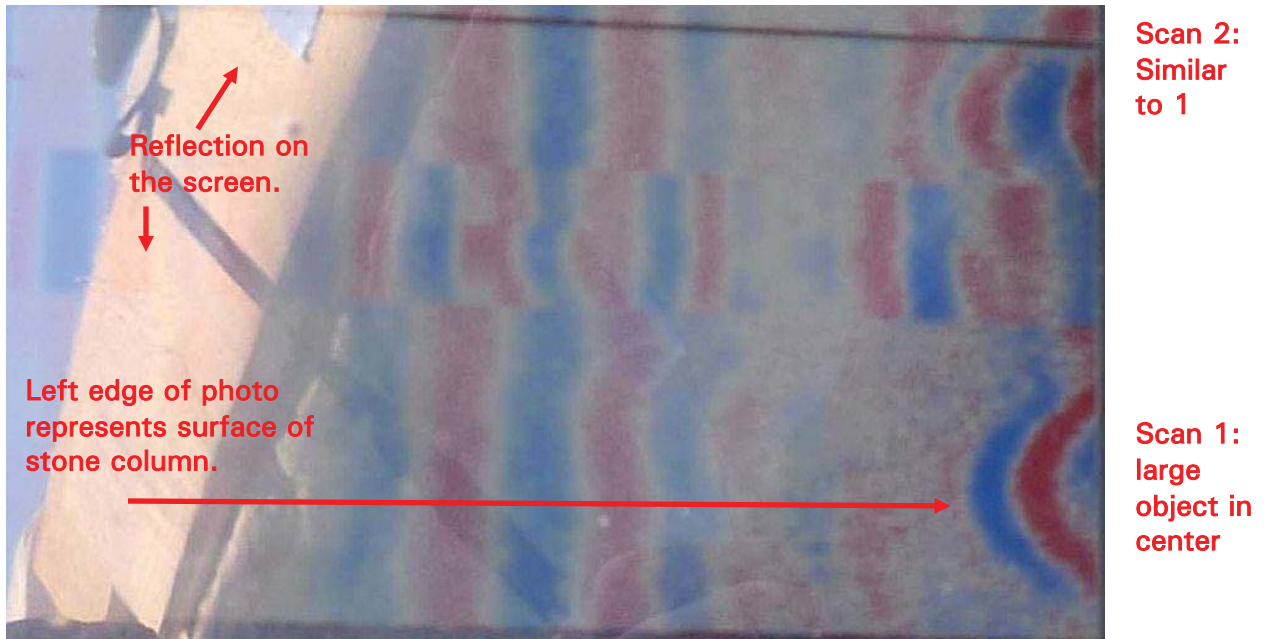
There are several antennas available for SPR. An additional set of scans was performed with a 900Mhz antenna. The manufacturer does not provide software for this antenna. Scan results are only available as individual views. Photograph 3 was taken of the screen showing two vertical scans at the joint between two drums. Unfortunately, the photograph picked up some reflection of the column itself. The wavelength is approximately 5.5 inches and the resolution is not as clear as the 1.6Ghz antenna. However in both scans, we noted that there is a large spherical object in the center of the joint. There is historical information that the architect, William Strickland, used a cannonball to join the column drums. It is likely he did so for this building as the 900Mhz antenna was able to clearly identify a center object. That same clarity is not evident in the scans performed with the 1.6Ghz antenna.

Photograph 3 - Scan at joint showing large object at center.

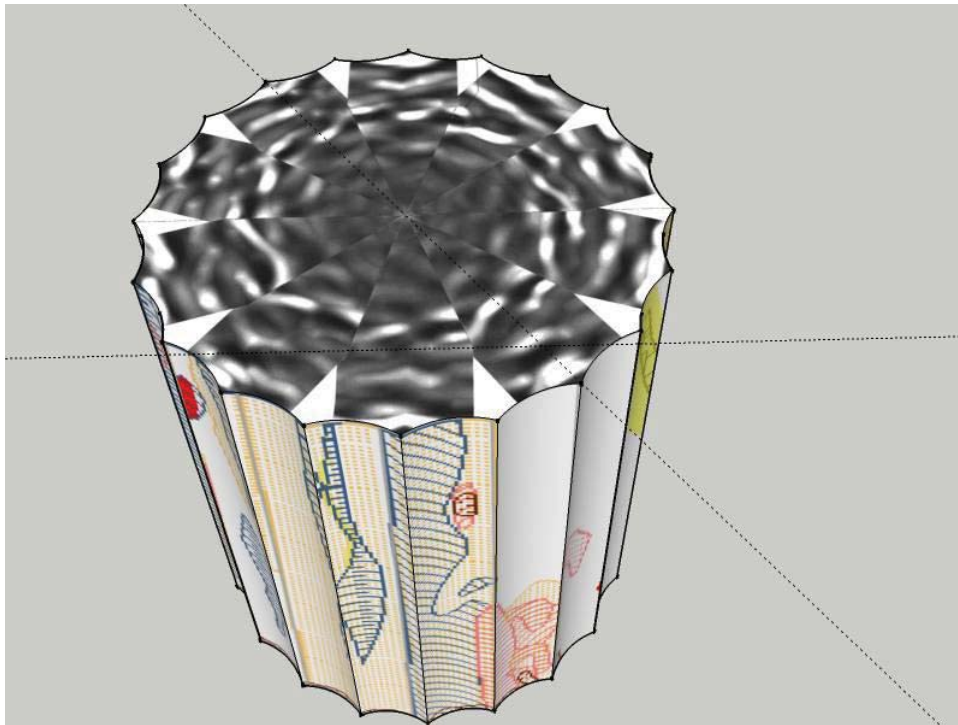
Figure 2 - Scan with visual results.

There is correlation of the surface defects with the scans. Internally, we see what appear to be radially-oriented anomalies (white areas). While they appear discontinuous from one scan to another, this can be a result of the accuracy of pasting multiple scans together. Digital improvements to the software could correct this.

From the scan slice, there does not appear to be any clear veining straight through this column section. However, the white areas likely represent a reduced density that shows up as an anomaly and could be veining or internal fracturing. These need to be confirmed.

Based upon the scan results, internal weakness is a concern for the long-term stability of the columns.

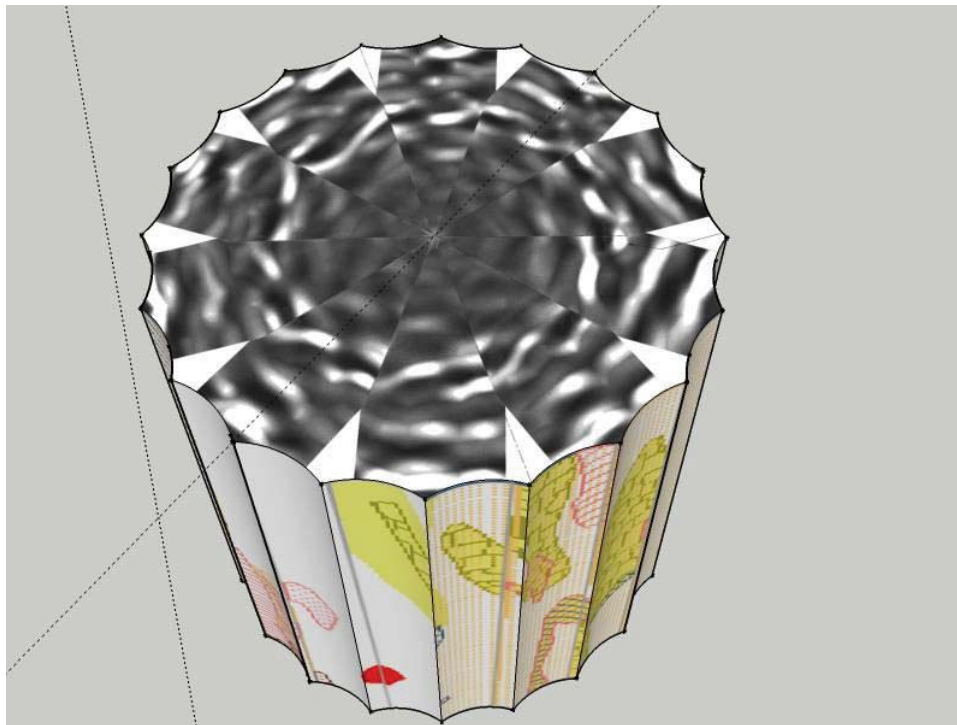
Figure 3 - Scan with visual results.

2. While the SPR scanning appears to be moderately successful, the weak areas within the stone need to be confirmed. Based upon the scan results in Figure 3, there appear to be internal flaws that weaken the columns.
3. The molded medium was fairly tight to the columns. We don't know if the moisture in the medium had a detrimental effect on the scanning.

2. After these scans are complete, perform destructive testing to determine the condition of the scanned white images and changes in the material. This information can be correlated back to the column scans.

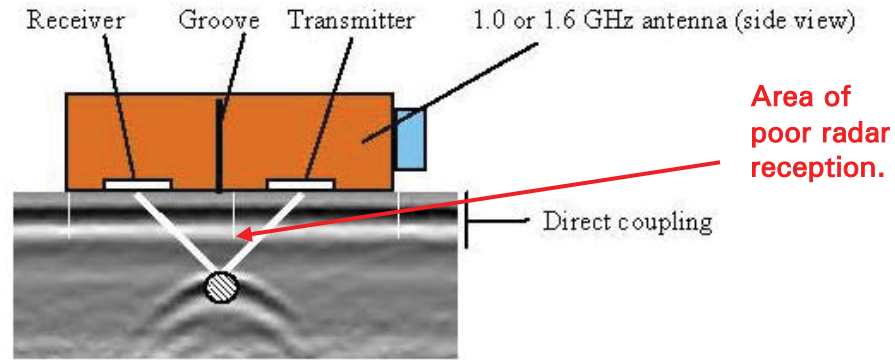
Figure 4 is a graphic of the relative location of the transmitter and receiver within the equipment. The area above the signals generally does not record accurately; usually the top 2 to 2.5 inches. For this project, that area is mostly in the molded medium. Thus, one unexpected result of using the molded medium is that the scanning is generally accurate on the surface of the columns because the medium places the surface of the stone below the area of poor reception.

Figure 4 - Graphic of radar transmitter and receiver.

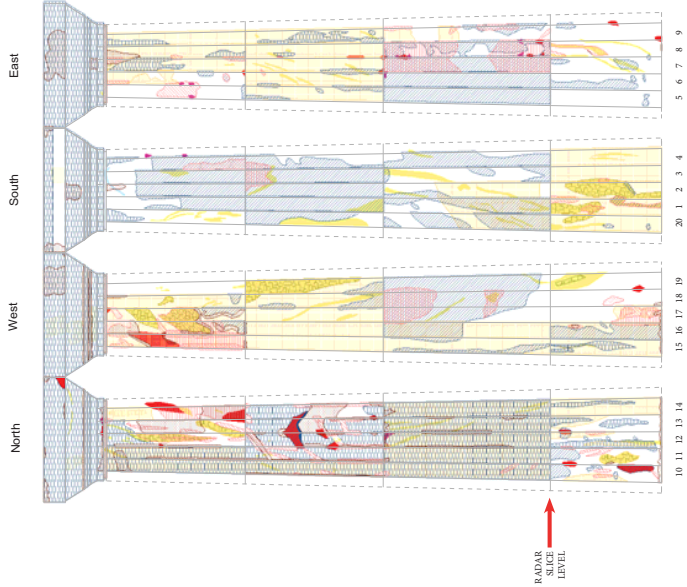
② SECTION
 S1 SCALE: 3" = 1'-0"

Existing Surface Conditions
 Column Number Seven
