A Structural Analysis of the Performance of
Nondestructive Testing Methods

Second Bank of the United States

Independence National Historical Park

**Re: Second National Bank
Philadelphia, PA
Ryan-Biggs Project 9644**

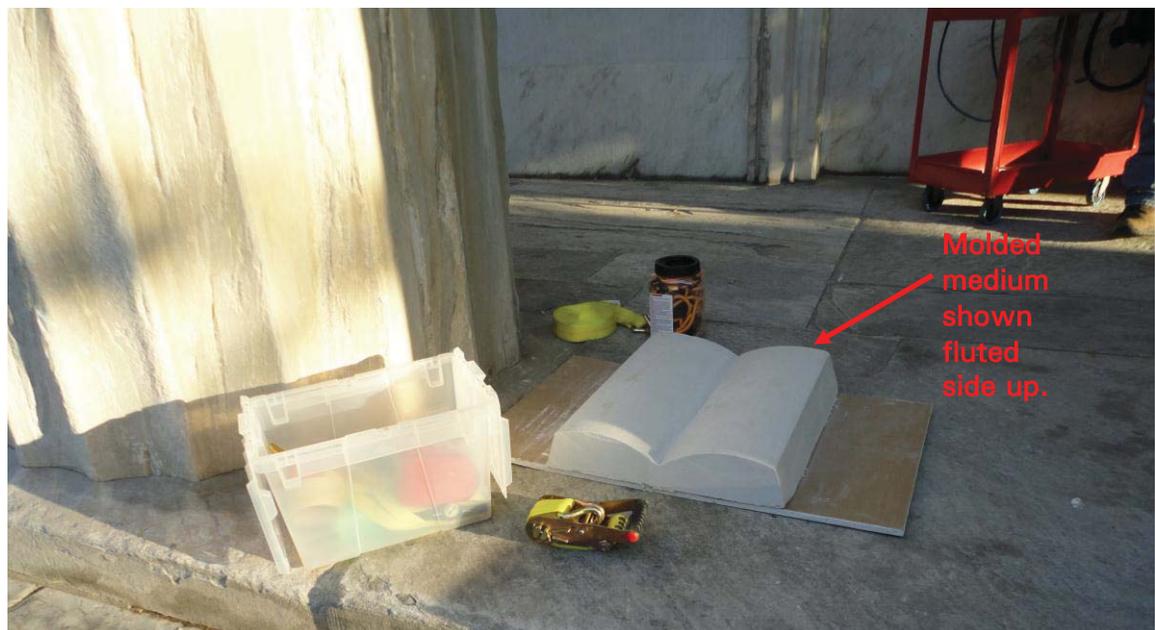
Photograph 1 - Molded medium for SPR.

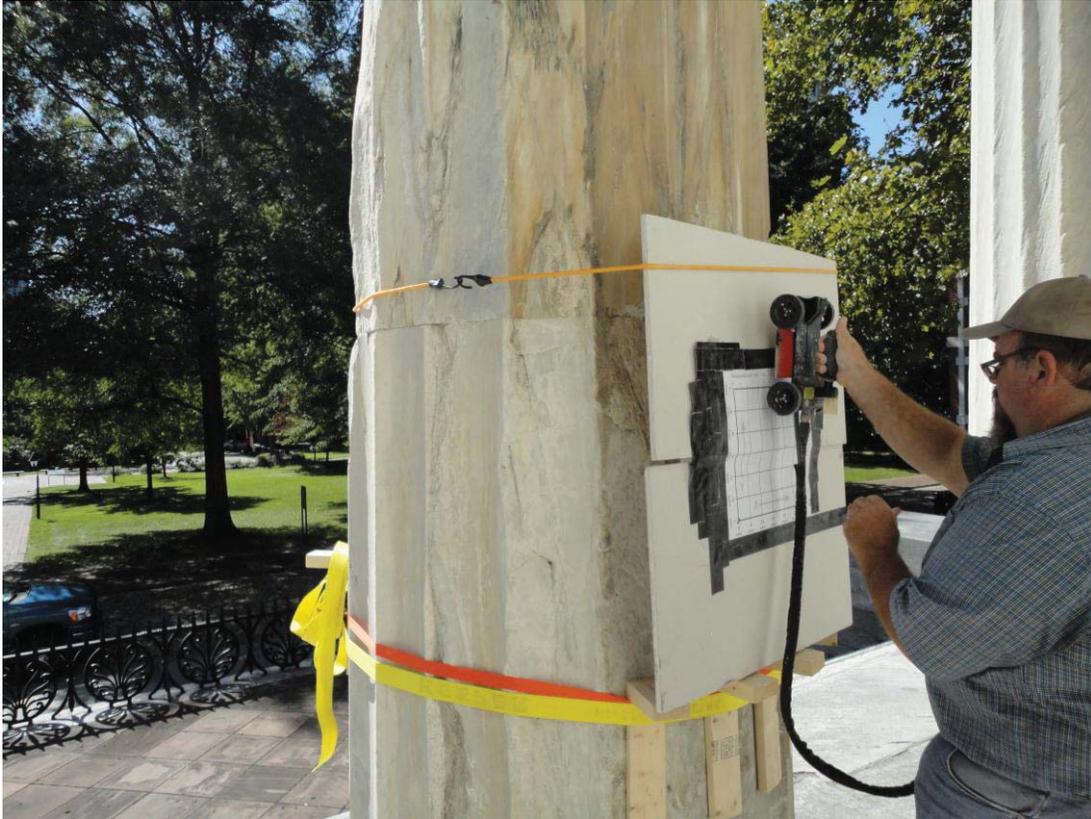
The medium was supported and strapped to a column. A paper target with a grid was attached to the smooth outer surface of the medium (Photograph 2). This method allowed one 12-inch by 12-inch scan that extended into the stone and covered most of two fluted areas. Since there are 20 flutes, 10 scans are required for each column at each level.

Photograph 2 - SPR scanning.

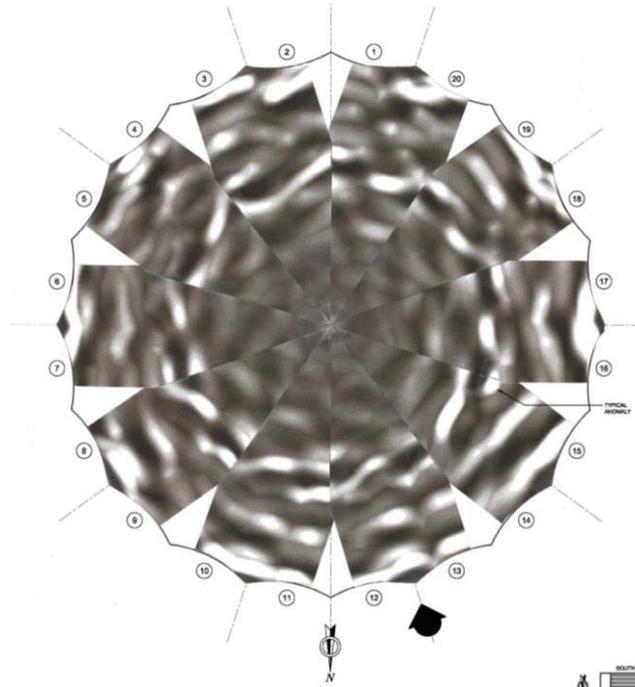
The software does not digitally join individual scans together. Figure 1 shows 10 individual scans from Column 7 that were printed and manually pasted together to represent a horizontal slice of the column. Photograph 2 was taken at Column 3 on the south elevation. Drawing S-1 is attached with this information.

Figure 1 - SPR scan slice.

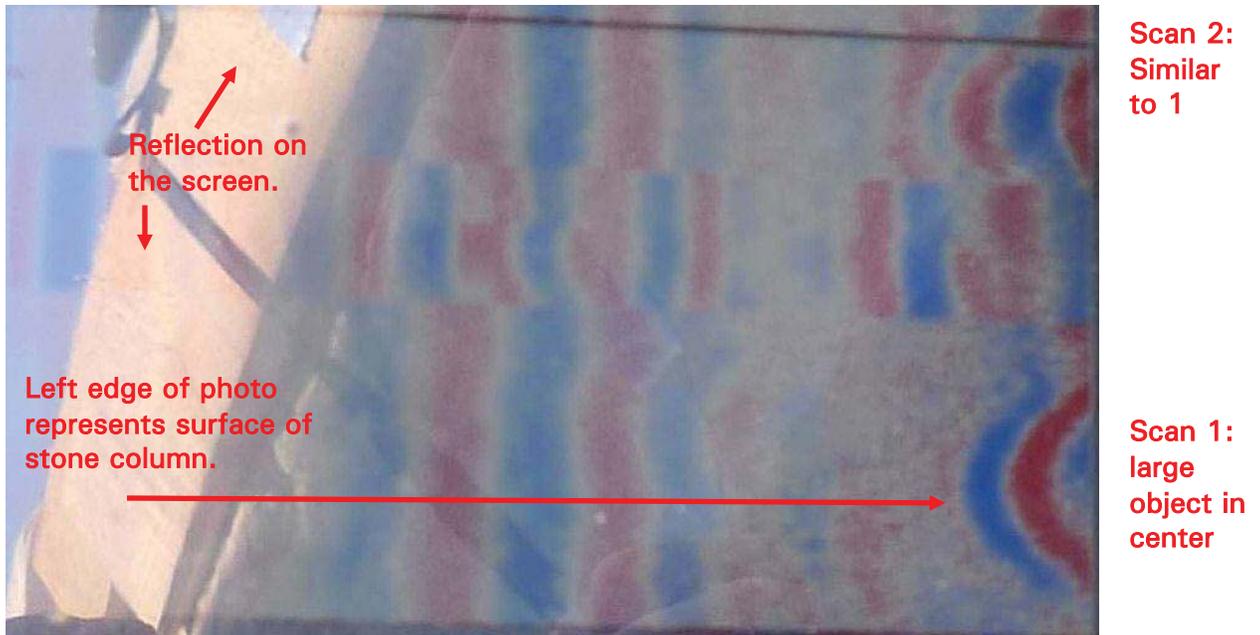
There are several antennas available for SPR. An additional set of scans was performed with a 900Mhz antenna. The manufacturer does not provide software for this antenna. Scan results are only available as individual views. Photograph 3 was taken of the screen showing two vertical scans at the joint between two drums. Unfortunately, the photograph picked up some reflection of the column itself. The wavelength is approximately 5.5 inches and the resolution is not as clear as the 1.6Ghz antenna. However in both scans, we noted that there is a large spherical object in the center of the joint. There is historical information that the architect, William Strickland, used a cannonball to join the column drums. It is likely he did so for this building as the 900Mhz antenna was able to clearly identify a center object. That same clarity is not evident in the scans performed with the 1.6Ghz antenna.

Photograph 3 - Scan at joint showing large object at center.

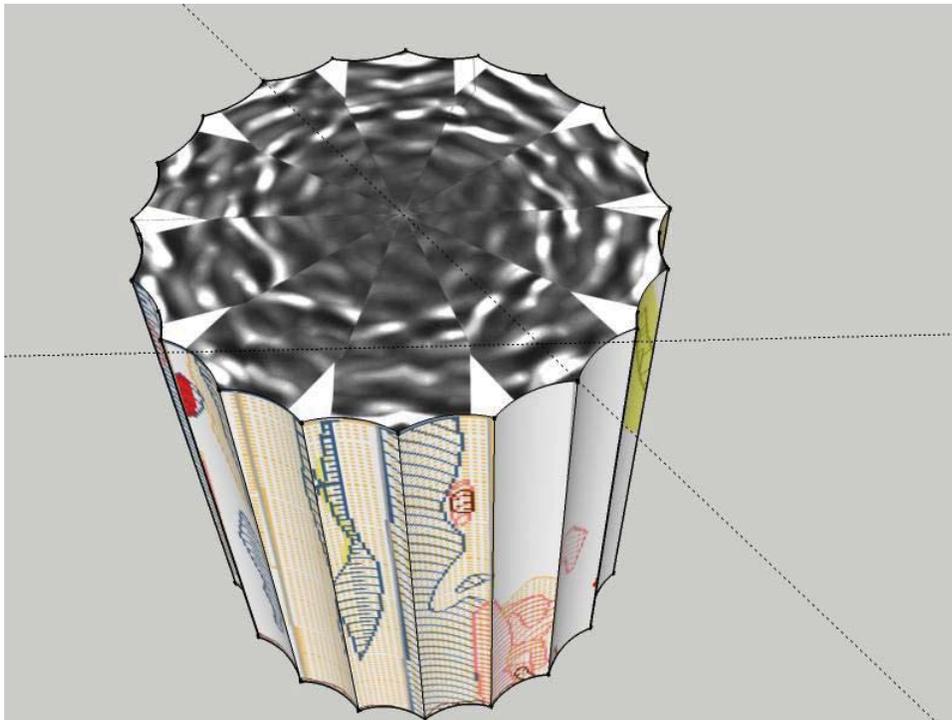
Figure 2 - Scan with visual results.

There is correlation of the surface defects with the scans. Internally, we see what appear to be radially-oriented anomalies (white areas). While they appear discontinuous from one scan to another, this can be a result of the accuracy of pasting multiple scans together. Digital improvements to the software could correct this.

From the scan slice, there does not appear to be any clear veining straight through this column section. However, the white areas likely represent a reduced density that shows up as an anomaly and could be veining or internal fracturing. These need to be confirmed.

Based upon the scan results, internal weakness is a concern for the long-term stability of the columns.

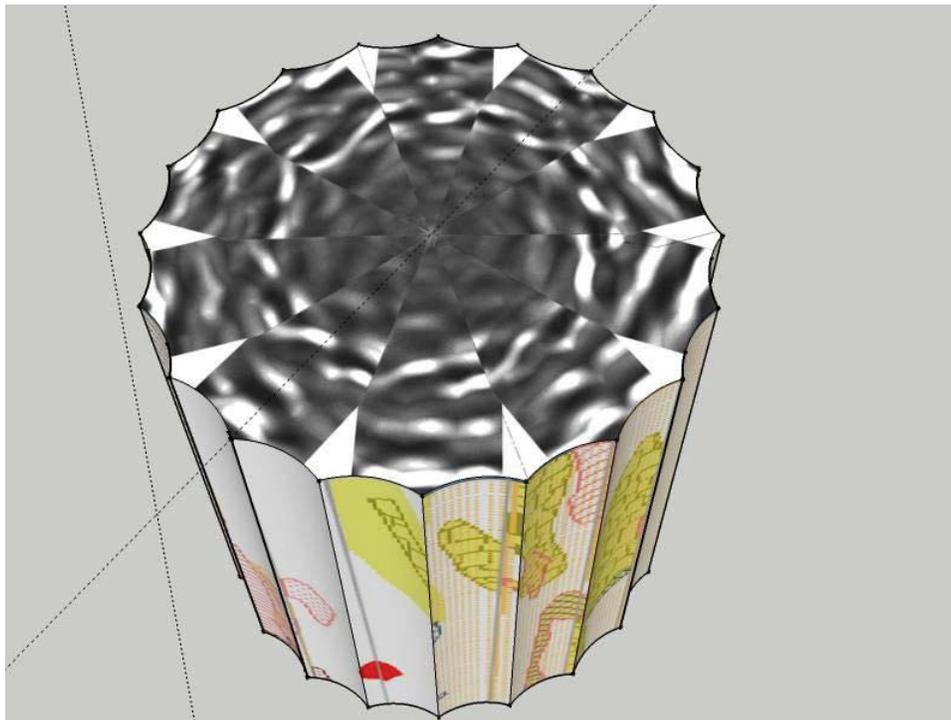
Figure 3 - Scan with visual results.

2. While the SPR scanning appears to be moderately successful, the weak areas within the stone need to be confirmed. Based upon the scan results in Figure 3, there appear to be internal flaws that weaken the columns.
3. The molded medium was fairly tight to the columns. We don't know if the moisture in the medium had a detrimental effect on the scanning.

1. Obtain a piece of stone from the building or the original quarry and perform radar scanning. Using a flat piece, perform scans with and without the medium. This might lead to a change in the medium for subsequent scans.

2. After these scans are complete, perform destructive testing to determine the condition of the scanned white images and changes in the material. This information can be correlated back to the column scans.

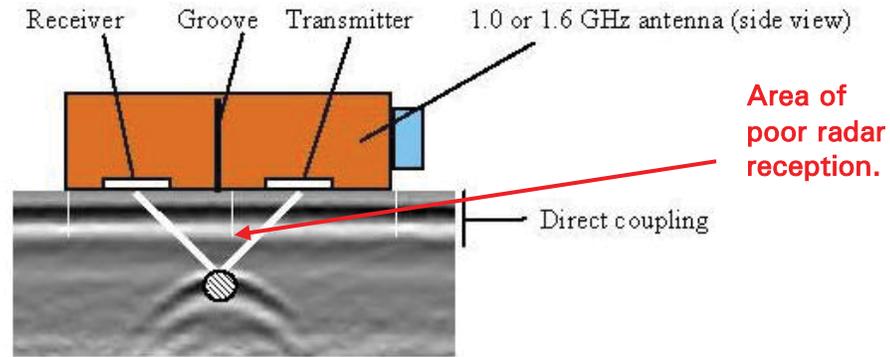
Figure 4 is a graphic of the relative location of the transmitter and receiver within the equipment. The area above the signals generally does not record accurately; usually the top 2 to 2.5 inches. For this project, that area is mostly in the molded medium. Thus, one unexpected result of using the molded medium is that the scanning is generally accurate on the surface of the columns because the medium places the surface of the stone below the area of poor reception.

Figure 4 - Graphic of radar transmitter and receiver.

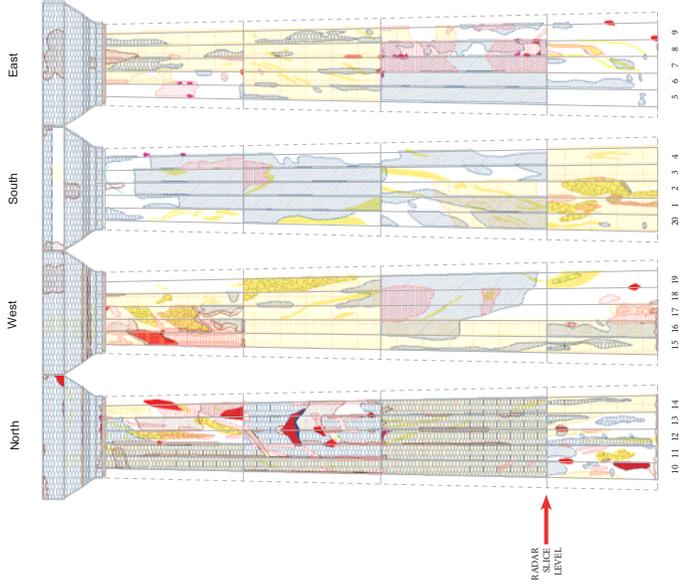
② SECTION
 S1 SCALE: 3" = 1'-0"

Existing Surface Conditions
 Column Number Seven

TEST COLUMN
 SCANS TAKEN AT JOINT
 SECOND DRIVING ABOVE
 LANDING
