OF THE UNITED STATES
INDEPENDENCE NATIONAL HISTORICAL PARK
PHILADELPHIA, PA

NORTH PORTICO COLUMNS AND BACKWALL

PHASE TWO PLOTTED:
CONDITIONS ASSESSMENT SURVEY:

PHASE ONE | PLOTTED: 08/20/99 - GRM
 CONDITIONS ASSESSMENT SURVEY: N-W ELEVATIONS

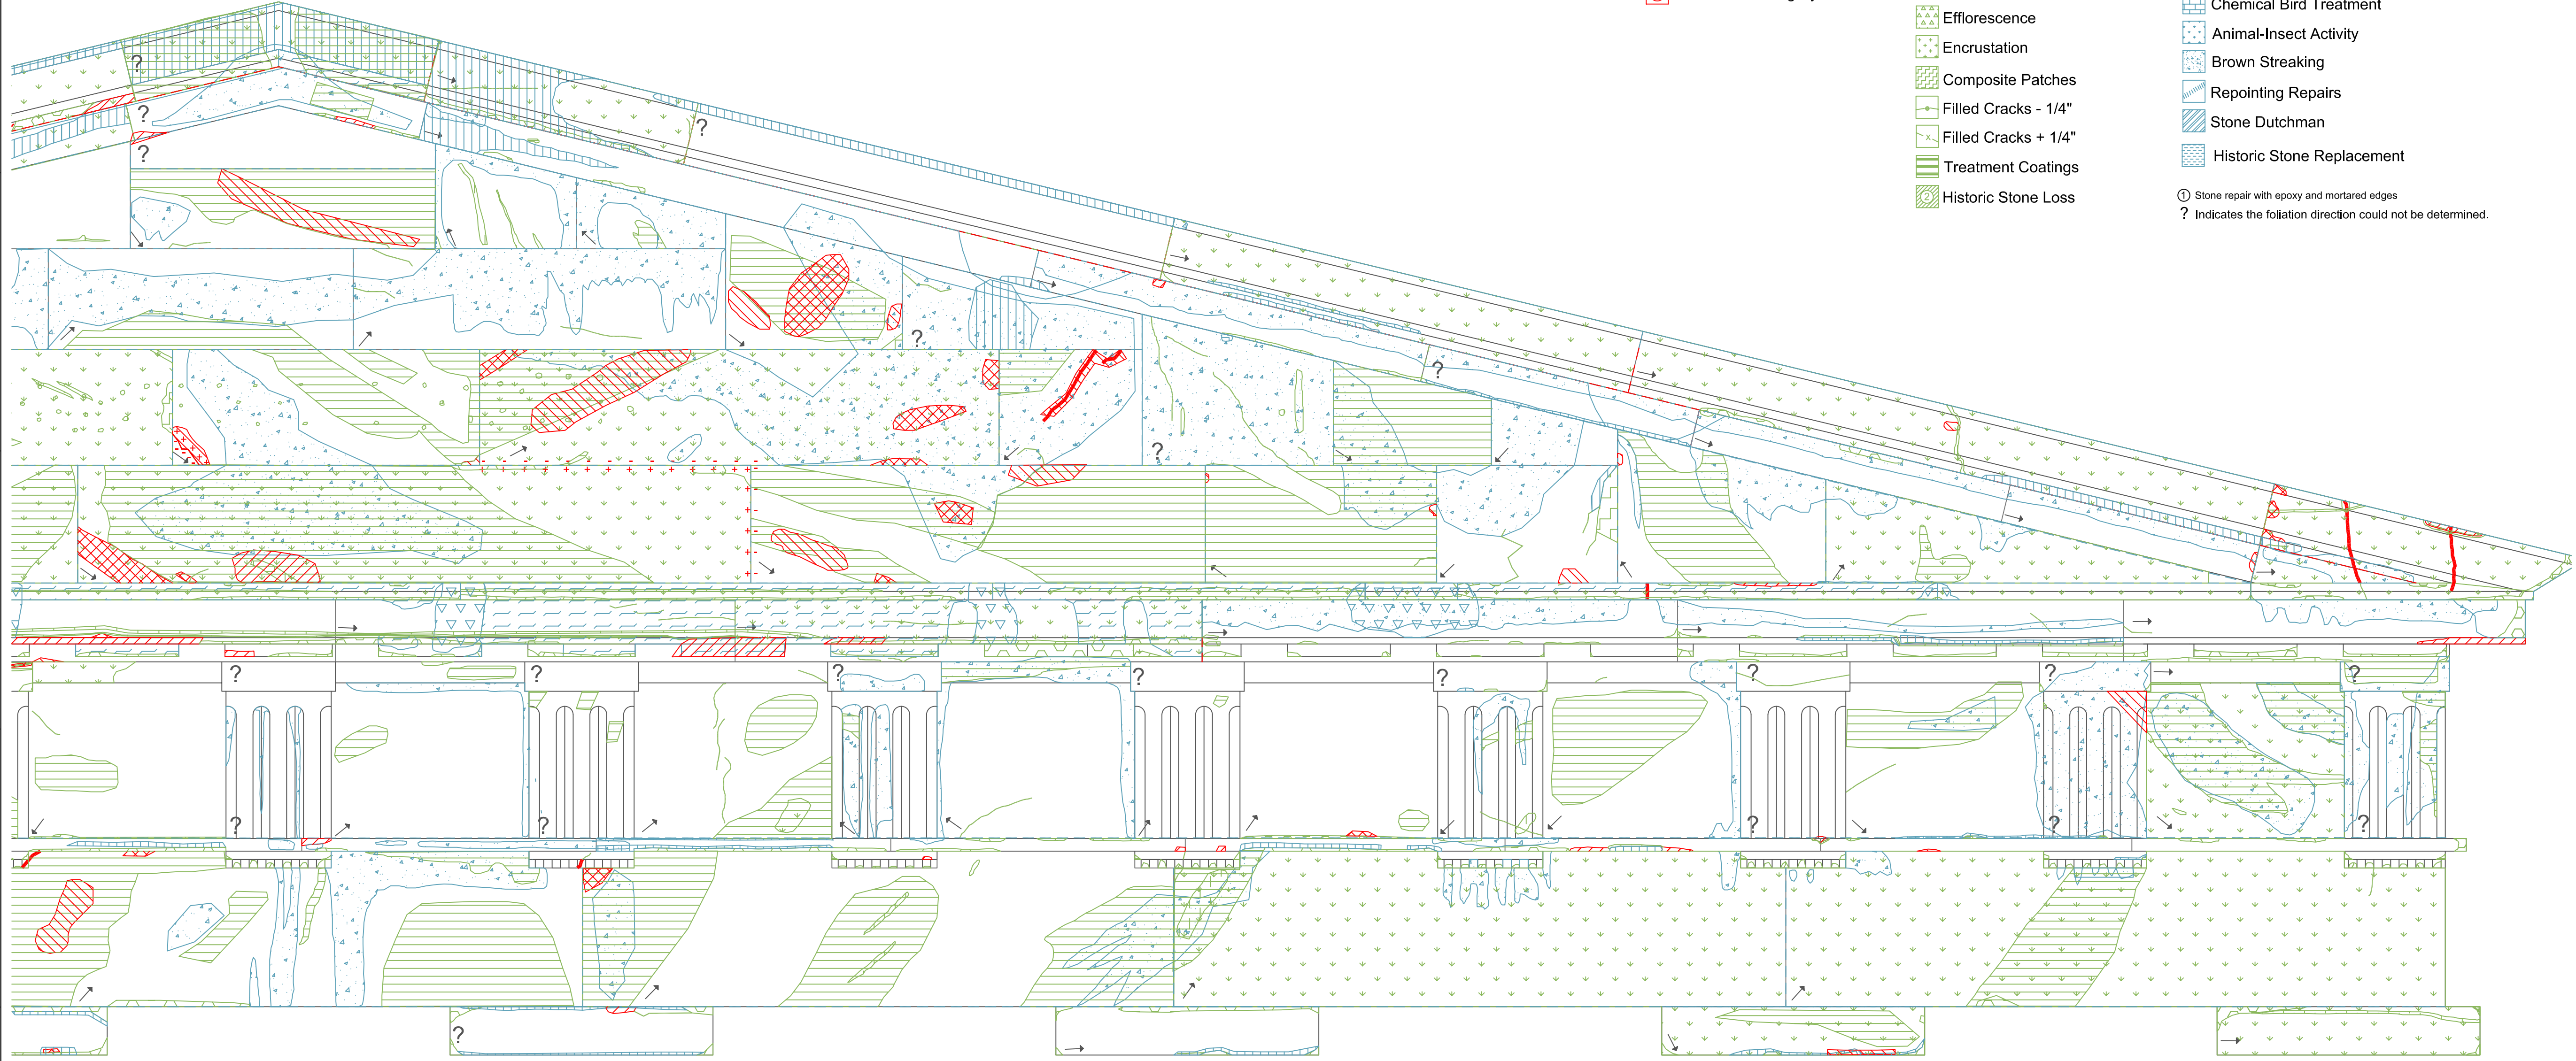
C1 NORTH PORTICO PEDIMENT - West Half
SCALE 1/4" = 1' 0"

1. Entire raking cornice has metallic staining from the roof

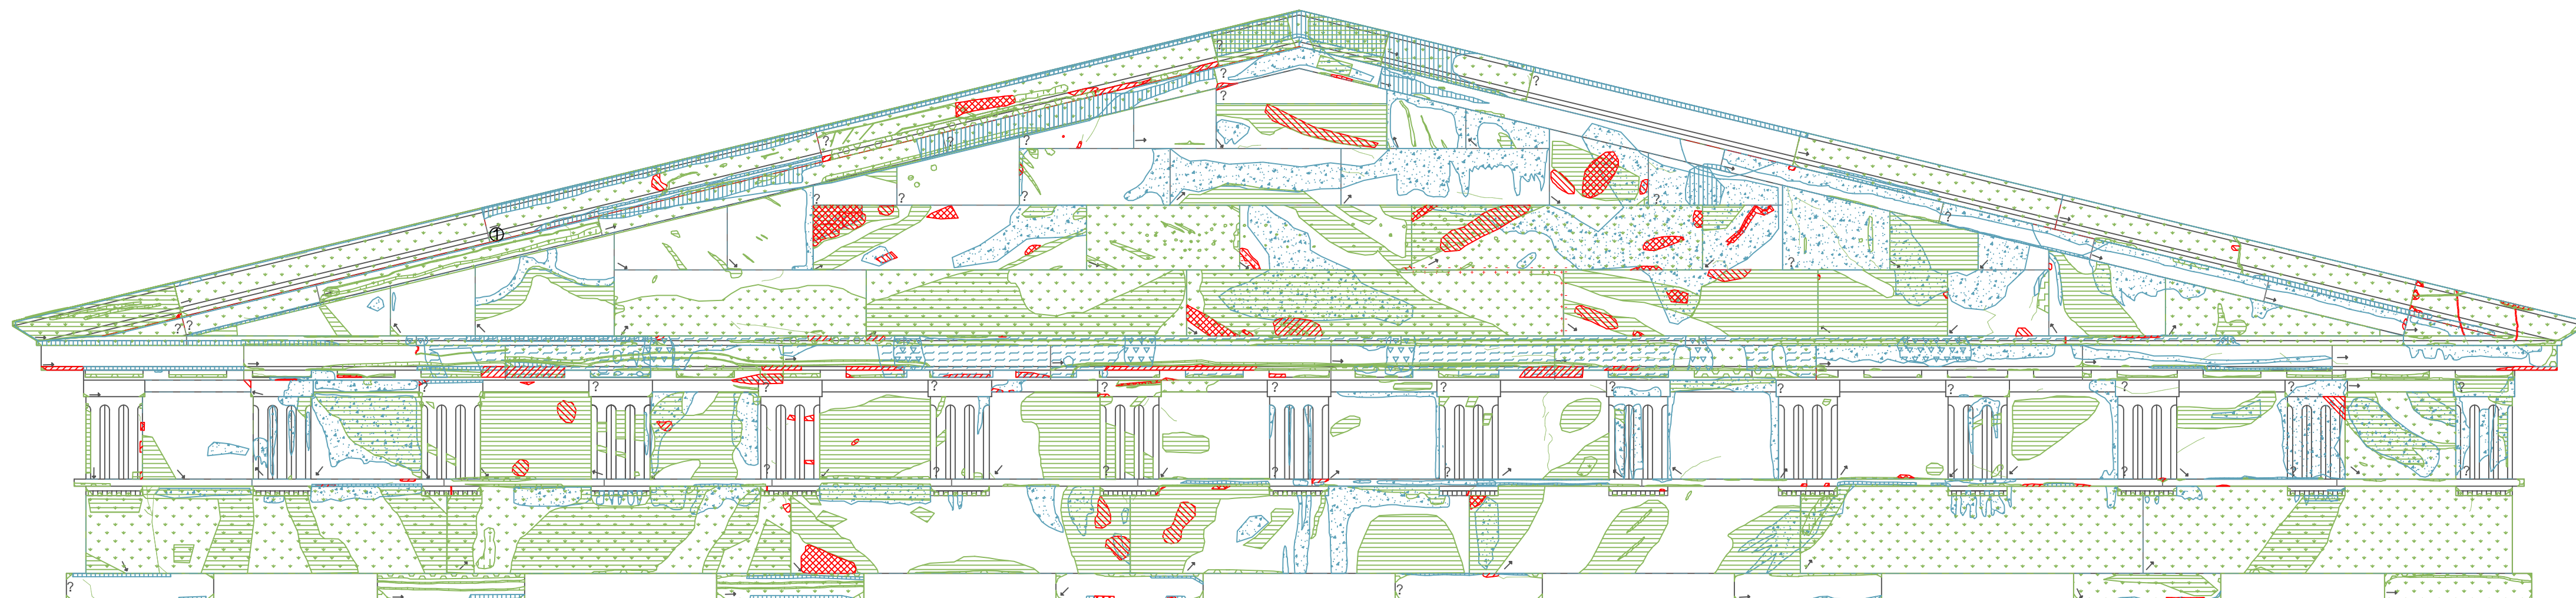
1. Entire raking cornice has metallic staining from the roof
