THE PENNSYLVANIA BLUE PROJECT

Documentation and Conditions Survey of the Exterior Marble Masonry

THE SECOND BANK OF THE UNITED STATES
INDEPENDENCE NATIONAL HISTORICAL PARK
PHILADELPHIA, PENNSYLVANIA

The Architectural Conservation Laboratory and Research Center
051 Duhring Wing
University of Pennsylvania

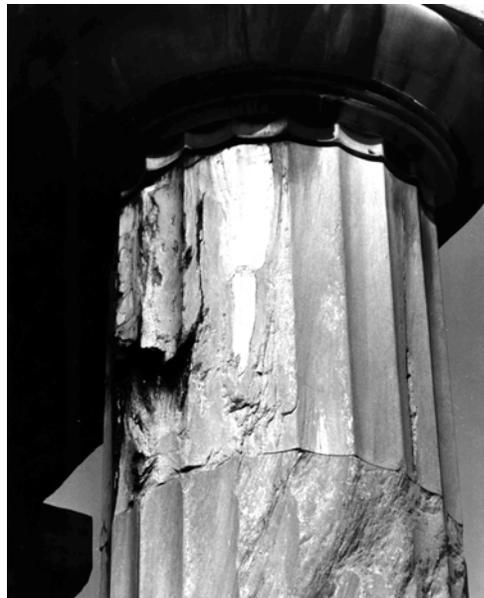
Figure 5: North portico, column 1, incipient spalling. 1961.

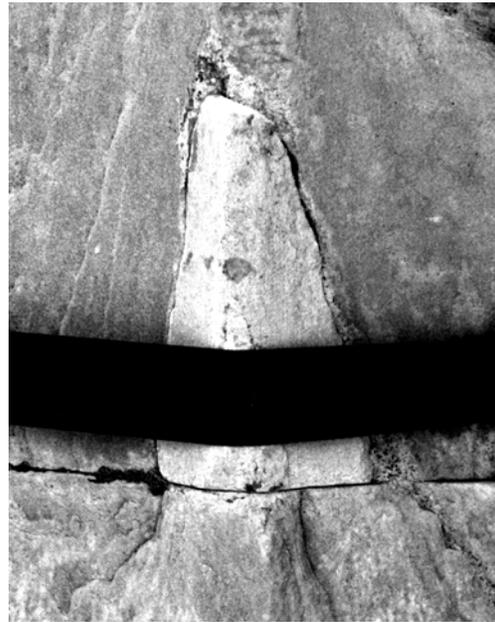
Figure 10: South portico, column 2, marble epoxy repair. 1986.

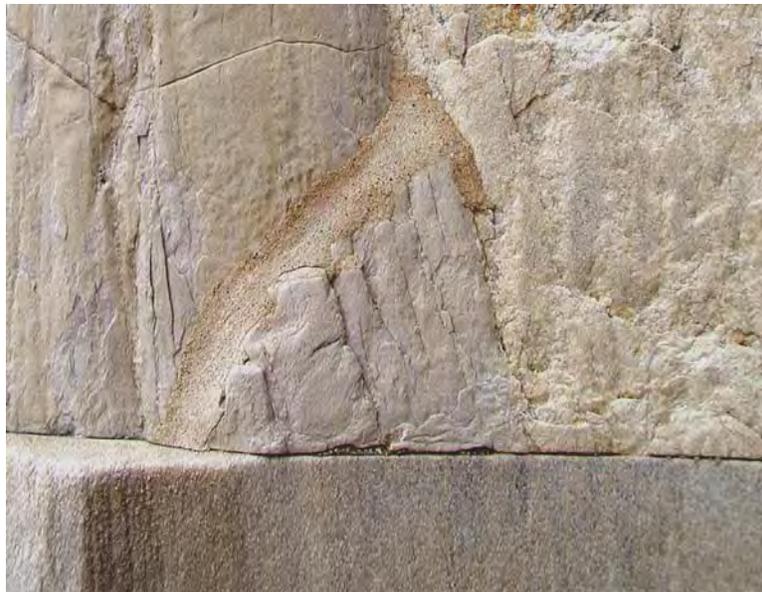
Figure 11: Existing conditions on the columns of the south elevation. Summer 2003.

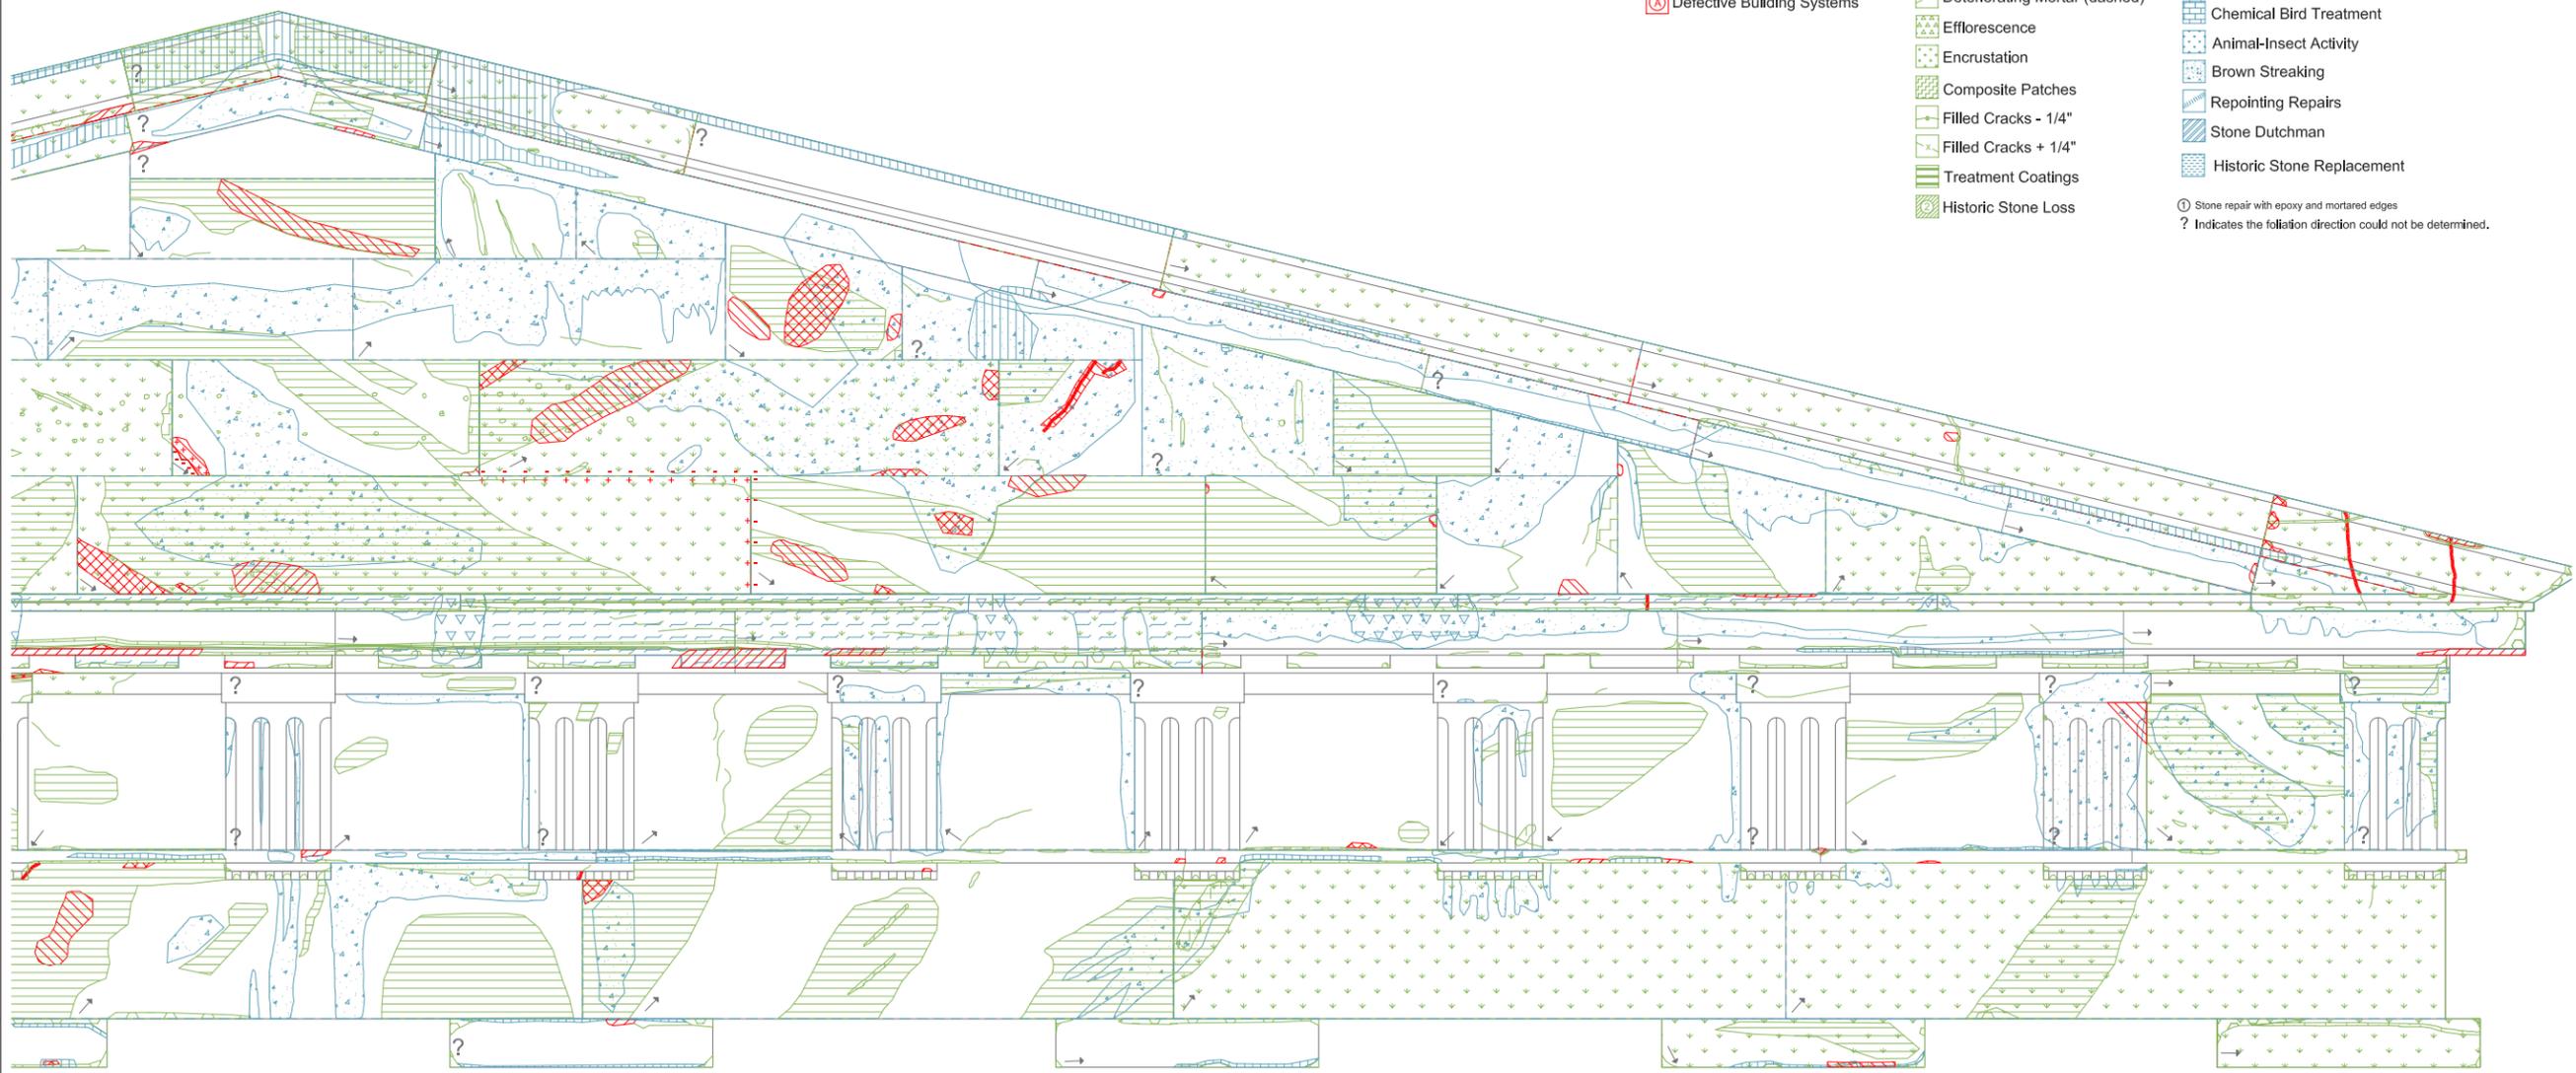
C1 NORTH PORTICO PEDIMENT - West Half
SCALE 1/4" = 1' 0"

1. Entire raking cornice has metallic staining from the roof

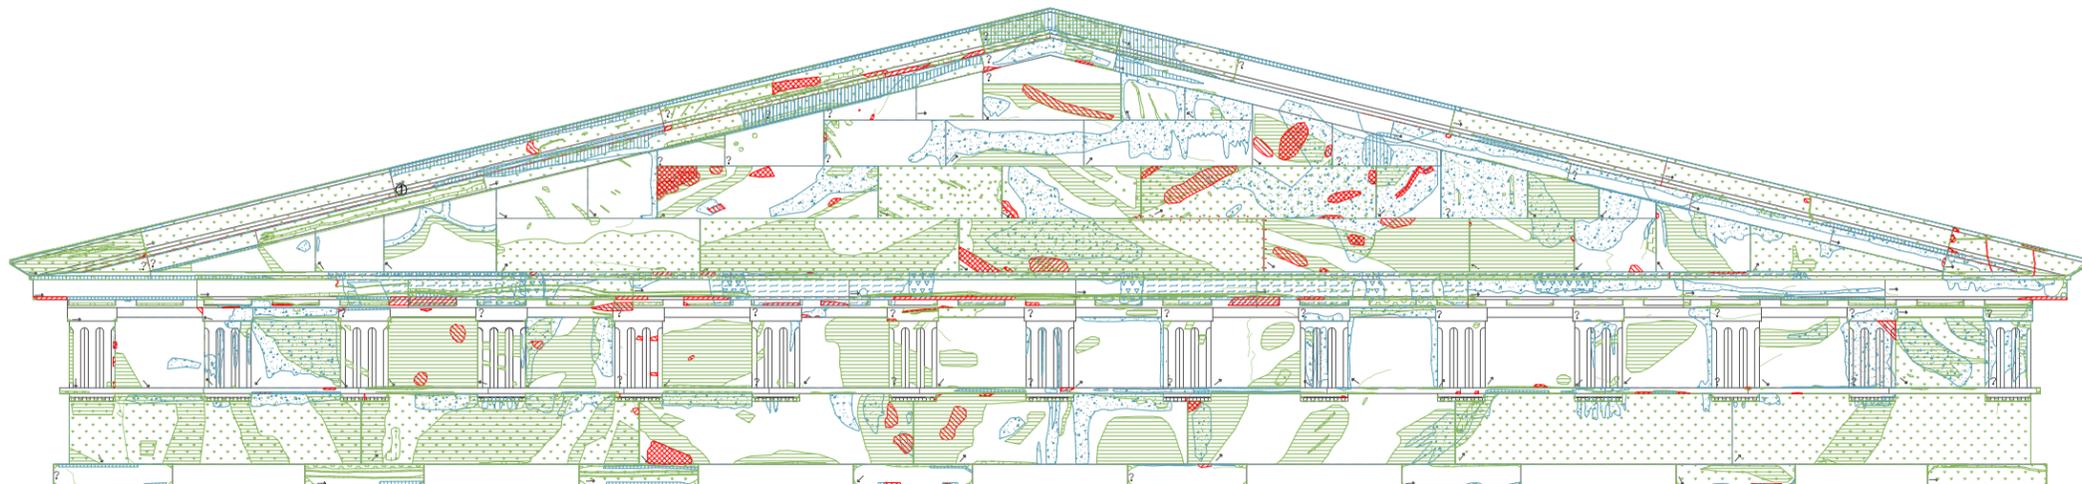
1. Entire raking cornice has metallic staining from the roof

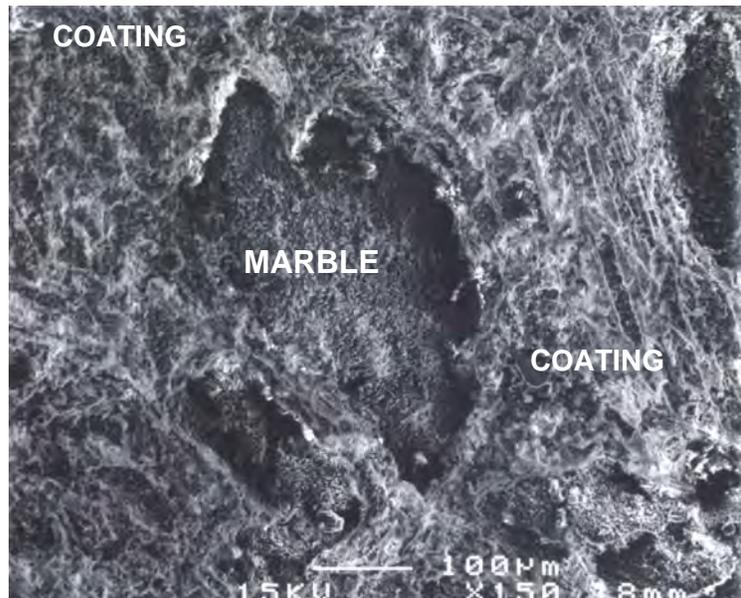
Scanning electron micrographs (SEM) of collected samples from protected areas show a blistered coating on the surface of the marble. (Fig. 13) To confirm the visual observations, an X-ray (EDS) analysis was performed. A central target inside the opening of the coating was selected and an elemental spectra was recorded. A second target over the coated surface was then used for a second reading.

Figure 13: SEMicrograph of north portico sample (Magnification 150x).

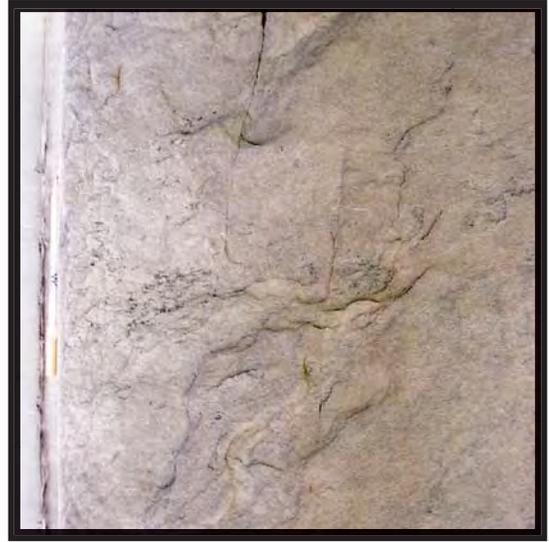
Incipient spalling

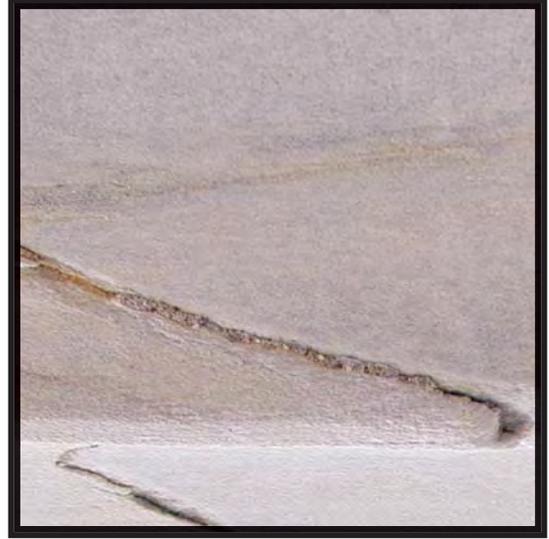
Dimensional loss

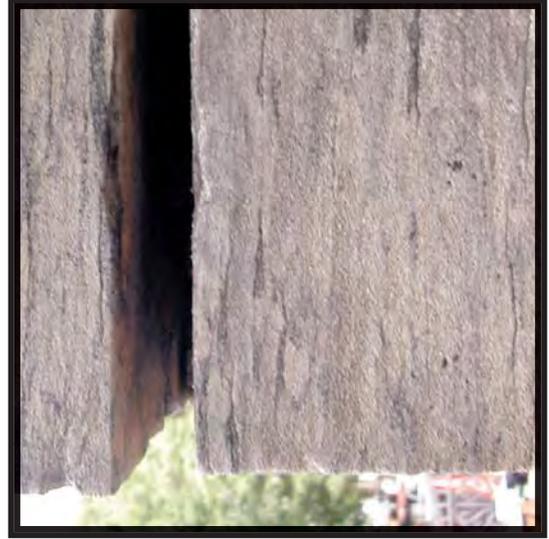
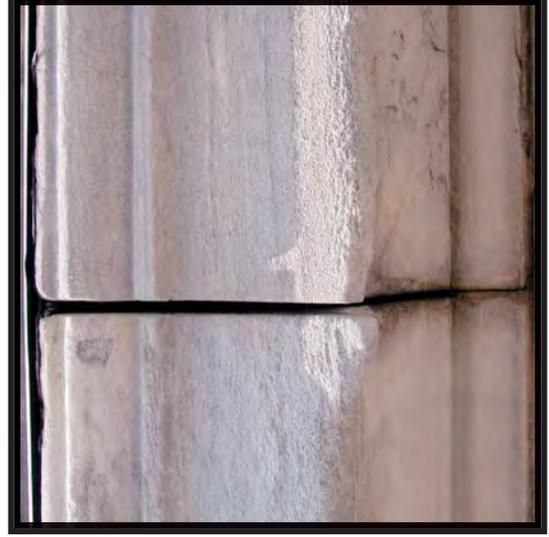
Deteriorated mortar joint

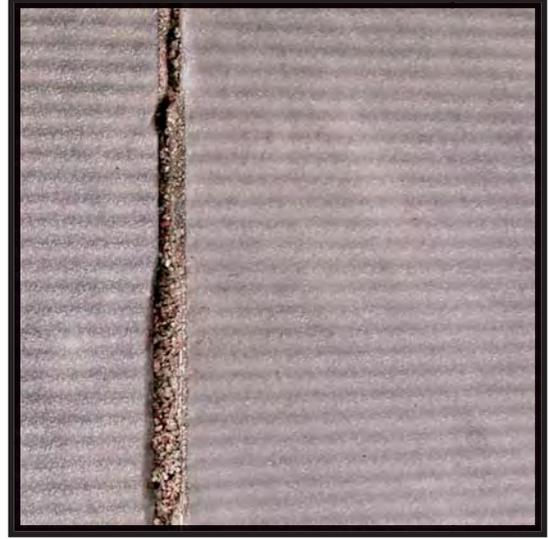
Efflorescence

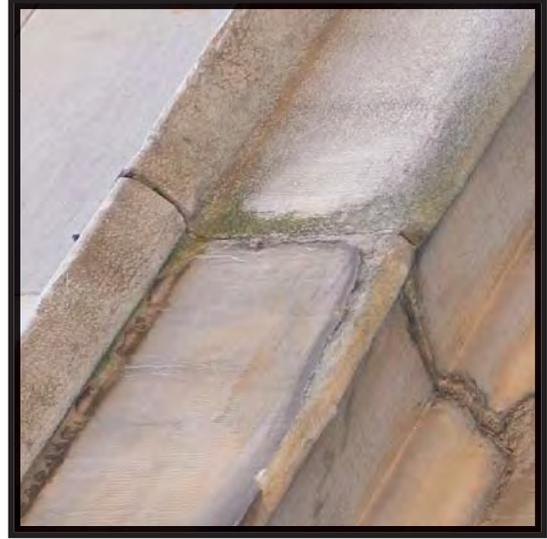
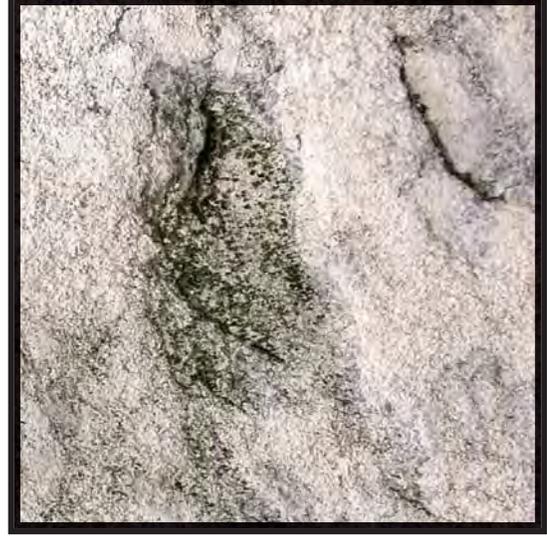
Chemical bird repellent treatments

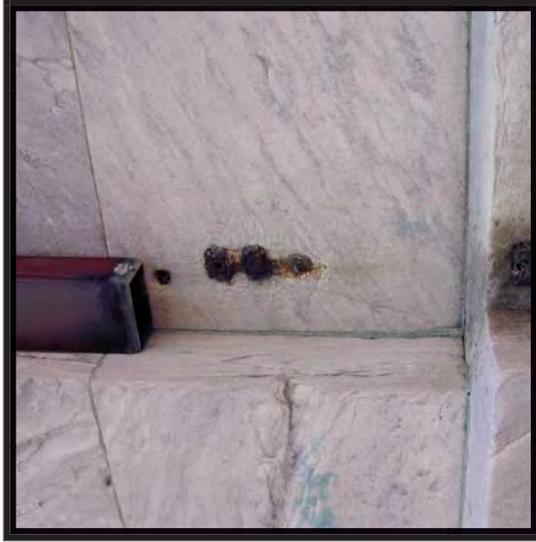
Building systems and/or anchoring hardware that is contributing to a stone deterioration condition.
