**VIZCAYA
MUSEUM
AND GARDENS**

CONDITION
SURVEY
GLOSSARY

Architectural
Features

UNIVERSITY
OF
PENNSYLVANIA
ARCHITECTURAL
CONSERVATION
LABORATORY
AND RESEARCH
CENTER

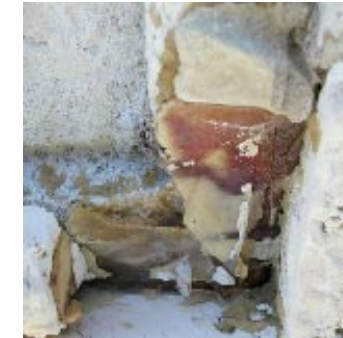
Synthetic resin repairs used for crack or loss infill.

(A) Resin Repair
(incompatible)

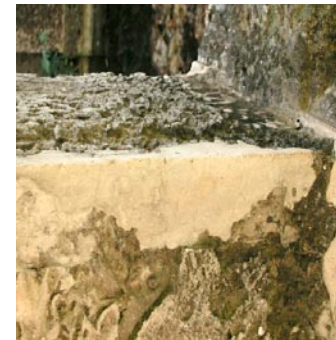
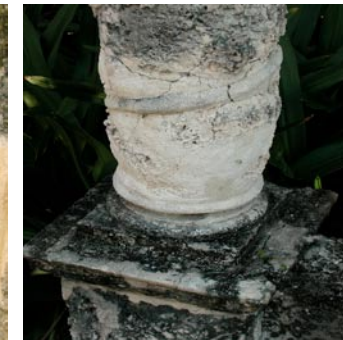
All mortars of various colors used for crack or loss infill.

(B) Mortar Repair
(left - incompatible)
(right - compatible)

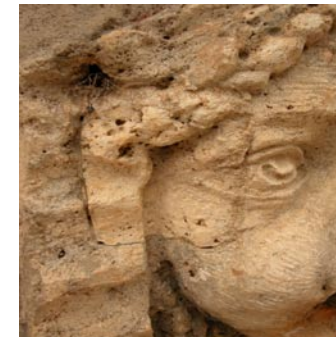
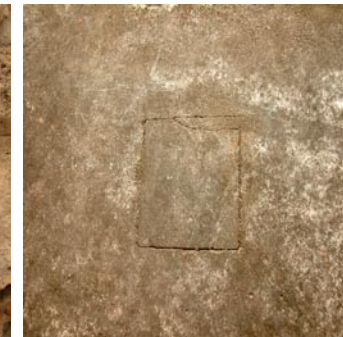
Carved stone repair set into the surrounding masonry, with or without associated adhesive or mortar.

(C) Stone Dutchman
(compatible)

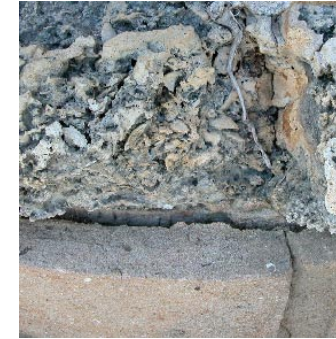
General absence of masonry resulting in incompleteness of form. For the purposes of this survey a degree of weathering of the surface is assumed.

moderate loss

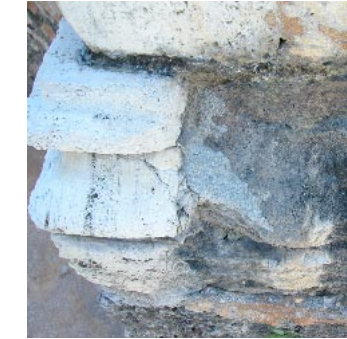
major loss

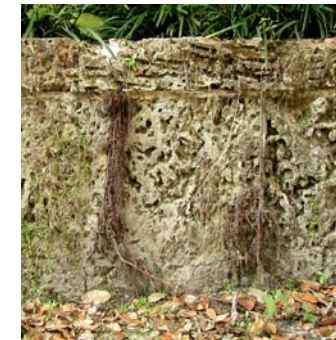
Physical erosion of the surface resulting in a loss of carved detail and illegibility.

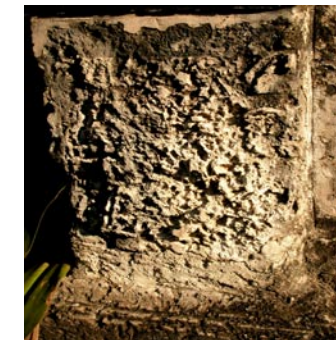
Localized deep erosion resulting in isolated cavities of varied depths. Cavity erosion is a condition associated primarily with the local oolitic limestone used throughout the site.

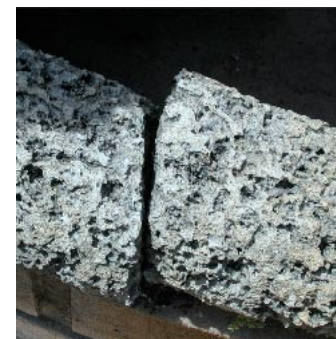
Movement or separation of masonry elements resulting in a shift of the surface plane, recorded as +/- accordingly.

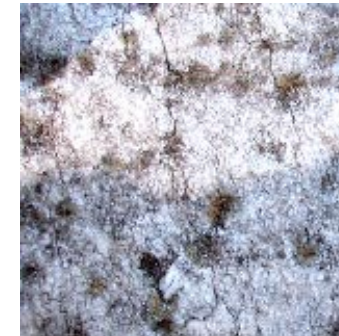
A patterned network of fine intersecting surface cracks

(A) network

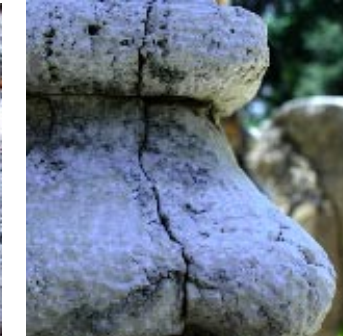
Cracks that are non-intersecting and less than or equal to 1/8 inch in width

(B) moderate

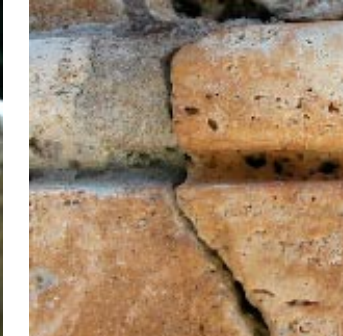
Cracks that are non-intersecting and greater than 1/8 inch in width

(C) major

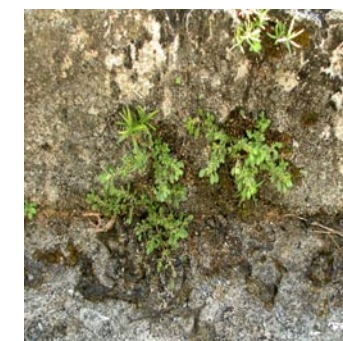
Minor vegetation present, which can be easily removed without damage to the feature.

(A) network

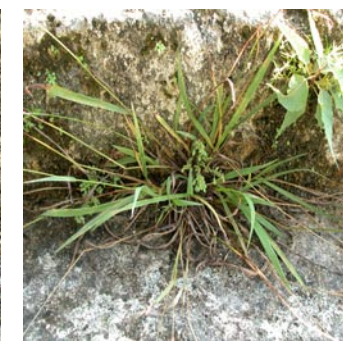
Plants where the root system can still be removed entirely by hand, however, damage to the masonry could result.

(B) moderate

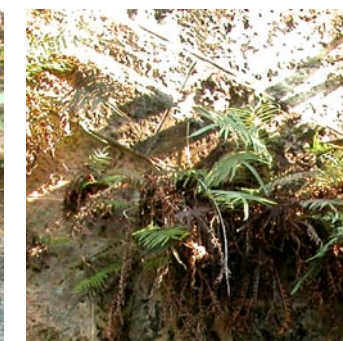
Plants that have grown to an extent where the plant must be chemically treated in order to be effectively removed. Mechanical removal would result in the separation of the body of the plant from its root system, leaving the roots imbedded behind in the feature.

(C) major

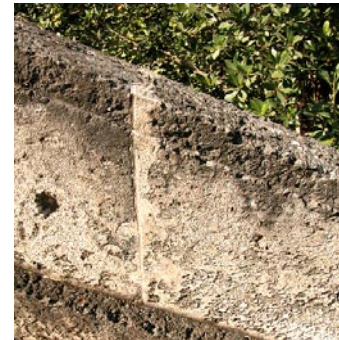
(A) Low Biogrowth

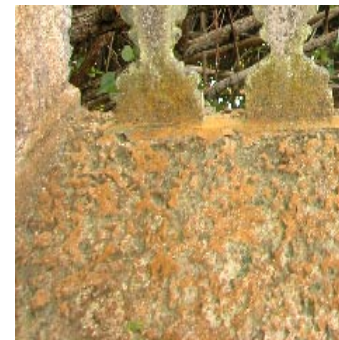
(B) Orange Biogrowth

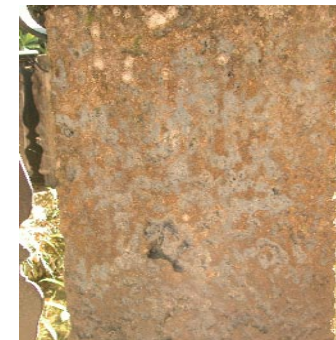
(C) Grey Biogrowth

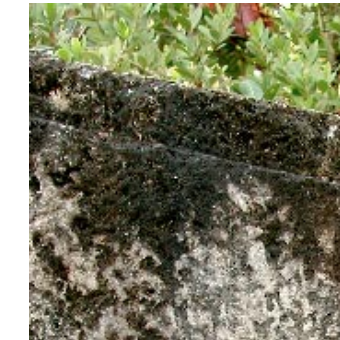
(D) Thick Black Biogrowth

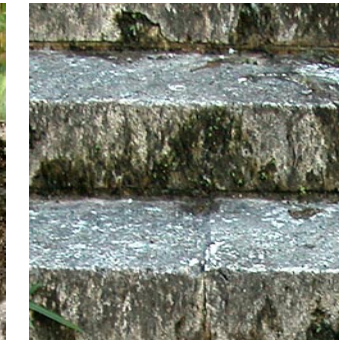
(E) Green Biogrowth

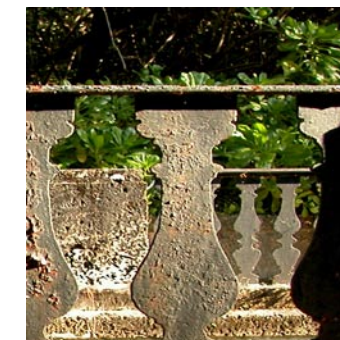
Localized discoloration resulting from the weathering of extrinsic (copper or iron) sources, usually black/brown (iron) or blue/green (copper) in color.

Orange

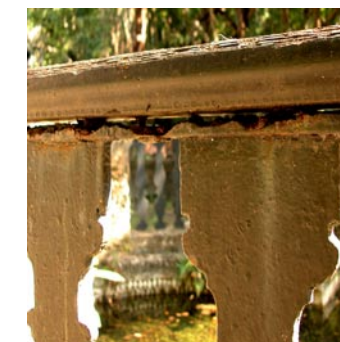
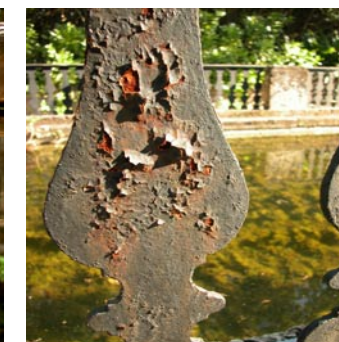
Rust formation that has damaged the surface and structural integrity of the metal architectural feature.

Metallic Corrosion

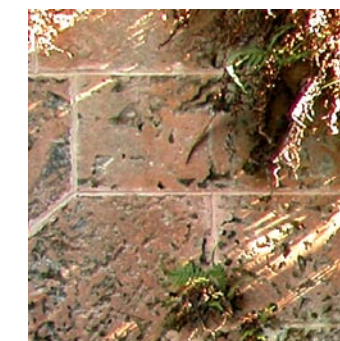
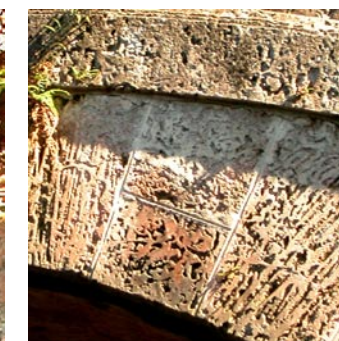
Brown or orange coloration that covers all or part of the stone face. The color does not appear to be related to any existing metal elements and generally occurs on the oolitic limestone found throughout the site.

Intrinsic Staining
