University of Pennsylvania Architectural Laboratory and Research Center

Marine Garden  
Locator Map  
Condition Survey

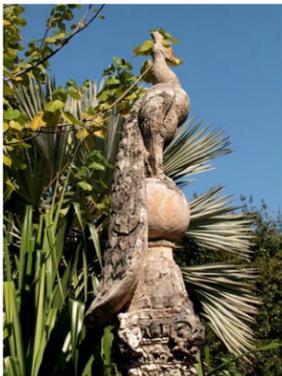
Although this sculpted peacock is largely original, the sphere on which the bird is standing is a cast reproduction. The base on which the sphere rests is cracked and suggests that the top sculpture was carved separately and is probably keyed to the column with a pin and socket joint.

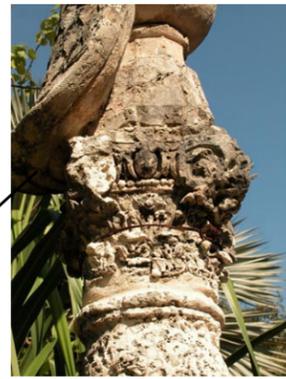
The column capital has major dimensional loss most notably on the southwest volute. In addition a ring of wire is located below the volutes which may be assisting in holding the capital together. At the intersection of the capital and the column shaft patching suggests that the elements are separate. The patching does not attempt to convey the quality of the original stone.

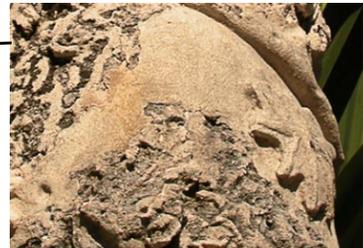
The original column shaft decoration contained a wound garland of stylistic leaves and fruit suspended from a vine. Previous replacement of the leaves appears unnatural and heavy in comparison to the original.

Mortar repairs on the upper third of the column do not recreate the texture and color of the original carved stone. However, an effort was made to recreate some of the garland details by attaching cast leaves and direct modelling the spiraled vine.

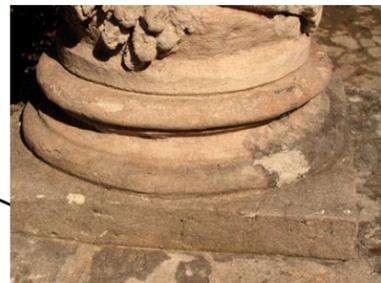
Patching at the bottom of the column appears to have been carried out in two campaigns. All mortar repairs are poorly executed.

The entire base of the column has been mortar repaired.

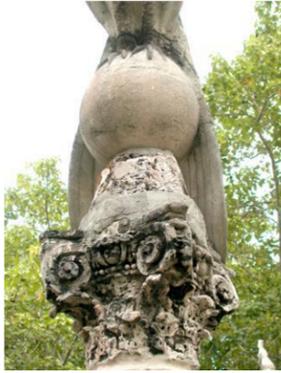
Extensive cementitious repairs are evident on the juncture of top of the capital and the base for the peacock sculpture. The repair conceals where the sculpture was completely separated from the column. The execution of this patch is poor.

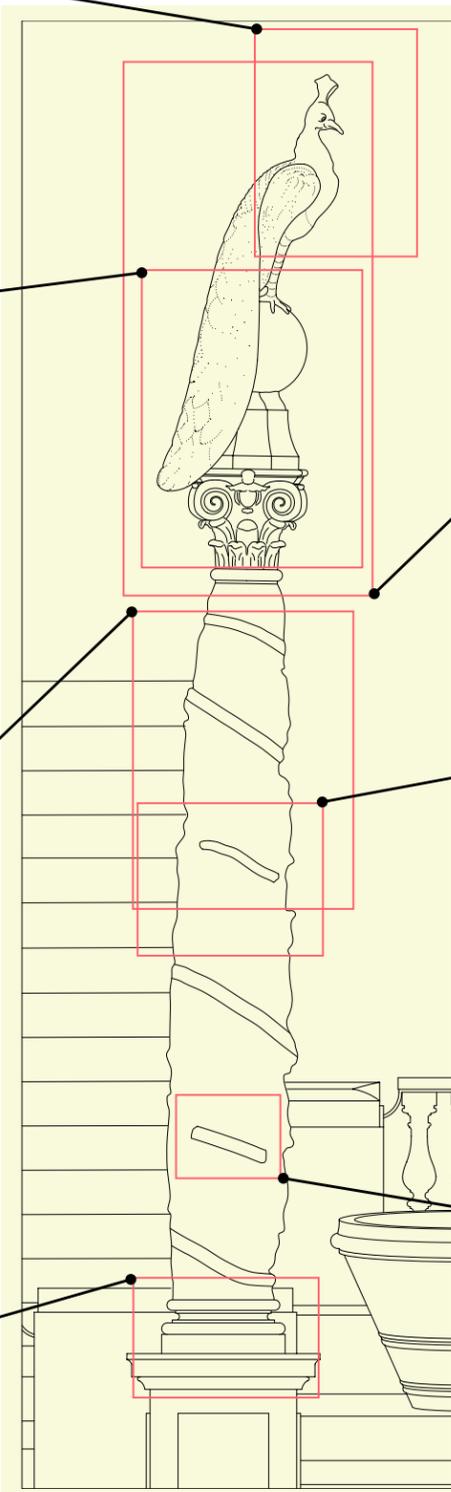
Although there is evidence of major repairs on all of the peacock sculptures, the Column 2 peacock appears to be a complete replacement casting. Seams along the tail are evident and the beak of the bird is oversized in comparison to those of the other columns. The chest, thighs, and feet all appear heavy and ungraceful. In addition the texture, color, and general appearance of the original stone has not reproduced in the replacement.

Due to excessive weathering of the stone, areas of the original carved relief of the columns have been lost.

With mortar repairs to all of the columns, there is evidence of multiple layers where the columns may have been repaired more than once, or a finish coat was added in an attempt to integrate the patch into the original form. For column 3 the top coat has begun to deteriorate, exposing the earlier patching material beneath.

As in other cases, the column base has been completely repaired.

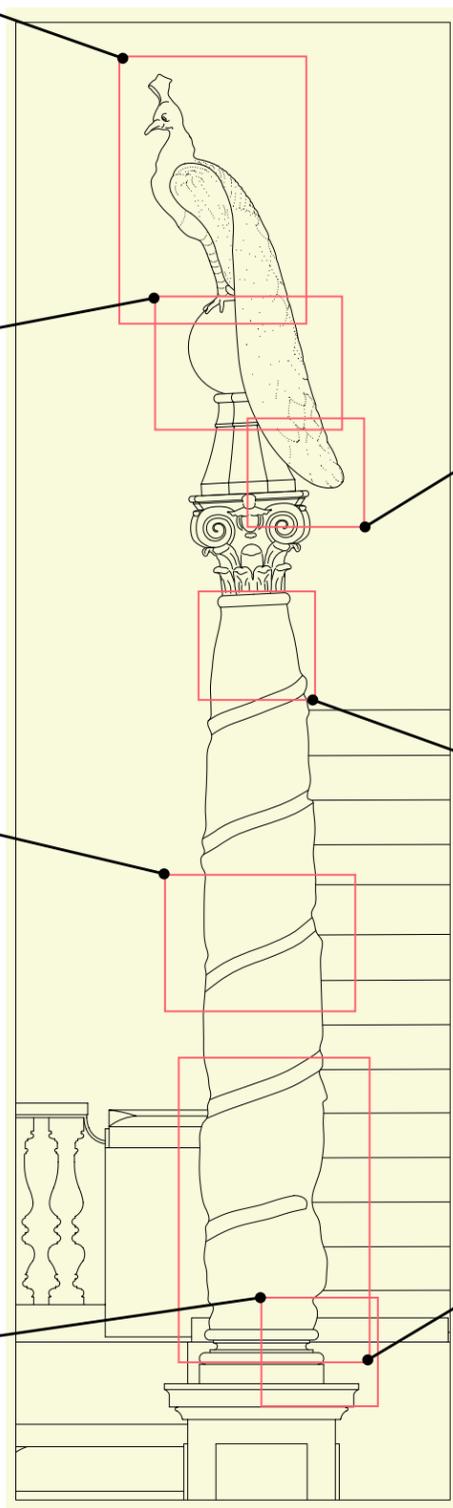
At mid-level in the shaft of Column 3 is a patch which was created in an effort to re-establish the continuity of the decorative garland. Although the vine has been re-established, no attempt was made to recreate the lost leaves and fruit. The patch is poorly executed creating a visually jarring effect to the continuity of the column.

Like all of the other columns, severe failure and repair is evident at the bottom of the column where the shaft meets the base. The patching effort here is extremely poor in execution with no attempt to visually match the original stone.

The Column 3 peacock sculpture appears to be the best preserved of the four figures. Although the head and portions of the feet are clearly replaced with mortar, the large sphere on which the bird sits is original stone. The form supporting the sphere is also completely replaced. Although the tail of the peacock on Column 3 appears to be of original stone, the underside has been repaired.

In two locations on Column 3, mortar patches have been applied and tooled to approximate the original stone carving. This type of patterning is not found in any other location on the four columns.

A large patch at the bottom of the shaft of the column clearly shows the visual inconsistency between the original carved stone and the applied mortar repairs.

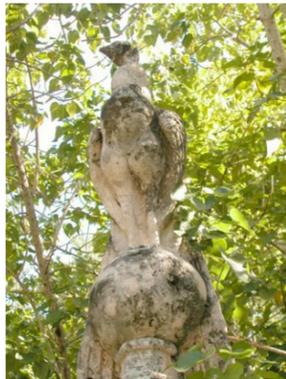
Although the majority of the peacock appears to be original including the head, several areas have been poorly patched. These areas include the neck, the lower portion of the legs and the bottom portion of the wing. The sphere on which the bird is placed is original stone.

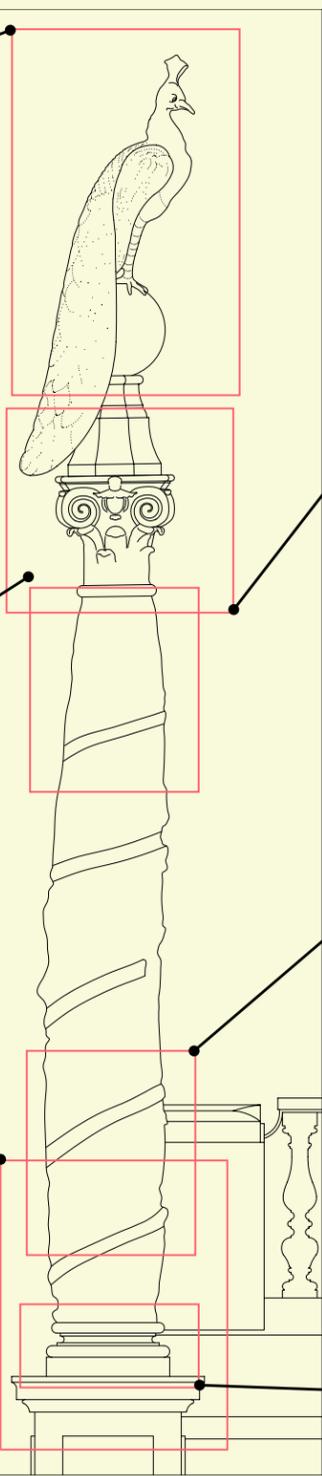
Unlike the other columns, there appears to be no severe damage between the peacock and the capital. Failure on this column is within the capital itself where an attempt has been made to model the acanthus leaves in mortar.

Patching found in the lower third of the column displays similar cracking found in the patches of the upper third.

A major area of patching exists within the top third of the column which shows excessive cracking. Some attempt has been made to recreate the decorative garland by incorporating cast replicas of leaves similar to those found in Column 1.

The patching at the juncture of the shaft of the column and the base is very poorly executed with little attempt to recreate the sharpness of the original. In addition, the proportion of moulding are inaccurate.
