Source: *APT Bulletin*, Vol. 37, No. 2/3 (2006), pp. 47-58

Performance of Injection Adhesives for the Great Hall Ceiling at Drayton Hall, Charleston

JOHN HINCHMAN, FRANK G. MATERO, and ALEXANDER RADIN

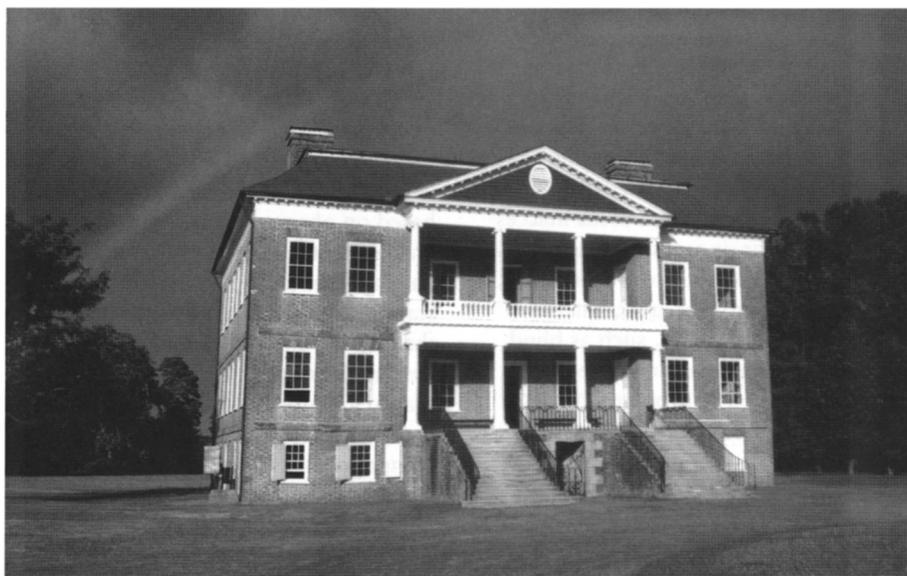
Fig. 1. Drayton Hall, Charleston, South Carolina, 2002. All images by the University of Pennsylvania Architectural Conservation Laboratory.

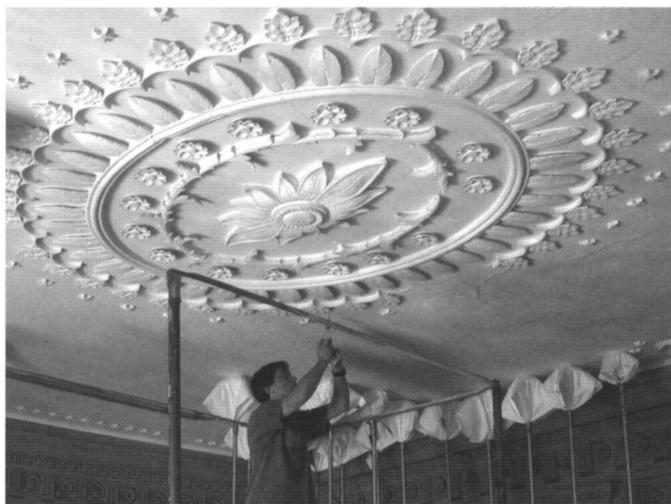
Fig. 2. Injection grouting of the Great Hall ceiling was carried out from below. Over 1,000 holes were drilled along existing cracks to create injection ports through which a canula was inserted to deliver the selected adhesive.

The next phase in the treatment involved injection of the filled, flexible acrylic dispersion formulations to reattach areas of the ceiling that were identified as detached and in some cases deformed but were still in place. Once cracks and their adjacent areas had been identified for injection, holes were drilled at an interval of approximately $\frac{1}{2}$ inch using a $\frac{3}{16}$ -inch drill bit. For each crack, drilling was begun in the center of designated lengths instead of at the ends. This procedure ensured that only truly detached areas were injected, rather than the entire crack. As each consecutive hole was drilled in a given direction along a crack, the amount of space between the plaster and the lathing was monitored by noting the resistance of the drill as it moved from the plaster, through the gap, to the lathing and poured plaster above. As the drilling progressed along the length of the crack, this gapping continued to shrink until it disappeared completely. When the gap-

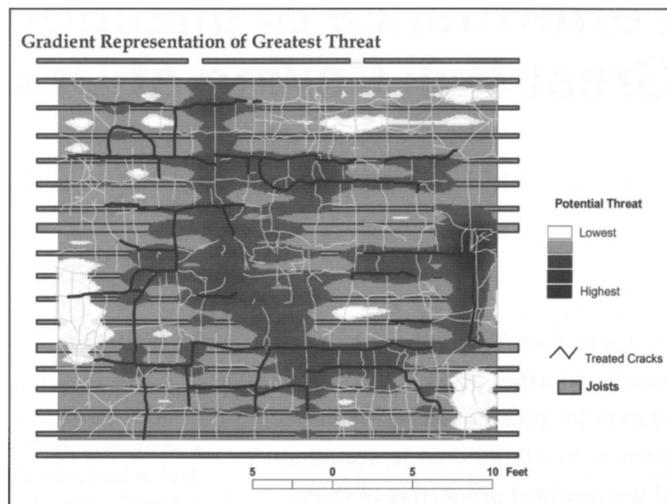
Fig. 3. Gradient representation of threat as determined by a GIS analysis. Note the high correlation between large cracks and detachment, which identifies two major areas of plaster failure and potential future damage across the center of the ceiling and under the fireplace hearth. Failure in these areas can be attributed to maximum joist bending (across the middle) and insufficient original keying (under the hearth).

A network of roughly orthogonal cracking appears across the entire ceiling (Fig. 3). Most of the large-width cracks run parallel to the long axis of the room and are closely associated with the joists located above them. Their slightly meandering quality suggests that they not only are below the centers of the joists but also occur to either side of a joist. This pattern can be explained by the differential movement from bending and shear cracking between undersized joists, as well as by tensile cracking across joists.

The condition of plaster detachment as determined by percussion is invariably associated with cracking, with a greater correlation between detachment and large cracks than any other crack type.

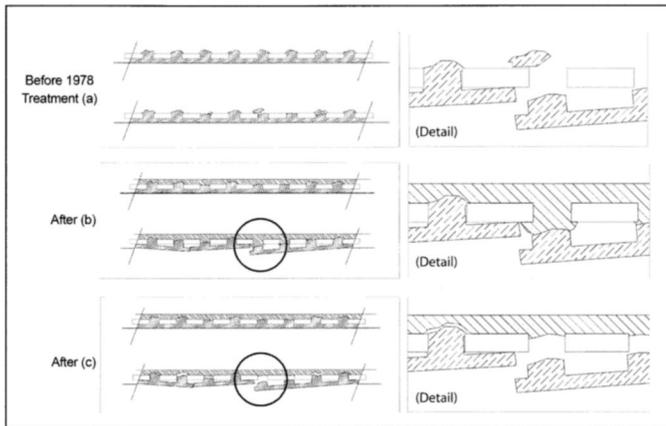
Fig. 4. Schematic sectional view of ceiling damage (a) before 1978 treatment, (b) repair after treatment, and (c) new damage after treatment.

The stabilization treatments of 1978 reattached those areas with broken and removed keys (Fig. 4a) and areas where plaster detachment and voids were sufficient for the gypsum pour to flow between the underside of the lath and the brown coat (Fig. 4b). Any detachment of the ceiling caused by the release of the lath from the undersides of the joists would have been corrected by the continuous contact of the gypsum-mesh application to the top of the lath. The treatment did not reattach areas inaccessible to the pour or areas of keys with hairline cracks, scratch-coat separation, and narrow gaps. Moreover, hard-to-detect treatment failures, such as blind detachment, could have occurred between 1978 and 1991, before the temporary bridge was installed (Fig. 4c).

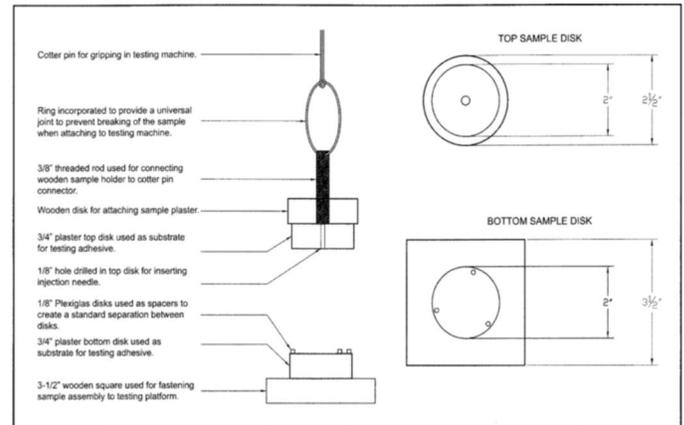
Fig. 5. Schematic of test specimen with assembly for testing tensile strength, per ASTM D2095-96.

The current testing program was designed using ASTM D897-00, Standard Test Method for Tensile Properties of Adhesive Bonds, and ASTM D2095-96, Standard Test Method for Tensile Strength of Adhesives by Means of Bar and Rod Specimens. For this particular situation, however, the testing was modified to accommodate the specified substrates (Fig. 5). Mechanical tests were run on two different sets of samples. The first set was comprised of cast surrogate coupons of gypsum plaster that were used as one adherend to test the tensile strength of the various adhesive formulas on sound plaster. For the gypsum samples, ¾-inch-thick disks of plaster of paris were cast with a 2-inch diameter to ensure that enough surface area would be in contact with the adhesive to calculate its tensile strength (see Appendix B).¹²

After attaching the spacers to the bottom disks, the upper disks (which contained the injection holes) were placed on top, and the two disks were taped together around the edges. Small openings were left in the tape to allow for air displacement during injection. Each set of disks was then epoxied to the surface of a 3½-inch square of plywood block ¾-inch thick, which allowed the finished assemblies to be attached to the surface of the testing apparatus. A wooden disk that allowed for the insertion of a threaded steel rod was epoxied to the top of each of the sample assemblies. This rod was fitted with a wire assembly that acted like a universal joint to limit the amount of breakage that could occur as the assemblies were being attached to the testing equipment (Fig. 5).

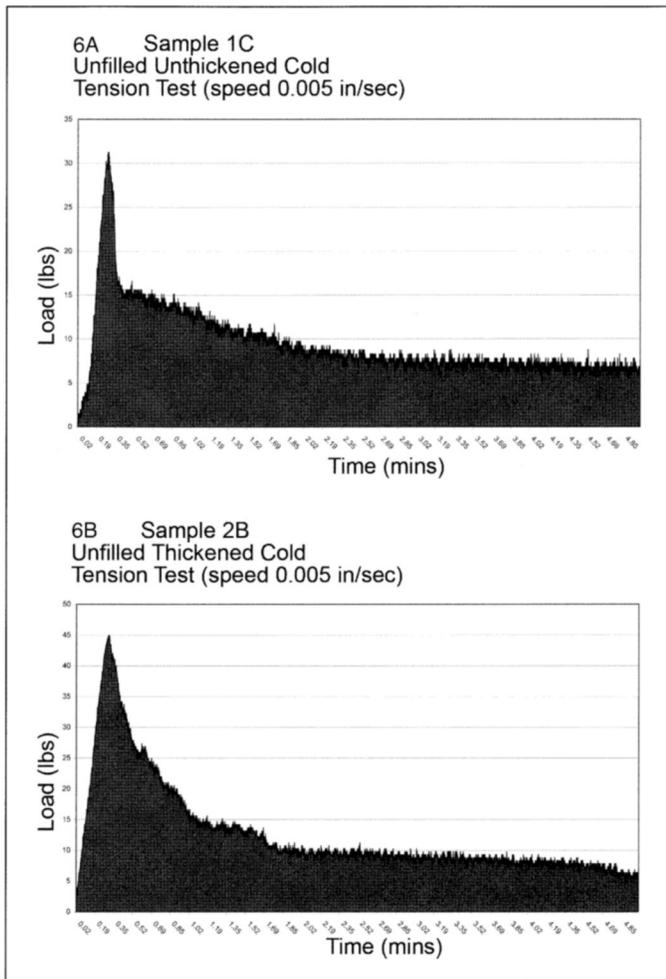
Fig. 6. Strength curves for (a) unfilled unthickened cold and (b) unfilled thickened cold formulations on surrogate plaster specimens.

Unfilled flexible unthickened cold (U/Fl/Uth/C). For this set of samples the maximum resistance for two samples was 9 to 10 pounds, while the third sample showed a noticeable increase to just over 30 pounds (Fig. 6a). Close examination revealed that the adhesive had not made full surface contact with both plaster adherends in the first two specimens due to shrinkage before set. All samples, however, did display elastic behavior.

Unfilled flexible thickened cold (U/Fl/Th/C). The resistance strength for the three replicates was higher than for the unthickened formulation, measured at 45, 50, and 62 pounds, respectively (Fig. 6b). Although these results might suggest that the thickened formula may be stronger than the unthickened, the observed adhesive contact in these samples was considerably greater in surface area than for the unthickened samples, providing higher apparent strength. Thus it seems that the thickener may have helped to improve surface contact by reducing the shrinkage during set.

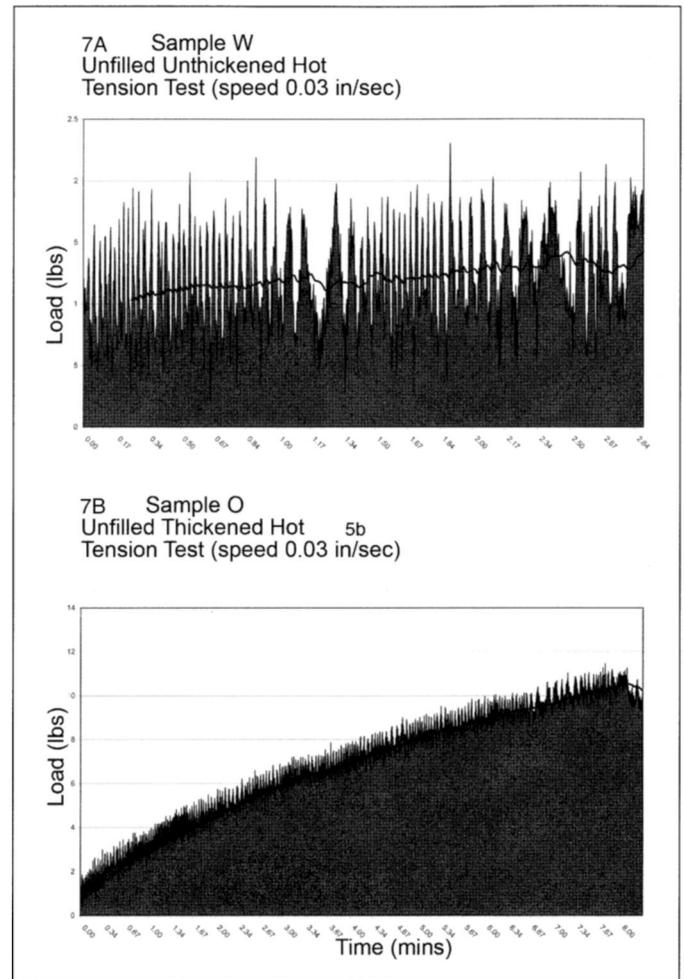
Fig. 7. Strength curves for (a) unfilled unthickened hot and (b) unfilled thickened hot formulations on surrogate plaster specimens.

Unfilled flexible unthickened hot (U/Fl/Uth/H). In contrast to the cold specimens of the same formulation, the heated specimens show a significant reduction in overall strength (Fig. 7a). The maximum resistance strength achieved was 2.2 pounds for the first sample and 4.0 pounds for the second. Although the graphs in both cases illustrate that the specimens exhibited little resistance to

load, both samples displayed a low increase in resistance throughout the test. In both cases the displacement was large, with limited signs of breakage, indicating high plasticity.

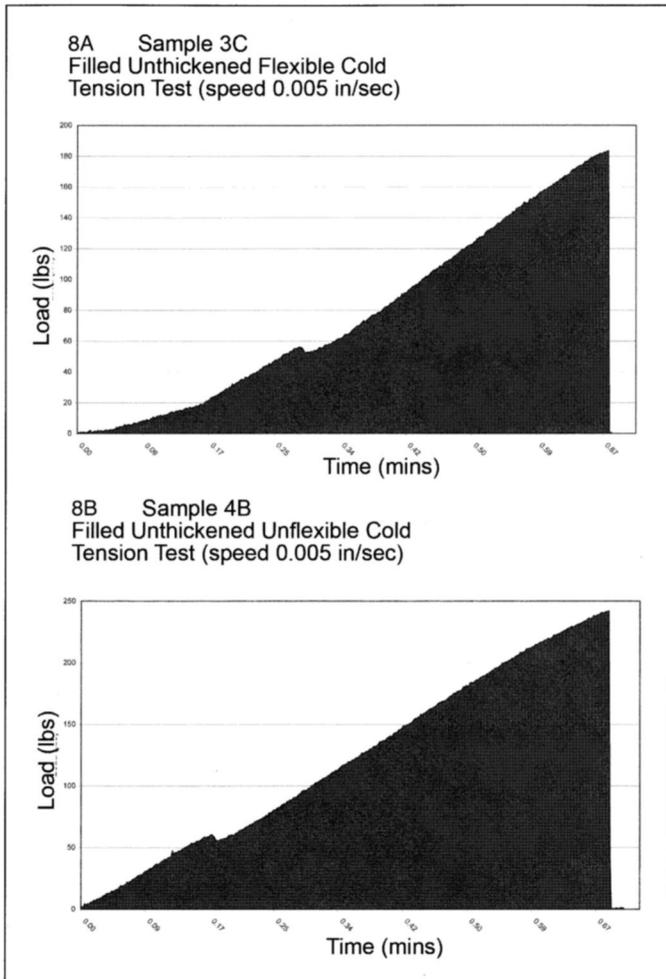
Fig. 8. Strength curves for (a) filled unthickened flexible cold and (b) filled unthickened unflexible cold formulations on surrogate plaster specimens.

Filled unthickened flexible cold (F/Uth/Fl/C). All three specimens tested had a considerable increase in maximum load capacity when compared with the unfilled formulas (Fig. 8a). Where the average maximum load capacity of the unfilled formulas was 16 pounds, the average maximum load capacity for the filled formula was 160 pounds, or more than ten times the resistance capacity to applied load. Additionally the graphs show a significant difference in physical response with no significant plastic response. For all samples in this test group displacement was limited and failure was complete and abrupt.

constant slope and abrupt break at the yield point in both cases suggests limited flexibility like that found in the unflexible formulas. The most significant difference is the overall tensile strength. For the flexible formulas the average load capacity was 160 pounds, while the unflexible formulation averaged 230 pounds (and in one case reached 250 pounds), suggesting a significant increase in overall strength, as expected.

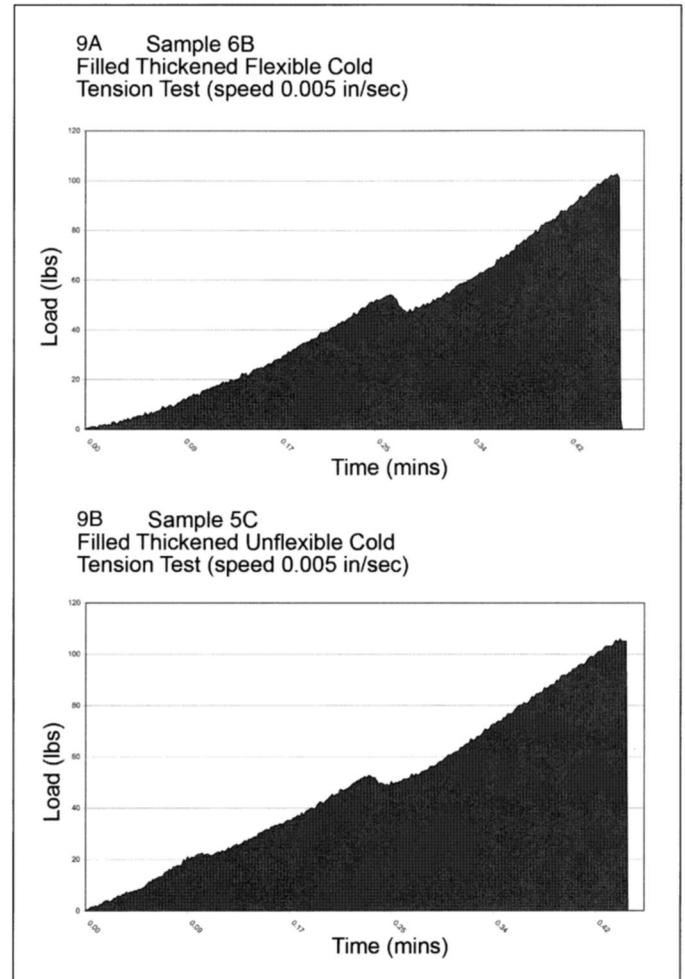
Fig. 9. Strength curves for (a) filled thickened flexible cold and (b) filled thickened unflexible cold formulations on surrogate plaster specimens.

Filled thickened flexible cold (F/Th/Fl/C). The most notable result of the addition of the thickener in this case is the reduction of overall strength from an average of 160 pounds to an average of 116 pounds (Fig. 9a). Based on these lower numbers it is likely that the addition of the thickener is reducing the strength. Acrysol ASE-60 is designed to help increase viscosity without greatly reducing injectability. As injectability and strength are both important properties, this could be a significant consideration when higher strength is needed. The graphs in this case suggest the same failure mode as seen in the unthickened, filled formulations just discussed. Failure was complete and abrupt. Once again, the constant slope of the graph suggests limited elasticity.

Filled thickened unflexible cold (F/Th/Ufl/C). These three samples revealed a similar pattern between the thickened and unthickened formulations for the unflexible formulation as observed for the two flexible mixtures (Fig. 9b). While the graphs again show no clear sign of elasticity, the thickened formulations display a reduction in the maximum load capacity before failure. In the case of the unthickened formula, the average maximum load capacity was 230 pounds, while the average maximum load capacity of this thickened formulation was 196 pounds. It is likely that with an increase of thickener, the overall strength of the formulation is reduced.

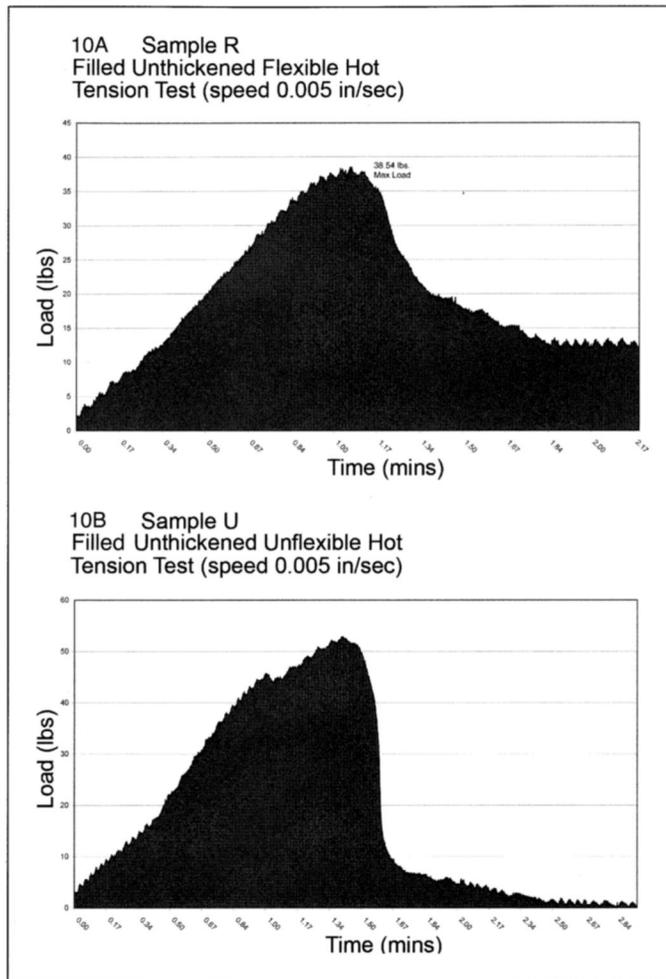
Fig. 10. Strength curves for (a) filled unthickened flexible hot and (b) filled unthickened unflexible hot formulations on surrogate plaster specimens.

Filled unthickened flexible hot (F/Uth/Fl/H). As was observed with the unfilled formulations, the introduction of heat as a variable had a significant impact on all of the filled formulations in similar ways (Fig. 10a). The two specimens in this group exhibited a maximum load capacity of only 39 and 57 pounds, respectively. When compared with the un-

heated formulas with similar variables (i.e., filled flexible unthickened cold), the maximum load capacity for the heated samples was significantly reduced, showing a reduction in strength of more than 60 percent. Perhaps more significant is the plastic response when heated. Unfortunately, the rate of failure in the heated specimens appears to be quite high. Once the graph has reached its peak, the slope becomes quite steep. Eventually this slope becomes more shallow, suggesting that the failure, although significant, is not complete. Upon close examination of the heated-set formula, the texture is similar to that of stiff toffee. Cold specimens are very hard, while the heated formulas remain elastic.

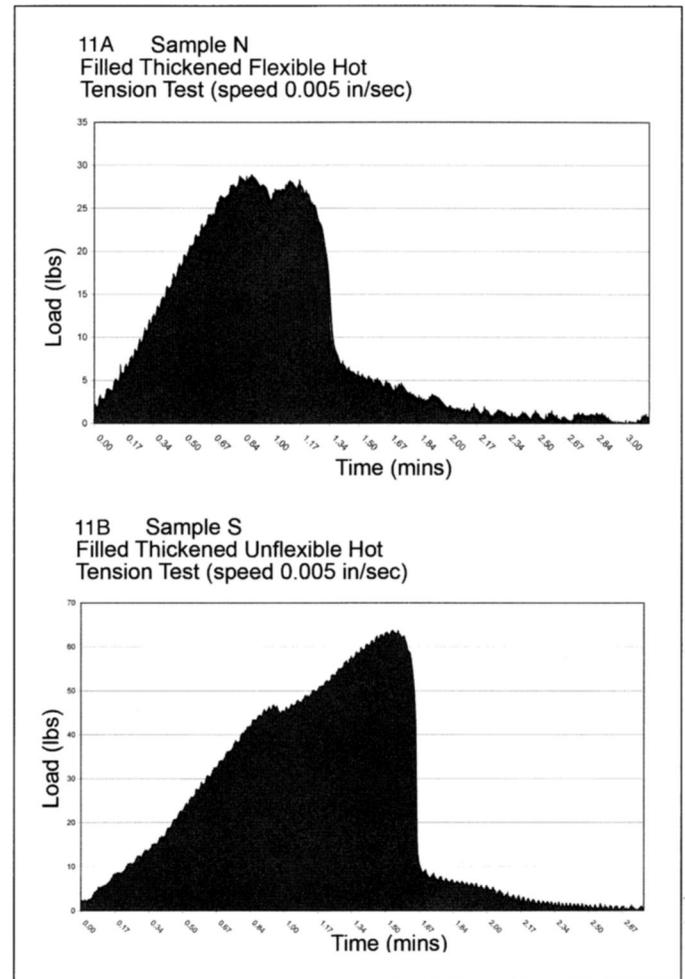
Fig. 11. Strength curves for (a) filled thickened flexible hot and (b) filled thickened unflexible hot formulations on surrogate plaster specimens.

Filled thickened flexible hot (F/Th/Fl/H). Once again a noticeable reduction in strength was seen as a result of the introduction of heat (Fig. 11a). For the two specimens tested, both were below 35 pounds of maximum load capacity, and in both cases the response to increased load as seen in the graph suggests that the sample had become weaker and less brittle. Both graphs display a curve at the top suggesting that failure is not catastrophic followed by a steep downward slope and then a much shall-

lower curve. This shallower curve, which was seen in all of the heated, filled samples, suggests that the failure is not complete and that as the displacement is increased, the failure continues but at a greatly reduced rate, as seen just after the peak load is achieved.

Filled thickened unflexible hot (F/Th/Ufl/H). Again, the lower overall strength is observed when compared to the matching cold formulation, and the response to failure is the same as seen in the other filled, heated samples (Fig. 11b). The constant slope at the bottom suggests that elasticity is limited; however, the curve at the top again shows that failure is not sudden. The elastic consistency of all of these heated, filled formulations is similar. The performance of all the formulations under heat show significantly low tensile strength and high plasticity,

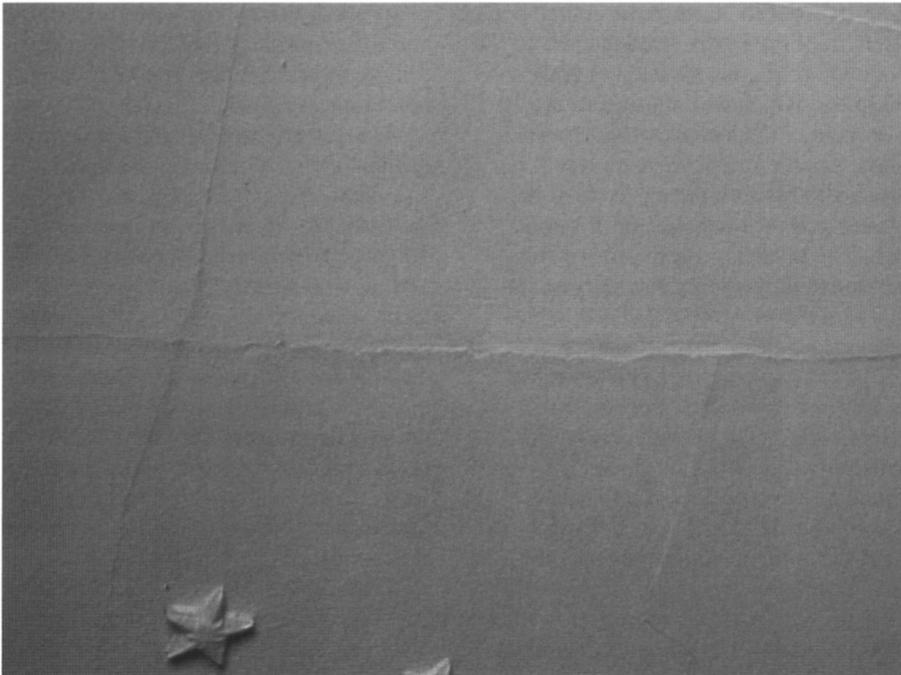
Fig. 12. Post-injection fill compensation, which stabilizes crack edges and will help show any movement of the ceiling.

All injection holes were filled with a commercial lightweight jointing compound, which was mixed with equal parts of microballoons to make a drier, weaker fill and one that closely matched the color and texture of the existing whitewashed finish plaster.¹⁸ In addition to the holes, several of the larger cracks were filled as well in an attempt to reduce their visual impact from below and to provide additional support to the crack edges (Fig. 12). The advantage of these soft, slightly elastic filled cracks is that they can now act as "telltales," helping to show movement resulting from the introduction of live load to the second floor above the Great Hall for the first time in more than 10 years. Should these fills crack over time from plaster movement, they can easily be replaced. Finally, loose and previously removed cast ceiling ornaments were reattached with the unfilled adhesive formula.
