GORDION SITE CONSERVATION PROGRAM

2009 FIELD REPORT

Project Director:
FRANK G. MATERO

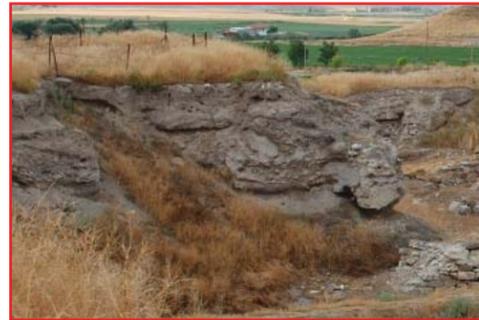
Unstable escarpments exhibiting basal erosion.

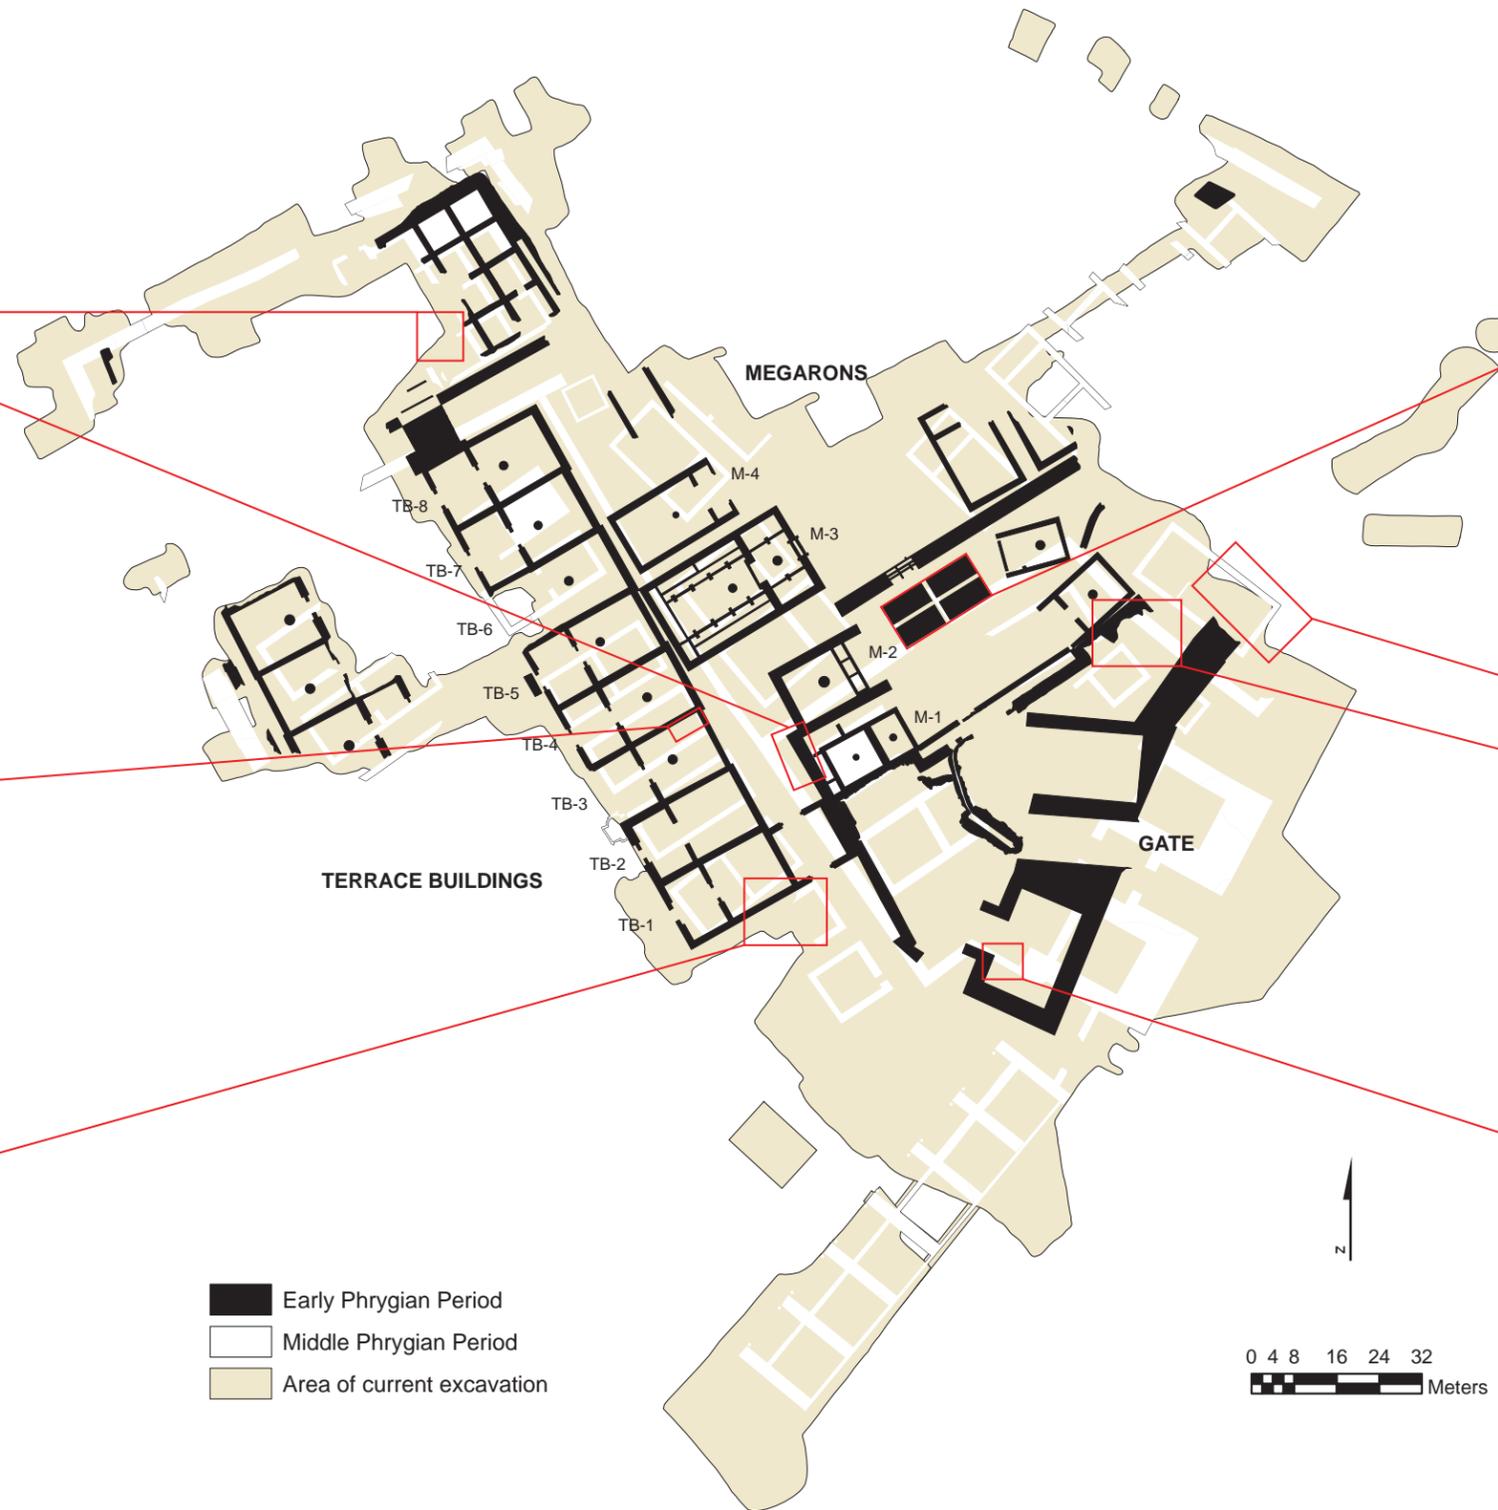
The excavation pit located northeast of Megaron 2.

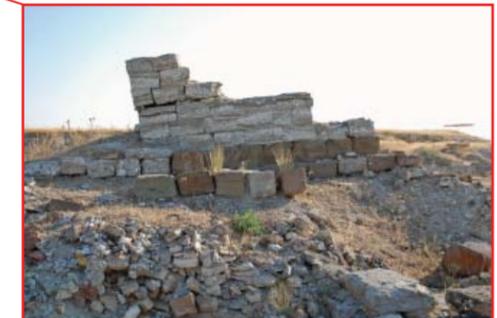
Middle Phrygian Gate courses exhibiting deterioration and instability.

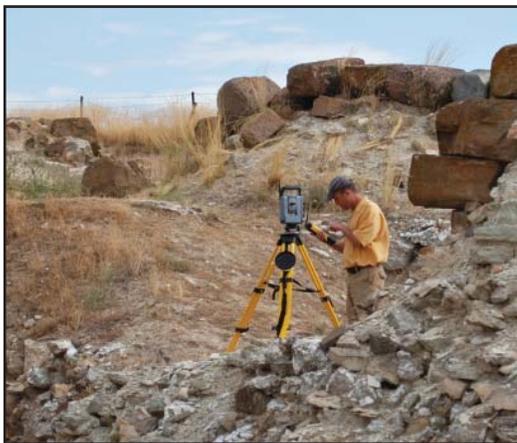
Scanning Middle Phrygian Gate courses east of the Early Phrygian Gate's north pylon.

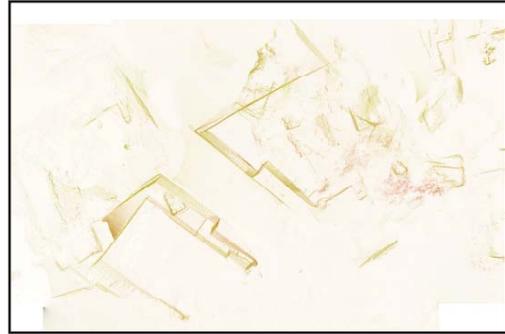
Point cloud data showing the Early Phrygian Gate.

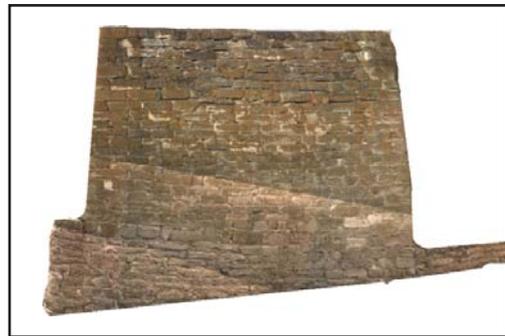
Rectified and montaged image of the south pylon at the central ramp.

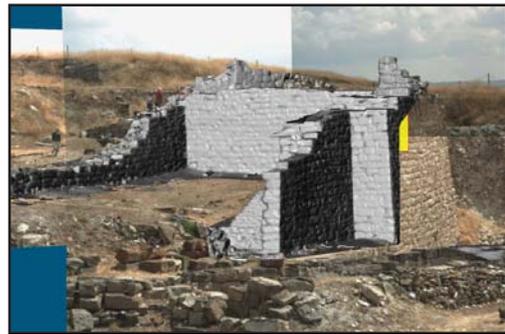
Point cloud data draped over montaged photographs.

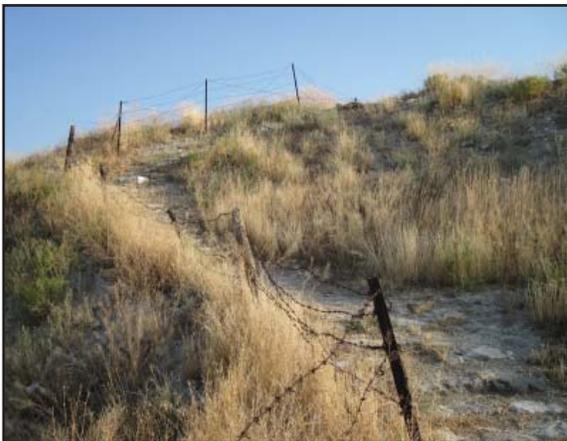
The segment of the visitor circuit before the prototype was installed.

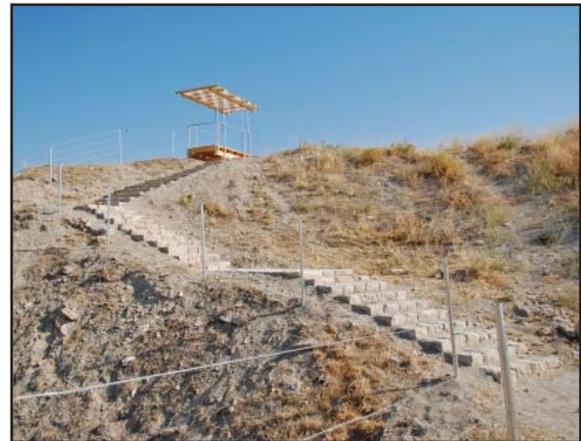
After installation of the wayside viewing platform, masonry steps and path and perimeter railings.

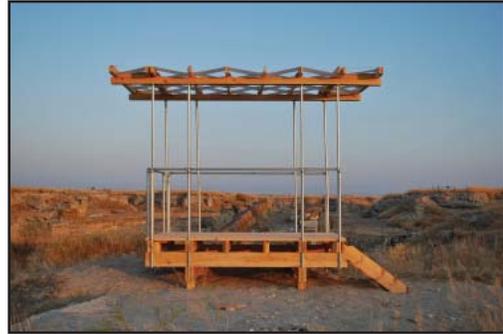
Wayside viewing platform #2 installed northeast of the Early Phrygian Gate.

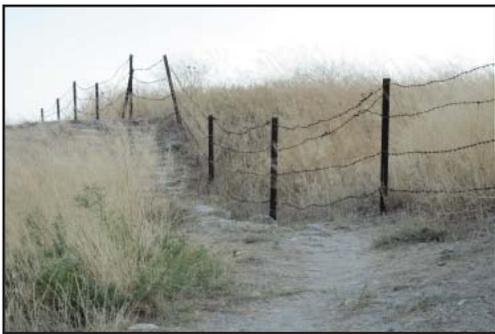
The existing rusted barbed wire perimeter railing.

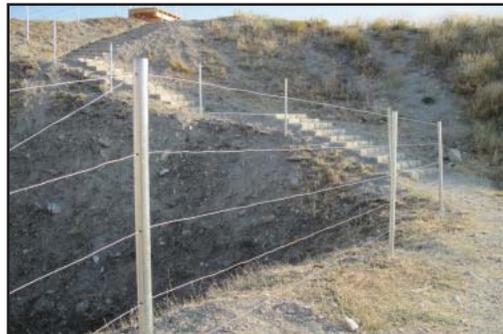
The galvanized piping and wire of the prototype perimeter railing.

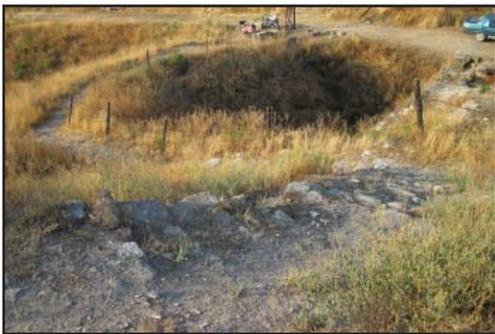
The deteriorated masonry steps and dirt path before replacement.

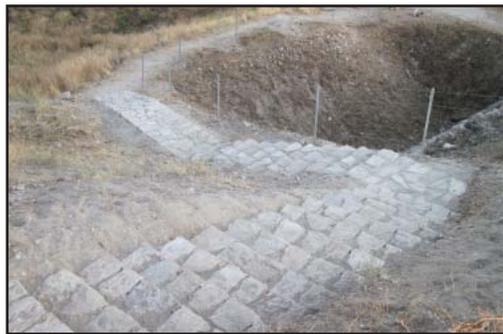
Installation of the new masonry steps and path leading to wayside platform #2.

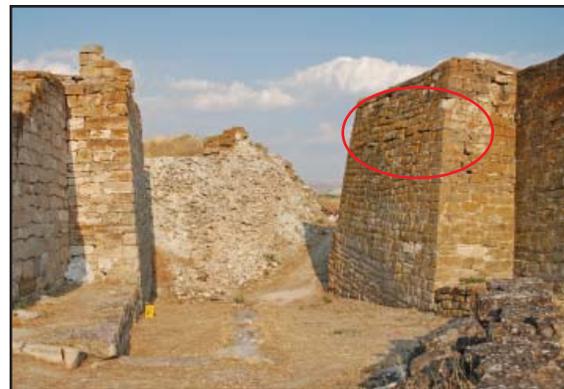
The gate in 2009 with evidence of displacement in the South Court elevation.

At nearly ten meters in height, the massive ashlar masonry gate is very complete. Structural settlement is evident with areas of shear cracking and course displacement. Veneer detachment has occurred as bulging, most evident on the north face of the south pylon. The southwest wall of the north pylon, rebuilt by Rodney Young, was rebuilt again after earthquake damage (1999) in 2006. The tops of both pylons—capped with cement and subsurface drains—have cracked over the years and have been periodically sealed with silicone sealant. Large cracks exist between the cement and the uppermost stone course allowing water to penetrate into the core. These caps are currently under redesign as vegetative caps. Injection grouting was discontinued in 2006 until structural monitoring and assessment are completed.

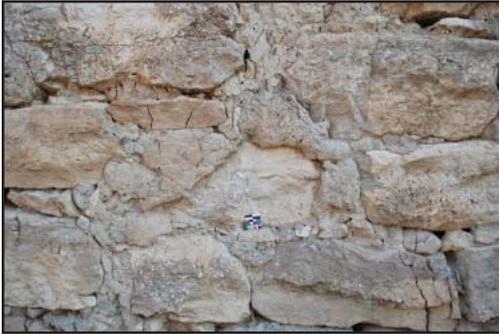
Extant earthen finish on the North Court elevation at the central ramp.

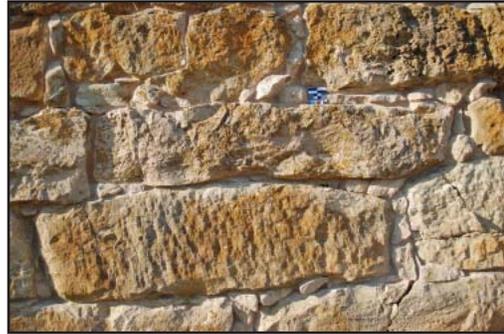
Shaped and tooled limestone on lower courses of the North Court.

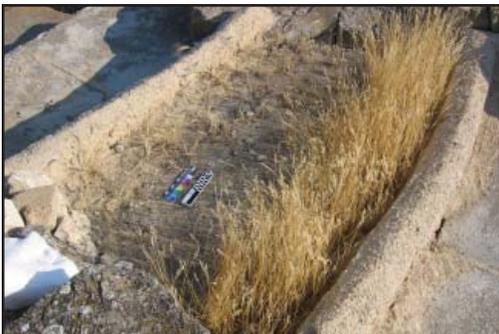
Pilot Area #1 installed in 2008 shows extensive growth of *poa* grasses.

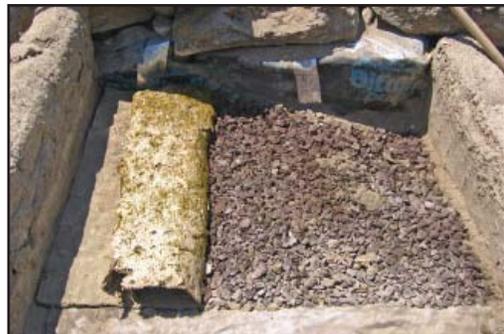
Biogrowth found during disassembly of Pilot Area #1.

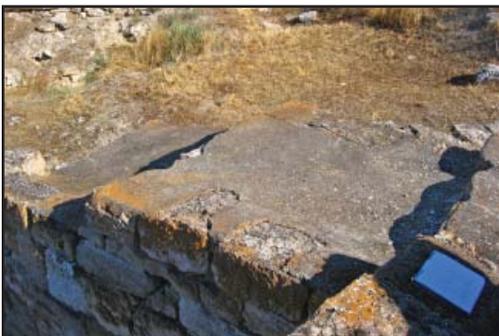
Pilot Area #2 prior to installation of soft capping.

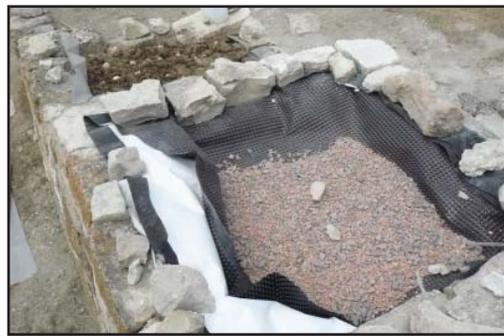
Protection sheet and gravel mix before inserting probes.

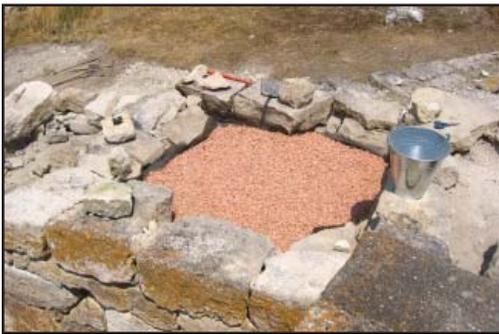
Gravel drainage layer prior to addition of *poa* sod.

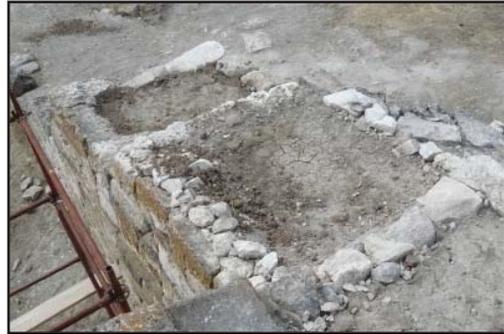
The completed soft capping system at Pilot Area #2 prior to revegetation.

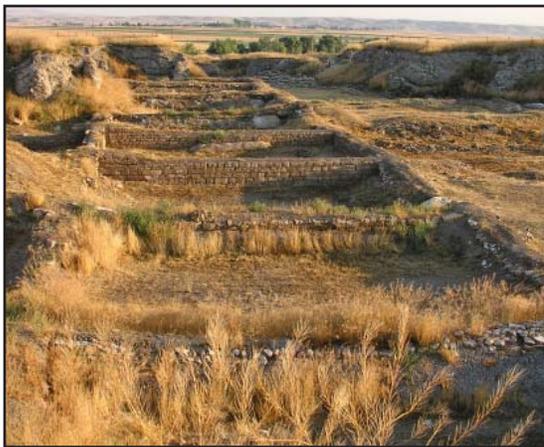
The Terrace Building Complex prior to exposure and treatment.

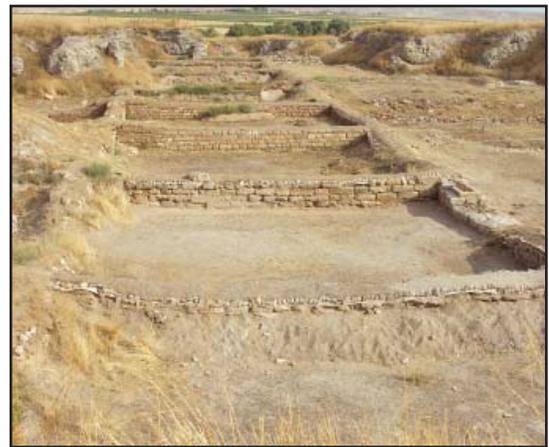
Following stabilization of Terrace Building 2 (center).

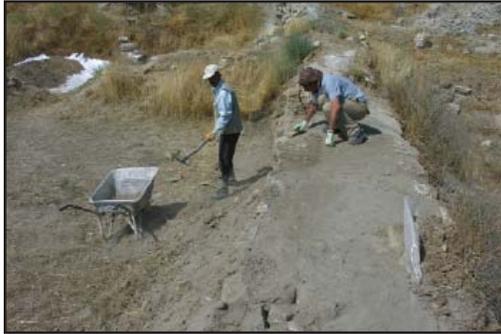
Disassembly of the wall capping and slopes of TB2-5.

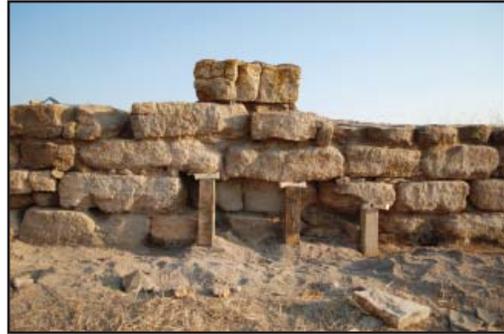
Missing stone blocks and temporary wall stabilization after exposure.

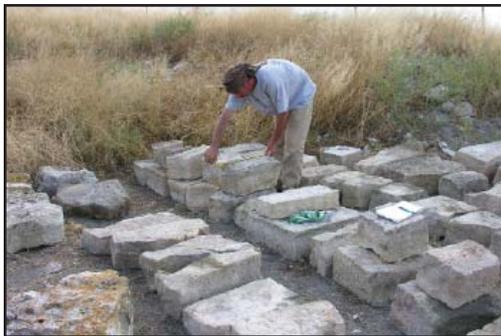
Choosing stone for replacement.

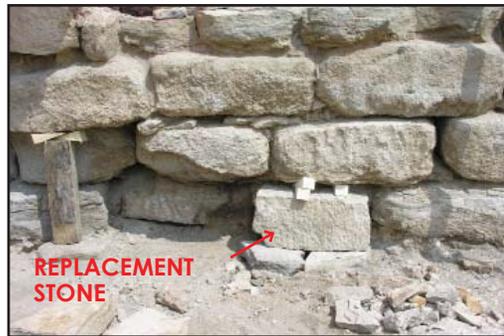
Stone replacement to stabilize TB2-5 elevation.

required stone replacement. Unused stone from the TB4 reconstruction project in the 1990s was shaped and laid in a hydraulic lime/sand/brick dust mortar (2.5:1:0.5) to bond the new material to the existing stone. Reattachment was performed on stone showing advanced deterioration, such as cracking and delamination; epoxy resins² mixed with calcium carbonate served as the stone to stone adhesive, and stainless steel rods were inserted, when necessary, for additional structural support or to secure large stone fragments.

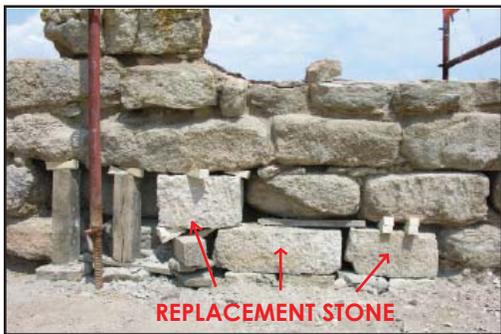
Replacement stones installed in wall with temporary wooden chinks.

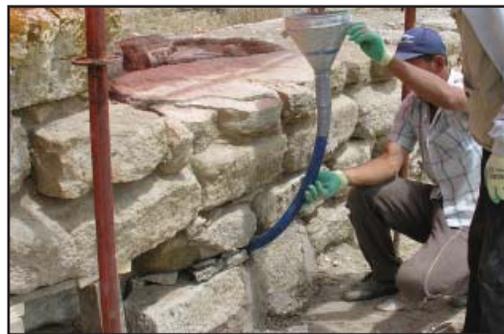
Grouting replacement stone.

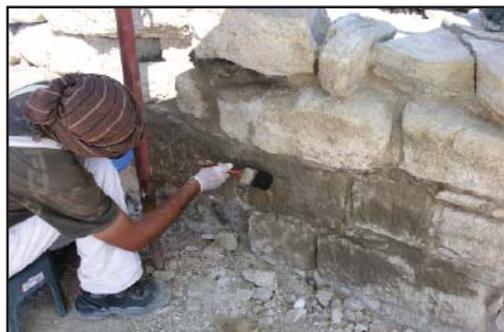
Applying a clay patina to darken the new stone.

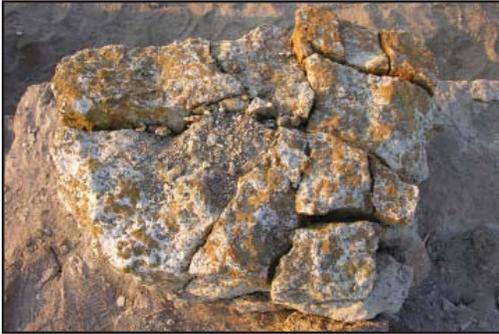
A deteriorated stone prior to adhesive repair.

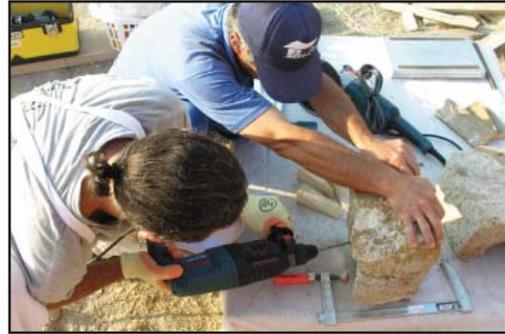
Drilling for insertion of a stainless steel pin.

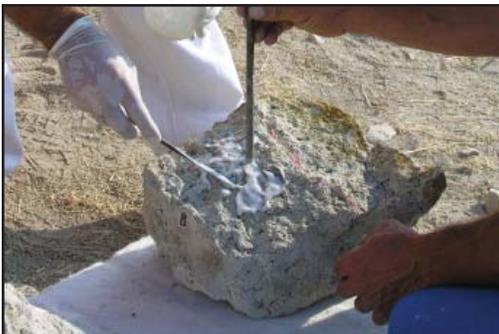
Insertion of stainless steel pin and application of epoxy resin.

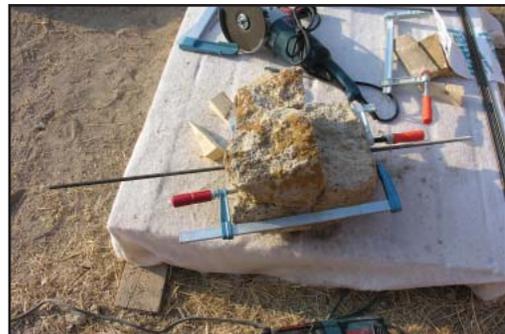
Clamping treated stone fragments after insertion of stainless steel pin.

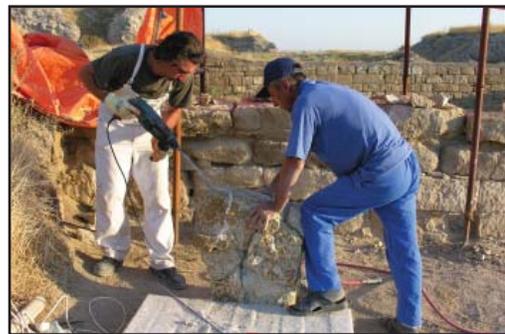
Drilling for insertion of a second stainless steel pin.

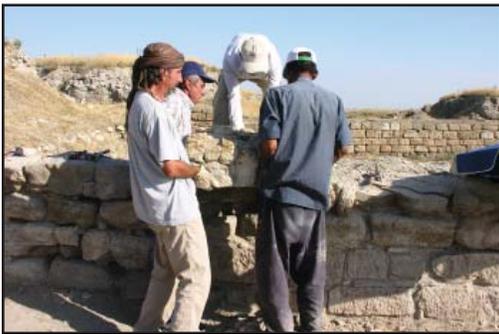
Lifting the treated stone for reinstallation on TB2-5.

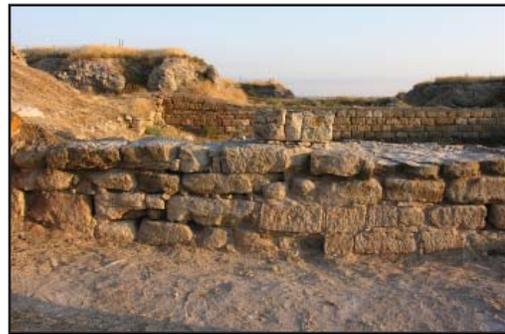
The stone in place following repairs.

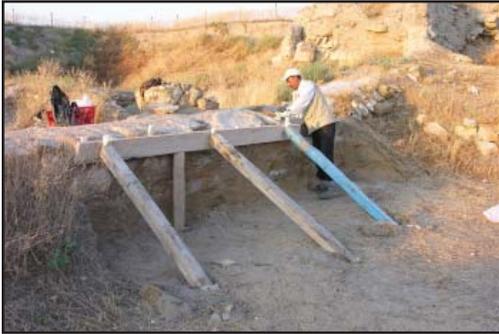
Temporary shoring of TB2-5 (from TB3).

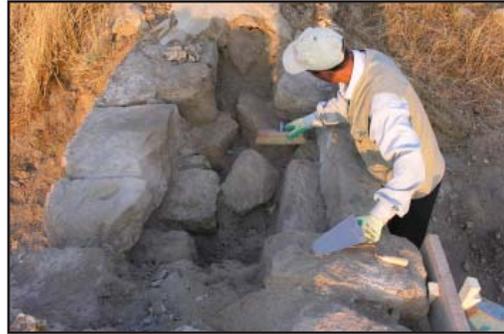
Clearing core material in preparation of structural retrofitting.

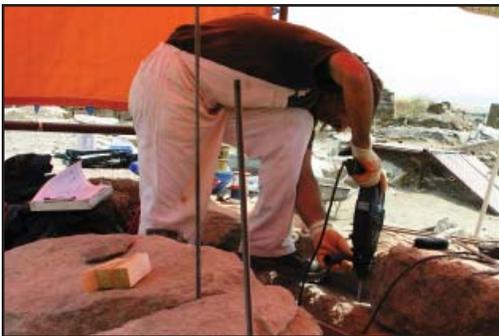
Drilling for insertion of stainless steel rods.

Structural stabilization measures included retrofitting the wall core with a system of interconnected stainless steel rods and tension cable. This preventive intervention method stabilizes the two ashlar veneer leafs in place, while allowing for individual stone movement without rebuilding. A temporary protective cap composed of geofabric, stone edging and expansive clay was installed to prevent moisture ingress over the winter. A more thorough analysis of the pilot treatment program is available in Appendix D: Terrace Building 2 Conservation Program.

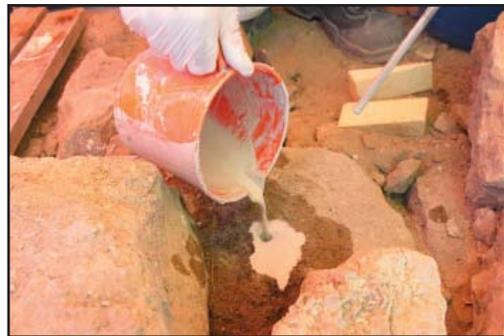
Pouring lime grout into hole prior to insertion of stainless steel rod.

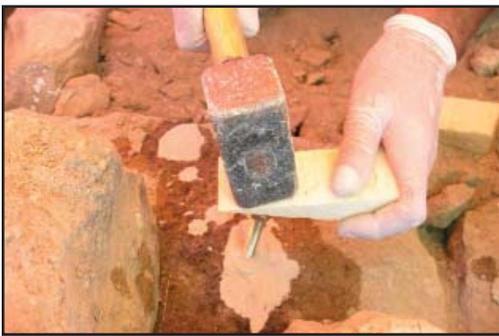
Hammering stainless steel rod into stone.

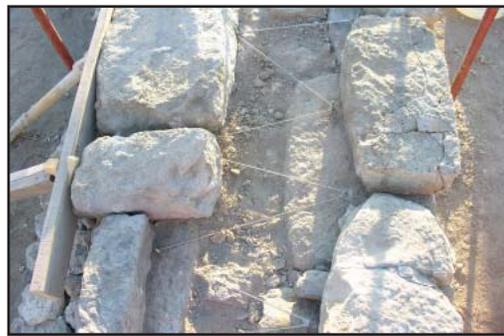
The cable system installed to prevent further spalling.

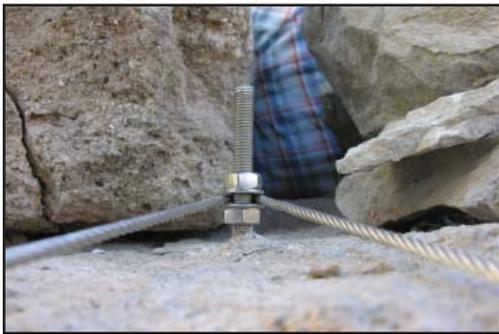
Detail of cable system.

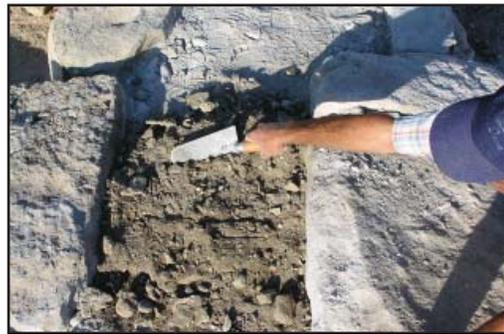
Refilling original dry core material after completion of structural retrofitting.

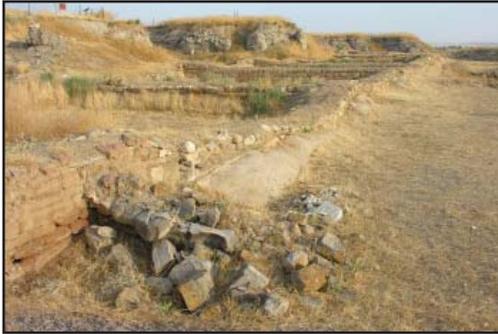
Exterior elevation of TB2-1 prior to intervention.

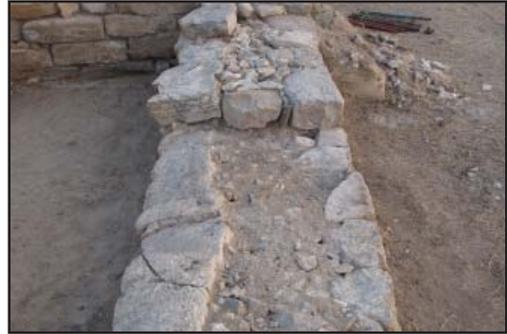
Plan view of TB2-1 after removal of capping and added coping material.

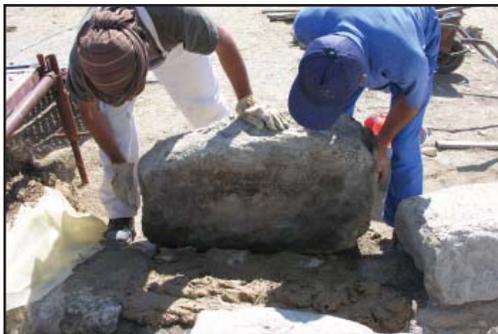
Reinstallation of an original stone with soil-based mortar.

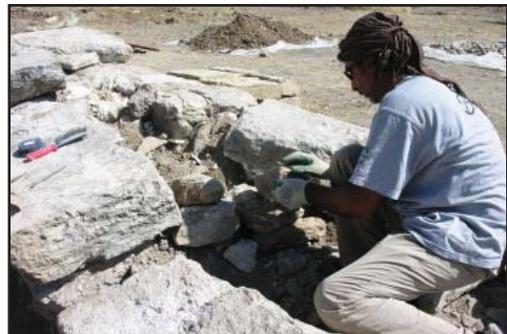
Filling with original core material.

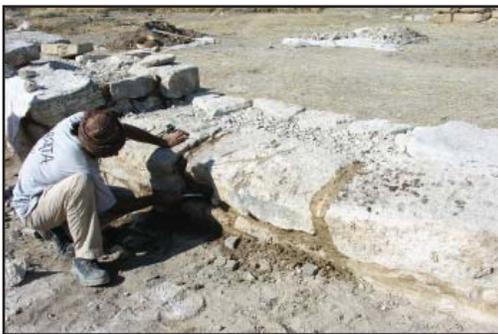
Repointing masonry with soil and lime-based mortar.

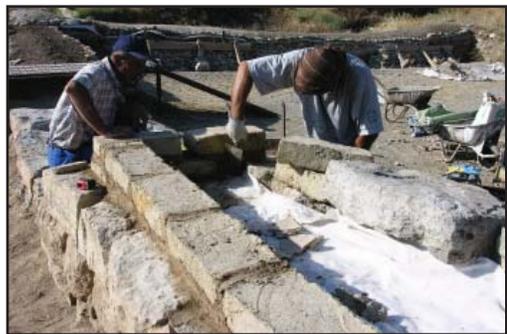
Construction of the capping system using mudbrick.

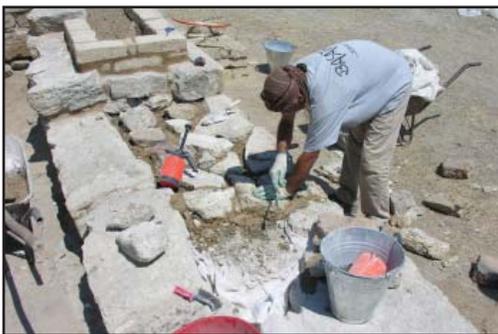
Installation of the stone and soil mortar capping system.

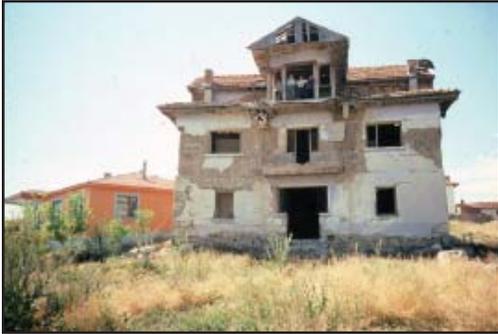
The first three-story mudbrick building in the village constructed around 1940.
