THE ARCHAEOLOGY OF MIDAS AND THE PHRYGIANS RECENT WORK AT GORDION

ARCHITECTURAL CONSERVATION AT GORDION

MARK GOODMAN

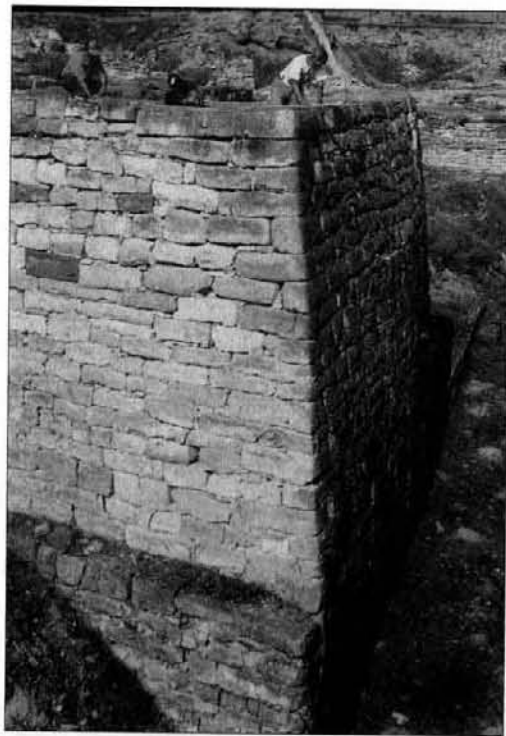
Figure 17-3 Monitoring structural displacement of the Citadel Gate using plumb lines, August 1999.

Excavation photographs taken in 1955 reveal relatively tight and flat walls retaining plaster in areas protected from the weather. To prevent water penetration over the exposed top of the gate, a cement capping was applied in 1956. This capping soon developed cracks, allowing water to erode and weaken the bond between the masonry core and the veneer (Rogers 1989). Although replaced in 1989 by an improved capping/drainage system, exposure to weather and seismic activity accelerated the deterioration and detachment of load-bearing veneer stones. This became particularly evident in the south chamber, where an ominous bulge developed.

In 1999, structural engineer Conor Power developed a simple method using a plumb bob to measure structural movement at critical points along the bulge (Fig. 17-3). As displacement continued, particularly during seismic activity, remedial work was deferred for safety reasons pending construction of supportive bracing. By 2001 sufficient funding enabled the installation of supportive scaffolding and trials of a specialized consolidation technique known as "gravity grouting" to stabilize the gate in its original configuration. As the name implies, the method uses gravitational pressure to inject a hydraulic lime consolidant into the wall, restoring the bond between veneer and core. Properly done, grouting can effectively preserve the structural and aesthetic integrity of a monument without having to dismantle and rebuild its components.

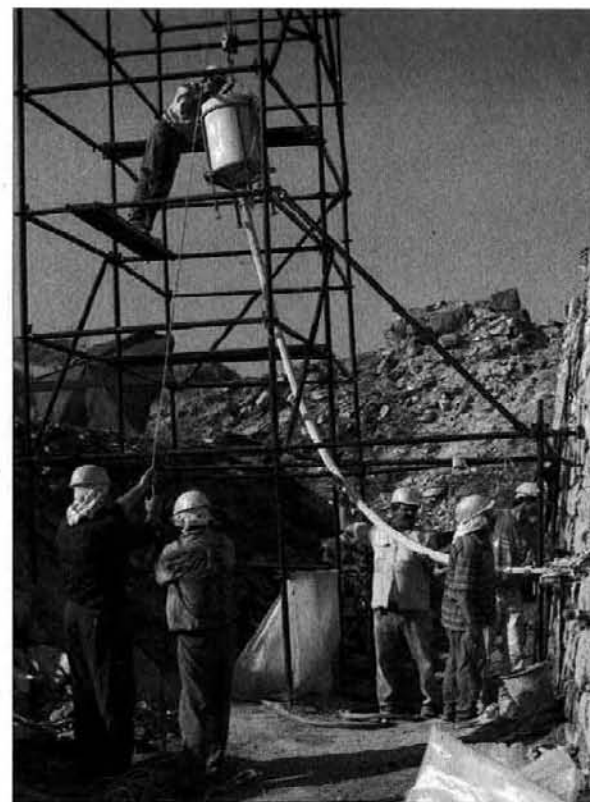
Figure 17-4 Grouting system being applied to the Citadel Gate.

The grouting system was tested on a relatively stable section of fortification wall south of the Citadel Gate (Fig. 17-4). The apparatus uses standard PVC pipe, firehose, and a specially constructed 70 liter grout bucket raised by a compound pulley to a height at least 2 m over the injection point. The mortar injected into the core is pumped upwards in grout "lifts" to ensure effective filling of interior voids.

Following successful trials, the system was adapted in 2002 to begin grouting the south court of the Citadel Gate. The wall face of the structure was digitally photographed and rectified to document pre-consolidation conditions and provide a visual reference for recording the amount of mortar injected into the walls. Additional scaffolding was used to construct an expanded work platform, paying particular attention to creating a safe and efficient setup to mix, move, and inject the large quantities of grout needed for this massive structure. The mining railroad originally used to excavate the site was reassembled to transport materials to the mortar mixer. A second railroad was constructed on the scaffold using a specially modified "grout wagon" to transport mortar to pumping stations at intervals along the wall (Fig. 17-5). Complete stabilization of the southern court is projected to take three more seasons, after which work will begin on the north court building.

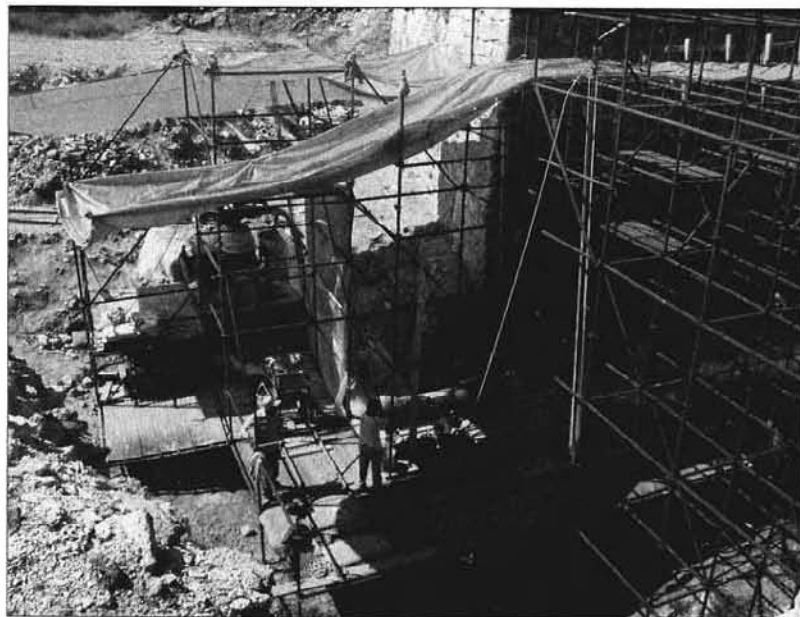
Figure 17-5 "Railroad" constructed on scaffolding to transport mortar to pumping stations for grouting the walls.

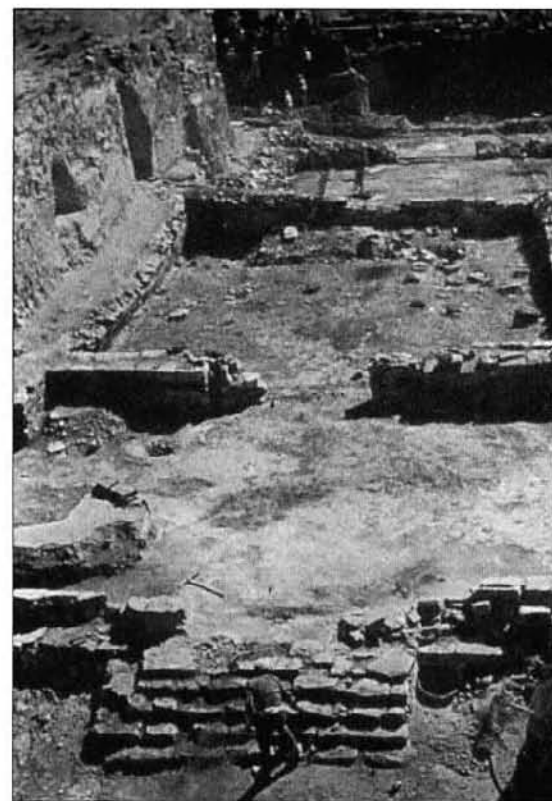
Figure 17-6 TB-5 immediately after excavation, 1961, illustrates the condition as excavated. Courtesy of Gordion Archives.

significant deterioration occurred after excavation (Fig. 17-6). The outward splay of walls increased due to seismic activity and "frost wedging." Numerous fire-damaged stones disintegrated. Entire features of buildings, such as doorjambs, had completely disappeared in some places.

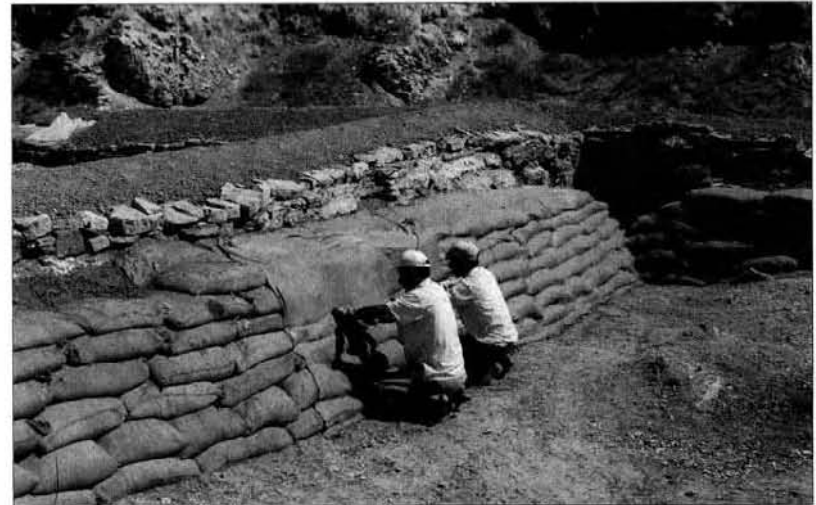
Figure 17-7 Applying protective Geotextile dressing over sandbag buttresses, August 2000.

theft. It was discovered that the unwoven polyester of geotextile adheres naturally to burlap sandbags, creating a form-fitting cover. As clean white geotextile is both conspicuous and degradable by ultraviolet radiation, the geotextile was saturated in a slurry mixture of lime-stabilized clay (Table 17-4). The resulting wet geotextile dressing was then molded to the contour of the sandbags. After drying, the geotextile was painted with two coats of clay/lime slurry. The technique was further refined to minimize water penetration into the buttress by covering exposed seams with expansive clay, burlap and saturated geotextile (Fig. 17-7). The finished product is aesthetically pleasing, with light brown buttresses contrasting with dark brown capping.

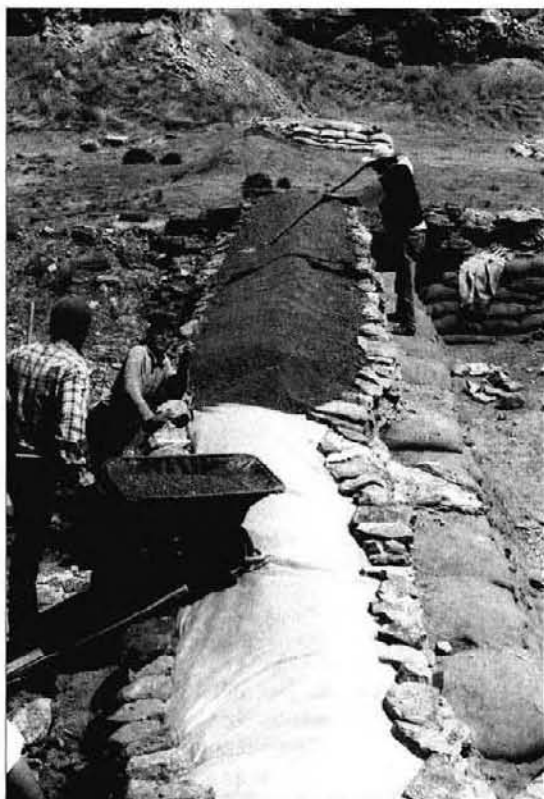
Figure 17-8 Tamping clay capping over buffered polyethylene, anchored at margins by rubble "capstones," July 2000.

The 1989 technique was implemented in the 2000 season, using clay as the capping material, with the following modifications. Following documentation, the wall tops were cleaned and a layer of sand contoured for drainage was applied to absorb condensation. The sand was covered with a double layer of 0.2 mm UV-resistant polyethylene sheeting later changed to geotextile for enhanced permeability, secured by "cappingstones" of similar color to the original wall. A deep layer of clay was mounded and tamped over the polyethylene (Fig. 17-8). To cover walls preserved to different heights, larger clods of clay were used to retain the finer material.

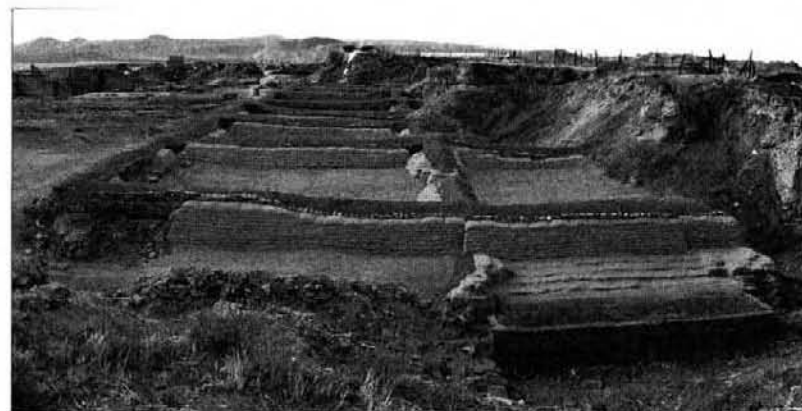
Figure 17-9 Terrace Building after interpretive stabilization. Supportive buttressing and capping protects eroded structure while providing a schematic and reversible restoration of the building plan. Pending evaluation of the stairway protection, the cinderblock encasement can be removed and the geotextile treatment extended along the steps to recover original site topography.

plan. Where local collapses created gaps in the walls, the caps provide visual linkage between surviving wall sections (Fig. 17-9). Protective buttressing of eroded doorjamb schematically restores features while preserving the original material underneath. As the Terrace Building was built of stones obtained from different sources, this was conveyed by using compatible rubble to retain the clay cappings. The contrast between the dark clay and the lighter earth shades of the site makes it possible to represent portions of the TB Complex that are obscured by eroded baulks (such as the cross walls of Terrace Building 3) by superimposed cappings.

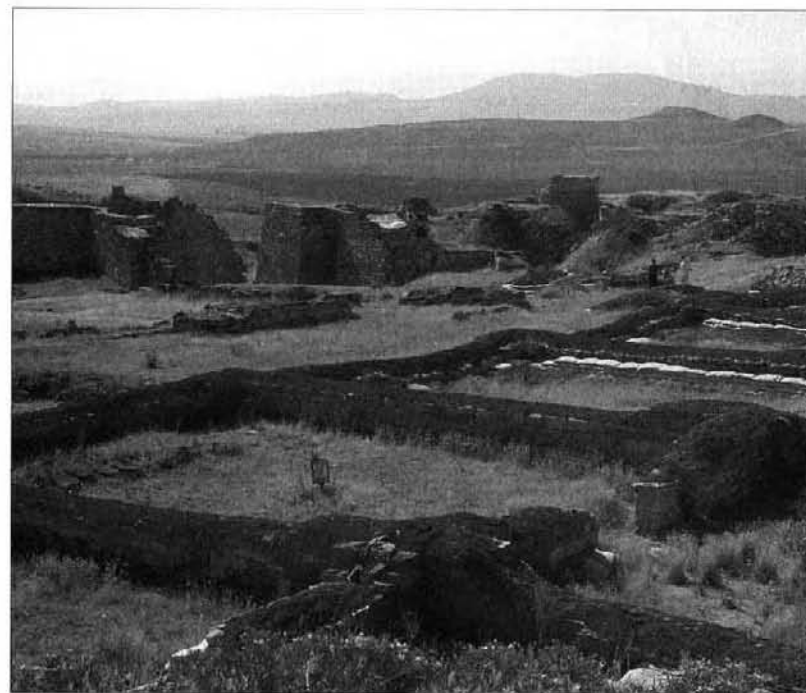
Figure 17-11 Restored Terrace Building unit 4 and stabilized complex after one year. Section of mortared wall capping (left of lower crosswall) is exposed to compare with protected section, June 2001. Courtesy of Richard Liebhart.

A section of buttressed capping was dismantled, revealing no signs of frost damage within the protected walls. Since frost can be an insidious process manifesting itself only after several years, a simple monitoring method was
