Resurrecting Gordion: Conservation as Interpretation and Display of a Phrygian Capital

Frank Matero

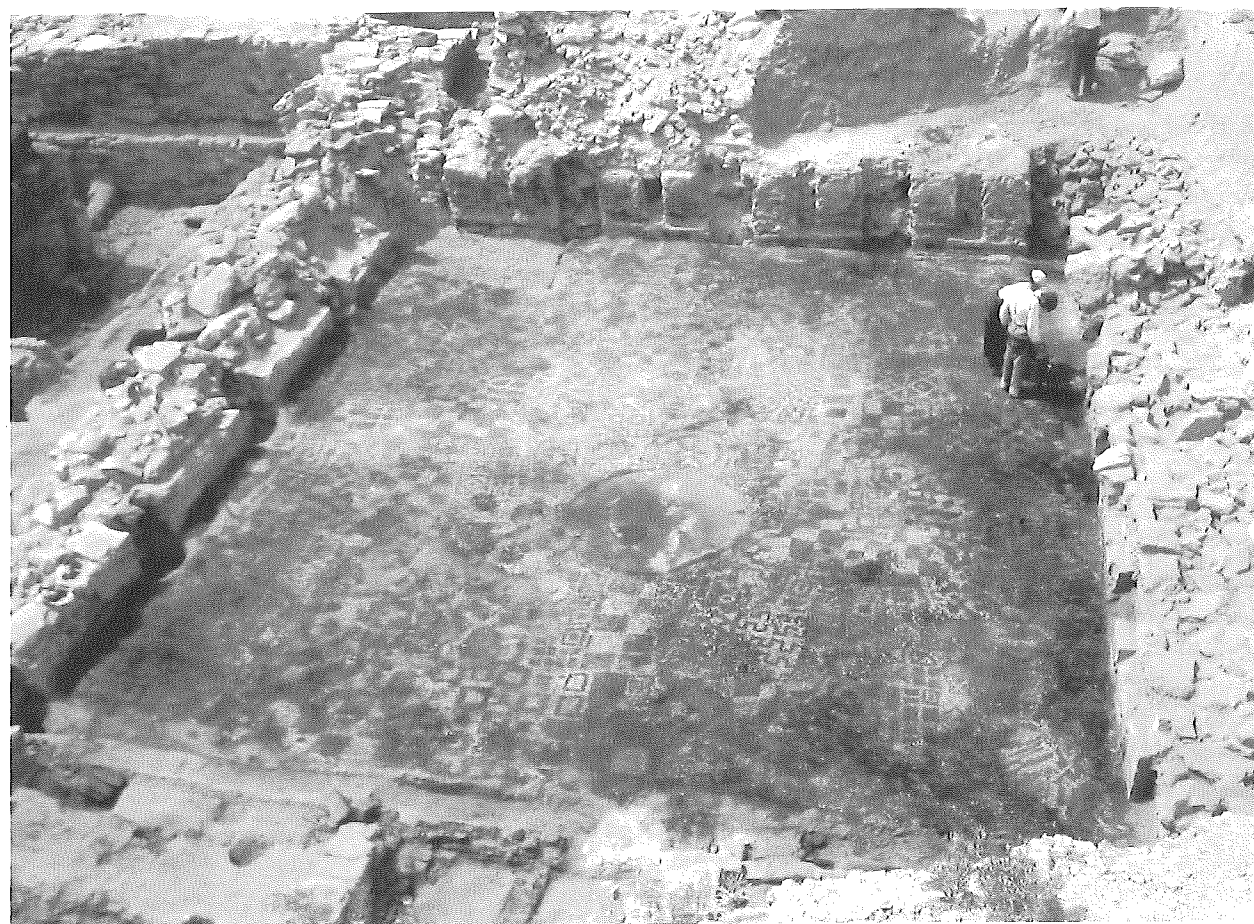
Fig. 16.1. Megaron 2 during excavation and discovery of pebble mosaic pavement, 1956. Source: Gordion Archive, Penn Museum.

Only the gate appears to have been subjected to minor reconstruction when, during its excavation in 1955, the northwest ramp wall of the North Court and the top of the southwest ramp wall of the South Court were rebuilt with stone blocks that had been recycled during the Middle Phrygian period in the construction of the later "dam wall" (see Voigt, this volume). In 1961 an important pebble mosaic—the earliest of its type—from Megaron 2 was cut and lifted in panels and transported to the Gordion

Museum, where it was later re-installed under an outdoor shelter. Despite the popularity of lifting ancient mosaics at that time, the result is usually damaging, and in this case, the piecemeal transfer of a clay-based pebble mosaic seriously compromised the overall integrity of this remarkable pavement (Figs. 16.1 and 16.2).

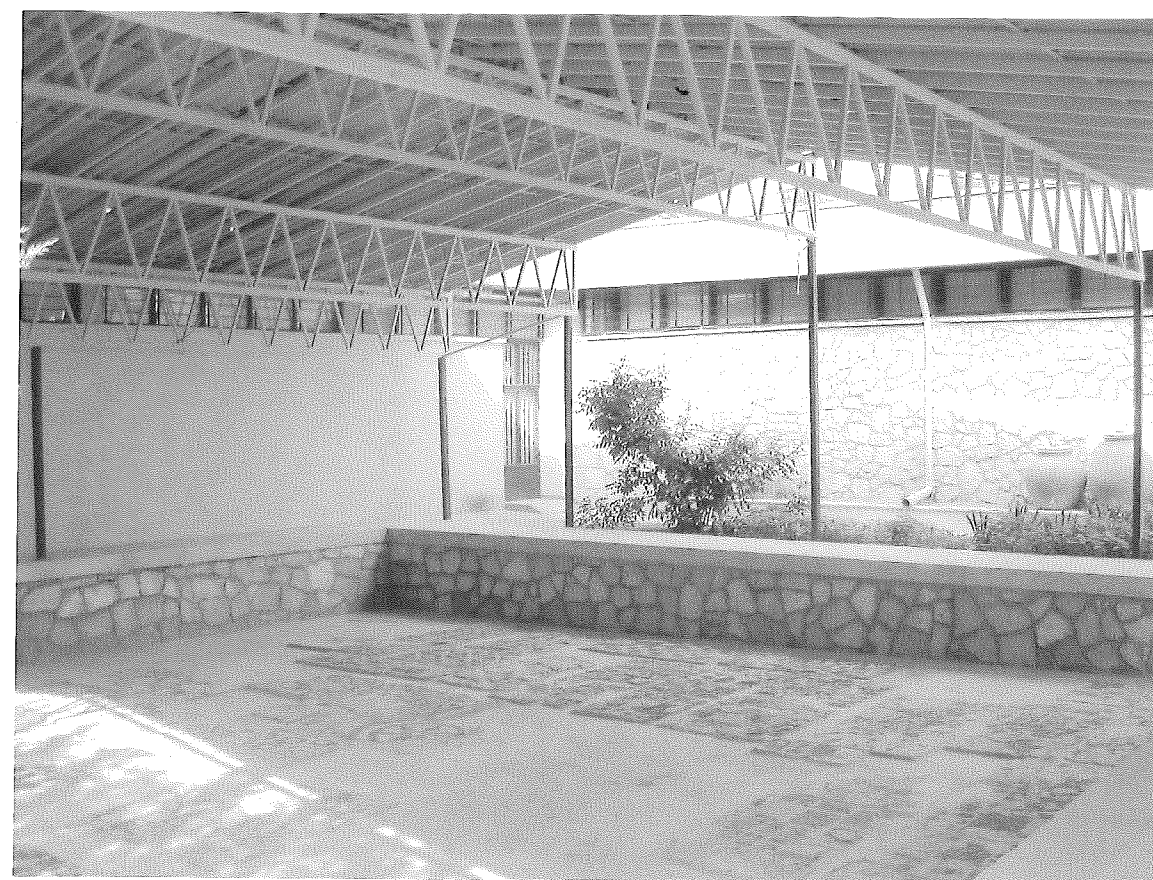
Fig. 16.2. Current display of lifted Megaron 2 mosaic at the Gordion Museum, 2005. Photo: author.

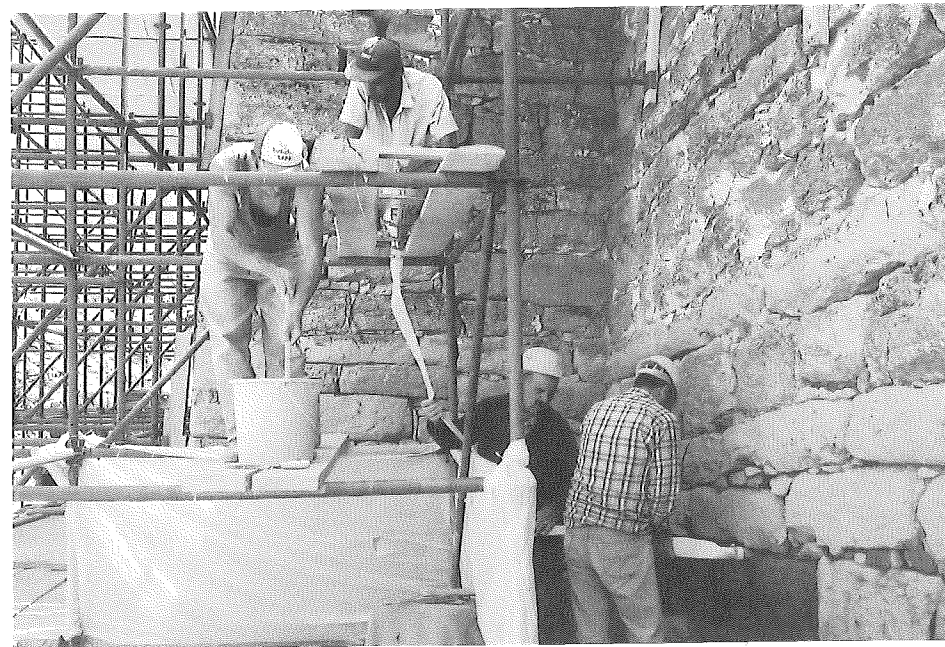
Fig. 16.3. Grouting the Early Phrygian Gate, 2003. Photo: Mark Goodman.

In 1999 conservator Mark Goodman introduced a well-developed set of formal guidelines for site conservation and a priority program based on condition and significance. Plumblin measurement monitoring began at the gate, a French drain was installed, and a temporary scaffolding system was built. In 2002 low-pressure gravity grouting was begun on the dry-laid masonry gate on the recommendation of Sir Bernard Feilden (Fig. 16.3). For the Terrace Building, TB4 masonry was rebuilt and an elaborate system of temporary protection employing sandbag buttressing and soil capping of the splayed walls was begun at TB1, 2, and 8, and later extended to the entire building and other masonry features (Fig. 16.4).

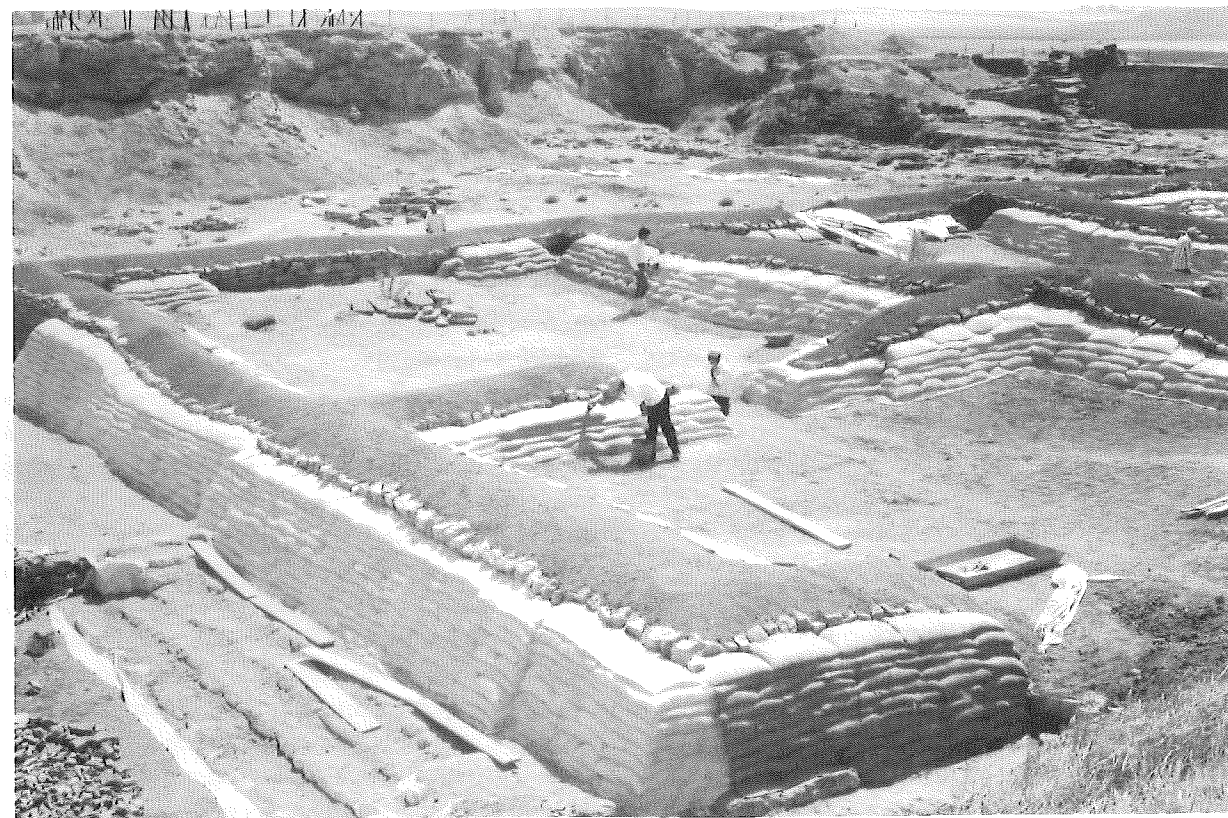
Fig. 16.4. General view of the Terrace Building with its temporary stabilization, 2001. Photo: Mark Goodman.

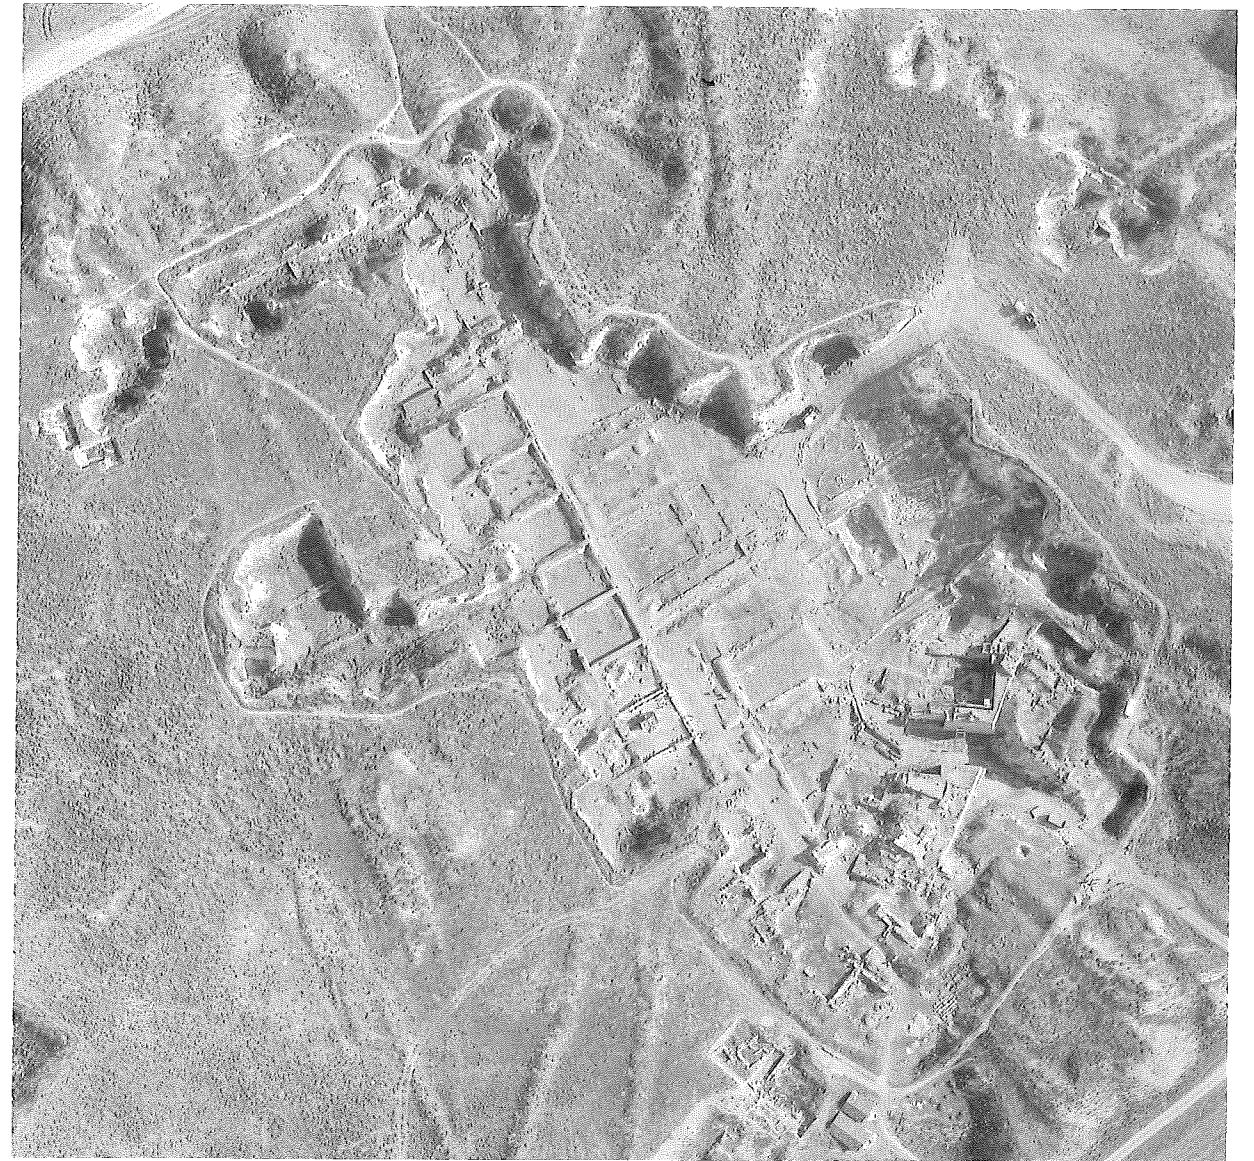
Fig. 16.5. Site plan of phased conservation activities over the next five years. Source: Penn Architectural Conservation Laboratory.

tions is the consideration of both the constructed (and deconstructed) mound itself and, by extension, the scarps that define the current extent of the excavation and the exposed citadel core (Fig. 16.5).

The first-order priority of the conservation plan is the ancient constructed form of the mound in terms of its mass and contour, as well as its dynamic reshaping by subsequent occupation and its disfigurement by excavation and weathering. Large-scale interventions, already underway, include the selective removal of excavation spoil dumps that have significantly altered the external form of the ancient mound, and the infill of dangerously eroded scarps that now rim the excavation and undermine the visitor circuit above. Also critical to the stabilization of the mound, the scarps, and the surrounding tumuli is the development of a re-vegetation plan to curtail erosion, already begun by the site's archaeobotanist, Naomi Miller (see Miller, this volume).

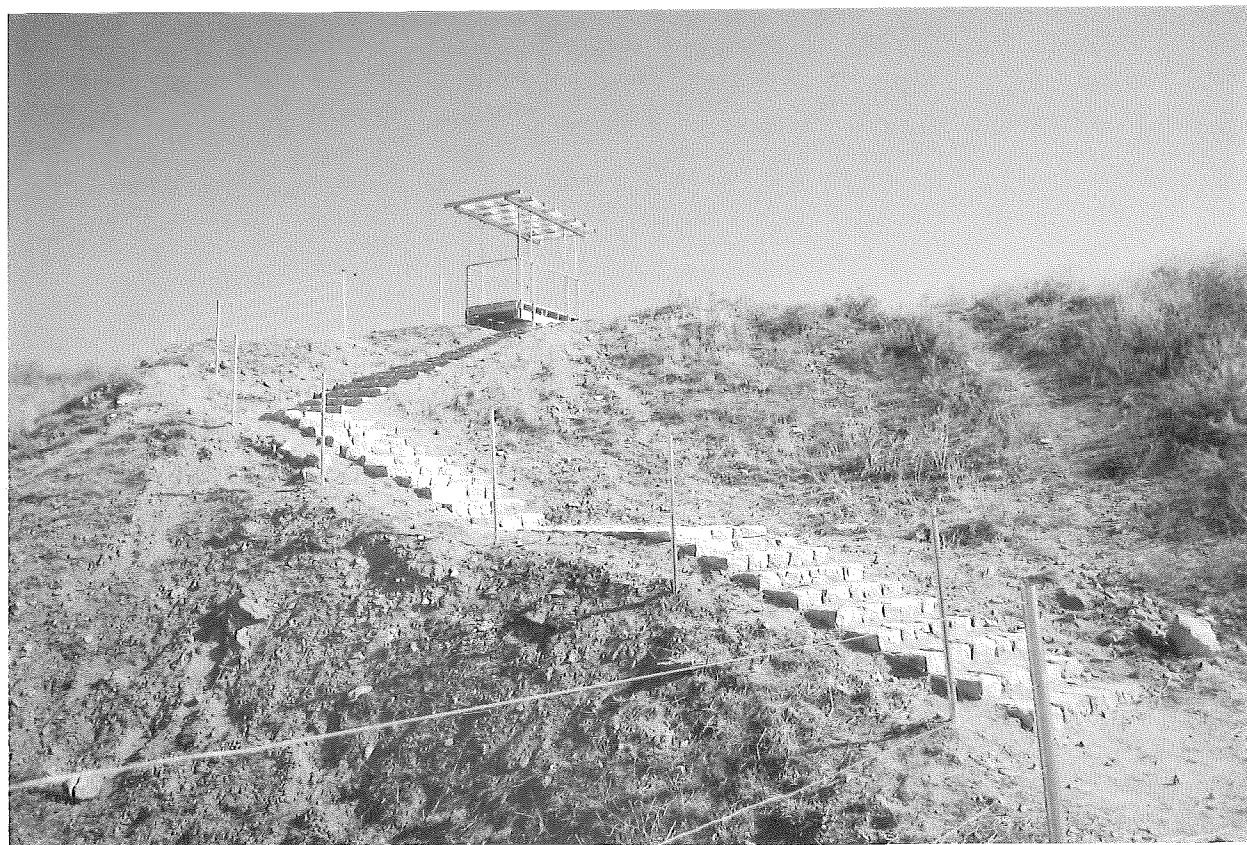
Fig. 16.6. Visitor circuit with new stone steps, railings, and wayside pavilion design. Source: Penn Architectural Conservation Laboratory.

Internally, the extent of the citadel, and especially the Early Phrygian period revealed by excavation deep within the mound, has created a unique situation for viewing. From the flat top of the mound, visitors have an extraordinary 360-degree view into the extensively excavated citadel. Unlike many such stratified sites, the citadel's diachronic urban plan can be understood relatively easily if the legibility of the building fabric is maintained and reinforced. This remains one of the site's most significant aspects and is currently threatened by the instability of both the eroding scarps and baulks and the poorly presented and eroded architectural fabric (Fig. 16.4). A new visitors' circuit utilizing the different vantage points above has been designed with 12 canopied wayside pavilions, each addressing a different set of themes depending on the views inward and outward toward the surrounding ancient and modern landscape (Fig. 16.6). Here the expansive views allow a

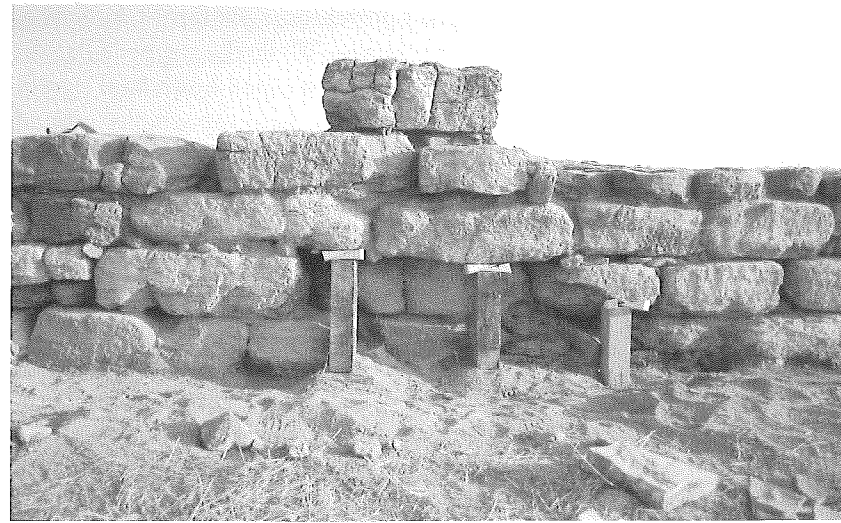
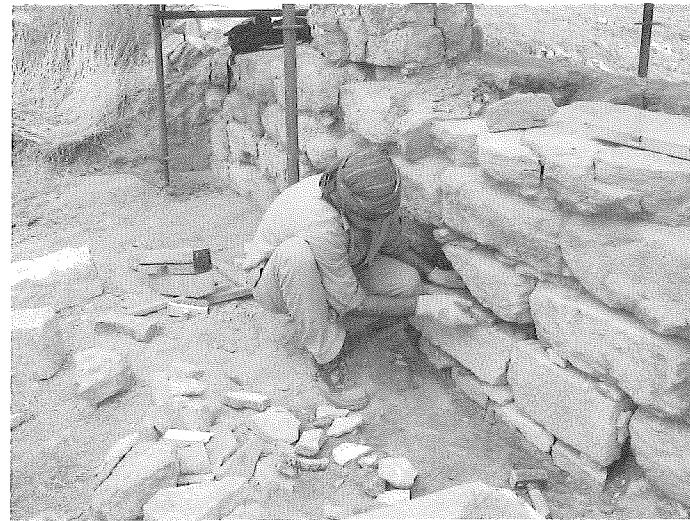
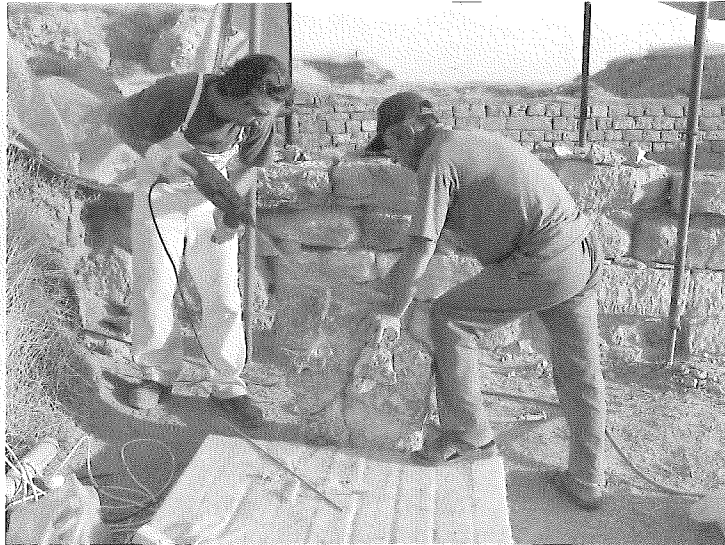
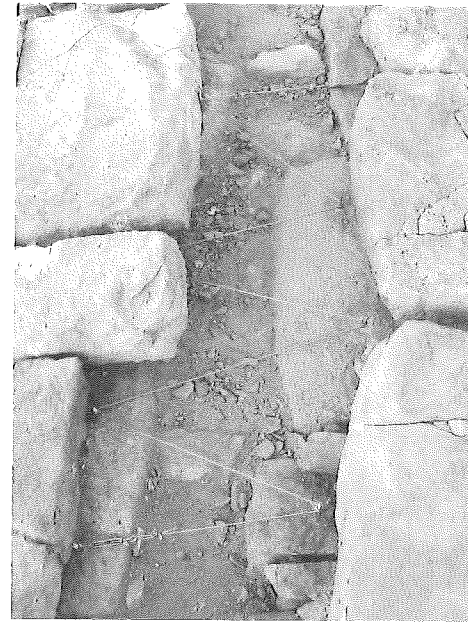
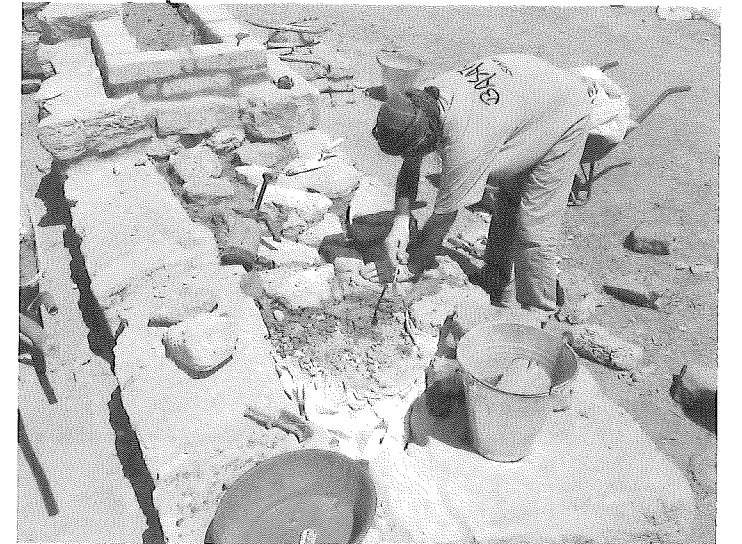
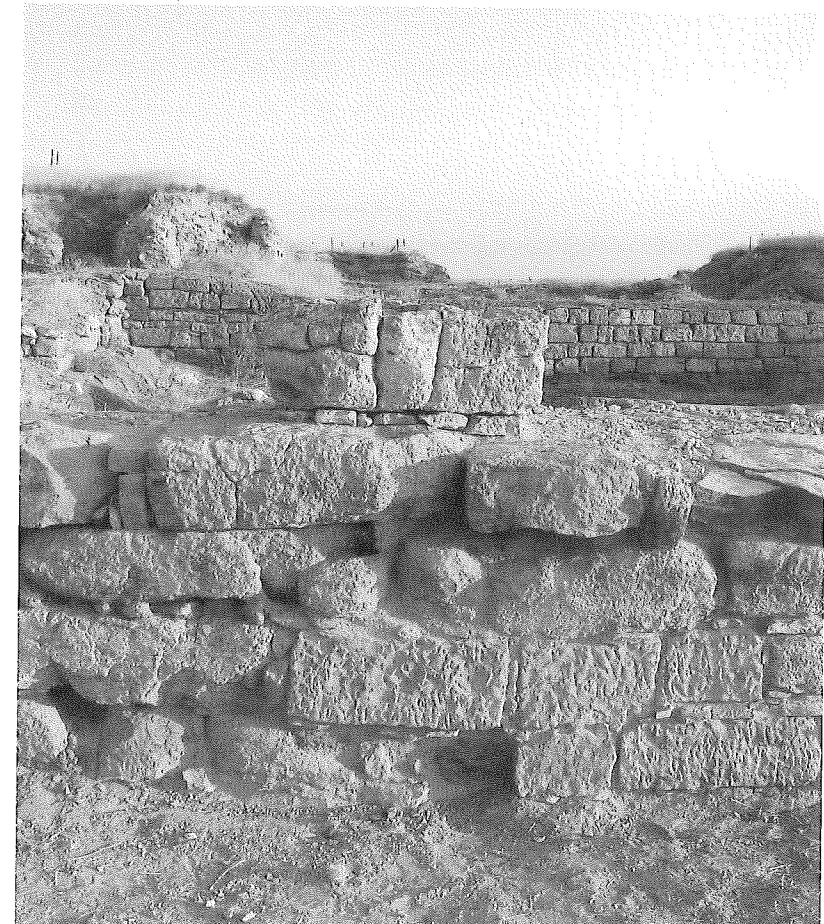
Fig. 16.7a-f. Terrace Building (TB2), demonstration of various wall masonry conservation techniques: (a) before treatment; (b) stone replacement; (c) drilling for adhesive repair; (d) structural retrofitting; (e) wall capping; (f) after treatment. Source: Penn Architectural Conservation Laboratory.

At the Terrace Building—a large linear building of successive rooms where goods were produced, processed, and stored—the architectural evidence (as well as associated finds) is well preserved, thus demanding an intervention approach that preserves the construction integrity as well as the visual legibility of this building's unique plan and the individual associated interior features (walls, floors, openings, hearths, and storage bins). Here recent conservation methods have included a range of techniques including selective stone block replacement, mechanical repair of original stones (grouting, adhesive repair, and pinning), and *in situ* wall stabilization (cable stitching) (Fig. 16.7). The end result is the preservation of the ancient walls as found without disassembly or reconstruction (as attempted earlier), thus preserving their structural integrity as well as overall form.

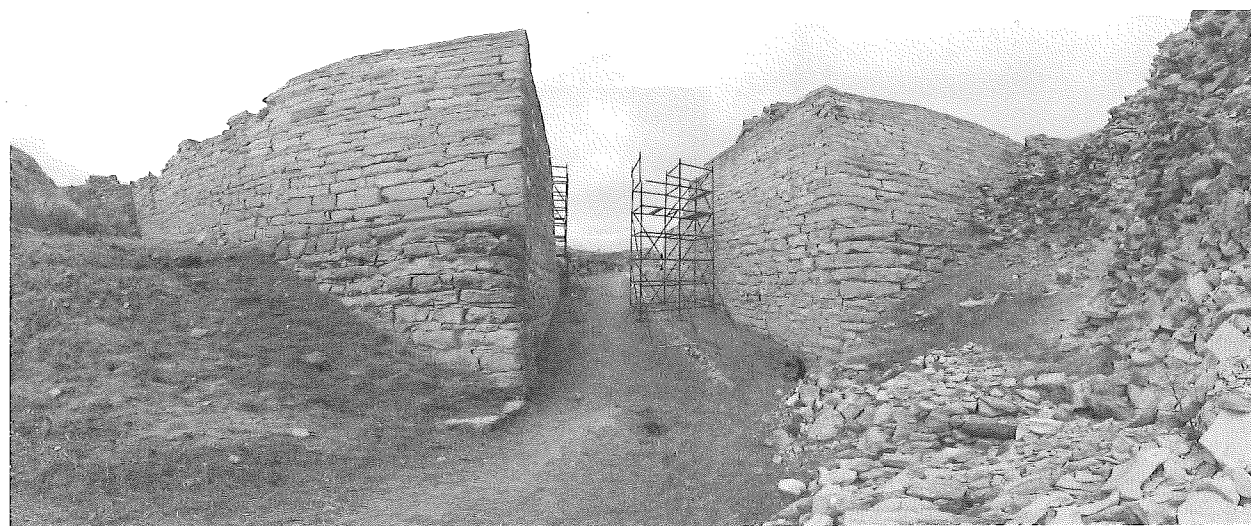
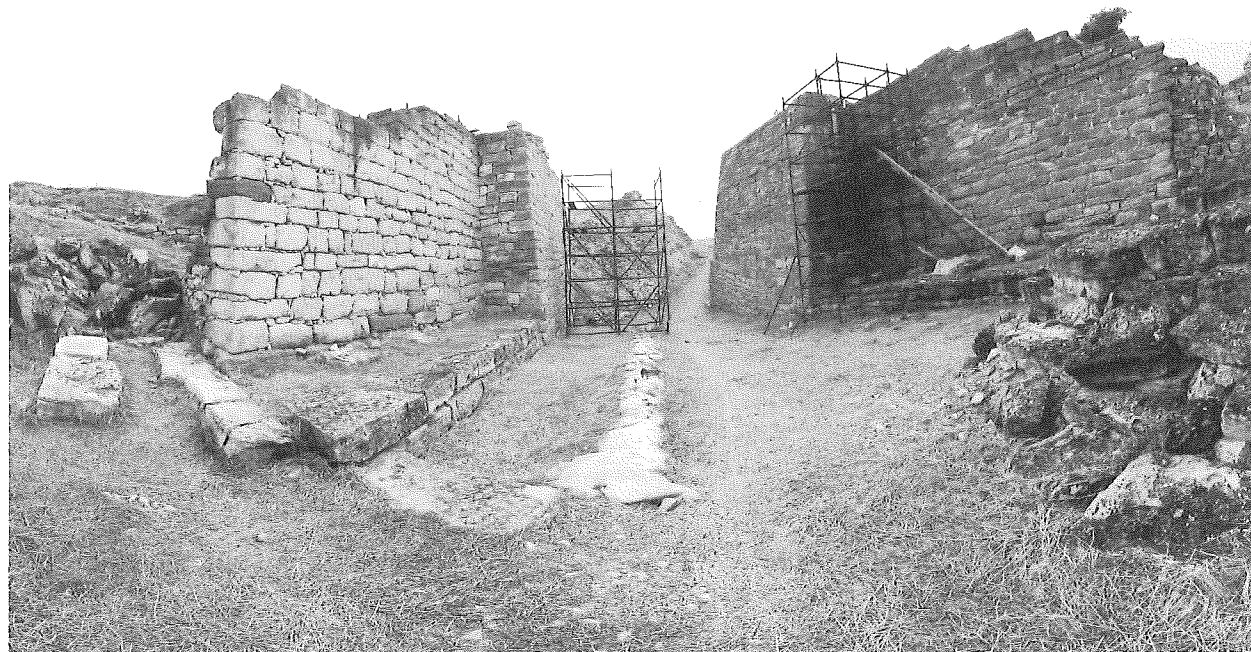
Fig. 16.8a (top), b. Gate entrance showing Early and Middle Phrygian masonry and trenched later Phrygian fill, view looking northwest (a) and east (b). Source: Penn Architectural Conservation Laboratory.

The entrance to the Citadel Mound affords a slightly different example of how one might reconcile the conservation, stabilization, and interpretation of built form at the urban scale. From all evidence Gordion was a raised fortified settlement with a series of ashlar walls and one or more gate structures. Today, as in antiquity, one approaches the citadel up a ramp through the massive gate (Fig. 16.8). The current Early Phrygian Gate survives nearly complete due to intentional burial during the Middle Phrygian period for a superimposed gate above it. Although the later gate was largely destroyed by subsequent reoccupation and stone reuse, Young's excavations removed much of the Middle Phrygian fill, which formed an

imposing stepped polychrome platform Glacis from which the later gate rose. While the stepped Glacis is still partially visible, Young's spoil heaps have significantly changed the immediate topography around the gate entrance and the overall outer contour of the Phrygian mound. The result is a confusing and less impressive entrance compromised by the looming spoil mounds, and it is dangerously unstable due to the exposed unsupported Middle Phrygian fill.

Current solutions to this complex problem address the three-fold requirements of (1) restoring the experiential sense of arrival and entry clearly intended by the Phrygians in their architecture and setting, (2) the display of time revealed and understood through the physical superimposition of building and stratigraphy, including the later rubble fill for the construction of the Middle Phrygian Gate, and (3) the necessity for stabilization and public safety. This will be achieved by re-establishing public entry to the citadel through the existing Early Phrygian Gate while at the same time exhibiting and interpreting the later Middle Phrygian Glacis and rubble fill. Such a plan will require the removal of the current excavation ramp and Young's spoil heaps, which disfigure the entrance and the distinctive mound profile. The cut rubble fill will be stabilized with limestone-filled gabions, which provide essential buttressing of this critical feature while visually referencing its rubble stone construction.

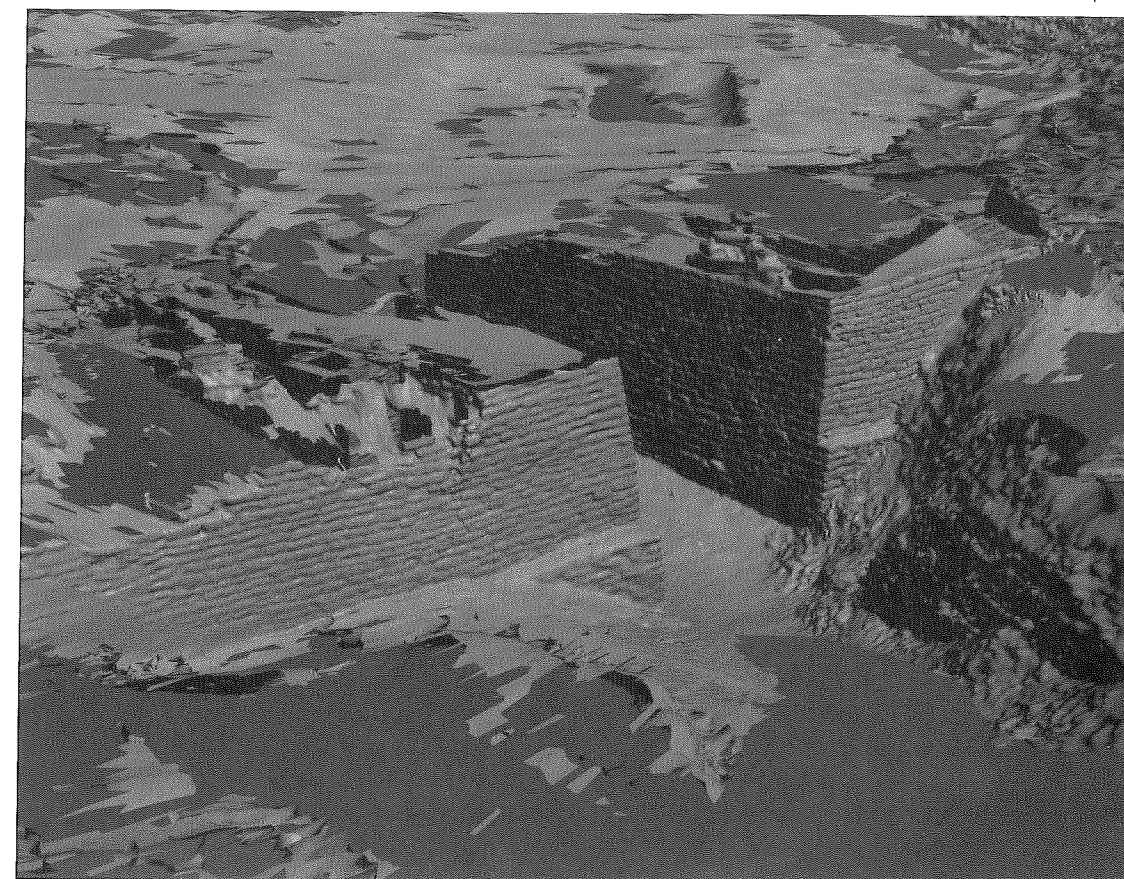
Fig. 16.9. Laser-image of the gate and surrounding area. Source: Penn Architectural Conservation Laboratory.

The use of dry-laid rubble stone fill behind the battered ashlar walls of the gate has rendered the structure potentially unstable, especially in a seismically active region. This became evident in the 1990s when a bulge and cracking were observed on the northwest corner of the South Court, which only worsened after the 1999 earthquake. Because of the incredible rarity

and integrity of the gate, any further remedial effort to stabilize the masonry must be minimal (i.e., not disassembly). Therefore, in advance of any structural solutions, mid-range laser imaging (scanning) and a stone-by-stone conditions survey of the gate have been recently completed, and structural and environmental monitoring is currently underway (Fig. 16.9).

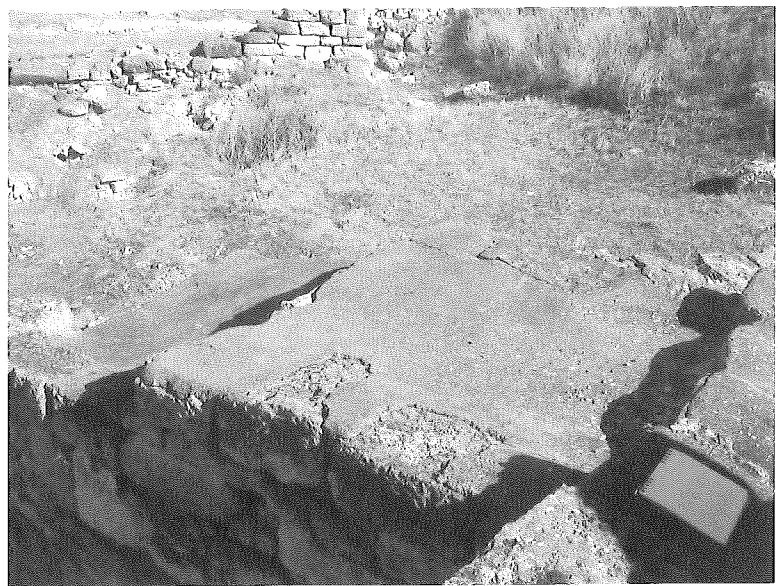
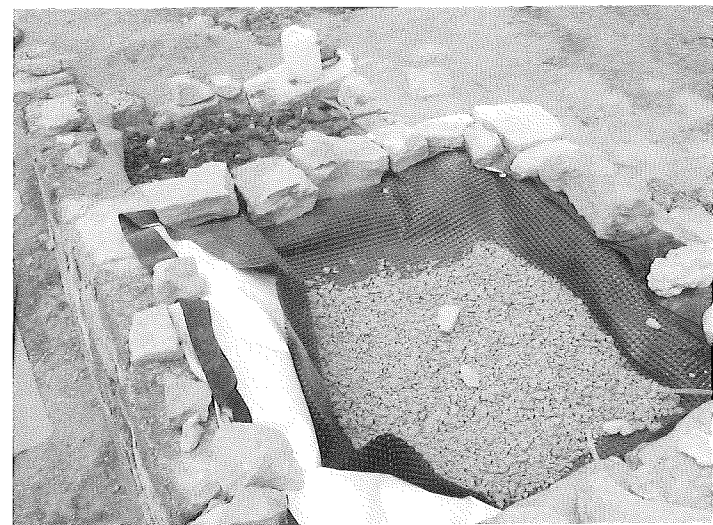
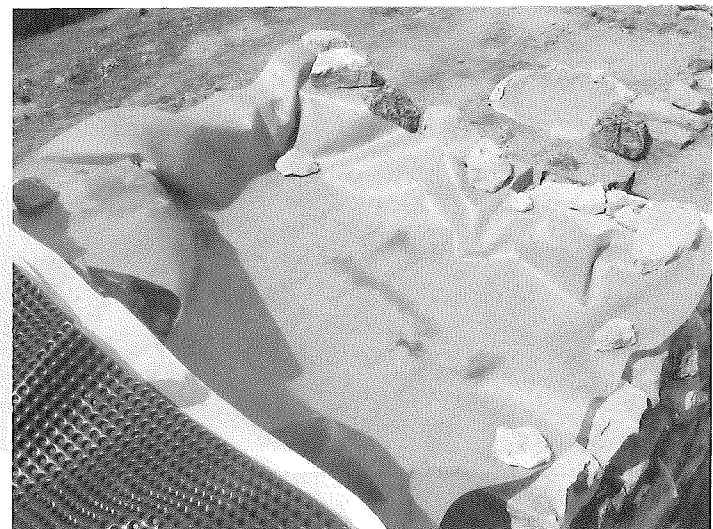
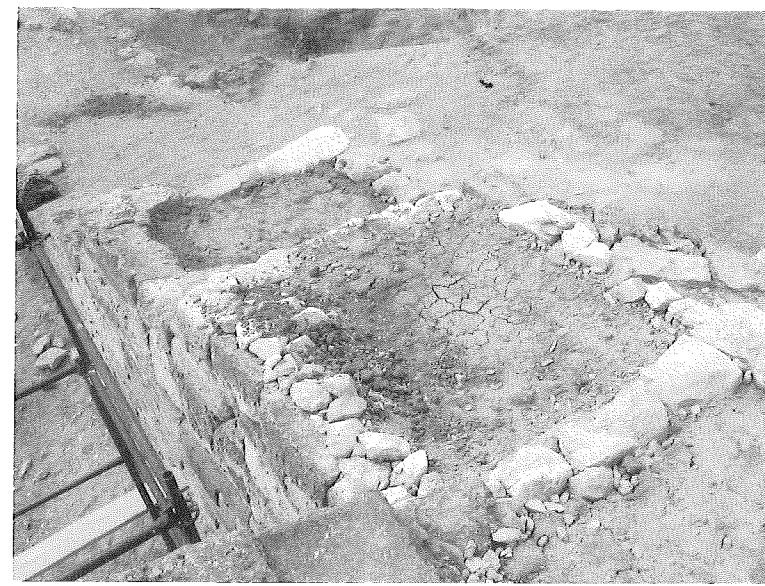
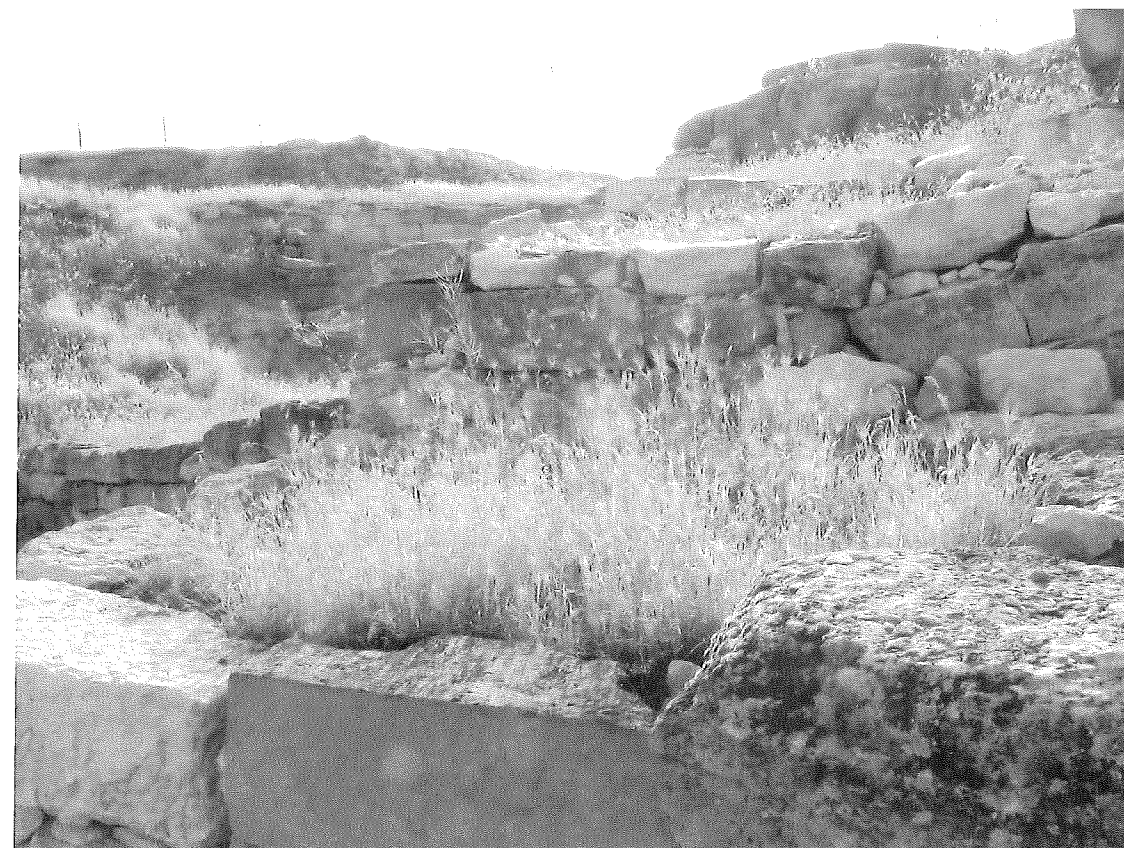
Fig. 16.10a–e. Installation of vegetative “soft” caps on north gate complex: (a) existing concrete cap prior to intervention; (b) capillary break layer; (c) filter layer; (d) completed “soft” caps; (e) view looking east of completed north gate “soft” wall caps. Source: Penn Architectural Conservation Laboratory.

In addition, an innovative program of protecting the gate and wall tops using “soft” vegetative capping holds great promise in ultimately providing a maintainable, sustainable solution that is both aesthetically acceptable and cost effective for so large a site (Fig. 16.10) (see Miller, this volume). These are some of the larger projects currently underway at the citadel that respond to the need for immediate stabilization, and interpret the site to the public during on-going conservation and excavation. While the process is open-ended and will benefit from professional and public input during this phase, its goals and objectives are based on a long-term plan that recognizes the site’s potential as an important visitor destination.
