RECREATING ACID STAINS ON HISTORIC CONCRETE

A THESIS

Historic Preservation

2016

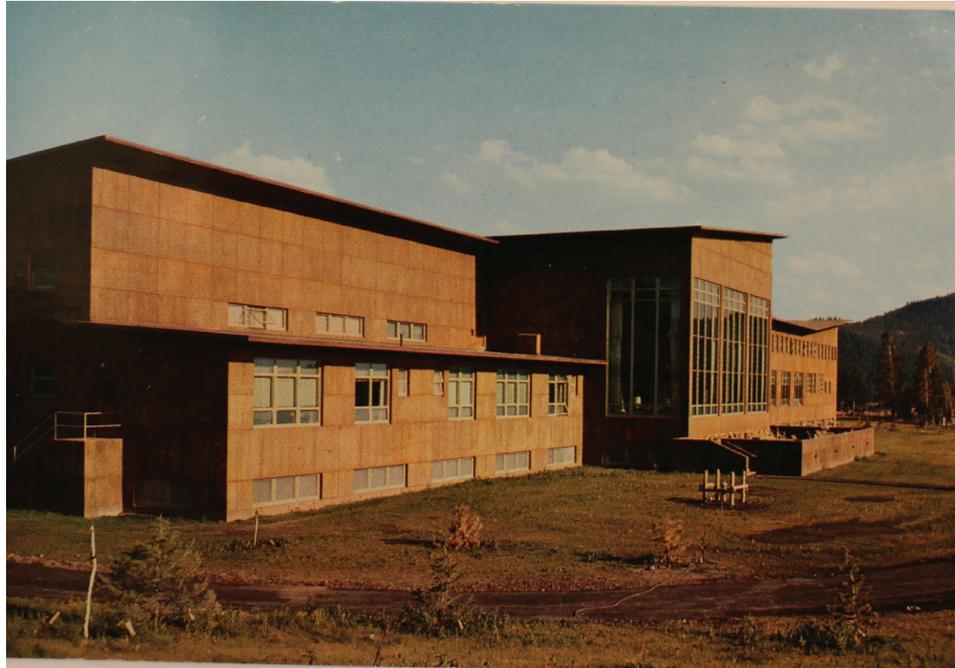
Figure 3. Jackson Lake lodge, Grand Tetons National Park. Built 1955. Note acid-stained concrete, which appears like redwood plywood. Image Credit: Rockefeller Archive Center.

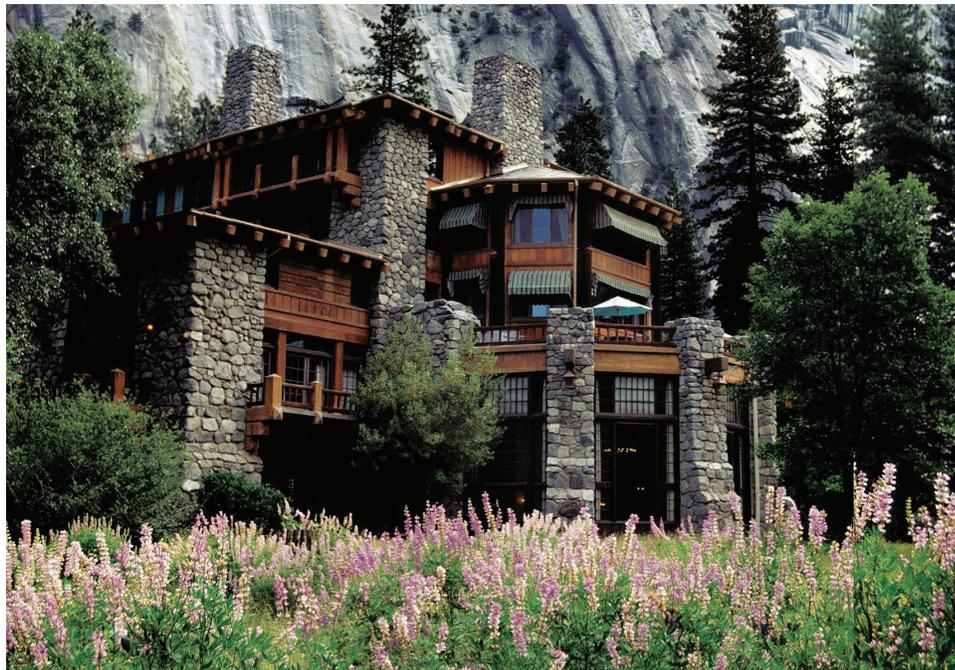
Figure 4. Ahwahnee Hotel, Yosemite National Park. Built 1927. Note brown, acid-stained concrete and natural stone exterior. Image Credit: www.easytobook.com.

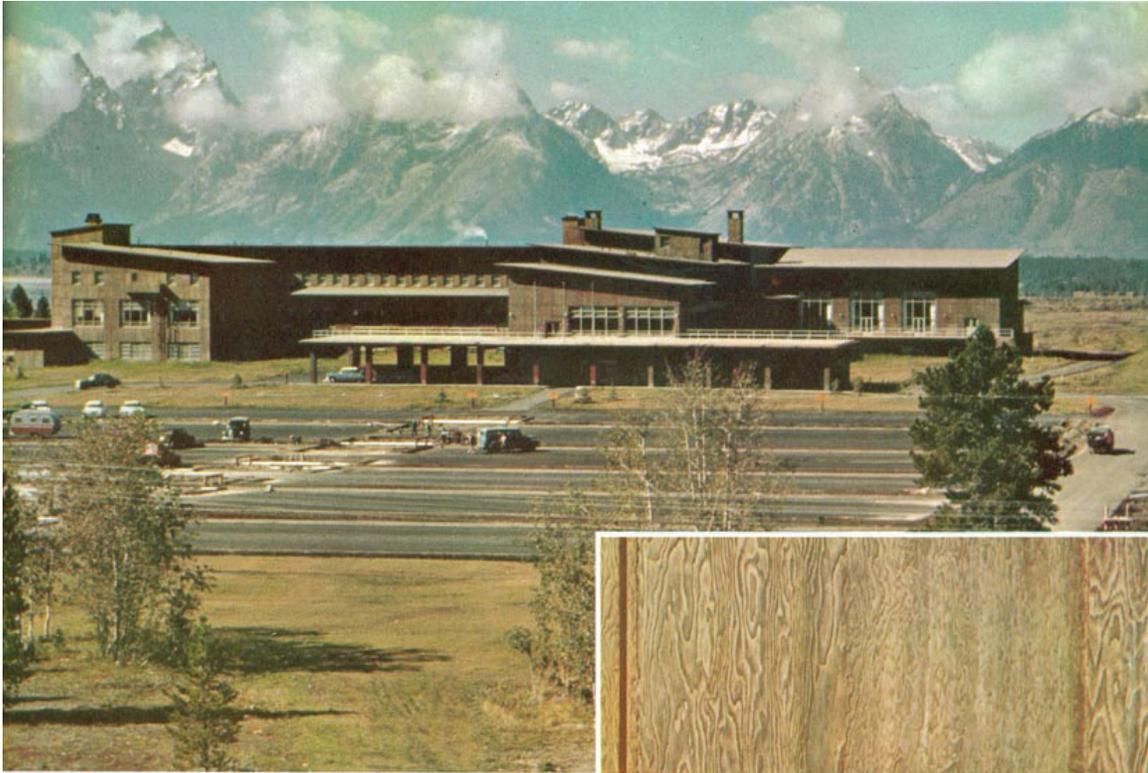
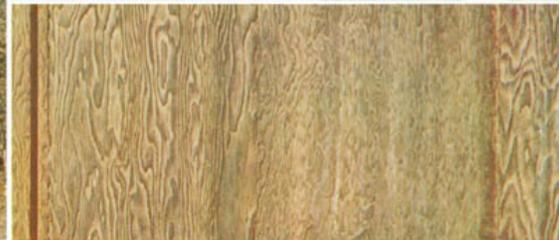
Faulty concrete color or finish Kemiko Stain with Col-r-tone Finish will produce uniformity and profound beauty on faded pigmented concrete or on surfaces that are dusting, stained, unevenly textured, patched or worn.

The snow-crested Grand Teton mountains are inspiring, colorful surroundings for Wyoming's famous, \$6,000,000 Jackson Lake Lodge. To harmonize with the natural beauty of the setting exterior lodge walls of concrete were cast against Shado-Wood, then stained with Kemiko's rich Malay Tan, highlighted with Colorado Brown and Black. Through sub-zero winters and summer sun, the stain provides permanent, maintenance-free color. A John D. Rockefeller, Jr. interest, the lodge is operated on a non-profit basis for tourists by Jackson Hole Preserve, Inc. Close-up illustrates natural beauty of concrete wall.

Figure 5. Kemiko Advertisement c. 1956. This advertisement was produced by Kemiko – the company that manufactured the stain that were originally applied to Jackson Lake Lodge. The insert contains the only color, detail shot of the original concrete finish. Image Credit: <http://www.kemikostainforconcrete.com/history.html>.

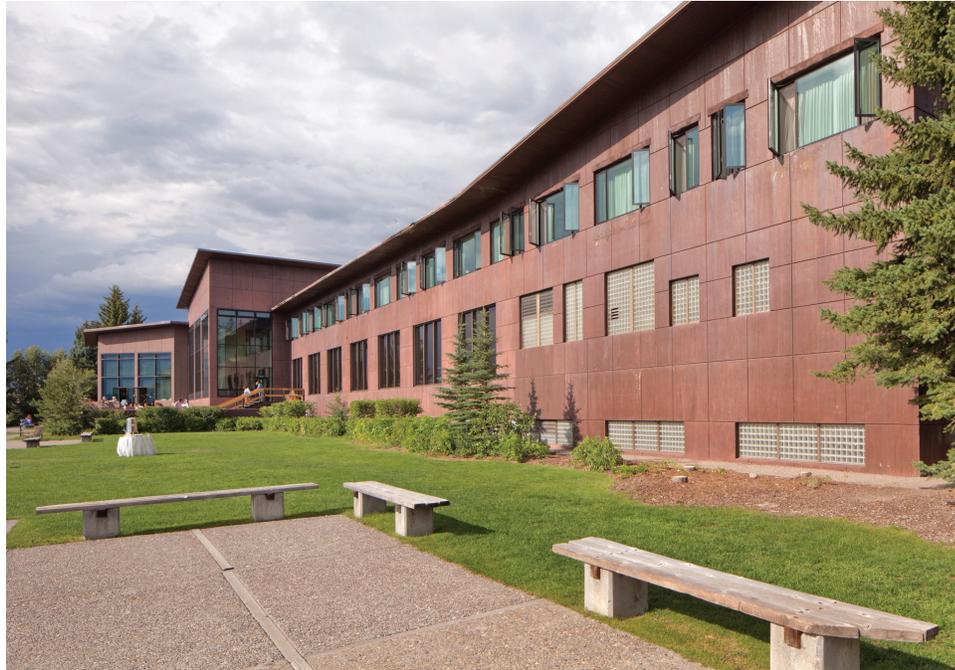
Figure 6. West elevation of Jackson Lake Lodge in 2014. Note the modern stain. Image Credit: Joseph Elliott.

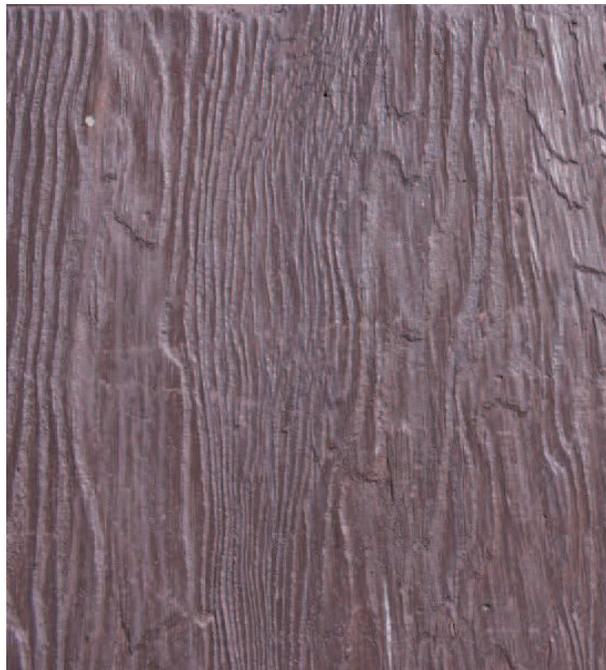
Figure 7. Detail of modern stain taken in 2015 Image Credit: Julianne Wiesner-Chianese.

years of exposure, the acid-stained surface was re-coated. Prior to the application of the existing brown stain, the exterior surface of the concrete was chemically cleaned, rinsed with pressurized water and then acid etched. The new coating is an opaque, monochromatic, brown stain that conceals the materiality of the concrete and diminishes the effect of the wood grain texture. The new stain is completely flat and no longer appears like redwood. This loss of materiality significantly changed the visual appearance of the lodge and compromises the aesthetic role the concrete skin plays in the overall design.

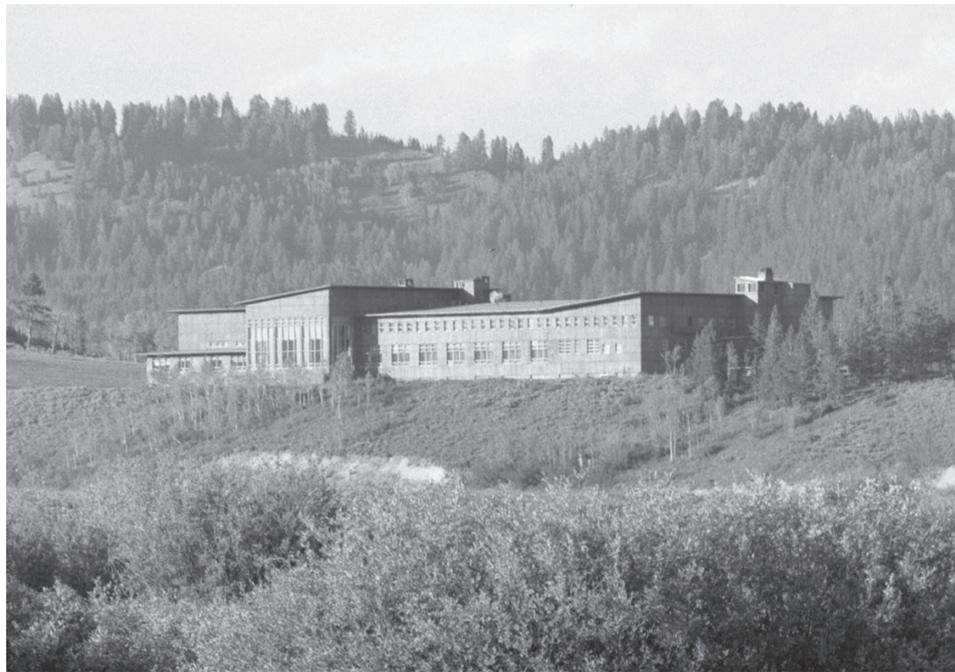
Figure 9. West elevation of Jackson Lake Lodge before 1960. View shows relationship between the lodge and the surrounding landscape. Image Credit: Grand Teton Lodge Company.

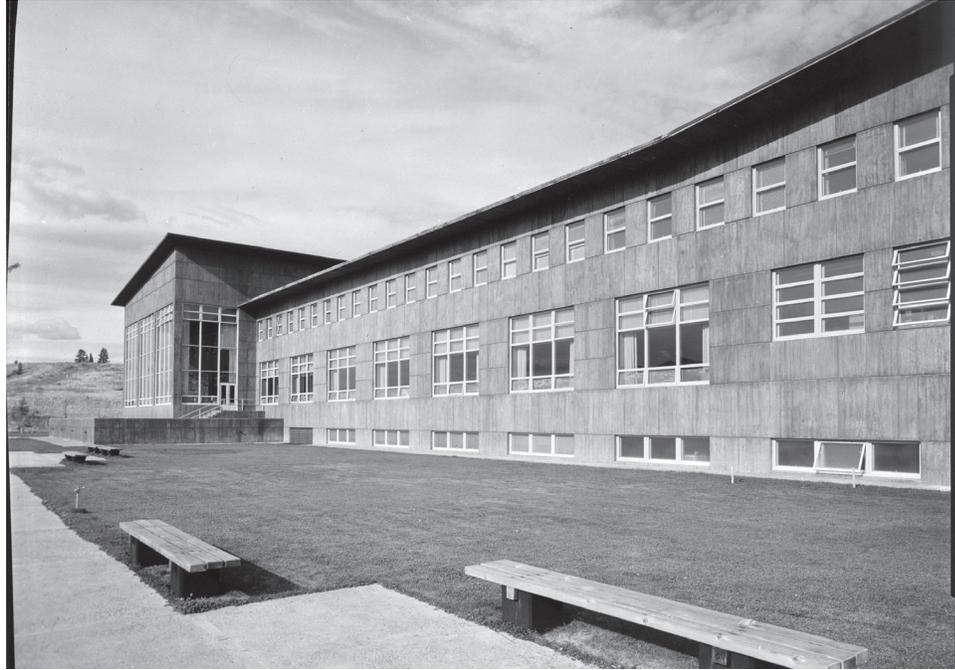
Figure 10. West elevation of Jackson Lake Lodge c. 1959. View shows the window arrangement within the grid. Image Credit: Grand Teton Lodge Company.

grid, which is created by deep, v-shaped expansion joints between the individual concrete panels, is most evident on the western elevation. The three horizontal bands of windows are arranged in relation to the squares of the grid, so that the vertical and horizontal expansion joints extend from the corners of the windows. This draws the eye across the elevation, creating a sense of rationality.

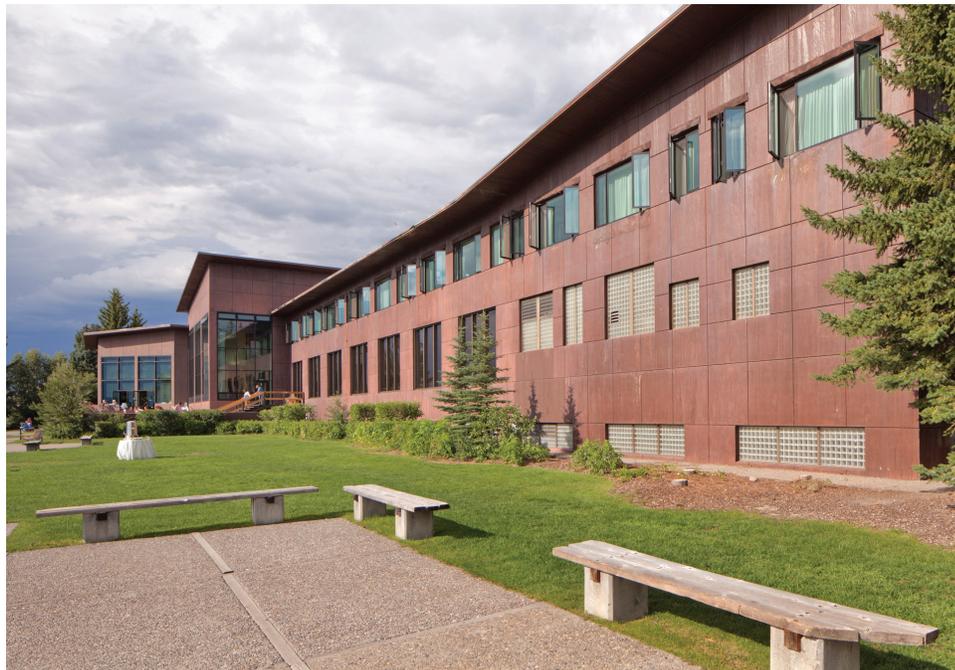
Figure 11. West elevation of Jackson Lake Lodge 2014. View shows the window alterations and the addition of the Blue Heron Bar. Image Credit: Joseph Elliott.

Throughout Jackson Lake Lodge's lifetime several characteristics that define the lodge as International Style have been significantly altered. First, the addition of the Blue Heron Bar in 1988, which protrudes from the western elevation, compromised the original rectilinear plane of

Second, the replacement of the original double hung windows with larger casement windows destroyed the relationship between the grid and the windows. Additionally the horizontal meeting rails of the original double-hung windows, which were purposely arranged to match the proportions of the grid, further emphasized the horizontality of the building. Several windows in the middle band of windows on the western elevation were replaced with glass block. This alteration not only interrupts the grid pattern, but it also gives the elevation a sense of mass that the original design did not have.

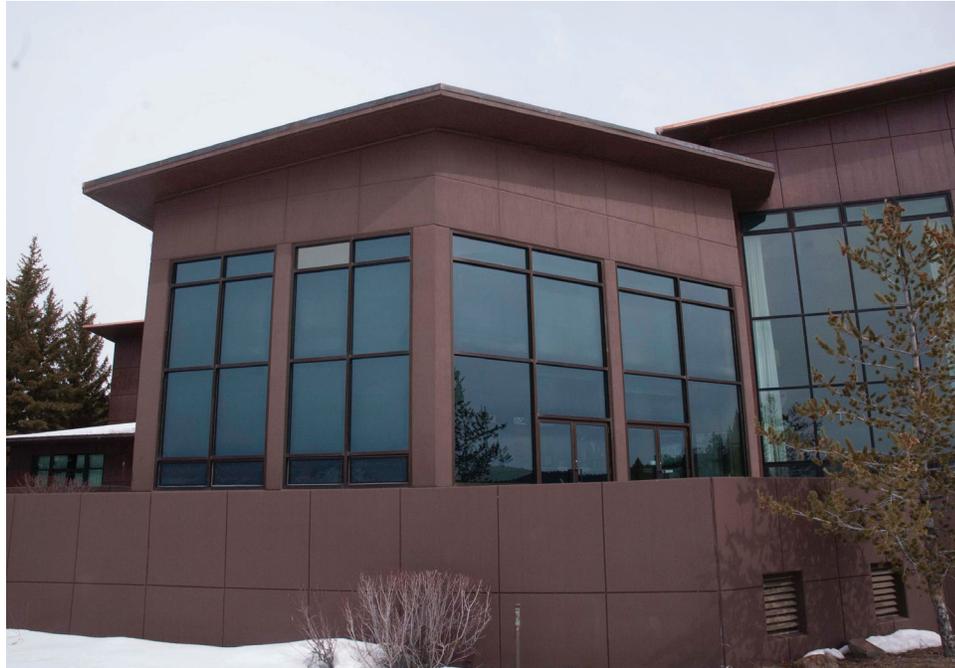
Figure 12. Addition of the Blue Heron Bar. View shows the angle that the addition meets the rest of the building. Image Credit: Architectural Conservation Lab.

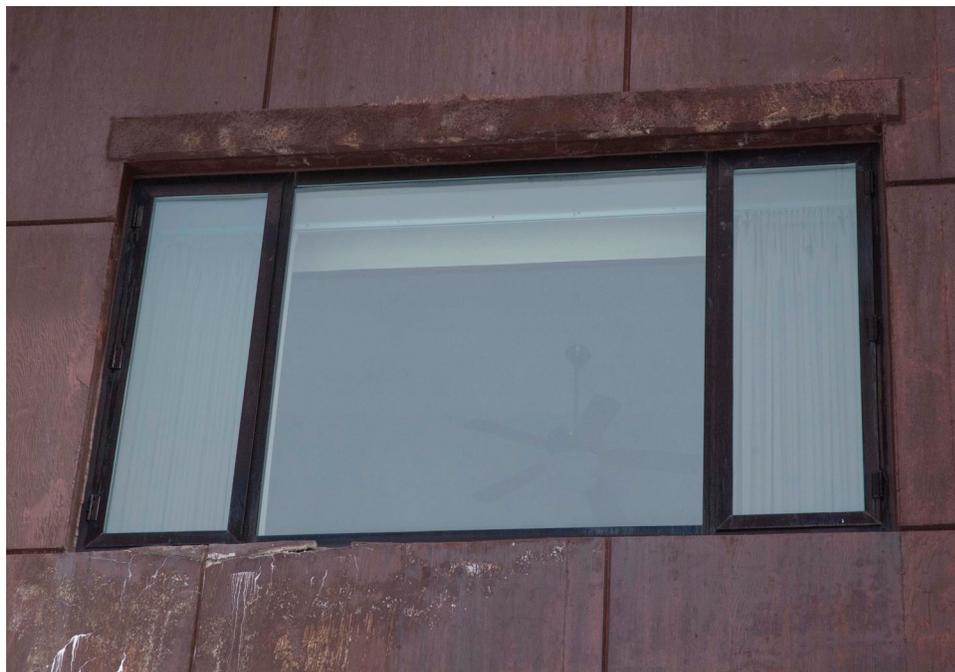
Figure 13. Image of replacement window with poor detailing. Image Credit: Architectural Conservation Lab.

The original window frames were aluminum and painted wood, and were both light gray in color, which created a contrast between the dark-colored concrete. In contrast, the window frames of the replacement windows are dark brown; the loss of color contrast diminishes the punctuating effect that the windows had on the façade. This effect contributed to the regularity and clean lines that dominated the original design. The alterations to the windows are made more pronounced by poor detailing around the replacement windows. In order to accommodate the larger span of the new windows, new lintels and sills were cut into the concrete façade, interrupting the "shadowood" effect and further disrupting the grid. These poorly designed and executed details compromise the integrity of the original design, as careful detailing is a critical aspect of the International Style. As the detailing of the Lodge has been compromised, its overall sense of order has been diminished and the enthusiastic embrace of modern, machine-made materials that defined mid-century modern design is significantly less legible.

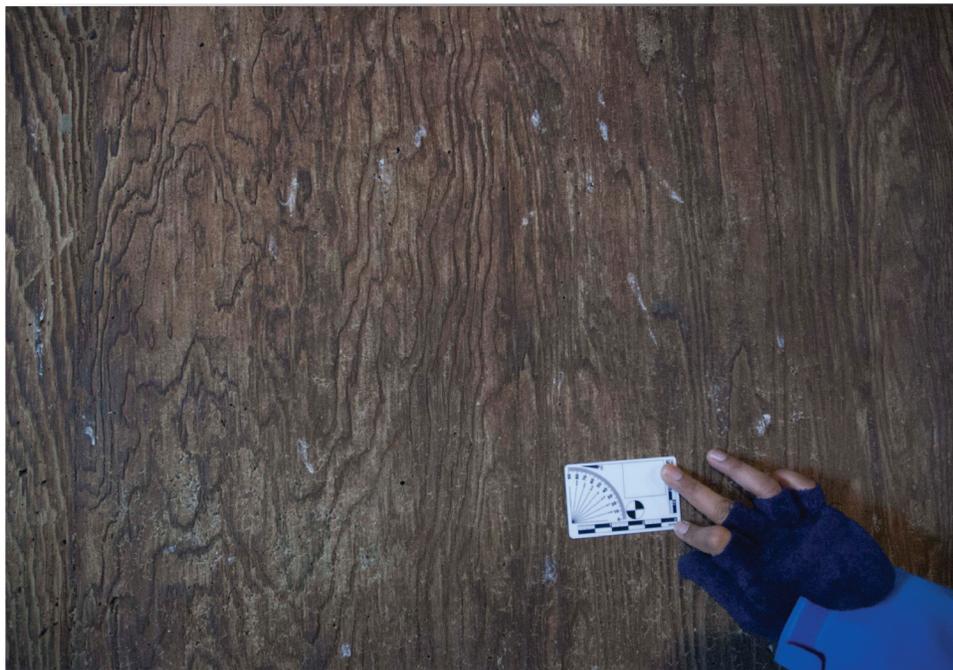
Figure 14. Area of original stain enclosed above the Blue Heron Bar. Image Credit: Architectural Conservation Lab.

Another important piece of information that helped in the recreation of the stain was an area of the original stain, preserved on the west elevation of the original Lodge, that was enclosed by the addition of the Blue Heron Bar in 1988. This area of concrete shows the

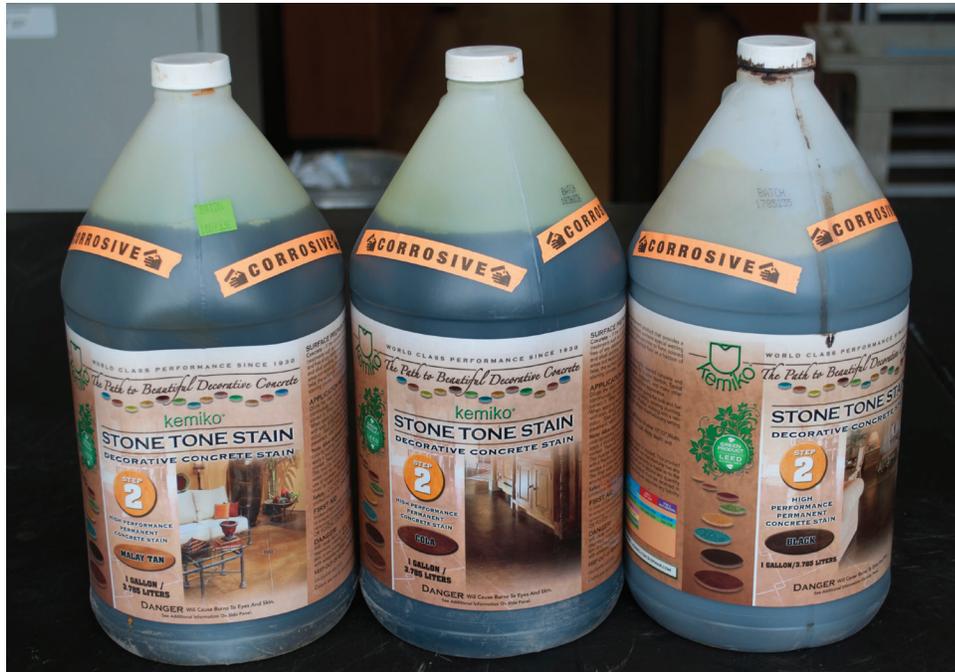
Figure 15: Stains used to make facsimile samples. Image by author.

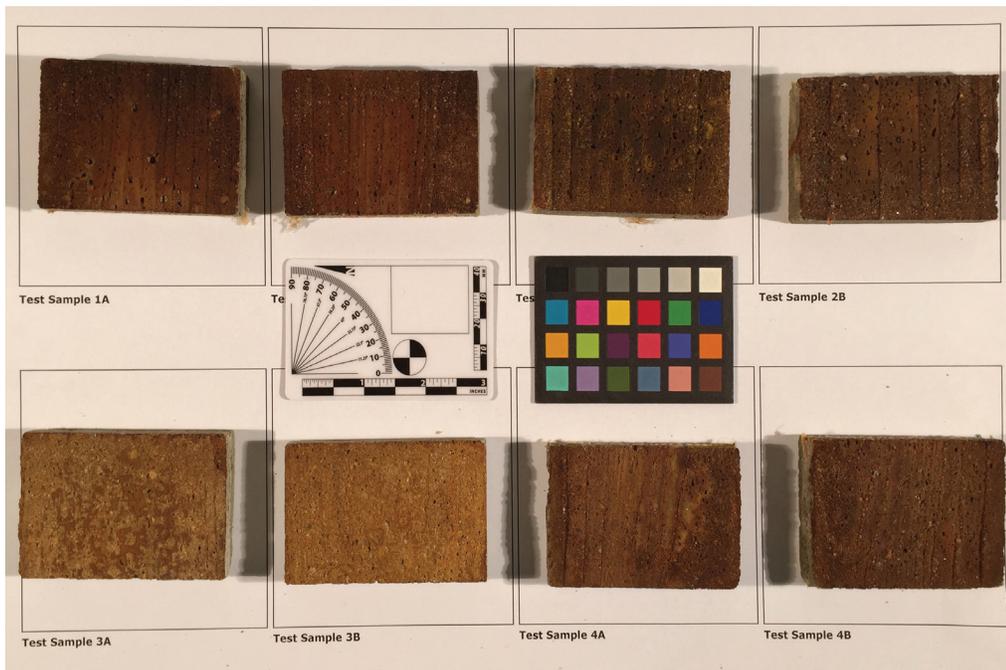
Figure 16: Examples of mock-ups that were made to determine the stain application process. Image by author.

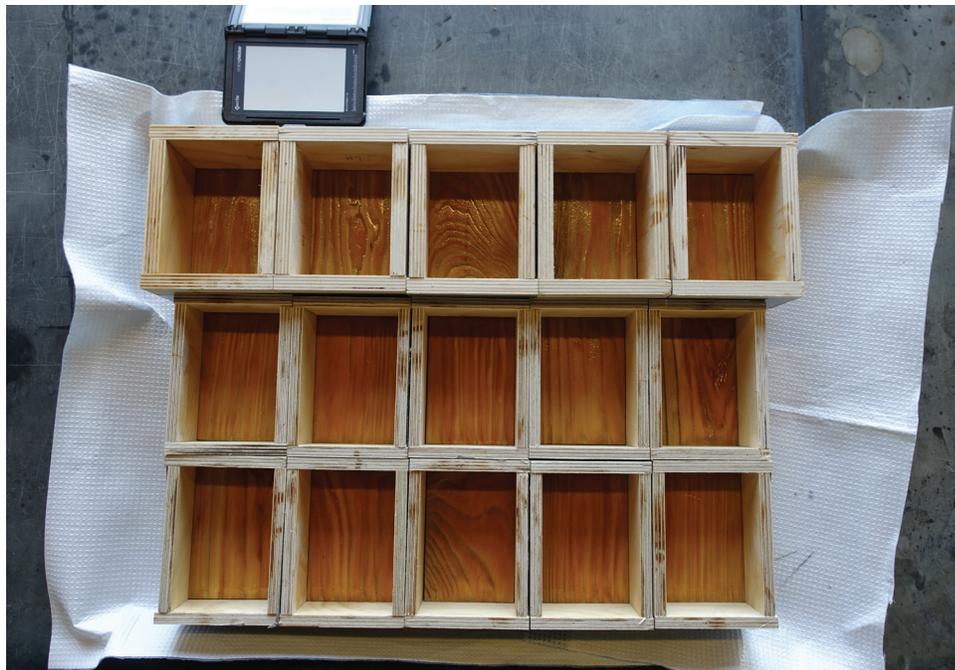
Figure 17: Molds that were made to cast facsimile samples. Image by author.

The profile and texture of the concrete is an integral part of the original surface finish

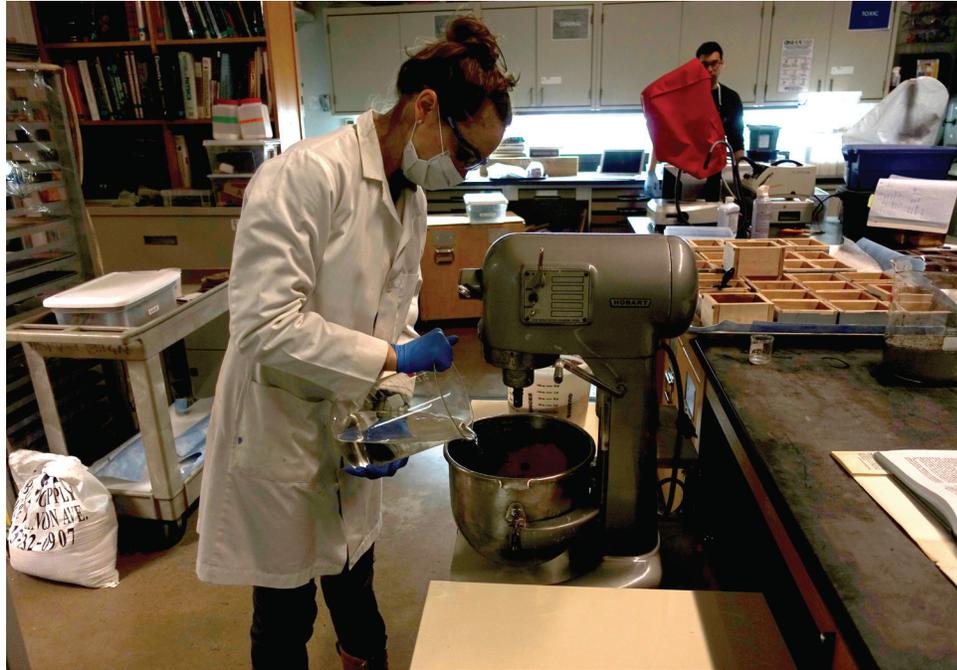
Figure 18: Adding water to the concrete mix. Image credit: Jean Jang.

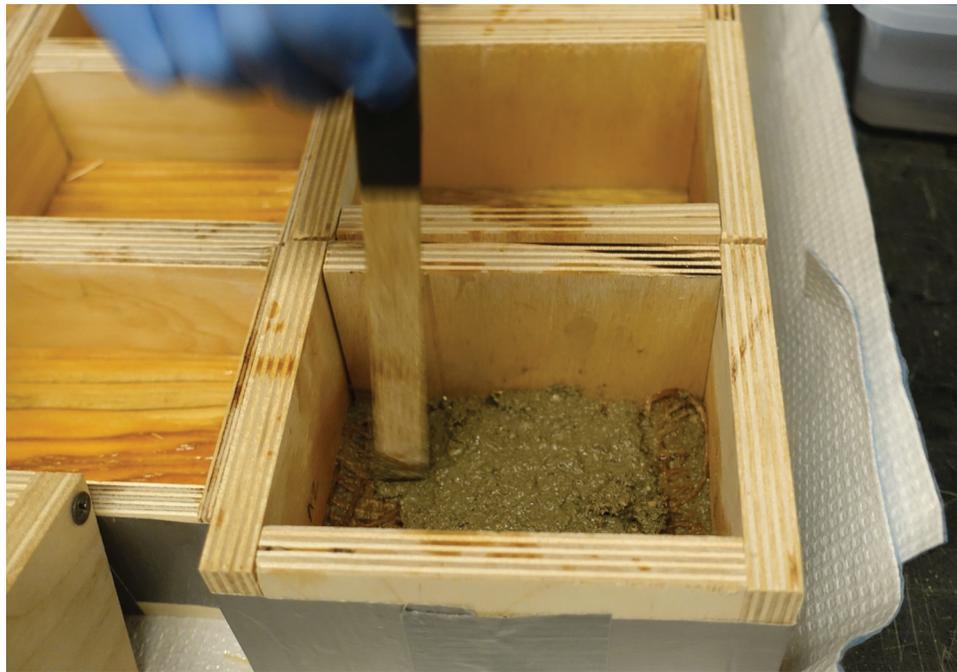
Figure 19: Tamping the concrete into the molds. Image credit: Jean Jang.

The first lift of concrete was tamped down with a rectangular tamper, which measured 1 cm x 2cm, and then shaken back and forth in both directions until the lift was level. Next a rectangular piece of burlap was pressed into the surface of the concrete. The purpose of the burlap was to give tensile reinforcement to the sample, to prevent cracking when the sample was removed from the mold. Following the burlap a second lift was added; it was also tamped down and the mold was shaken back and forth until each sample was level and appeared well compacted. Finally, the molds were tapped forcefully against the counter so that any air bubbles in the concrete were forced to the surface.

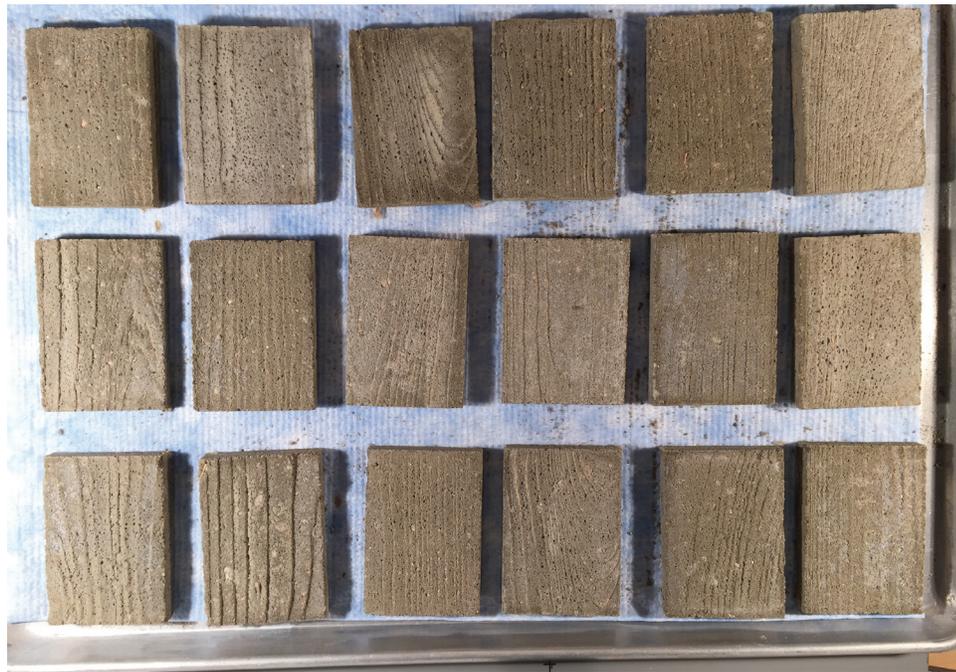
Figure 20: Samples after they were removed from the molds. Image by author.

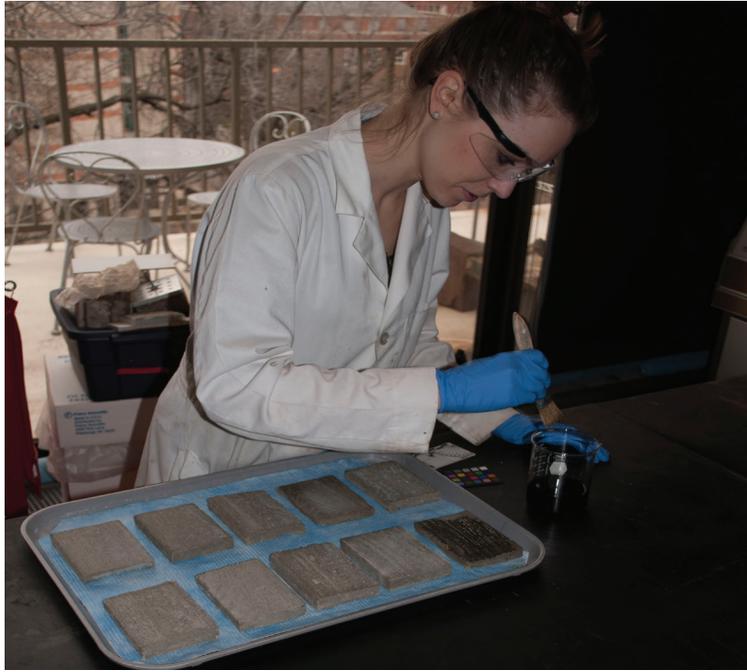
Figure 21: Applying stains to the test samples. Image Credit: Joe Mester.

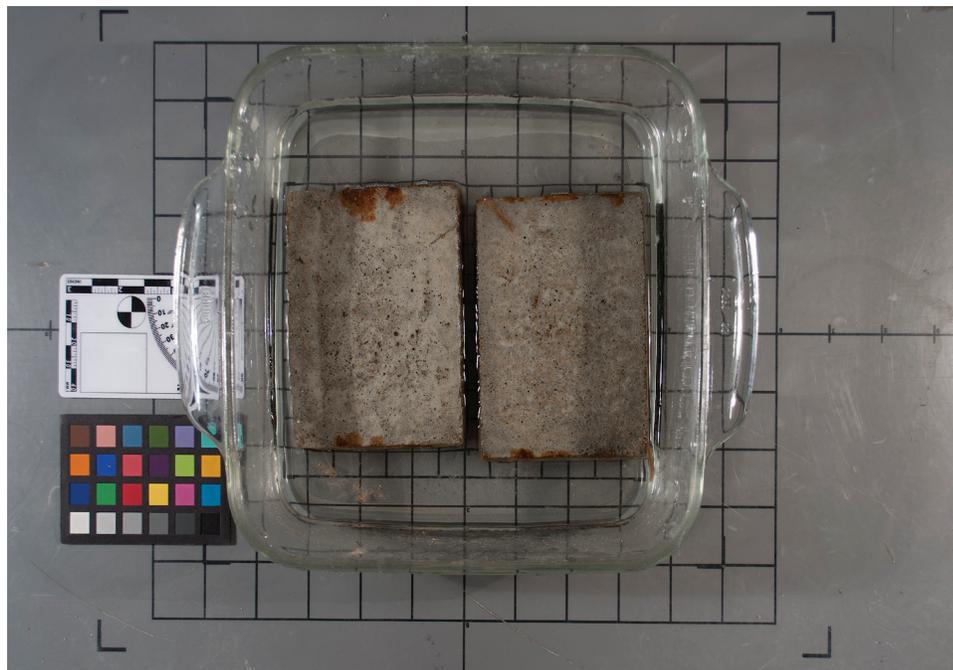
Figure 22: Samples soaking in the neutralizing baking soda bath. Image by author.

During the drying process, residual solids were left on the surface of the sample. In order to both achieve the intended color and to neutralize the acidity of the stain, the samples had to

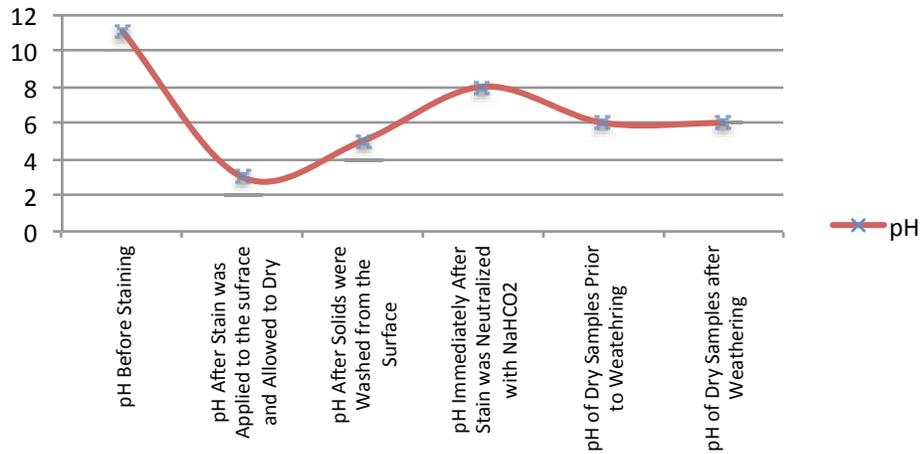
Table 2: Graph depicting pH fluctuations during staining process.

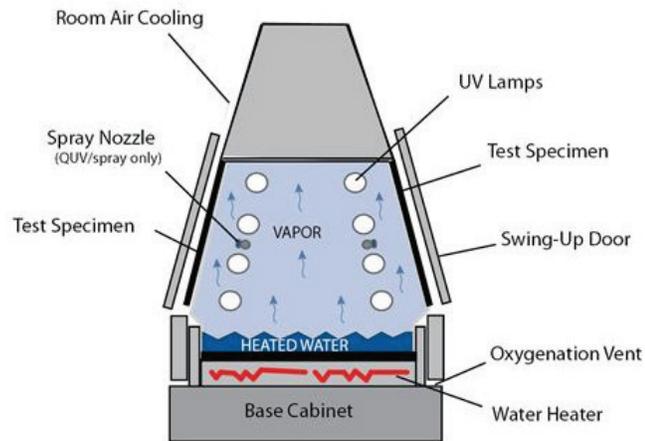
Figure 23: Cross section of the QUV Accelerated Weathering machine. Image credit:

The samples are placed in brackets that are aligned parallel to the lamps. There is a small gap between the trays that hold the samples and the doors that swing down over them. When the samples are in the Weatherometer, it is essential that all gaps between the sample brackets are filled either by additional brackets outfitted with flat aluminum panels or by flat metal panels that are sized to fit the gaps that occur depending on the size of the bracket utilized for the testing program. This creates a seal so the samples (and their brackets) form the wall of the chamber, which encapsulates the condensation. The back side of the samples is exposed to the ambient air temperature, which is much cooler than the interior of the chamber. This temperature

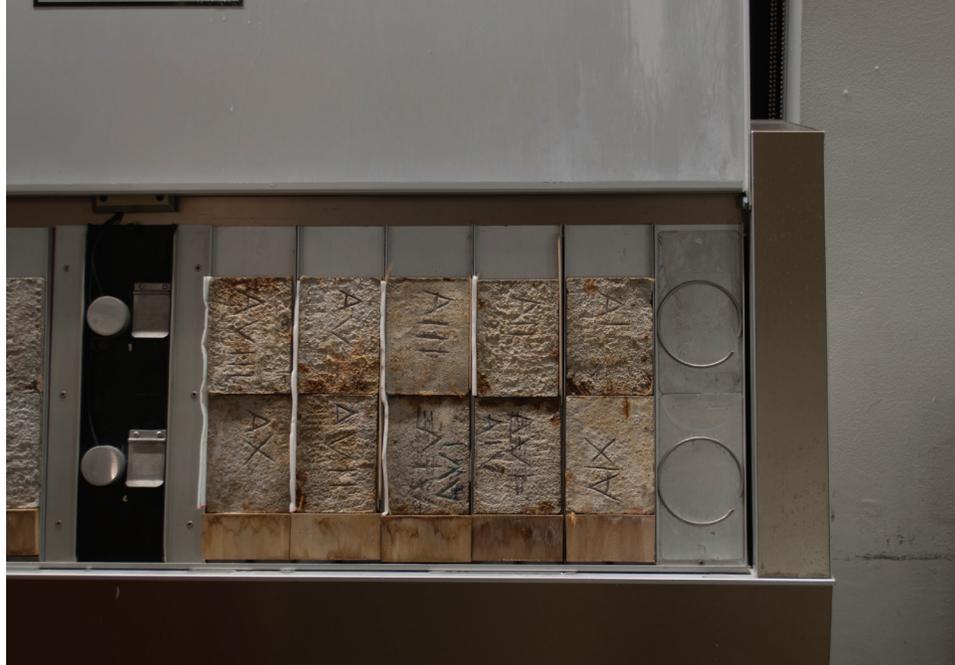
Figure 24: Samples in their brackets in the weatherometer. Image by author.

Although the samples were sized to fit the Weatherometer brackets, it was still necessary to secure them into the brackets to ensure that they would remain in place during the weathering cycles. The samples were secured with a piece of polyethylene foam on one side and a wooden tongue depressor on the other. A narrow strip of polyethylene foam was placed on the left side of the bracket first, then the sample was set into place in the center of the bracket. To create a tighter fit, the samples were pressed into the foam to create a small gap on the right side of the bracket, and the tongue depressor was wedged into place. This created a pressure fit between the sample and the walls of the bracket. The foam gave the samples an appropriate amount of cushion. Prior placement, which utilized a tongue depressor on each side of the bracket, resulted in chipping the edges of the samples. In addition to the foam, a block of wood was placed at the base of the bracket to prevent the samples from sliding down below the exposure window.

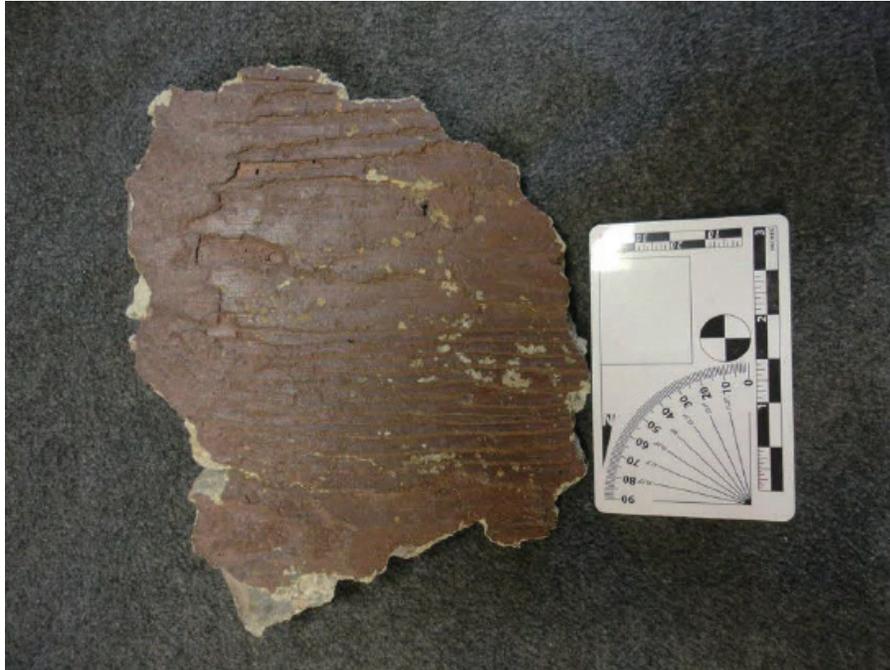
Figure 25: Large spall that samples JLL_1 thru JLL_5 were cast from. Image credit: Julianne Wiesner-Chianese.

Samples JJJL_1 thru JJJL_5 were taken from a large fragment of concrete, approximately 5 to 7 inches, that had spalled off the building. The spalled fragment is coated with the modern, resinous stain that was applied c. 2000; however, it is likely that traces of the original finish

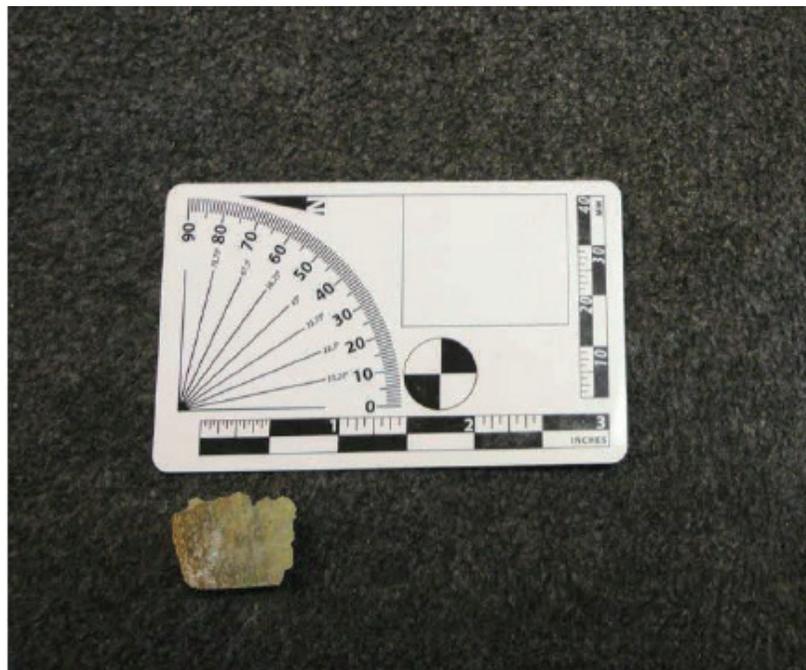
Figure 26: Fragment removed from about the Blue Heron Bar that samples JLL_6 and JLL_7 were cast from. Image credit: Julianne Wiesner-Chianese.

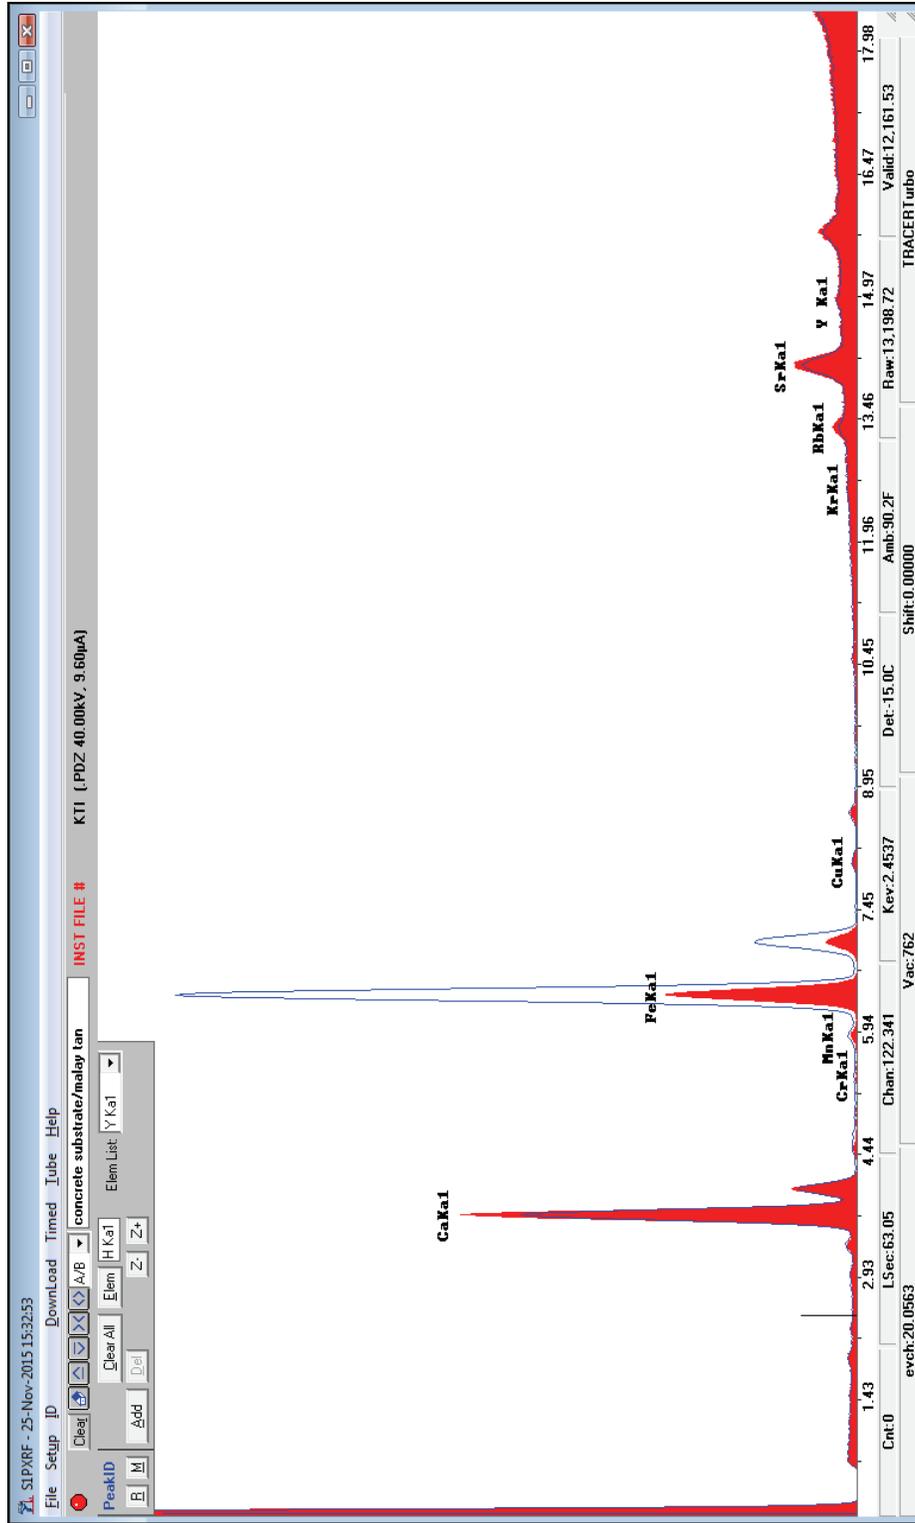
Appendix D. Figure 1: Red spectrum represents the concrete which includes the following elements (Potassium (K), Calcium (Ca), Manganese (Mn), Iron (Fe), Rhodium (Rb), Strontium (Sr), Yttrium (Y), Zirconium (Zr)). The blue spectrum represents the Malay Tan stain Iron (Fe).

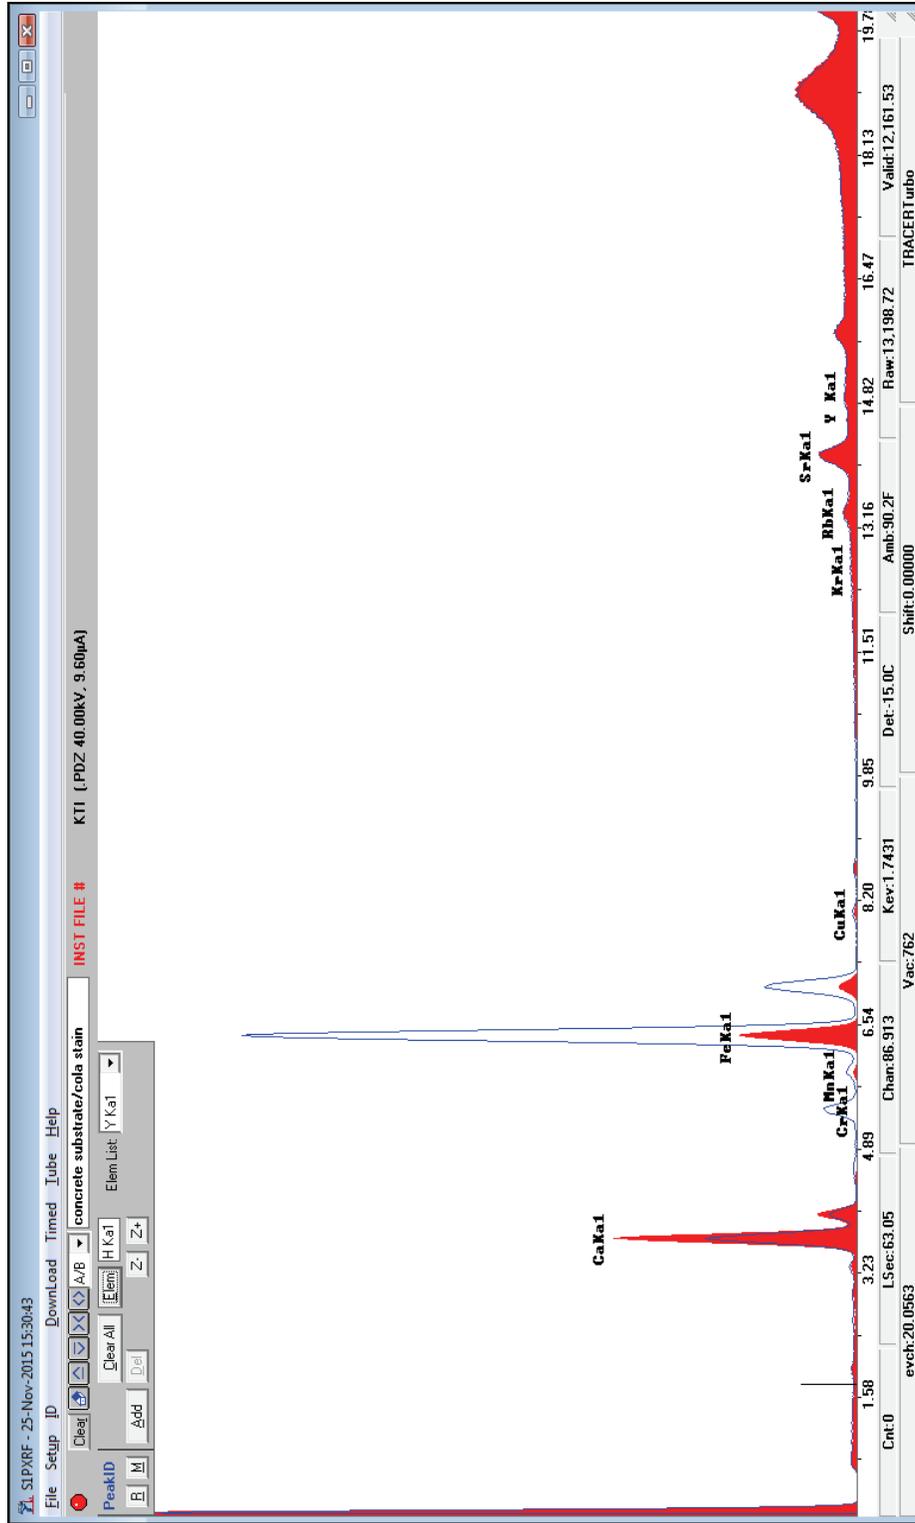
Appendix D. Figure 2: Red spectrum represents the concrete which includes the following elements (Potassium (K), Calcium (Ca), Manganese (Mn), Iron (Fe), Rhodium (Rb), Strontium (Sr), Yttrium (Y), Zirconium (Zr)). The blue spectrum represents the Cola stain Chromium (Cr) and Manganese (Mn) and Iron (Fe).

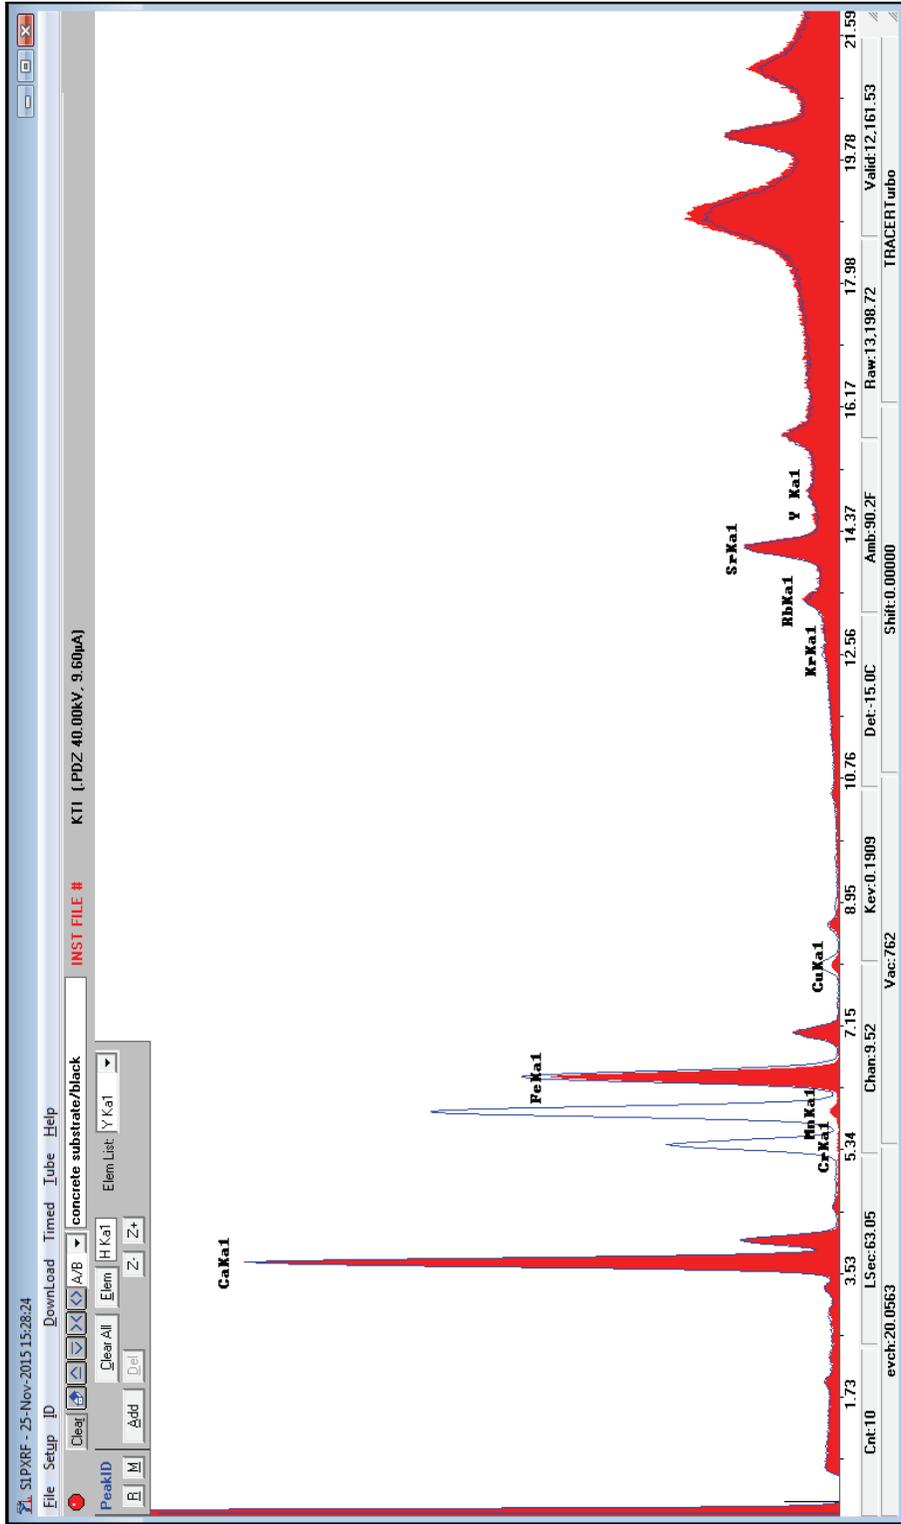
Appendix D. Figure 3: Red spectrum represents the concrete which includes the following elements (Potassium (K), Calcium (Ca), Manganese (Mn), Iron (Fe), Rhodium (Rb), Strontium (Sr), Yttrium (Y), Zirconium (Zr)). The blue spectrum represents the Black stain Chromium (Cr) and Manganese (Mn) .

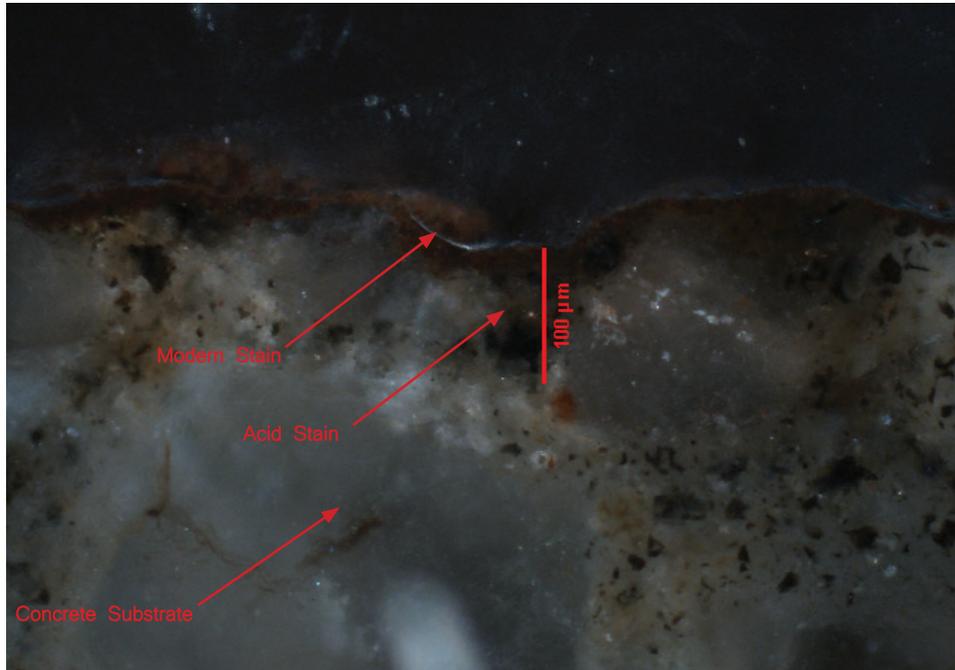
Appendix E. Figure 1. Sample JLL_1. Fragment of large spall removed from site in 2014. 100x. Reflected Light.
