RECREATING ACID STAINS ON HISTORIC CONCRETE

A THESIS

Historic Preservation

2016

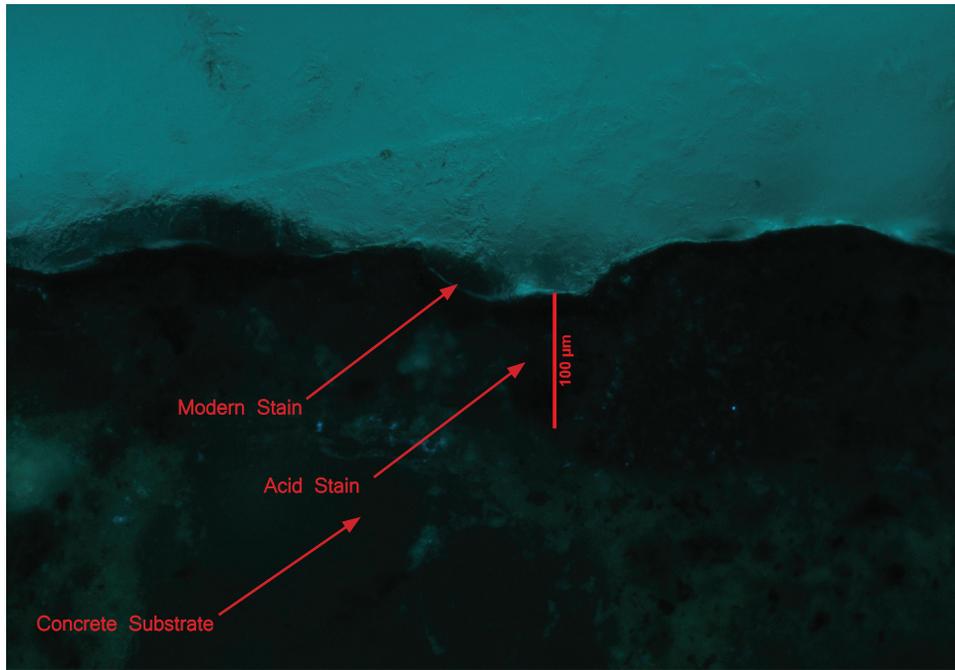
Appendix E. Figure 2. Sample JLL_1. Fragment of large spall removed from site in 2014. 100x. Ultraviolet Light.

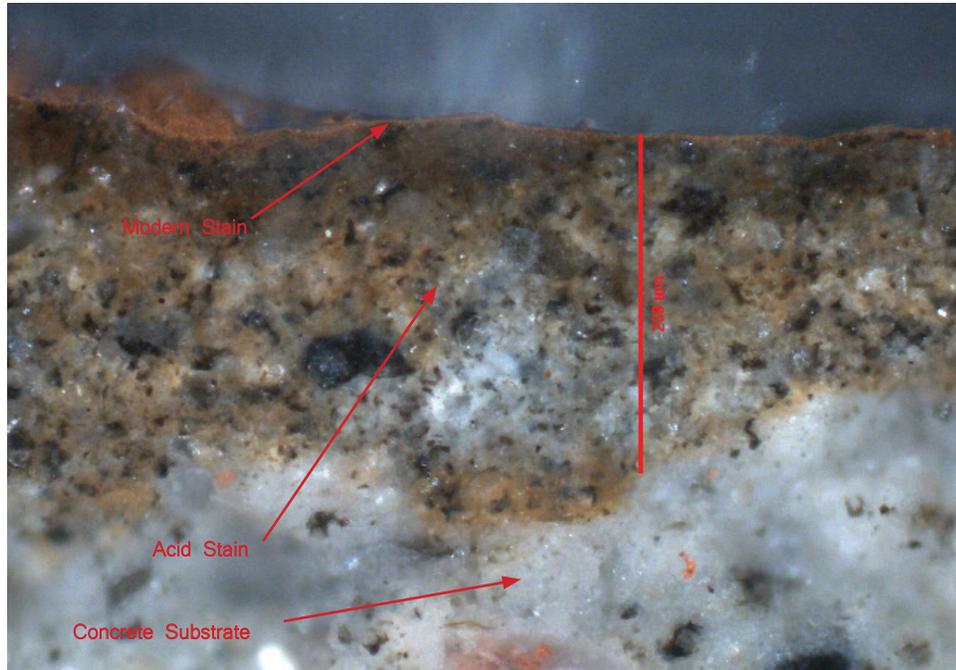
Appendix E. Figure 3. Sample JYL_2A. Fragment of large spall removed from site in 2014. 100x. Reflected Light.

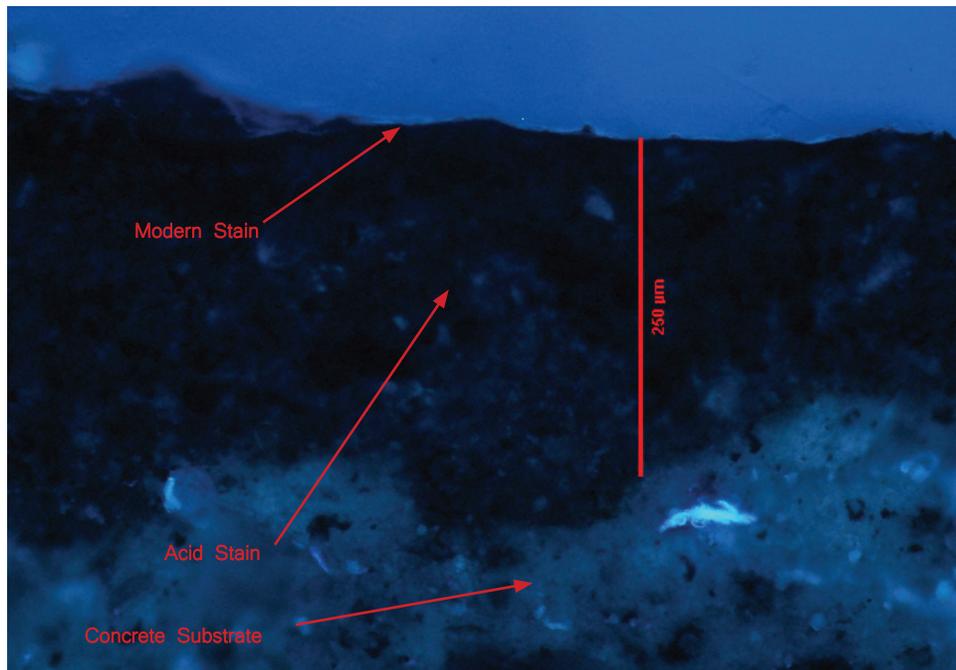
Appendix E. Figure 4. Sample JYL_2A. Fragment of large spall removed from site in 2014. 100x. Ultraviolet Light.

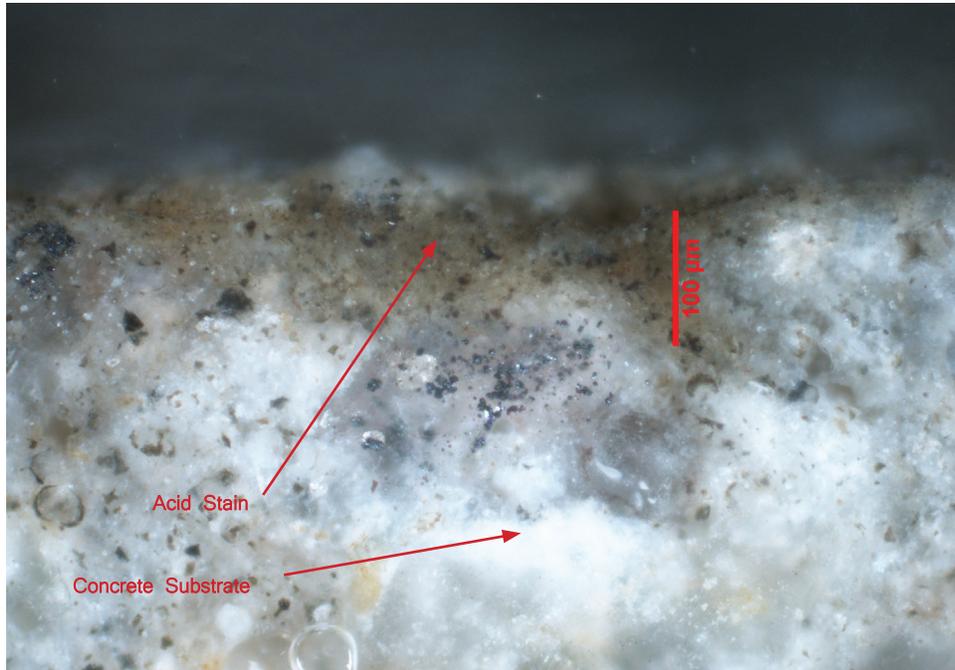
Appendix E. Figure 5. Sample JJJ_6. Fragment removed from the enclosed are above the Blue Heron Bar, with original finish. 100x. Reflected Light.

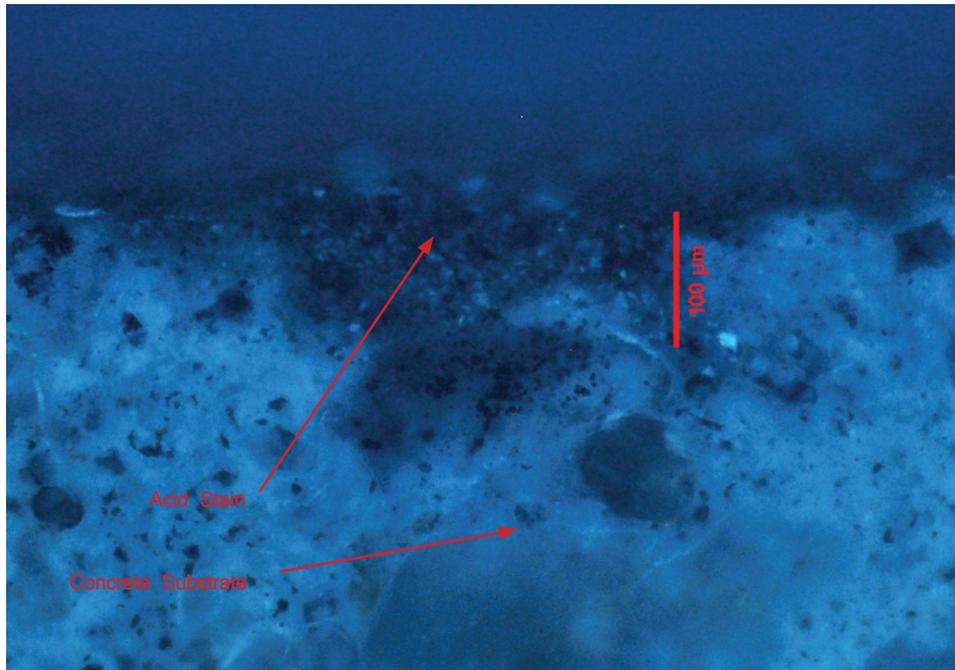
Appendix E. Figure 6. Sample JJJ_6. Fragment removed from the enclosed are above the Blue Heron Bar, with original finish. 100x. Ultraviolet Light.

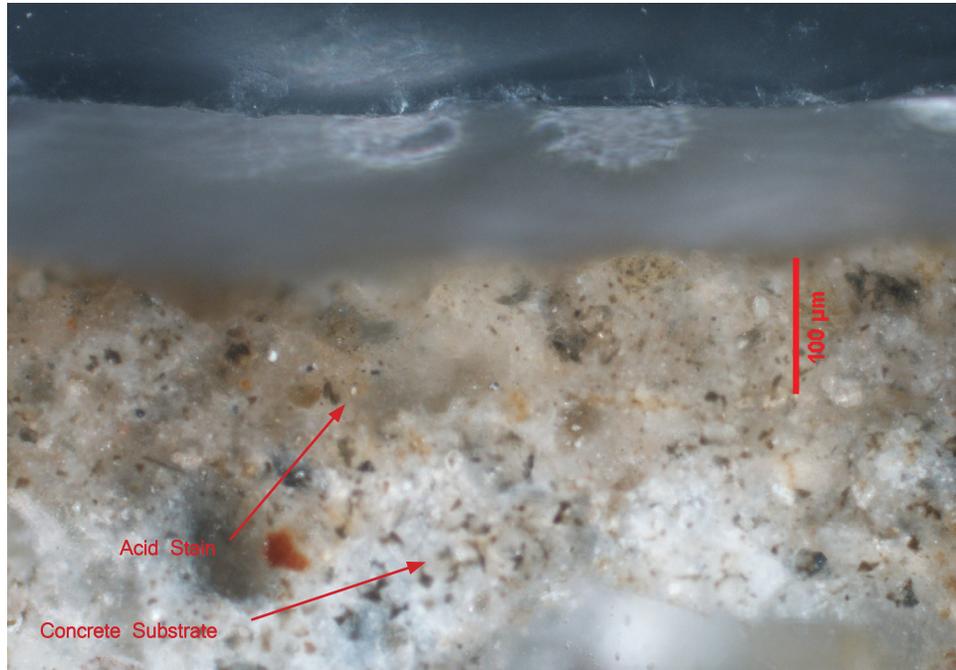
Appendix E. Figure 7. Sample JLL_6. Fragment removed from the enclosed are above the Blue Heron Bar, with original finish. 100x. Reflected Light.

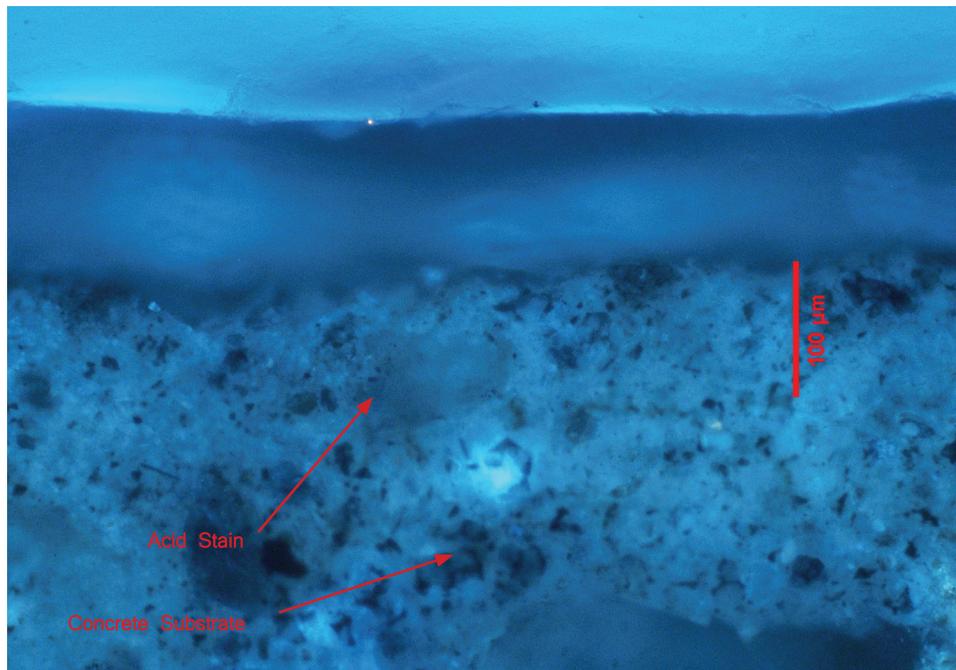
Appendix E. Figure 8. Sample JLL_7. Fragment removed from the enclosed are above the Blue Heron Bar, with original finish. 100x. Ultraviolet Light.

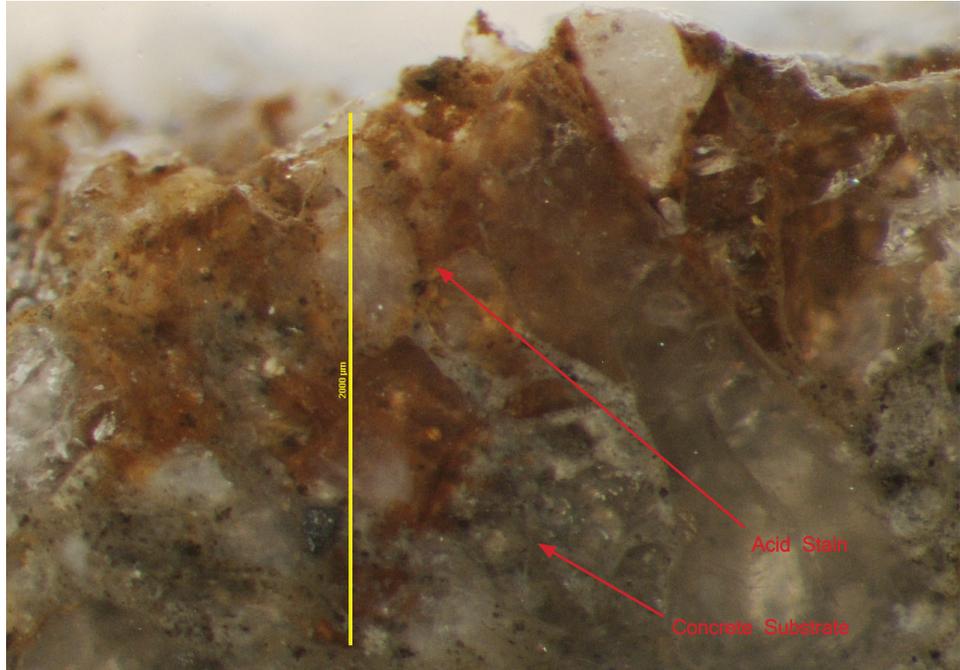
Appendix E. Figure 9. Sample JLL_9. Facsimile sample with acid stains. 10x. Reflected Light.

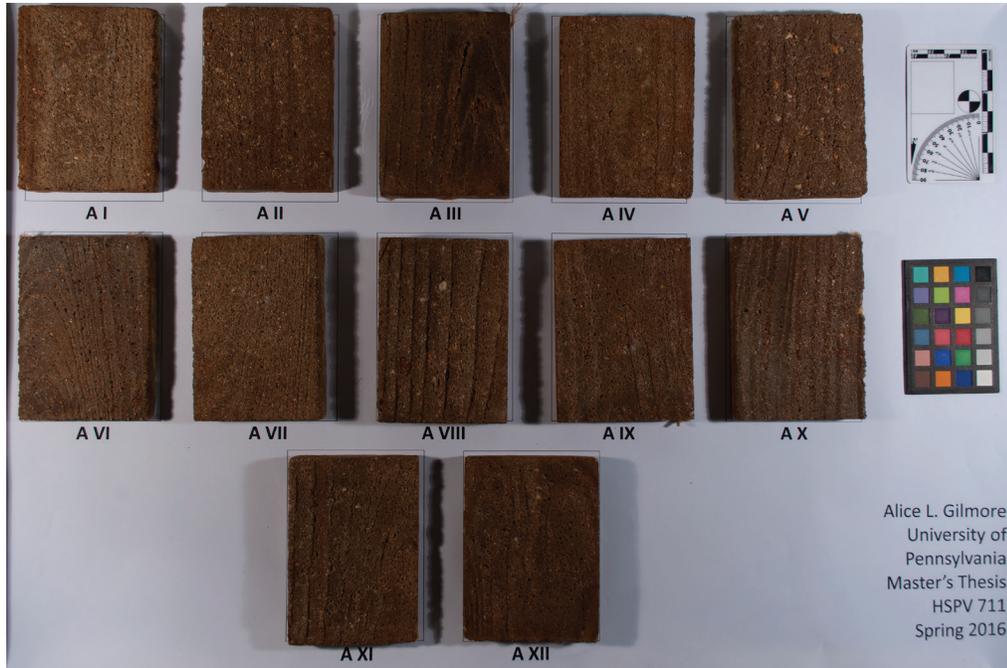
Appendix F. Figure 1. Samples before weathering. Top row is the cohort that was treated with the water repellent, The second row is the cohort that was left untreated and the bottom two samples are the controls.

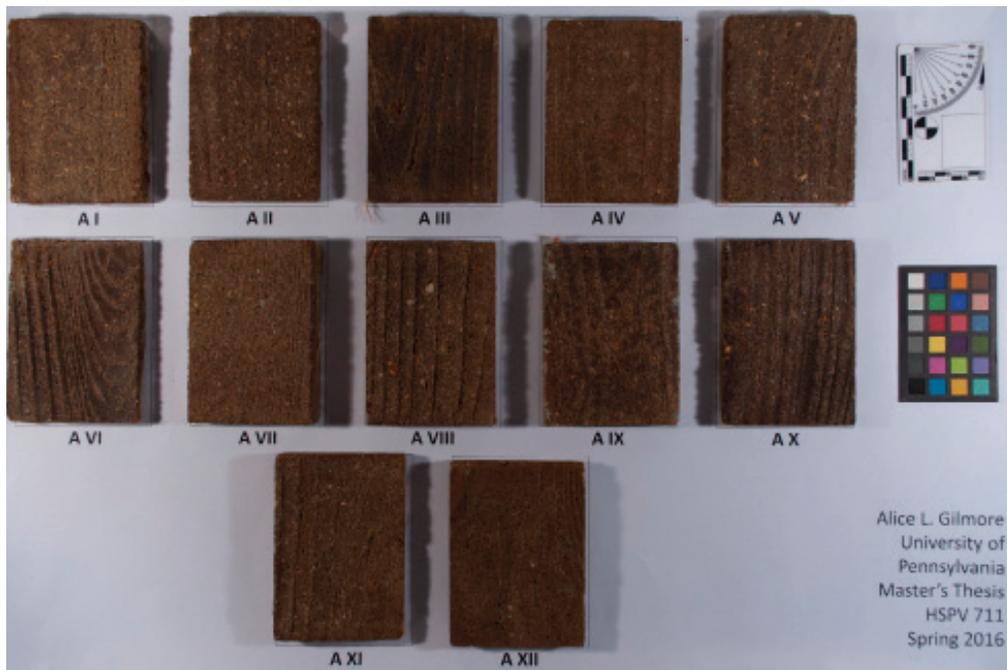
Appendix F. Figure 2. Samples After 845 hours of weathering. Top row is the cohort that was treated with the water repellent, The second row is the cohort that was left untreated and the bottom two samples are the controls.

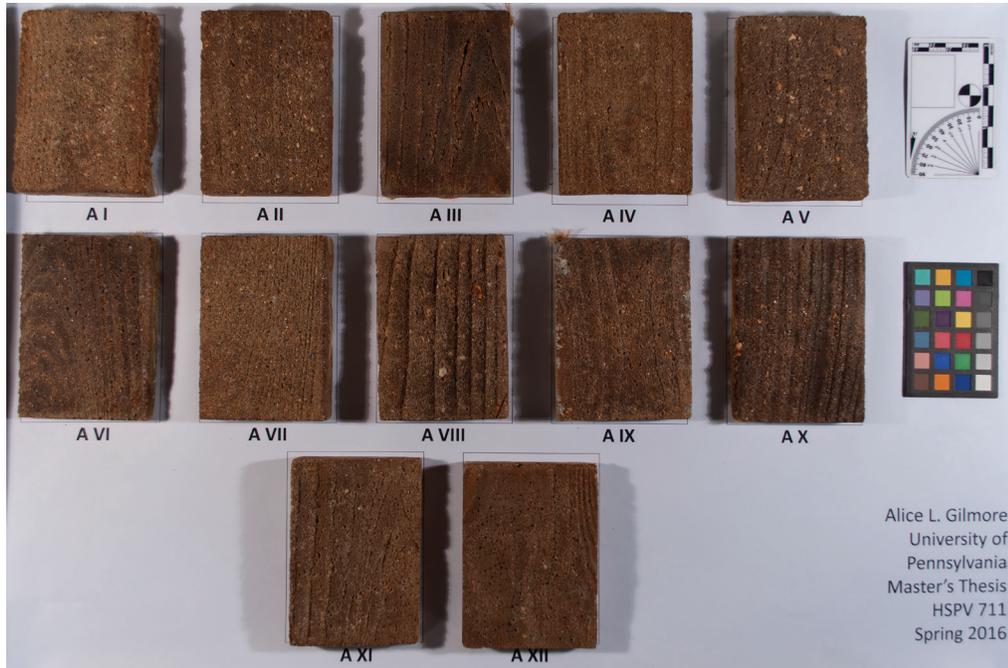
Appendix F. Figure 3. Samples After 125 hours of weathering. Top row is the cohort that was treated with the water repellent, The second row is the cohort that was left untreated and the bottom two samples are the controls.

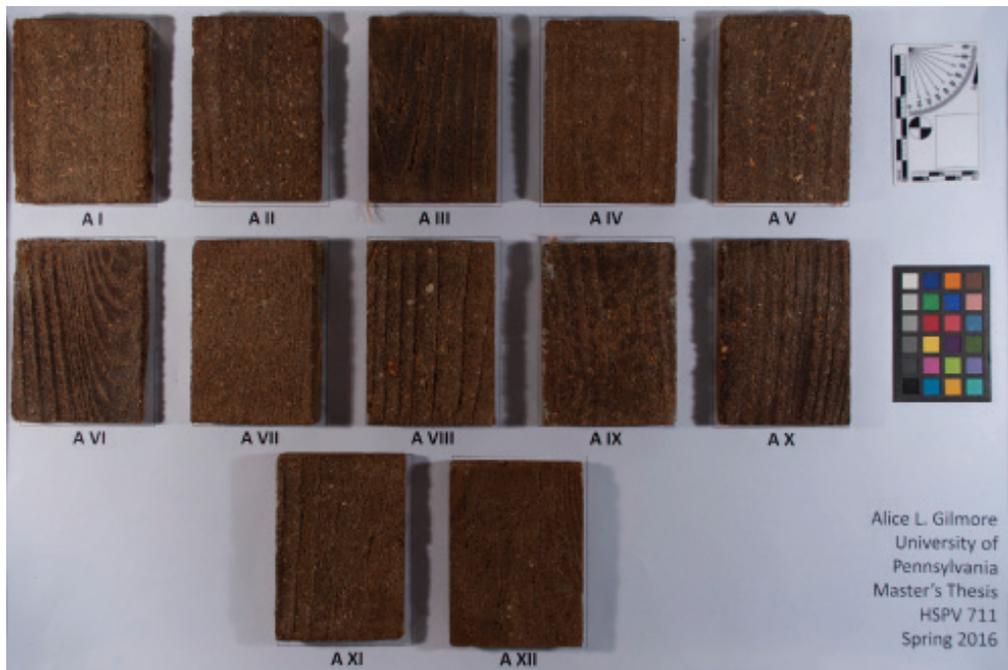
Appendix F. Figure 4. Samples After 845 hours of weathering. Top row is the cohort that was treated with the water repellent, The second row is the cohort that was left untreated and the bottom two samples are the controls.

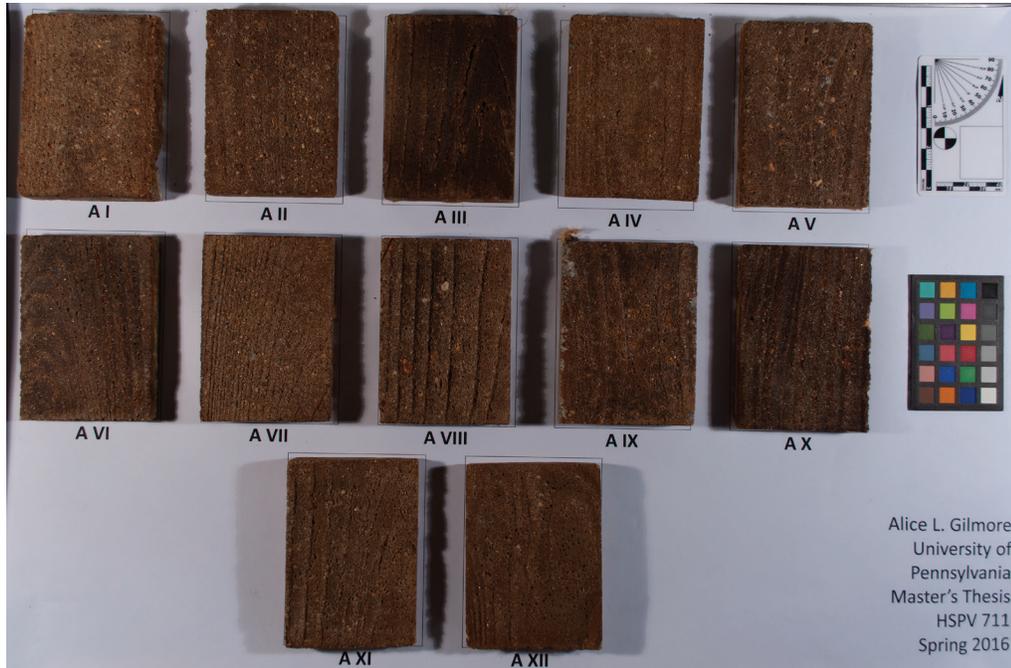
Appendix F. Figure 5. Samples After 245 hours of weathering. Top row is the cohort that was treated with the water repellent, The second row is the cohort that was left untreated and the bottom two samples are the controls.

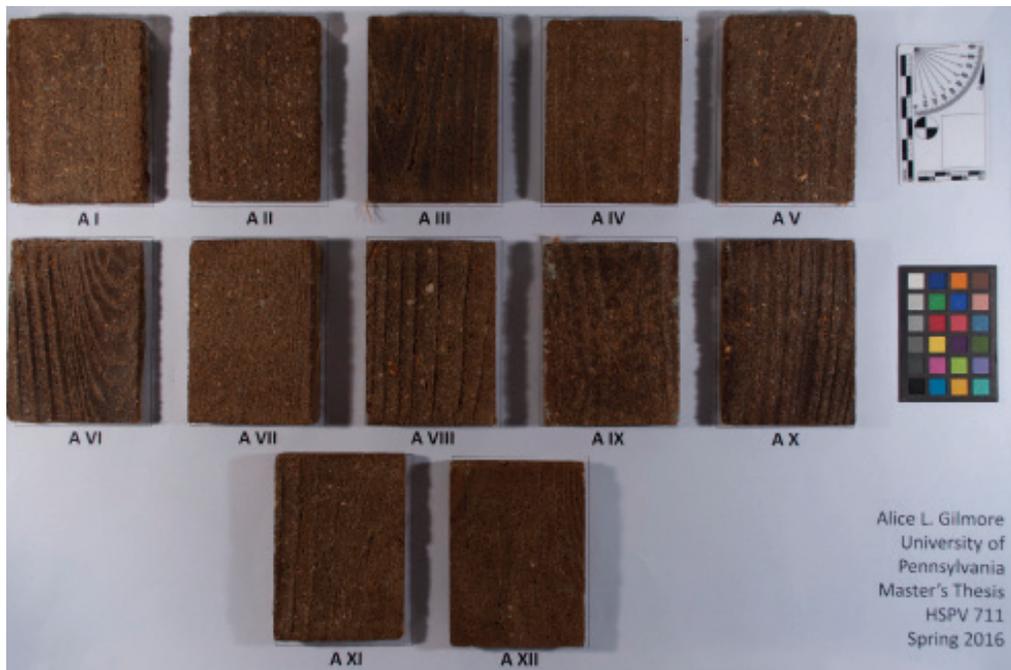
Appendix F. Figure 6. Samples After 845 hours of weathering. Top row is the cohort that was treated with the water repellent, The second row is the cohort that was left untreated and the bottom two samples are the controls.

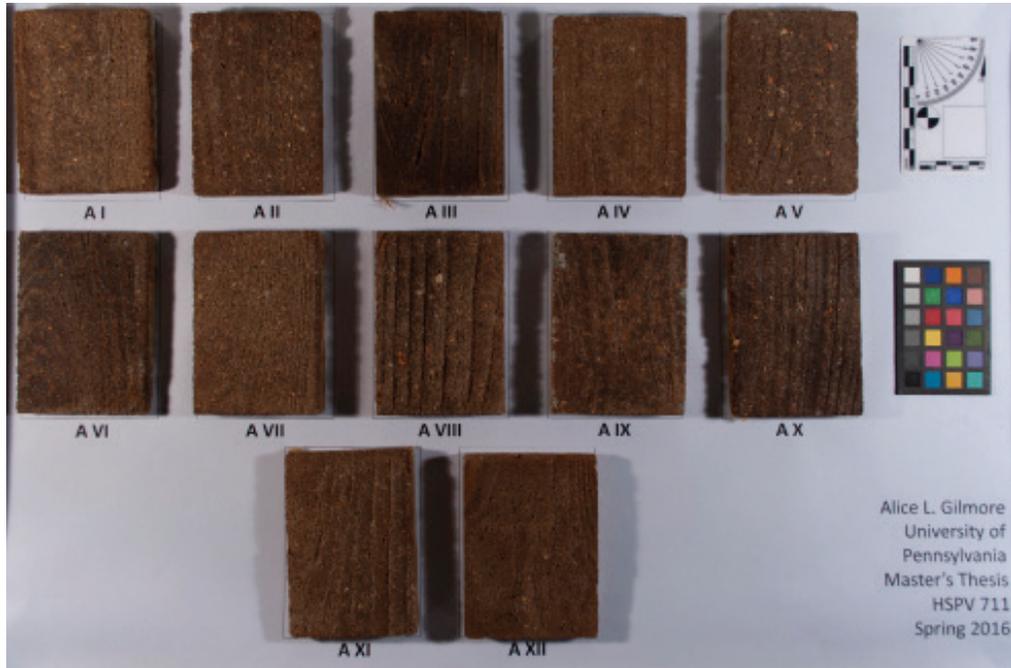
Appendix F. Figure 7. Samples After 381 hours of weathering. Top row is the cohort that was treated with the water repellent, The second row is the cohort that was left untreated and the bottom two samples are the controls.

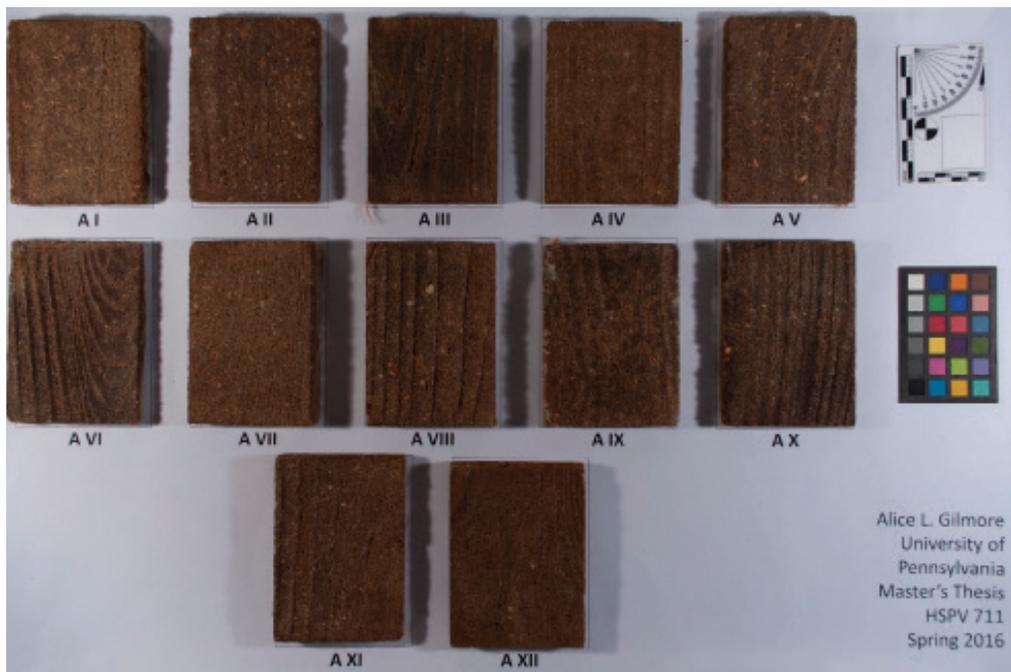
Appendix F. Figure 8. Samples After 845 hours of weathering. Top row is the cohort that was treated with the water repellent, The second row is the cohort that was left untreated and the bottom two samples are the controls.

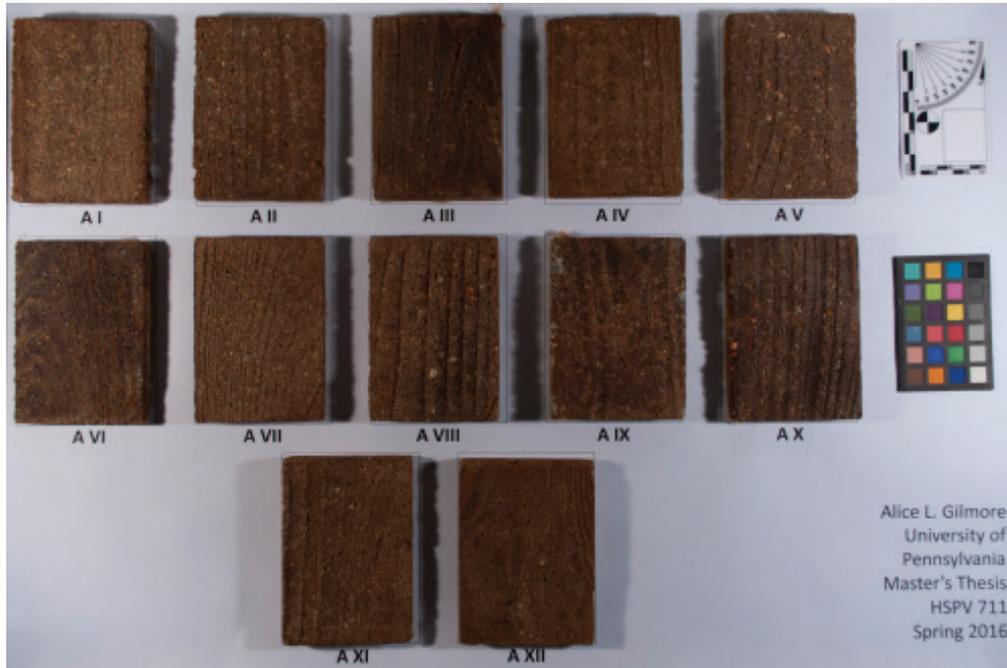
Appendix F. Figure 9. Samples After 486 hours of weathering. Top row is the cohort that was treated with the water repellent, The second row is the cohort that was left untreated and the bottom two samples are the controls.

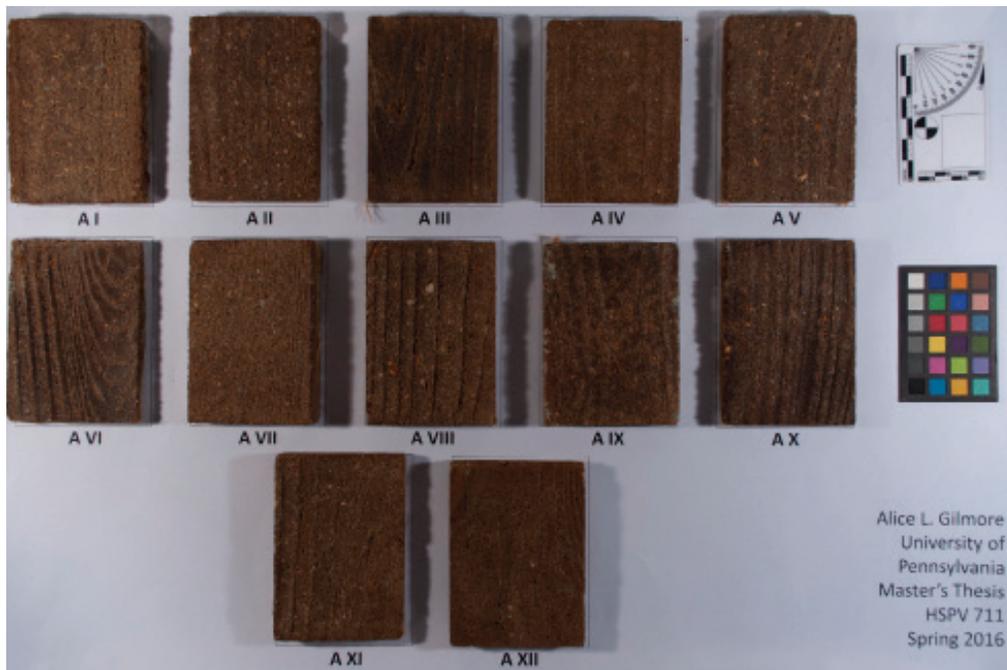
Appendix F. Figure 10. Samples After 845 hours of weathering. Top row is the cohort that was treated with the water repellent, The second row is the cohort that was left untreated and the bottom two samples are the controls.

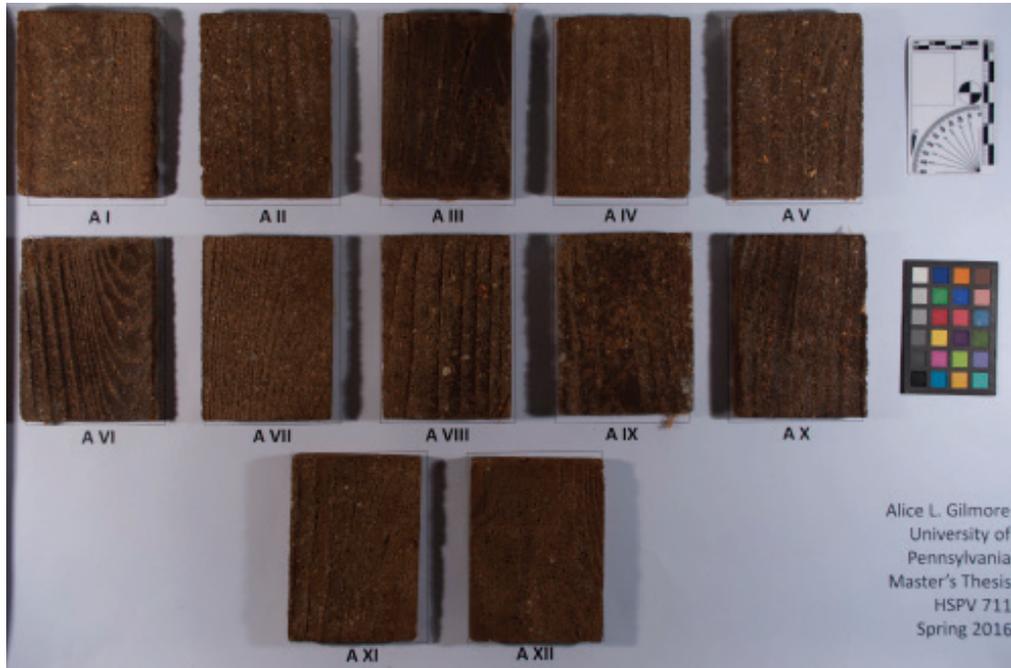
Appendix F. Figure 11. Samples After 608 hours of weathering. Top row is the cohort that was treated with the water repellent, The second row is the cohort that was left untreated and the bottom two samples are the controls.

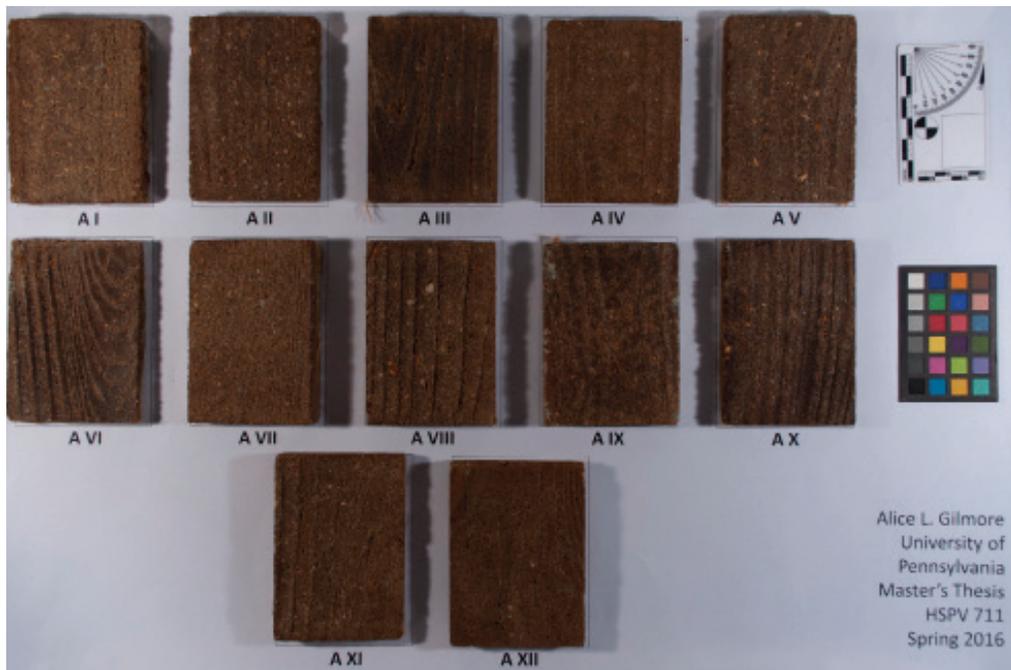
Appendix F. Figure 12. Samples After 845 hours of weathering. Top row is the cohort that was treated with the water repellent, The second row is the cohort that was left untreated and the bottom two samples are the controls.
