# TREATMENT REPORT

## Analysis and Conservation of the Great Hall Ceiling

DRAYTON HALL  
CHARLESTON, SOUTH CAROLINA

Prepared by:  
The Architectural Conservation Laboratory and Research Center  
University of Pennsylvania

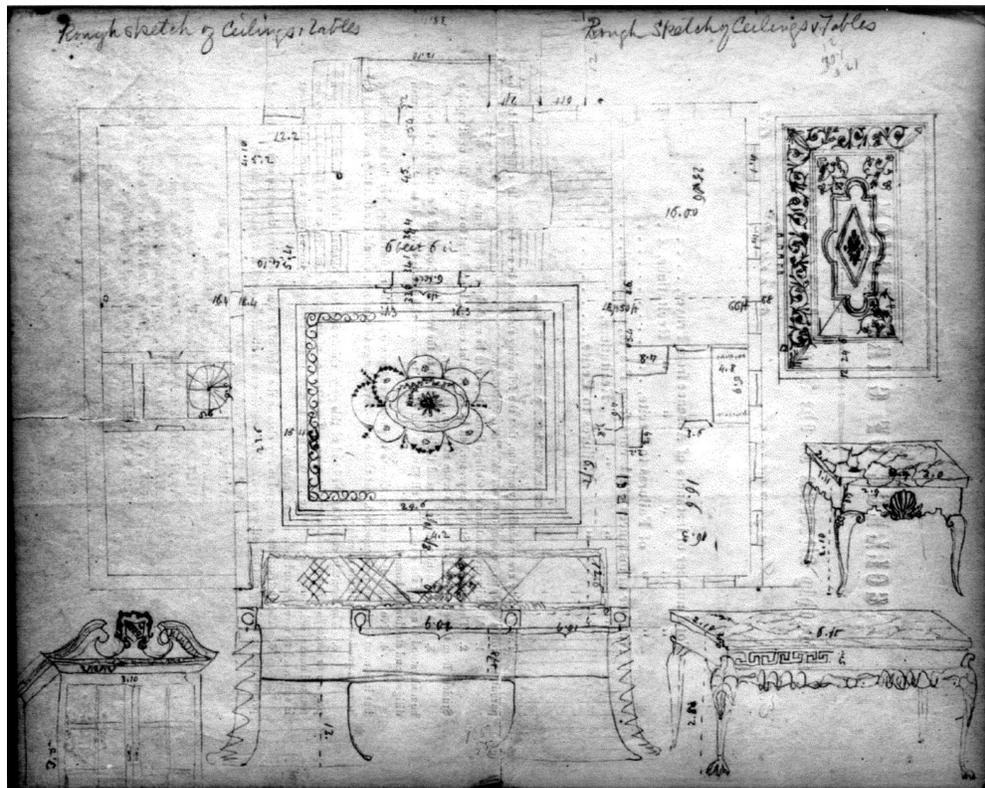
attenuated neoclassical motifs. This ceiling survived at least until circa 1845, when a drawing was made of it (Fig. 7).<sup>6</sup>

Figure 7: Great Hall ceiling (center design) from Louis Reeve Gibbes sketchbook, ca.1845.

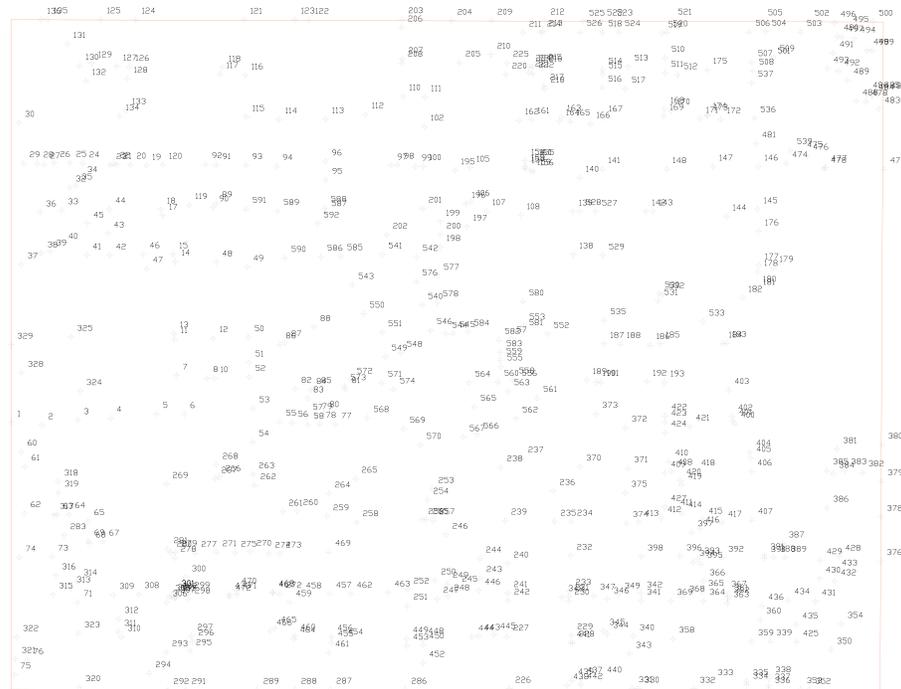
was collected using a plumb bob and two known datum points located at the northeast and southeast corners of the plaster field. Each of the intersections were plumbed to the floor where the distances from each of the two datum points were measured. The intersection of each crack was identified and mapped in AutoCAD® using X, Y coordinates based on the measurements taken from the datum points (Fig. 11). Additionally the Z coordinate or vertical shift out of the theoretical horizontal plane of the ceiling was mapped from these points using a laser level which created a level datum line around the room. Once all of the data was collected and digitally drawn in AutoCAD®, each condition was then imported into ArcView 3.2®. From this point Arcview was used to create regression modeling to identify the correlation between the crack patterns and their variables. Spatial analysis was conducted using three extensions including Spatial Analyst®, 3-D Analyst®, and Geostatistical Analyst® in order to find the spatial structure of the cracks such as density, as well as to create predictive maps to identify the location of potential threats to the surface (Fig. 12).

Figure 11: AutoCAD Map of crack intersections.

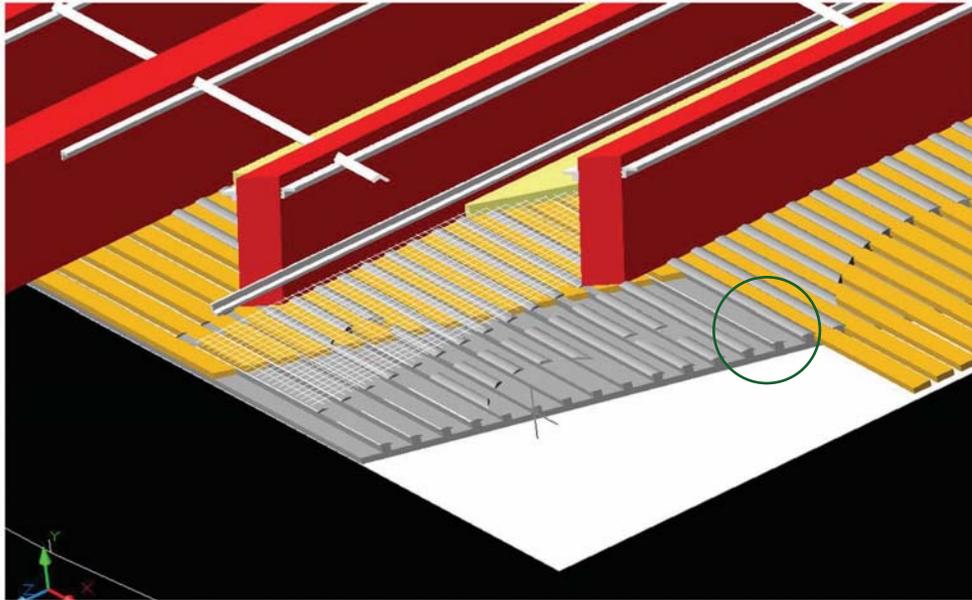
The undersized thickness of the original plaster may have played a role in the overall failure of the ceiling. According to William Millar's *Plastering Plain and Decorative* (1897/1998) the minimum thickness for any scratch coat is 3/8". Combined with an additional 3/8" for the most minimal brown coat, as well as an additional 1/16" for the finish coat, the minimum dimension for any plaster ceiling should be 13/16". Since the Great Hall ceiling plaster is only 1/2", it fails to meet this minimum requirement by 5/16" (Fig. 13). This problem goes beyond the simple fact that the plaster would be susceptible to deflection from the undersized joisting since Millar goes on to state,

Figure 13A: Schematic isometric view of existing floor-ceiling system (view from above)

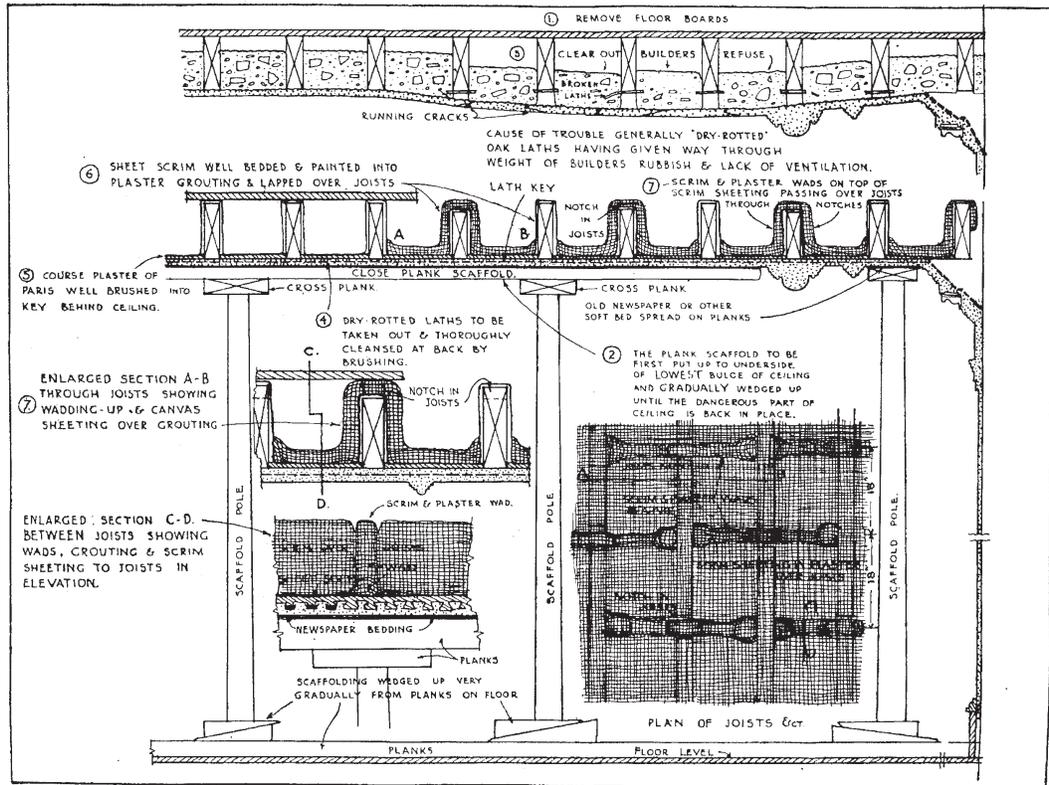
Figure 14: Method of strapping and reinforcing defective old plaster ceilings. (Millar, 1897)

A review of the 1978 treatment suggests that while the overall approach may have been excessive in its extent, it has been relatively successful. This treatment method, also used at Philipse Manor in Yonkers New York in 1971, dates back at least as far as Millar (1897) who outlined a very similar process (Fig 14).<sup>12</sup> During early visits to the site in 2001, guides were overheard commenting on the fact that the 1978 treatment had been viewed at the time of installation as being a final solution to the problem; however it was later apparent that that treatment had not eliminated continued plaster failure.

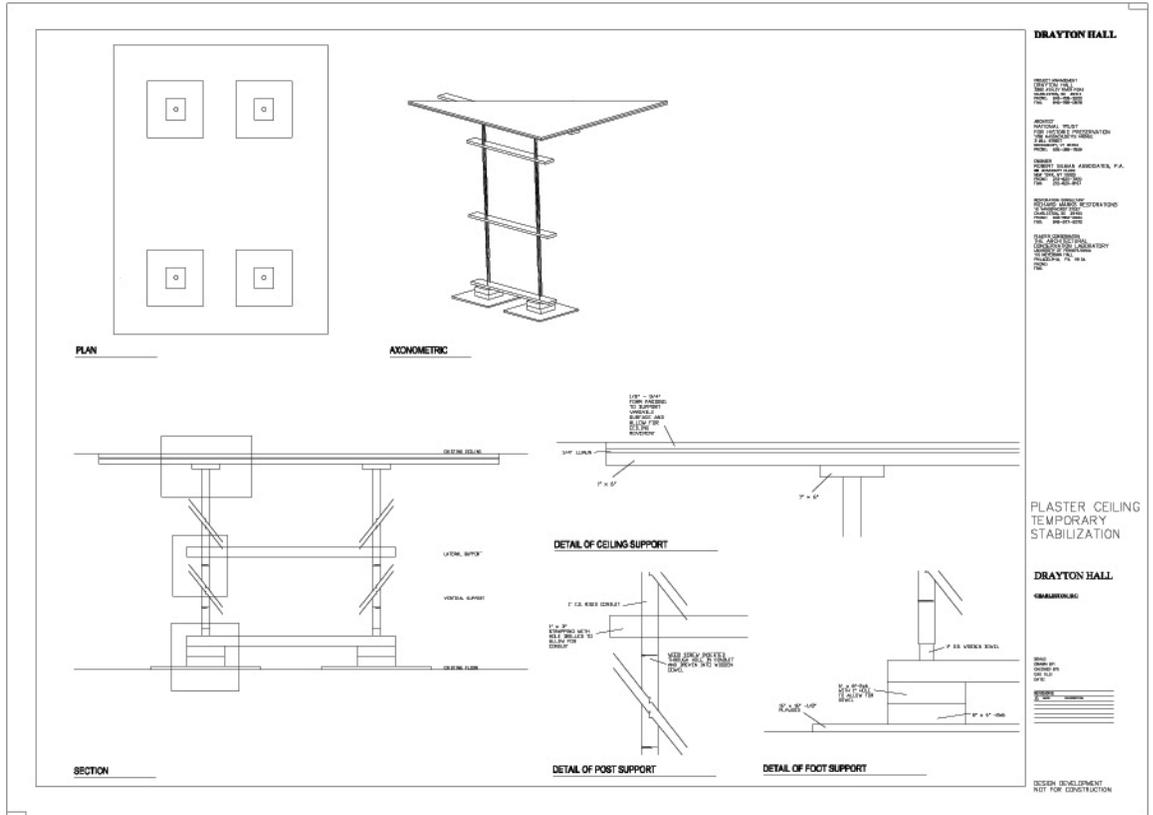
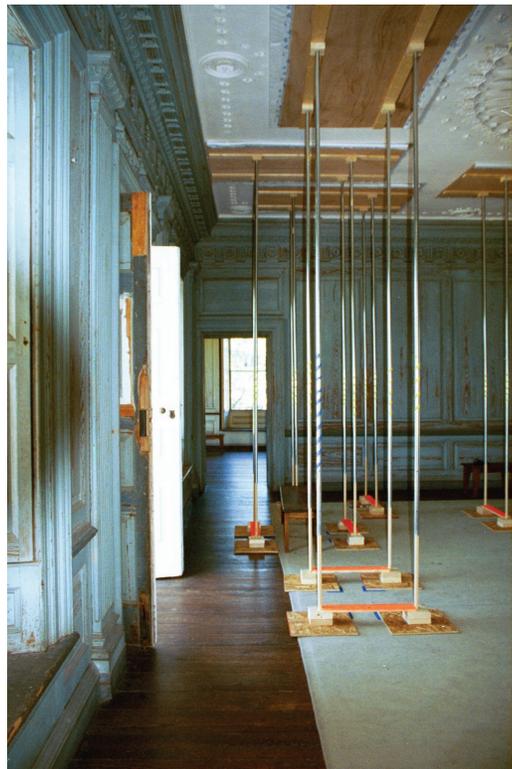
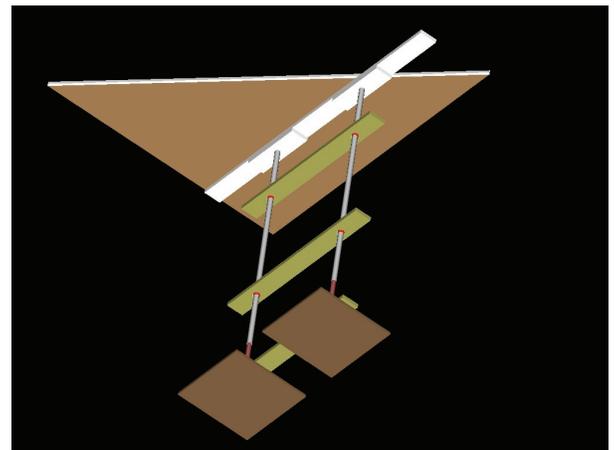
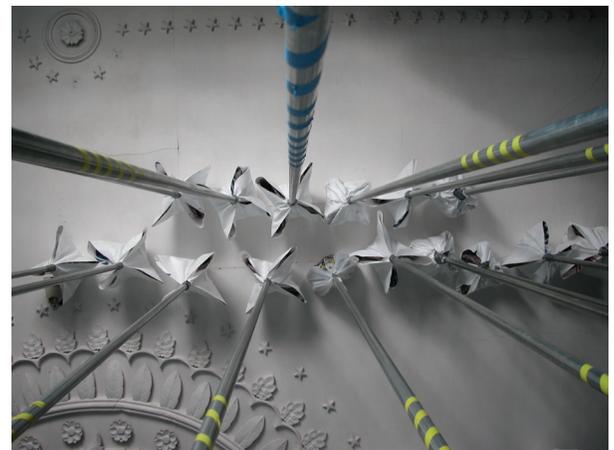
Figure 16: Temporary stabilization support

Eight stabilizing units were built; each unit consisted of four telescoping legs which supported a 4' X 6' sheet of 1/8" padded lauan plywood (Fig. 16). To create each unit, legs were manufactured using 4' lengths of dowel with a 1" diameter. In order to create the telescoping feature for the legs, 10' lengths of rigid conduit were purchased which had a 1" interior diameter allowing the conduit to slip over the top of the dowel. At the base of each section of conduit two small holes were drilled which allowed screws to be driven into the dowel, once the leg had been extended. This ensured that an extended leg would remain in place. 16" square bases were created using oriented strand board (OSB) to keep costs down. To the center of each of these bases was attached the dowel using a 2" X 4" X 4" plate with a one" hole drilled in the center into which the dowel was inserted.

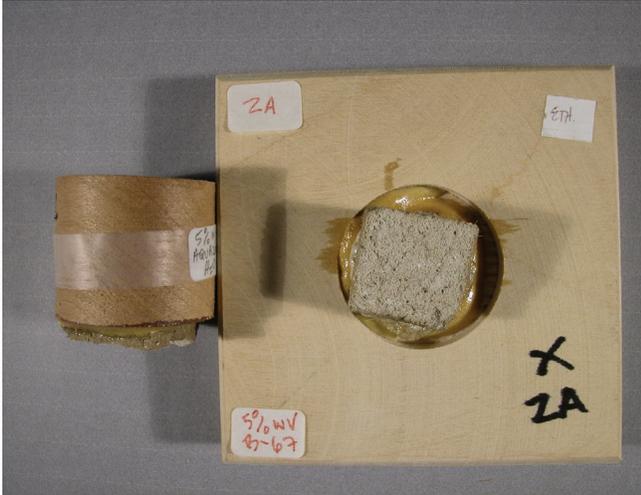
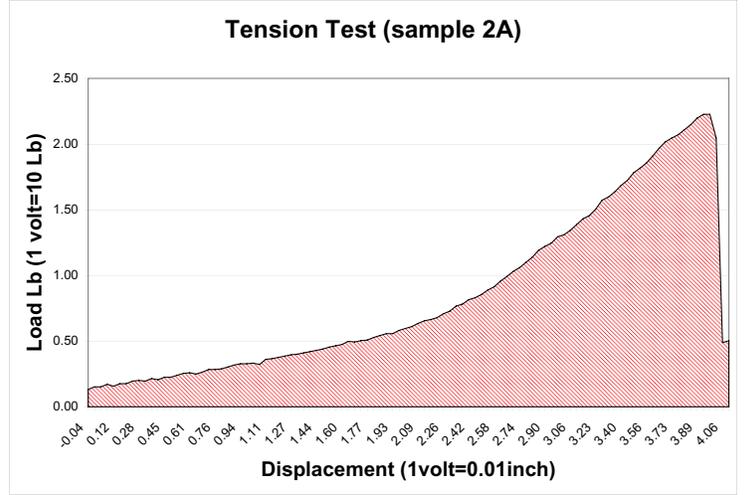
used the same basic four ingredients consisting of two acrylic emulsions (Rhoplex MC-76, the stronger component originally designed as a masonry bonding agent and Rhoplex 1950, the more flexible component originally designed as a binder for elastomeric sealants), water and a thickener (Acrysol ASE-60) to control viscosity and flow. By varying the quantities of the acrylic emulsions, Phillips was able to develop two different mixes for varying situations. Filled and unfilled options for each of these two mixes were designed to provide for filling both small gaps where the distance between the surfaces was less than 1/16 of an inch as well as large gaps where the distance between the surfaces was much greater. An important aspect of the current study was the mechanical testing of some of these formulations alone and in combination with wood and original ceiling plaster (Figs. 17, 18 and 19).

Based on the research which had already been conducted by Phillips, the only quantitation testing carried out in 2003 was mechanical bond strength.<sup>14</sup> The results of the mechanical testing showed that while the two formulas (flexible and non-flexible) possessed sufficient bond strength for the treatment, they differed in strength based on whether they were filled or unfilled. A matrix of sample assemblies was designed to allow for testing of bonding strength for each possible formulation in conjunction with the various combinations of adherends. These combinations included scratch coat to scratch coat (Fig. 17), scratch coat to finish coat (Fig. 19) and scratch coat to wood lath (Fig. 18). A decision was made to run the tests only on original materials gathered from the site, limiting the number of samples which could be tested. Although only 17 combinations were possible with the limited amount of original material and not all the tests were successful, the results of the mechanical testing were significant enough to warrant further study.

Figure 17A: Sample 2A- Scratch coat to scratch coat with filled adhesive.

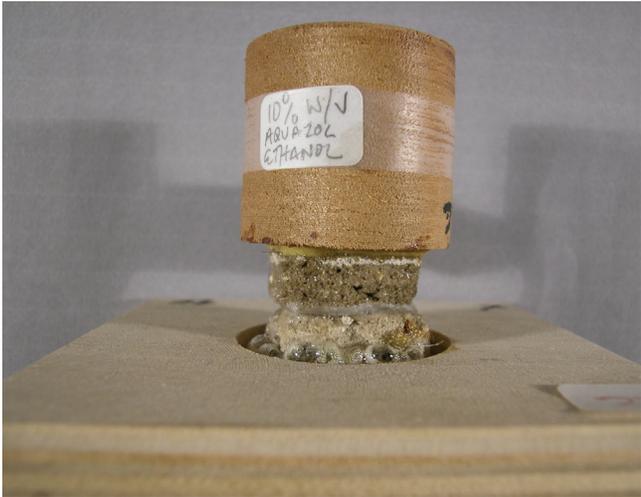
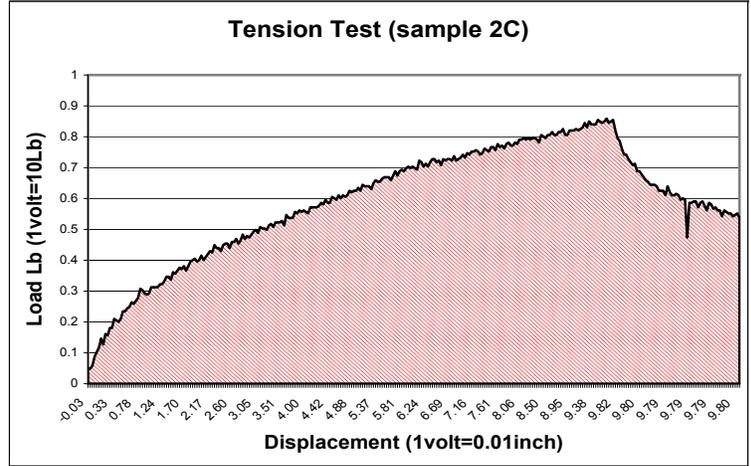
Figure 17B: Sample 2C- Scratch coat to scratch coat with unfilled adhesive.

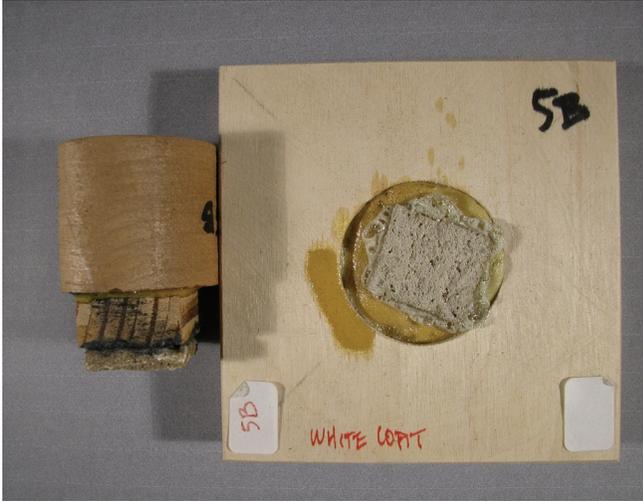
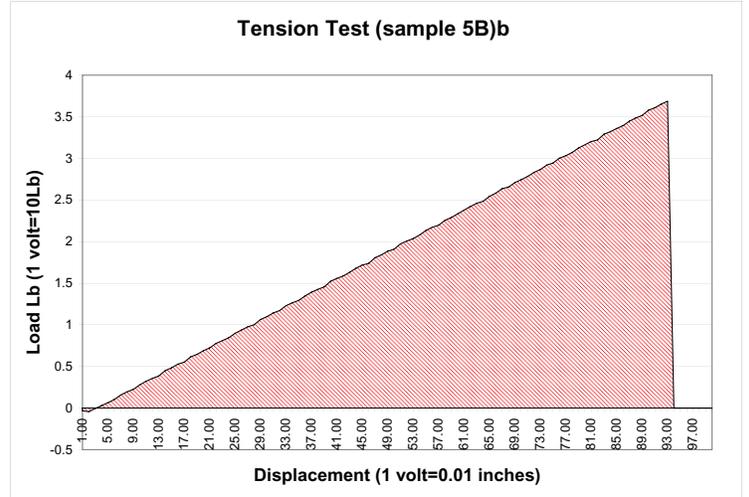
Figure 18A: Sample 5B- Scratch coat to wood with filled adhesive.

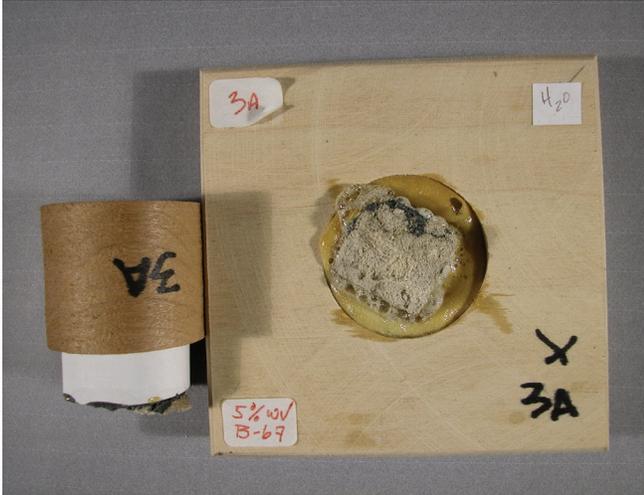
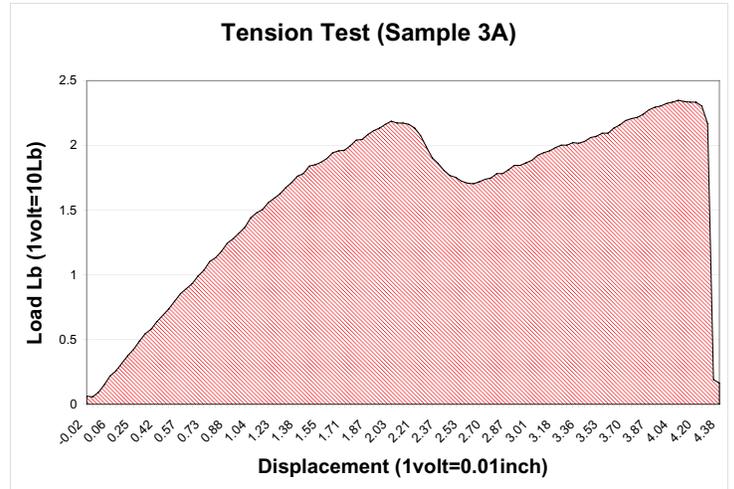
Figure 19A: Sample 3A- Scratch coat to finish coat with filled adhesive.

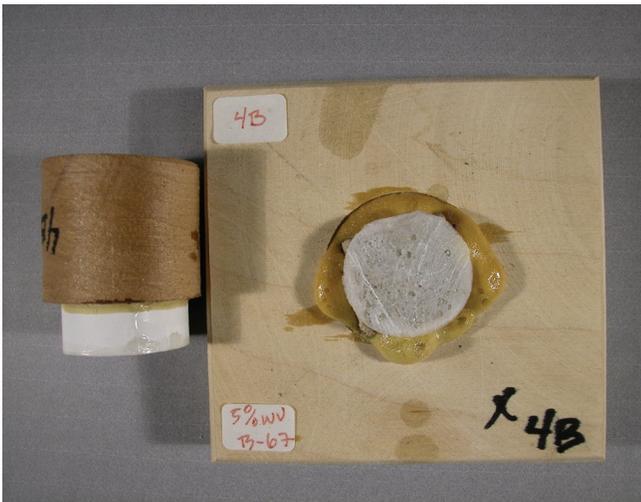
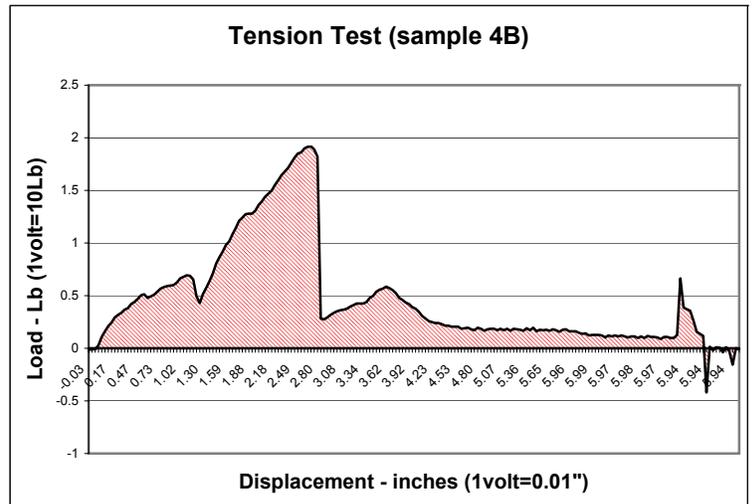
Figure 19B: Sample 4B- Scratch coat to finish coat with unfilled adhesive.
