THE EARLY PHRYGIAN GATE AT GORDION, TURKEY: 2012 INVESTIGATION AND RECOMMENDATIONS FOR STRUCTURAL STRENGTHENING AND STABILIZATION

Prepared for:
Mr. Frank Matero
University of Pennsylvania
115 Meyerson Hall
210 South 34th Street
University of Pennsylvania
Philadelphia, PA 19104

Prepared by:
David T. Biggs, P.E., S.E.
Biggs Consulting Engineering PLLC
740 Hoosick Road, Suite 4305
Troy, New York 12180
(518) 495-5739

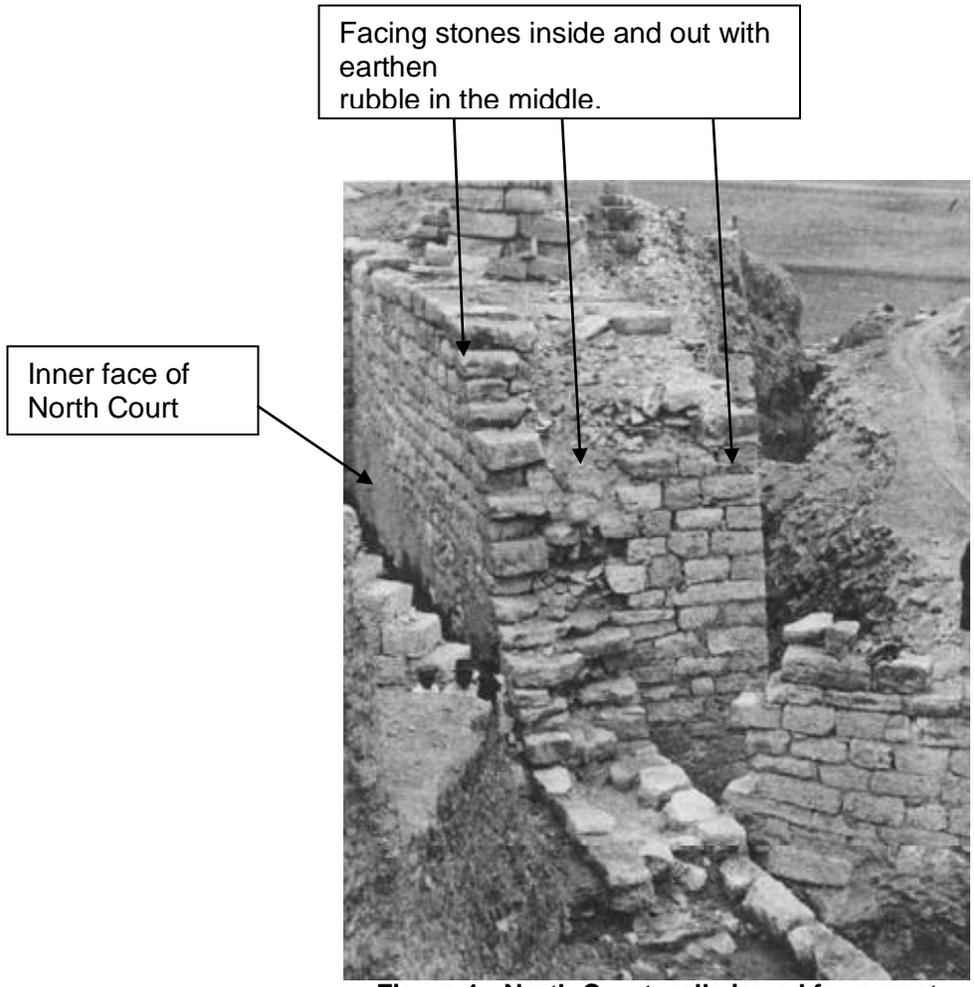
Figure 1 - North Court wall viewed from west

Figure 1 shows the North Court walls as viewed from the west during the 1955 excavation. The earthen filled, interior rubble core is clearly visible. Earthen mortar formed the joints of the facing stone along with chinking stones. Figure 1A is a blowup of the north wall of the South Court showing full earthen mortar bedding (arrow). The earthen mortar apparently was not consistently a full bedding mortar but was used to key in a mud plaster coating. Reportedly, the plaster coating had a lime wash (Young 1955).

Facing stones inside and out with earthen rubble in the middle.

Inner face of North Court

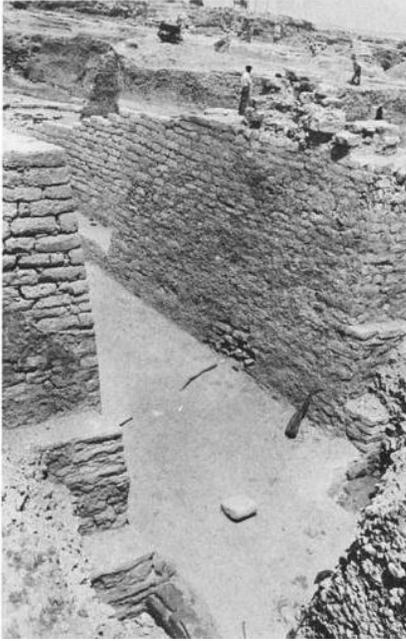
Figure 2 - From 1955

The gateway was excavated in 1955. Reports indicate the stone joints were "relatively tight and flat walls which still retained a considerable portion of original plaster at areas not directly exposed to weather" (Goodman 2003). Photographs from 1955 clearly show that both earthen mortar and plaster were generally intact following excavation (Figures 2 and 3).

In Figure 2, the plaster on the south face of the North Court walls is visible. Almost none of the plaster or the earthen mortar exists in Figure 3. Figure 4 shows a close up of the lower right corner of Figure 2 where the plaster and earthen mortar still exist. The majority of the mortar in the facing stones has been eroded.

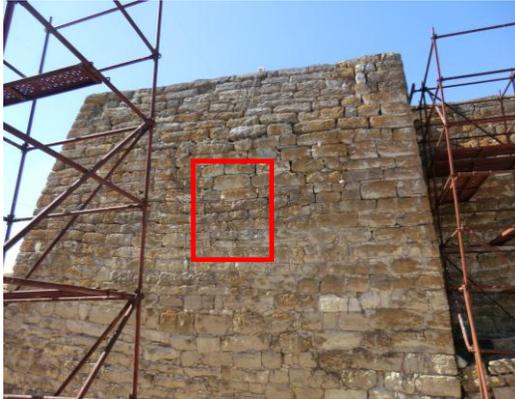
Figure 6 - North wall of South Court

1. Essentially, there is no visible earthen mortar or plaster remaining on the exposed facing stones. The lower portions of the north wall and east wall have been grout injected (Wong 2006) and those areas of walls have mortared or grouted joints. Figure 6 shows the north wall of the South Court. Figure 7 shows a close up of a portion of the wall from Figure 6 where the lower joints are filled from the previous grouting (lower arrow) and the upper joints are not filled (upper arrow).

No cracks were observed in the mortared/grouted joints.

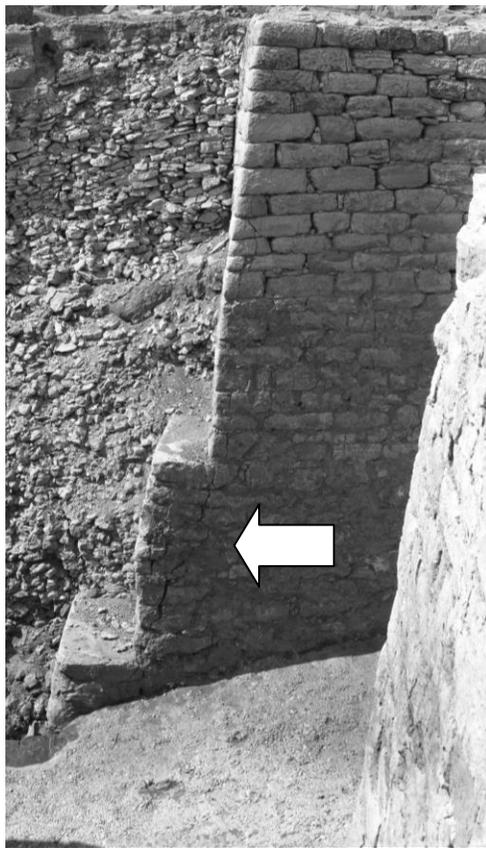
Figure 10 - 1955 Photograph

Figures 10 and 11 show the crack following the 1955 excavation. Both ledges are exposed. The crack is essentially unchanged between 1955 and 2012.

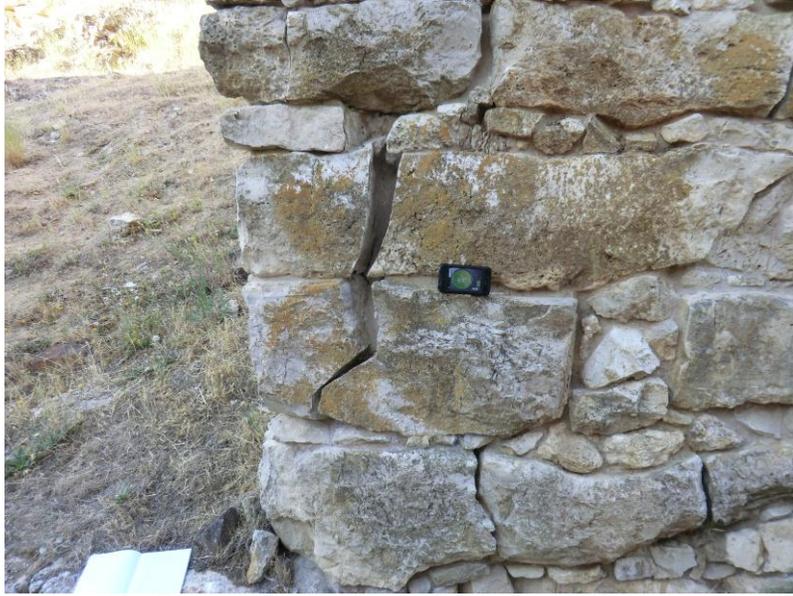
This crack has been discussed in previous literature. Rogers 1989 mentions that a repair method was proposed in 1987 by William C.S. Remsen that would pin the broken stones together. Figure 12 shows the current condition of the crack. While the corner was grout injected, apparently no pins were used to stitch the stones together as proposed by Remsen. However, no cracking of the grouted joints was observed in 2012.

Figure 12 - Southeast corner with mortared/grouted joints.

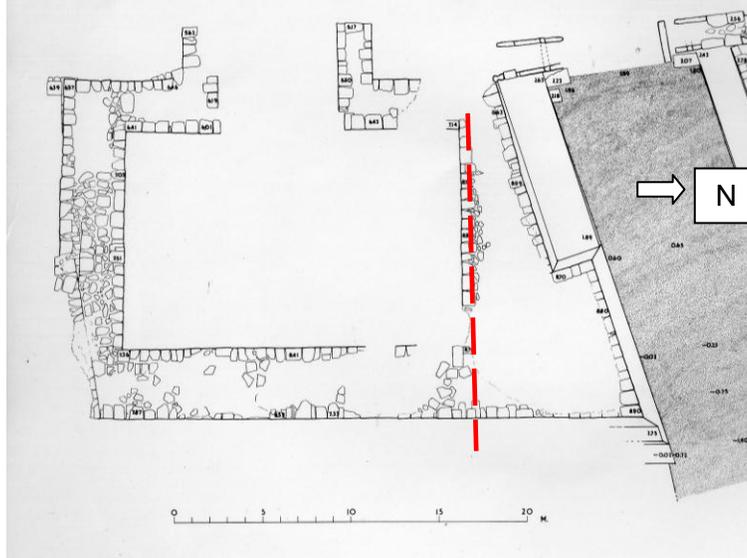
Figure 14 - Plan of South Court

5. The east wall has cracks also. Figure 13 shows the crack locations compared to the interior wall as shown by the red line on Figure 14. There is no direct correlation based upon the known information. The east wall shows no signs of global displacement due to the backfill. Cracking could be due to settlement, overload from upper walls, lateral pressure, or rubble fill settlement within the core.

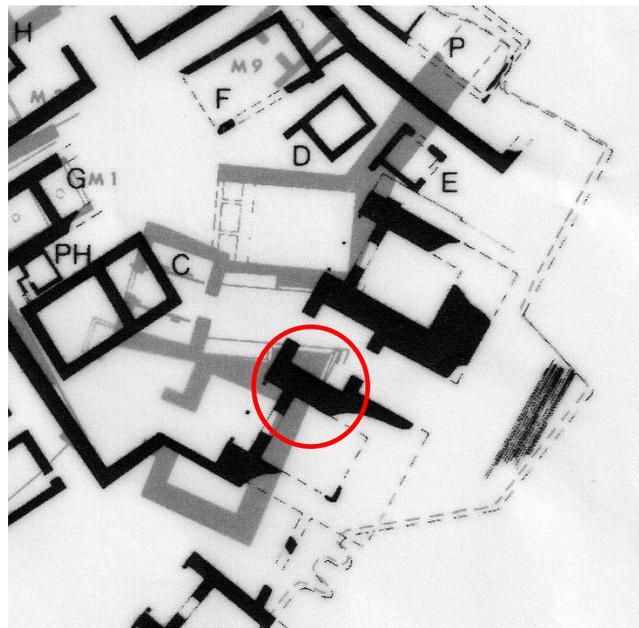
Figure 15 - Overlay plan of Middle Phrygian walls over Early Phrygian walls

Figure 15 shows an overlay of the Middle Phrygian walls (dark black walls) over the early walls (grey walls). The red circle indicates there was another wall built over the area of the east wall cracks. Of all the possible causes, overload from the upper walls and some settlement are the most likely causes of the cracking.

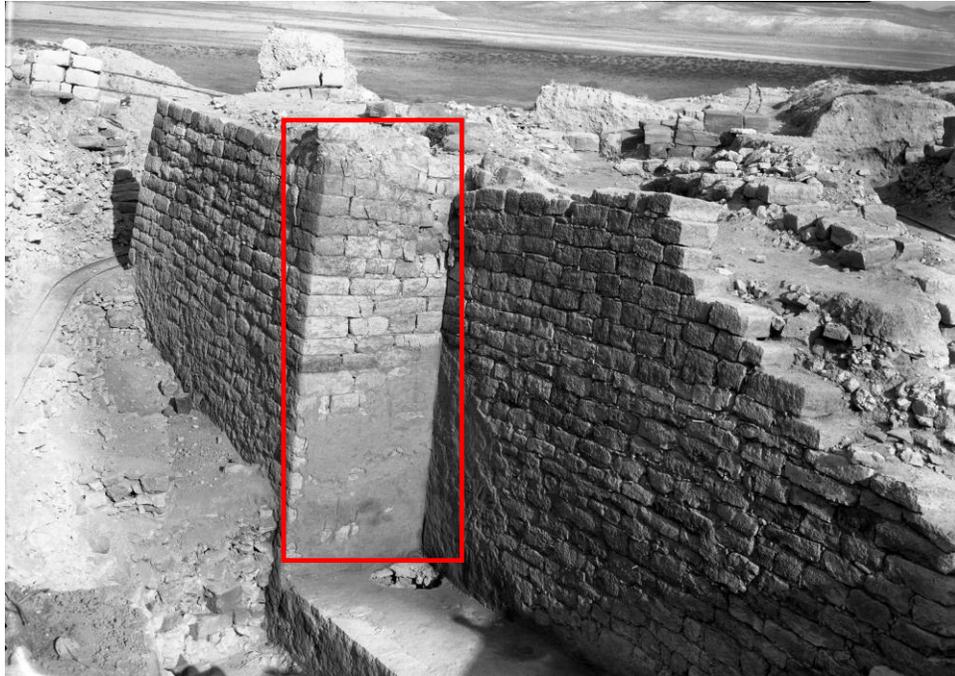
Figure 20 is a photograph from 1955. The west return wall is visible (box) and there is some cracking but little horizontal displacement that is visible in Figure 18.

Figure 20 - 1955 photograph of west return wall.

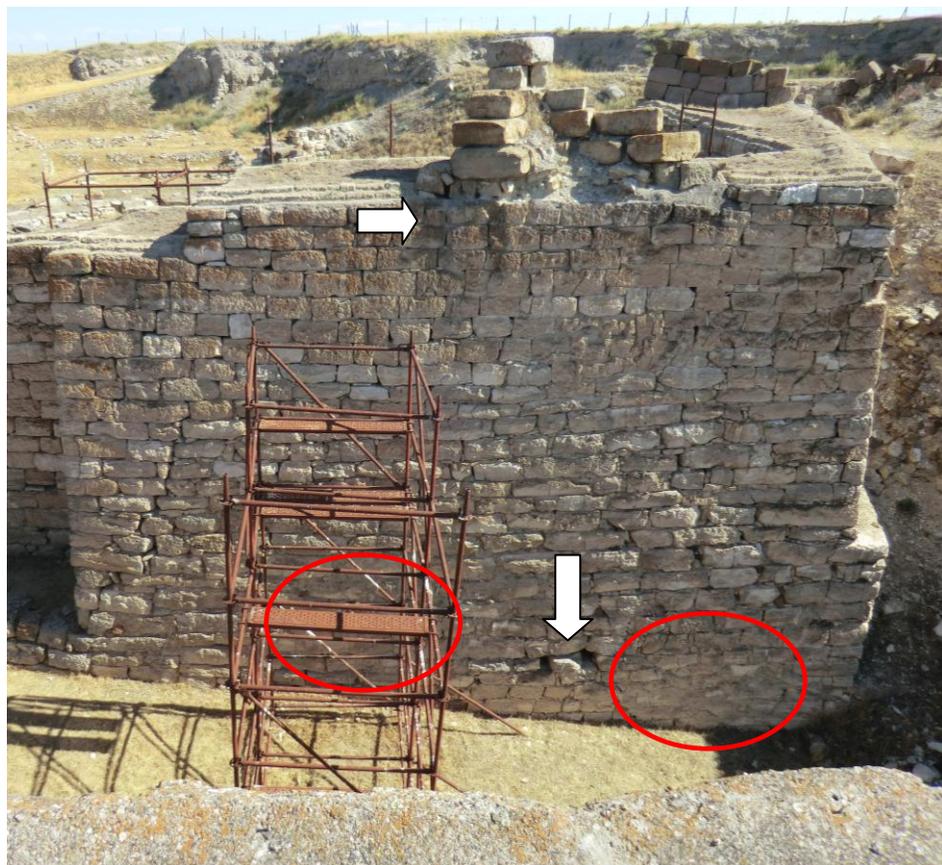
Figure 24 - South wall of North Court

1. The south wall of the North Court has some earthen mortar and plaster remaining on the exposed facing stones (two ovals, Figure 24). There is no lime wash visible. There was no grout injection performed on the North Court walls.
2. There is a void at the bottom of the wall (lower arrow, Figure 24). Figure 25 shows that there was a void present following excavation in 1955. However, the void shown in Figure 25 is several courses below the one in Figure 24.
3. Figure 24 also shows a soft cap above the South Court walls. The mud bricks that line the cap are weathering but the cap appears to be effective in preventing water infiltration. Reportedly, there is a hard cap beneath the soft cap.
4. The upper arrow in Figure 24 indicates a minor bulge. It is directly beneath the upper wall. The 1955 photograph (Figure 25) does not indicate any bulge at that location.

5. Figure 24 shows a diagonal crack at the left end of the wall. Figure 27 shows this crack and the return wall (arrow). The joints of the return wall indicate some displacement has occurred.

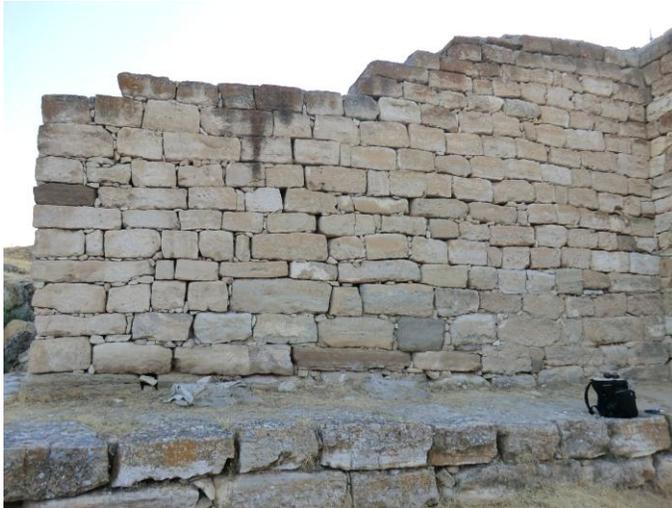
Figure 30 - West end of South wall

6. The North Court's south wall has a return section and then the remainder of the west wall. Figure 30 shows the south elevation. The west wall was partially rebuilt and buttressed (Keller 2009). Reportedly, this rebuilt section of wall had

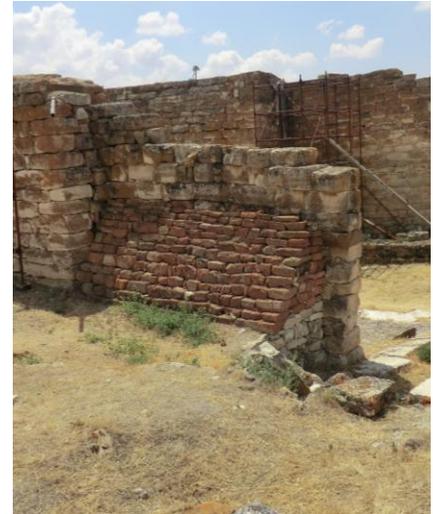
Figure 31 - North elevation of west end

been partially dismantled by the Phrygians to use the stone to construct other Middle Phrygian walls. Following the 1955 excavations, the stone from the Middle Phrygian walls were used to rebuild the west wall. Figure 31 shows the rear (north) with the buttressing that was done as part of the rebuild.

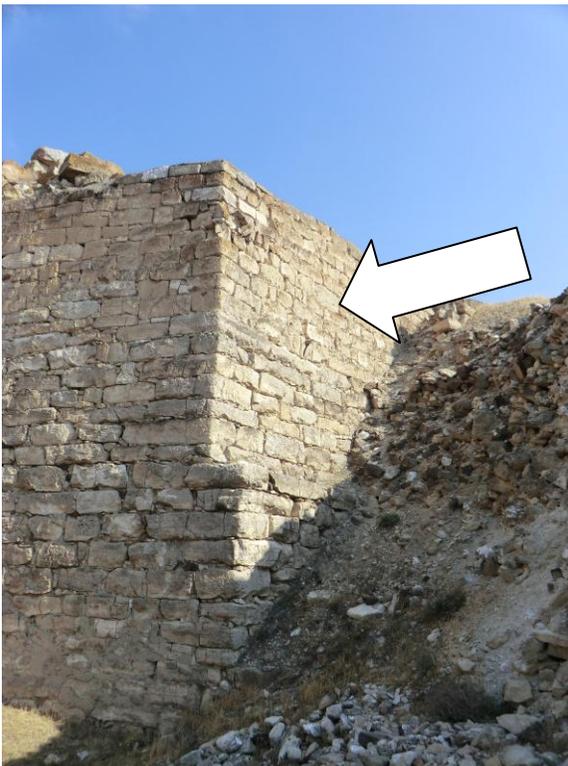
Figure 32 - East wall of North Court

6. The east wall is partially exposed (arrow, Figure 32). One ledge is visible. The upper corner has a small bulge and some displaced stones (oval, Figure 33). From Figure 15, there was a Middle Phrygian wall above this corner. From Figure 25, the bulge and displaced stones were evident in 1955.

Figure 34 is a view of the soft capping of the North Court walls; the South Court walls are beyond. The figure also shows the wall thickness is reduced to approximately 1.2m at the location of the bulge (oval, Figure 33 and Figure 32). Based upon Figure 15, this narrow corner once supported Middle Phrygian walls.

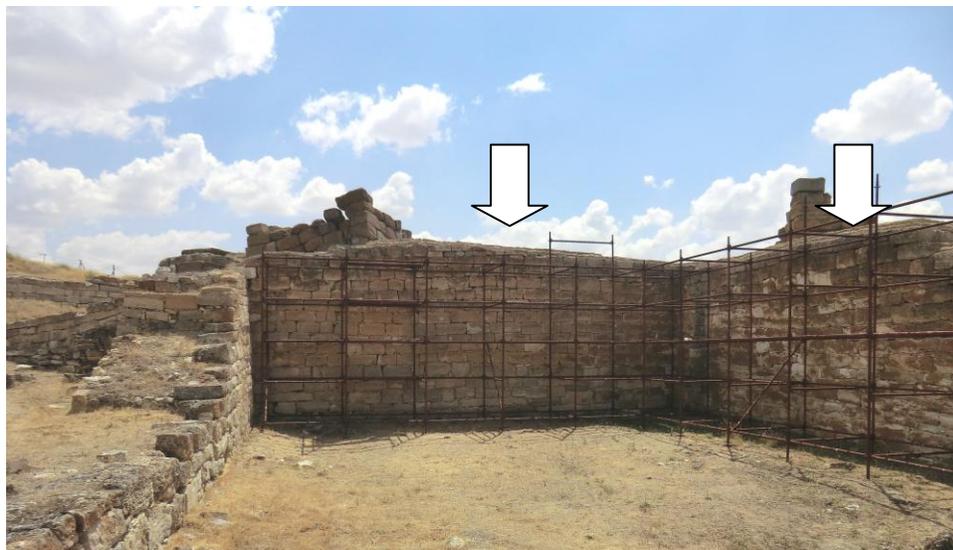
7. Unlike the South Court, the North Court was partially excavated and the interior walls are exposed (Figure 35). The east wall is denoted by the left arrow; the right arrow is the rear of the south wall that was shown in Figure 24. The low walls on the left are the remains of the north wall. The scaffolding was erected for work access.

Figure 35 - Interior walls of North Court with remnants of Middle Phrygian walls above

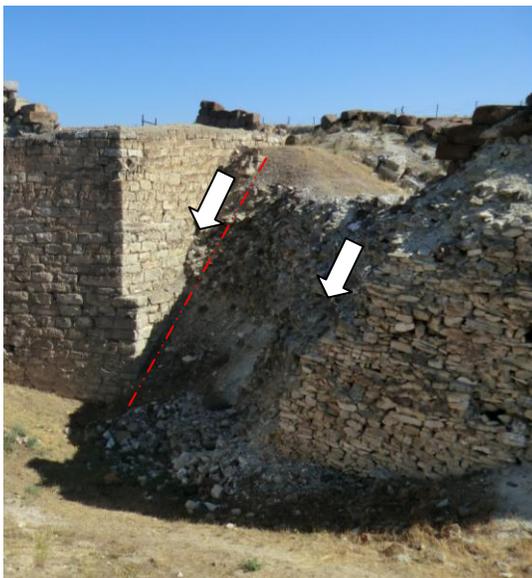
Figure 40 - Rubble

3. The Middle Phrygian backfill was installed systematically. There are indications the rubble was constructed in "strips" and timber ties were used to stabilize each strip. Figure 40 shows the rubble just east of the gate walls. The existing angle of repose is approximately 45 degrees where the rubble has been partially excavated (arrows).

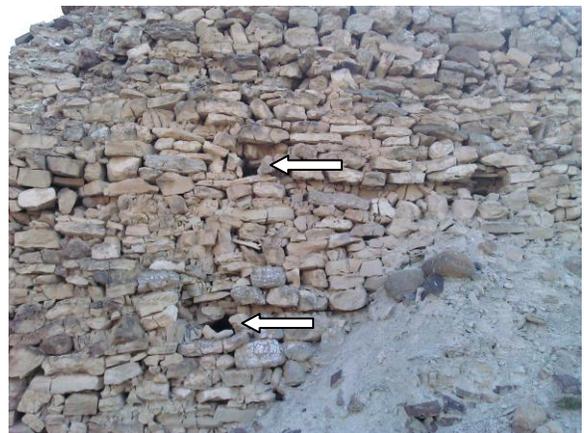
Figure 41 - Rubble

Figures 41 and 42 are close-up views of the rubble. Remains of timber were found in several locations (arrows, Figure 41 and Figure 42).

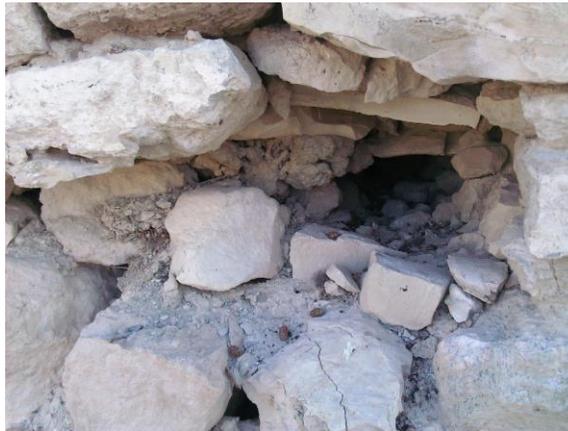
The face of the rubble is nearly vertical at the sides of the strips (Figure 43). Figure 44 shows the 1955 excavation where the rubble is standing nearly vertical. The primary difference between 1955 and 2012 is that the earthen portion of the rubble has been eroded.

Figure 42 - Void from timber tie

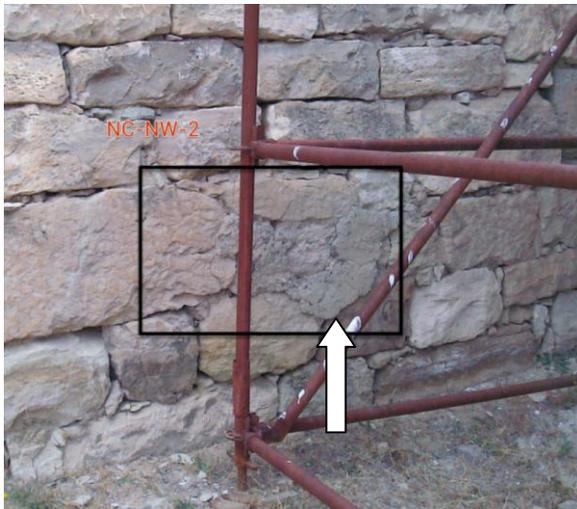
Figure 45 - North wall of North Court

Figure 45 shows a section of the north wall of the North Court where a sample was taken. In general, the plaster was still adhered to the stone and keyed to the earthen mortar. Figure 46 is a close-up of the plaster (arrow, Figure 45). In removing some of the plaster, the adhesion was better on the smoother stone on the right (limestone) in comparison to the stone with more surface texture on the left (rhyolite). This indicates that moisture absorption of the stone may be a better indicator of adhesion and should be evaluated.

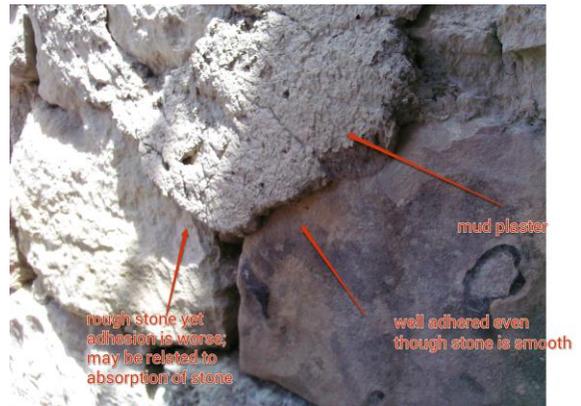
Figure 46 - Close of earthen mortar and plaster

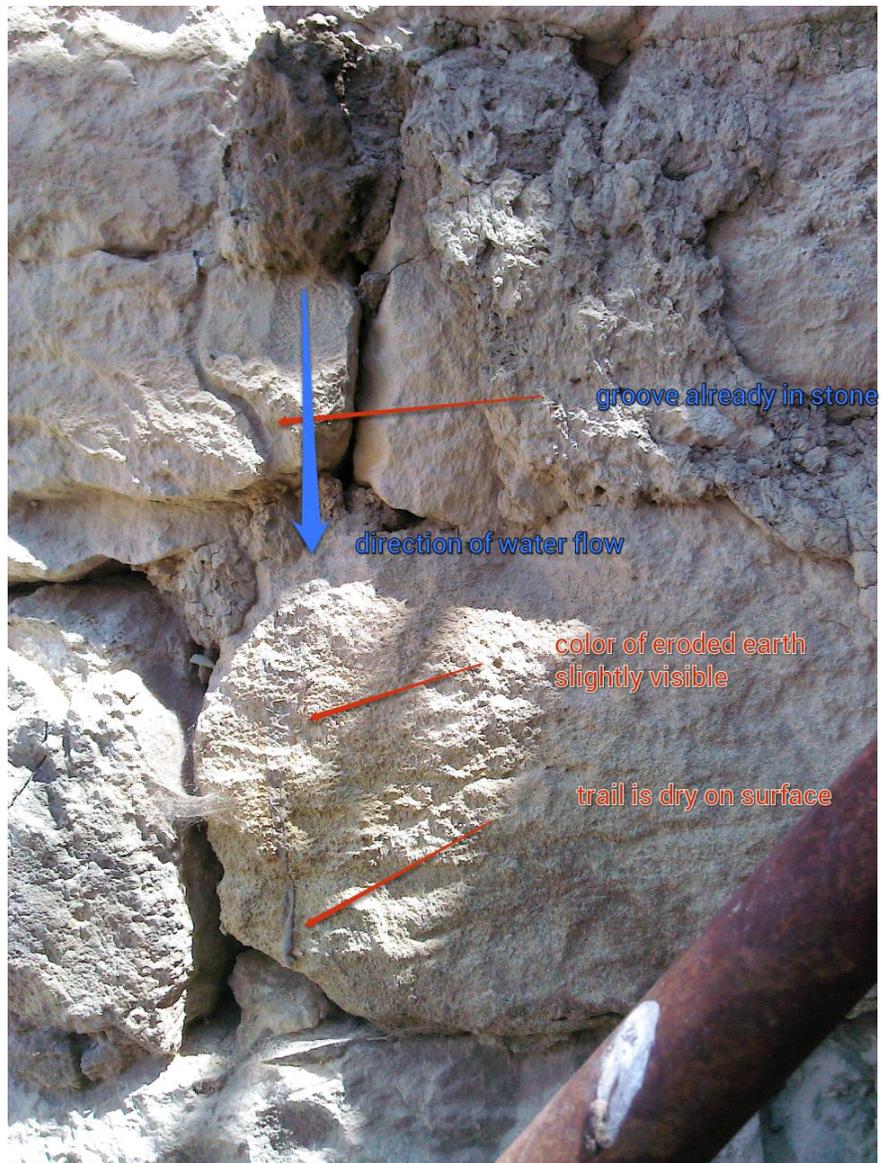
Figure 48 - Wet test on mortar and plaster

A small test was done on site. A sample of the plaster was wetted and the effects were observed for over an hour. Figure 48 shows a wetted area of mortar and plaster. Enough water was applied to cause some erosion. The wetted material felt silty and likely has clay.

The dried trails of the material are visible in the lower portion of the figure. No such trails were found on the stone walls near existing mortar and plaster. The lack of dried mortar trails may indicate that water erosion is a slow process and wind abrasion or freeze-thaw effects may be the more likely failure mechanism for the deterioration of earthen plaster.

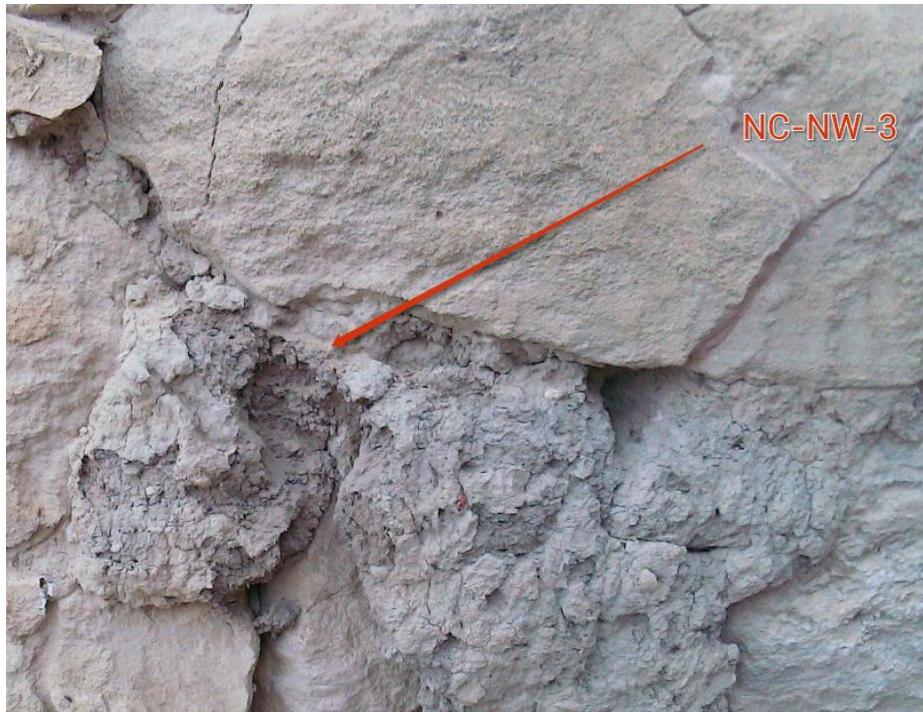
Figure 49 shows a close-up of plaster. It was generally dense and firm. The surface had a skin coat of clay that seemed to be protecting it. This coating was dissolved silty material that had redried on the surface, much like the dried material visible in the test seen on Figure 48.

Figure 49 - Earthen plaster

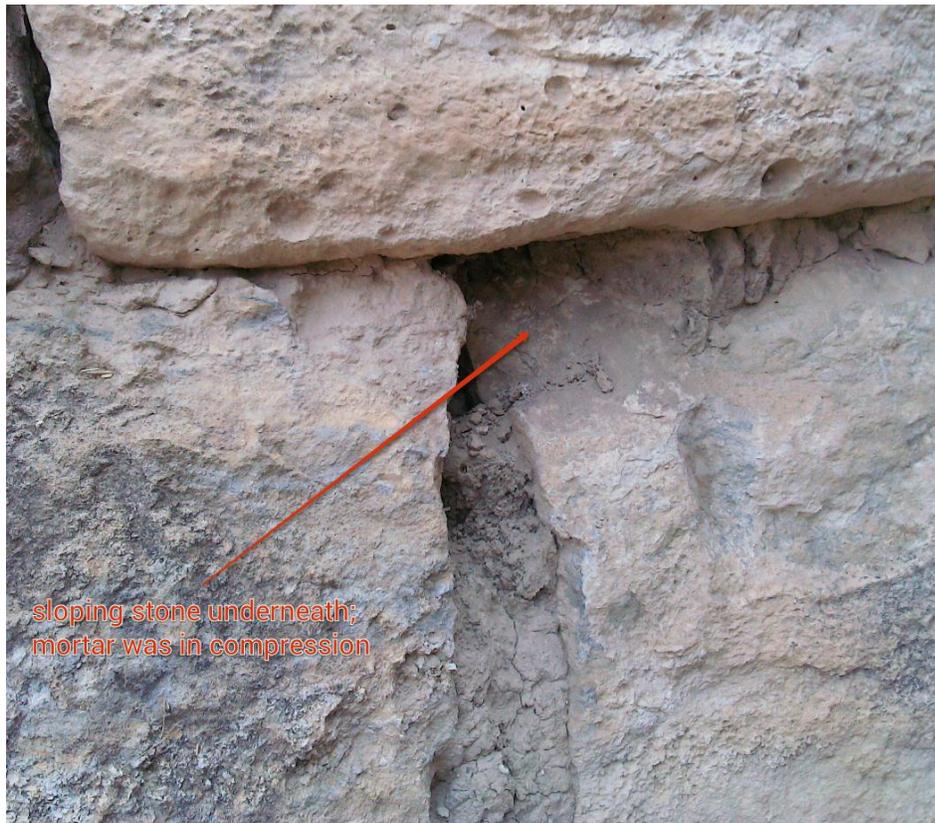
Figure 50 shows earthen mortar under compression and still intact. The mortar is dense and firm.

Figure 50 - Earthen mortar

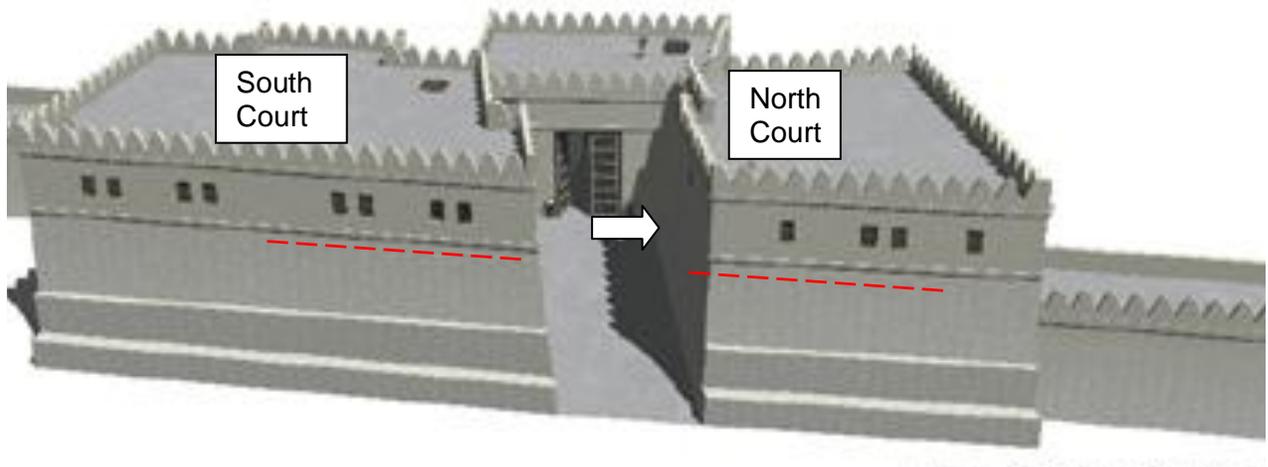
Figure 51 - Artist's rendering of Early Phrygian gate (East Elevation)

Figure 51 is an artist's rendering provided to me that could represent the Early Phrygian construction at the gate. The red line is the approximate height of the stone walls as they currently exist. The literature indicates that above the existing stone walls were additional stone courses, mud brick walls, a parapet and the roof construction.

Based upon these assumptions, axial stresses in the wall were determined at various stages for the south wall of the North Court (arrow, Figure 51). This wall was measured as approximately 3m wide. The facing stones are approximately 0.8m thick. The wall is estimated to be approximately 9m tall although the exposed height is less.

While these are only approximations, the order of magnitude of the results are reasonable (less than 100 psi) and indicate the stone walls were adequately sized to support the assumed vertical loads. If the walls were founded on juniper logs, even the wood could support these stresses in cross-grain bearing if the wood is in good condition.

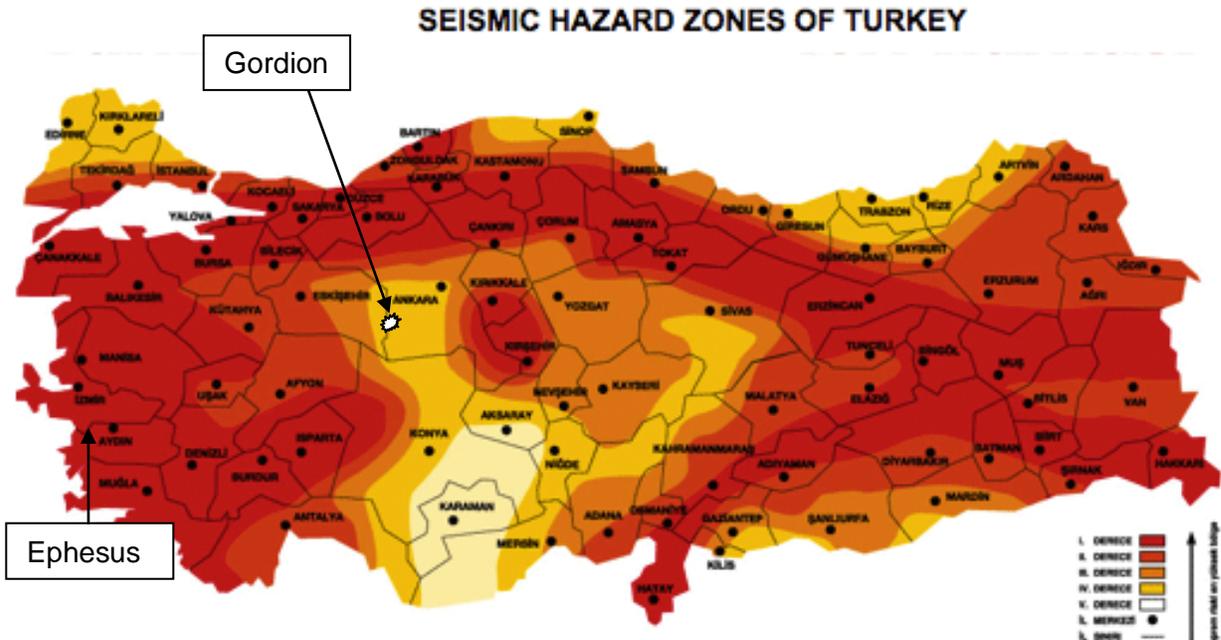
Figure 52 - Turkey's Seismicity

Turkey is a seismically active country with a major fault line along its northern border. The country is divided into five seismic zones from Zone 1 (highest) to Zone 5 (lowest). The Gordion region is in Zone 4 (Figure 52) which has relatively low seismicity. The seismicity of the Gordion region might be considered comparable to the east coast of the United States.

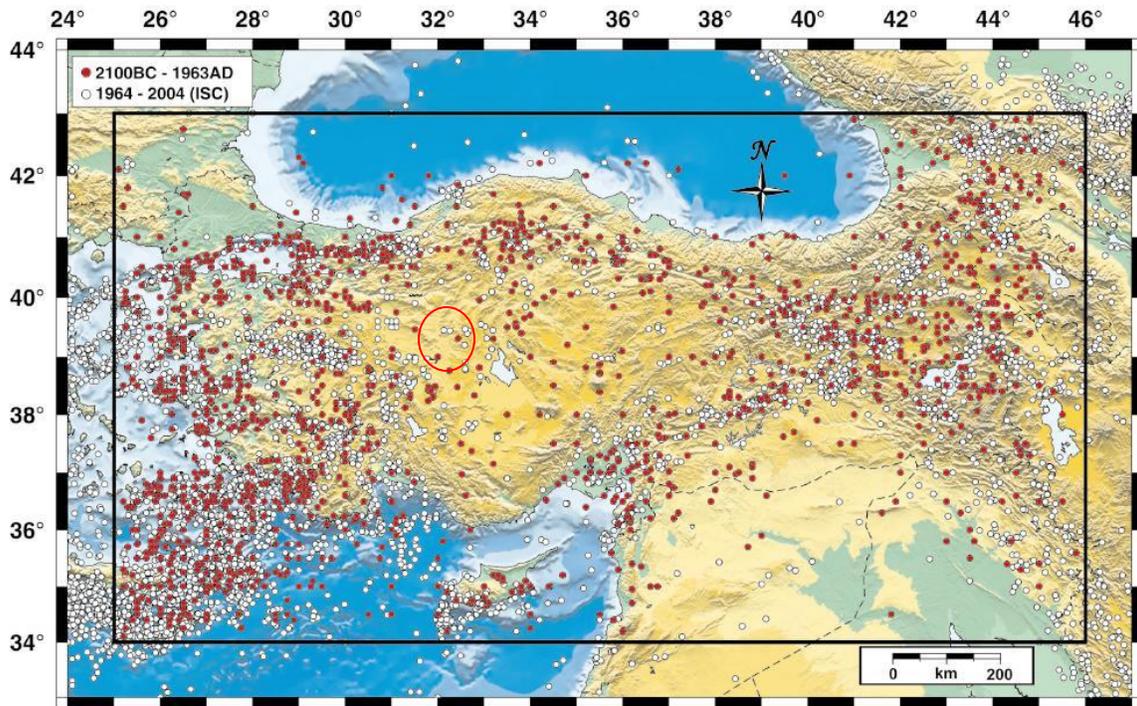
Figure 53 - Historical earthquakes in Turkey

Doğan 2010 provided a map showing the location of various earthquakes (Figure 53). The Gordion area is marked with an oval. There have been very few earthquakes originating in the Gordion area, but many east and north within a couple hundred kilometers.

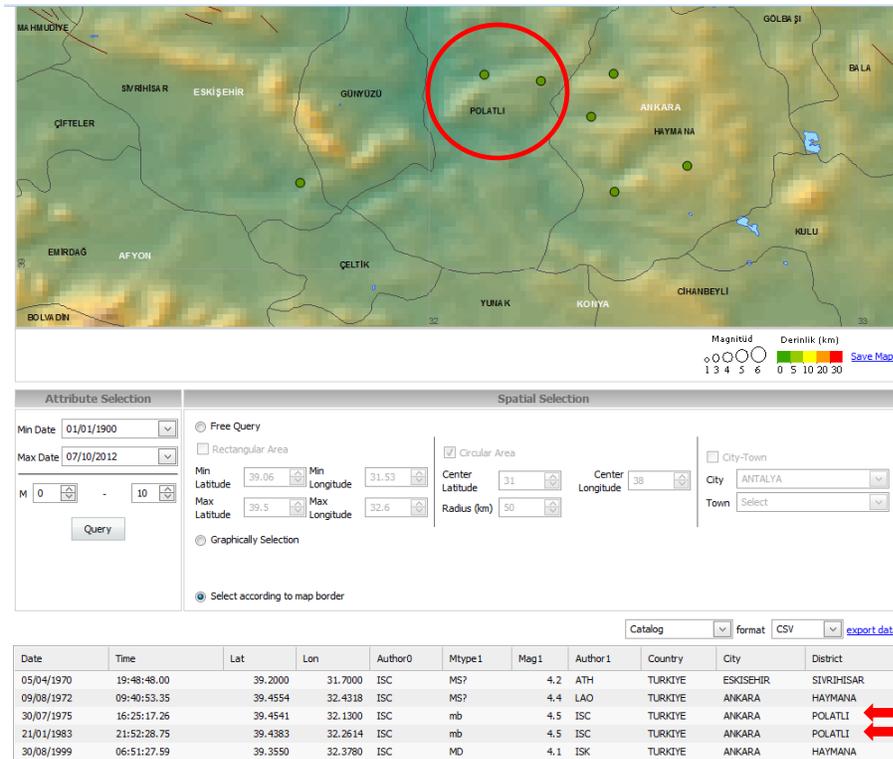
Figure 54 - Seismic activity near Polatli, Turkey

According to the Republic of Turkey Prime Ministry, Disaster and Emergency Management Presidency, Earthquake Department, the two largest earthquakes recorded in nearby Polatli were 4.5M in both 1975 and 1983 (arrows, Figure 54). None of the literature provided reported damage at Gordion from these two earthquakes. However, no one may have been looking for damage at an excavation site.

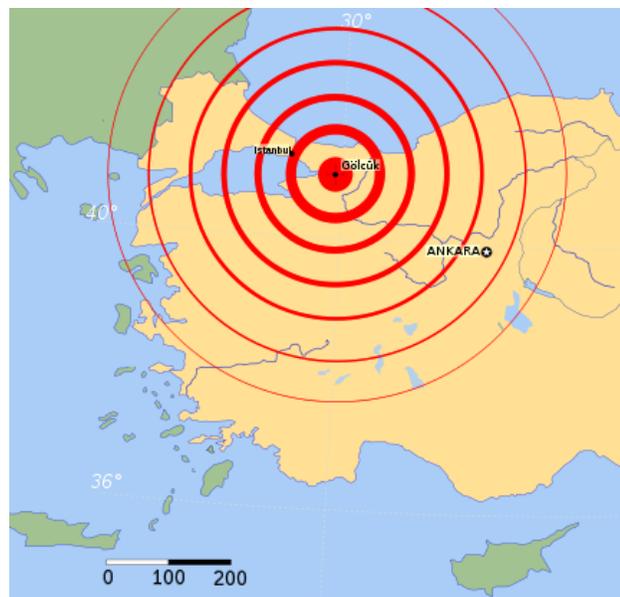
Figure 55 - 1999 Izmit earthquake

As previously noted, the Gordion site experienced seismic effects as a result of the 7.4 M, 1999 Izmit Earthquake. The 1999 epicenter was approximately 240 km away from Gordion (Figure 55).

We have no recorded data of movement of the gate walls at Gordion due to the earthquakes in 1975 and 1983. The only data is related to the movement measured following the 1999 earthquake.

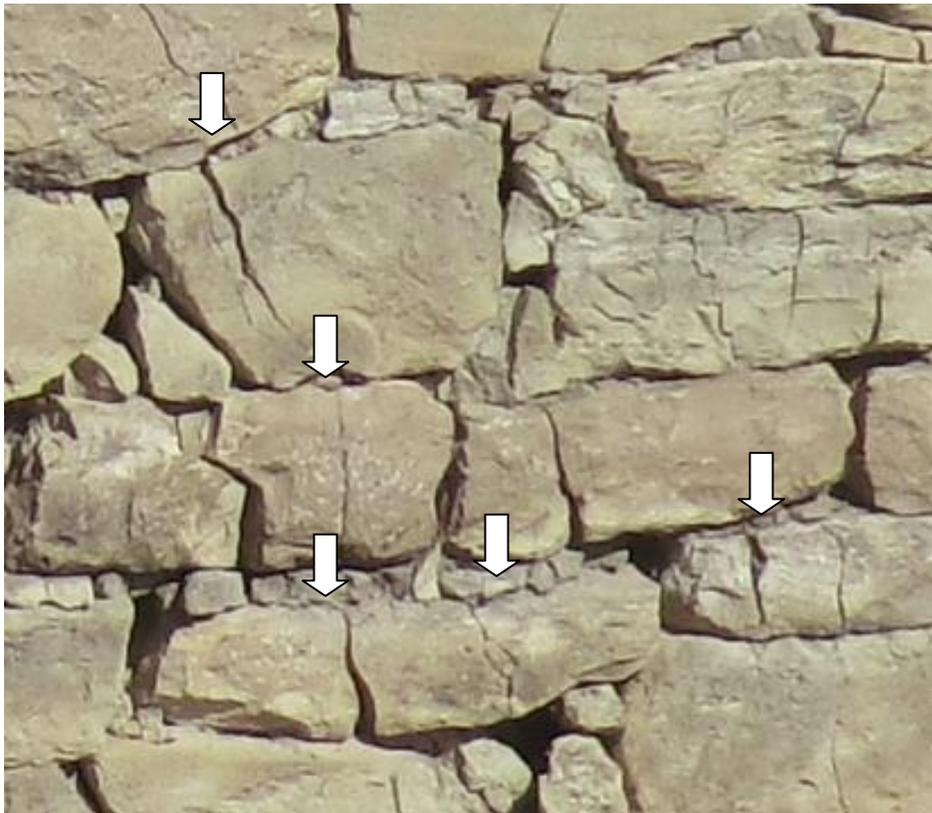
Figure 56 - Point loading of stones

The partial bedding contact of the stones along with the loss of the partial earthen mortar material in the joints accentuate the bearing conditions of the chinking stones. Once the partial bedding mortar is missing, the chinking stones become the primary support. These randomly placed chinking stones produce point loadings on the facing stones (arrows, Figure 56) that are eccentric. The point loading can cause stress concentrations that result in cracking and stone rotation.

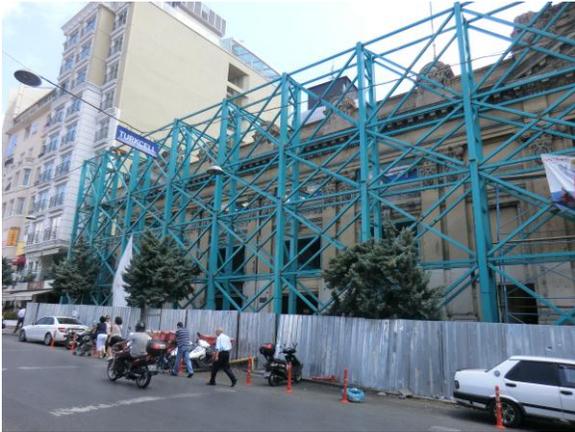
Figure 57 - Building façade bracing

There are two viable options for strengthening. One option is to provide external bracing. Figures 57 and 58 show historic two structures in Turkey that were provided with external bracing. In Figure 57, the bracing is for a building façade in Istanbul; except for the façade, the building has been demolished. The bracing prevents the façade from falling into the street and protects pedestrians and motorists passing by.

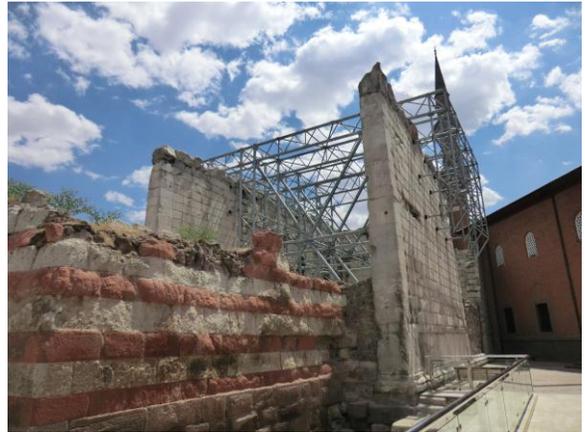
Figure 58 - Monument bracing

The bracing in Figure 58 is for the Temple of Augustus and Rome in Ankara. The site is adjacent to an active mosque and receives many visitors and tourists daily.

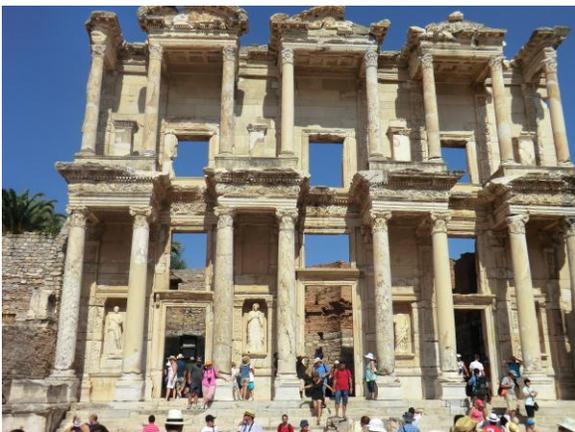
Figure 59 - Library at Ephesus

Figures 59 and 60 show two Roman the historic monuments at ancient Ephesus in Turkey. Figure 59 is the library and Figure 69 is the coliseum. The library was reconstructed without external bracing and the coliseum is undergoing a partial reconstruction and strengthening. Ephesus is in Seismic Zone 1 (the highest possible level in Turkey, Figure 52) and has experienced numerous earthquakes (Figure 53). Neither uses external bracing and each receives numerous tourists daily.
