Jackson Lake Lodge
Grand Teton National Park
Moran, WY

Historic Structure Report

Part 3

Prepared by:
The Architectural Conservation Laboratory
School of Design
University of Pennsylvania

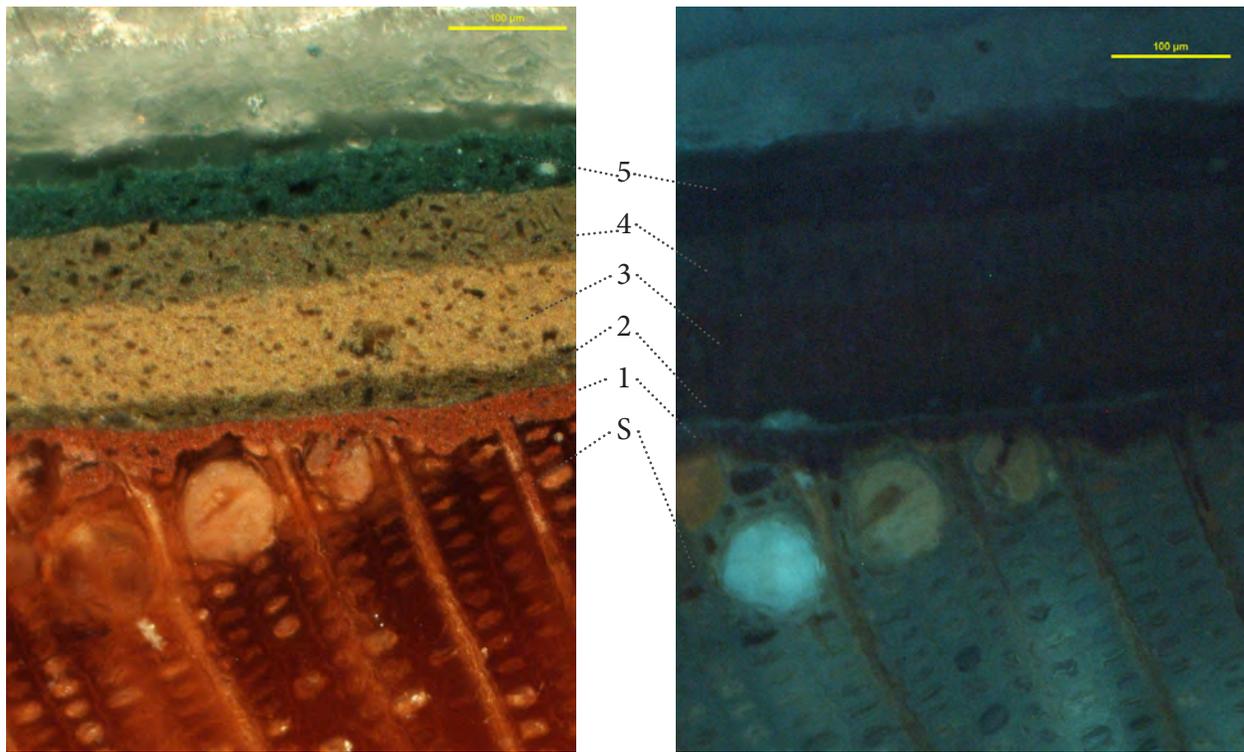
Architectural Finishes Analysis of GC4

<i>Microscopy Metadata</i>				
Location	Sampled By	Sampling Date	Analyzed By	Date
Guest Lodge JL-26. Rafter on west elevation.	Araba Prah	7/5/2016	Cesar Bagues Araba Prah	11/29/2016
Microscope	Light Source	Filters	Camera	Magnification
Nikon Alphahot YS2	Visible: reflected quart halogen UV: Nikon mercury lamp	Daylight	Nikon DS Fi-1 camera NIS Elements BR software	10x
Notes				
Substrate	Wood			
Layer 1	Reddish brown stain			
Layer 2	Brown green coating			
Layer 3	Light brown coating			
Layer 4	Brown green coating			
Layer 5	Blue green coating

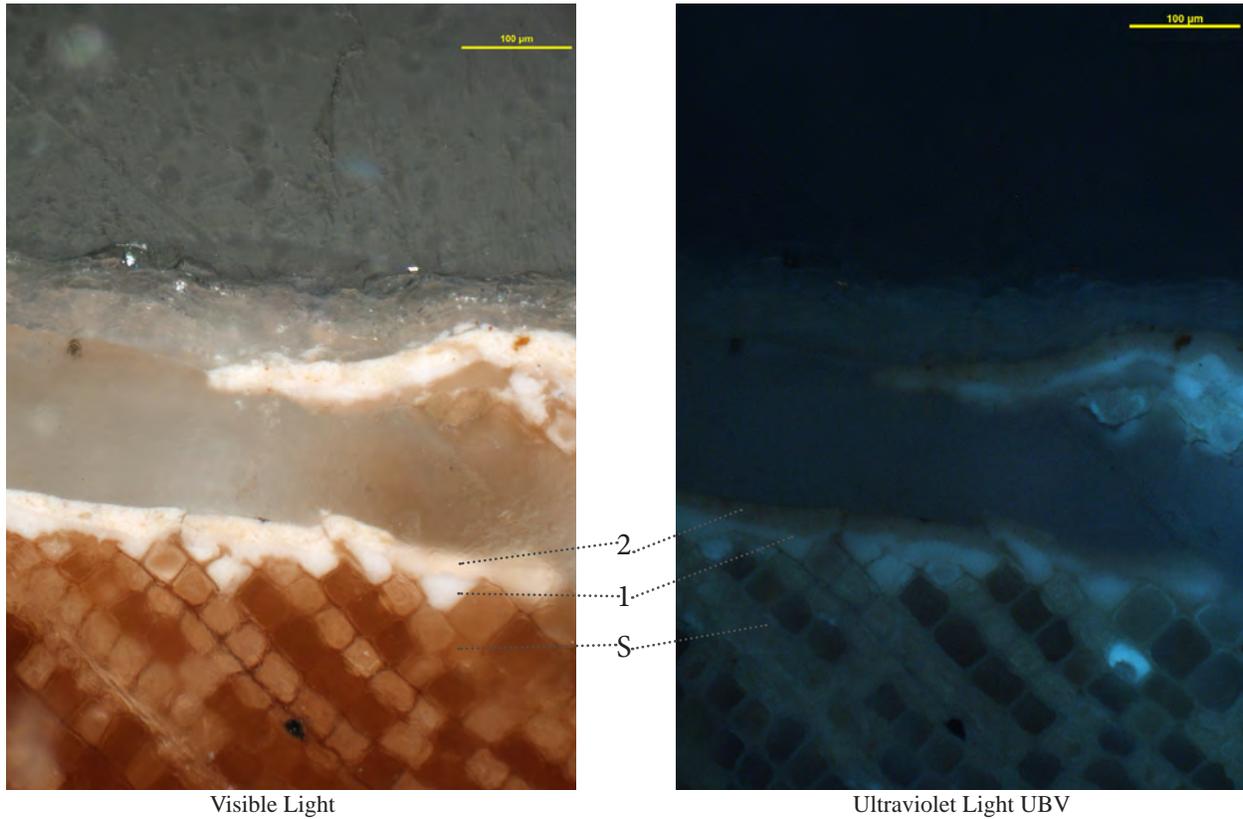
Architectural Finishes Analysis of GC5

<i>Microscopy Metadata</i>				
Location	Sampled By	Sampling Date	Analyzed By	Date
Guest Lodge JL-26. East elevation. Room 607. Window bottom sash interior.	Araba Prah	7/5/2016	Cesar Bagues Araba Prah	11/29/2016
Microscope	Light Source	Filters	Camera	Magnification
Nikon Alphahot YS2	Visible: reflected quart halogen UV: Nikon mercury lamp	Daylight	Nikon DS Fi-1 camera NIS Elements BR software	10x
Notes				
Substrate	Wood			
Layer 1	White primer			
Layer 2	Cream coating

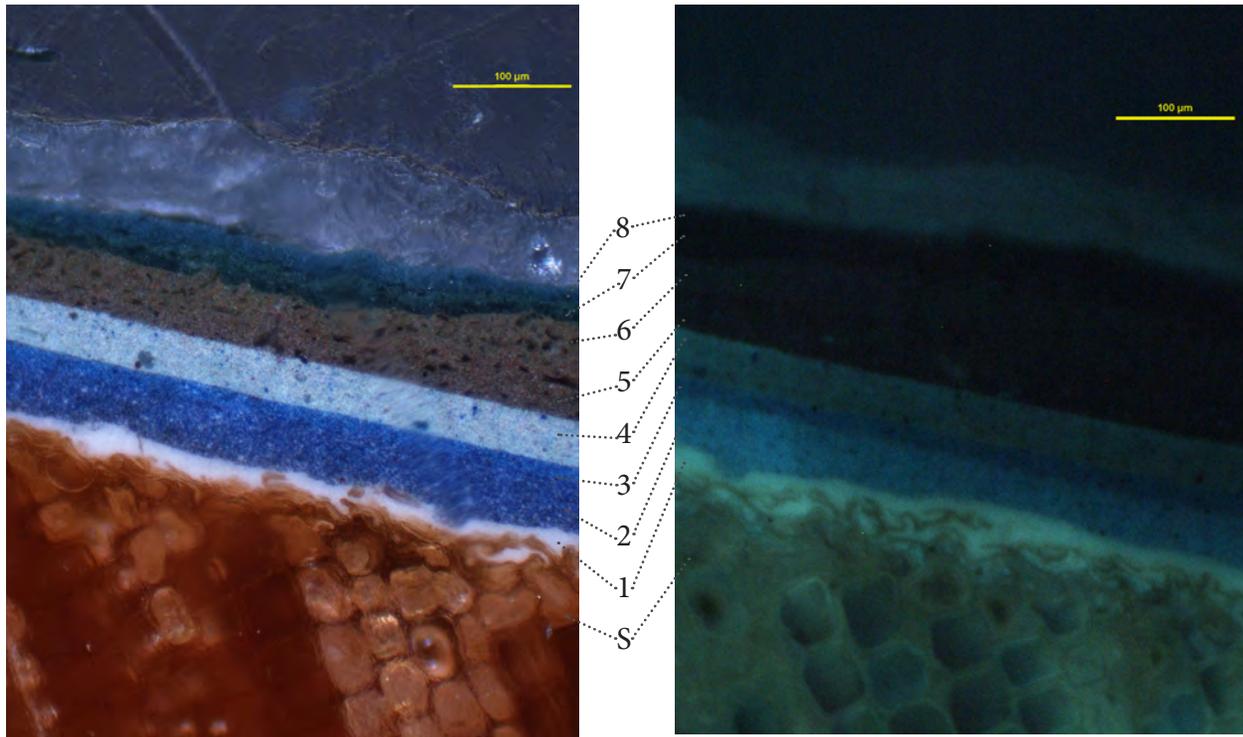
Architectural Finishes Analysis of GC6

<i>Microscopy Metadata</i>				
Location	Sampled By	Sampling Date	Analyzed By	Date
Guest Lodge JL-26. East elevation. Room 607. Window bottom sash exterior.	Nicole M. Deplet	7/5/2016	Cesar Bagues Araba Prah	11/29/2016
Microscope	Light Source	Filters	Camera	Magnification
Nikon Alphahot YS2	Visible: reflected quart halogen UV: Nikon mercury lamp	Daylight	Nikon DS Fi-1 camera NIS Elements BR software	10x
Notes				
Substrate	Wood			
Layer 1	White primer (possibly House Paint Exterior Primer as mentioned in specs)			
Layer 2	Purple ultramarine blue coating			
Layer 3	Ultramarine blue coating			
Layer 4	Light blue coating			
Layer 5	Brown green coating			
Layer 6	Brown green coting			
Layer 7	Dark green coating			
Layer 8	Blue green coating

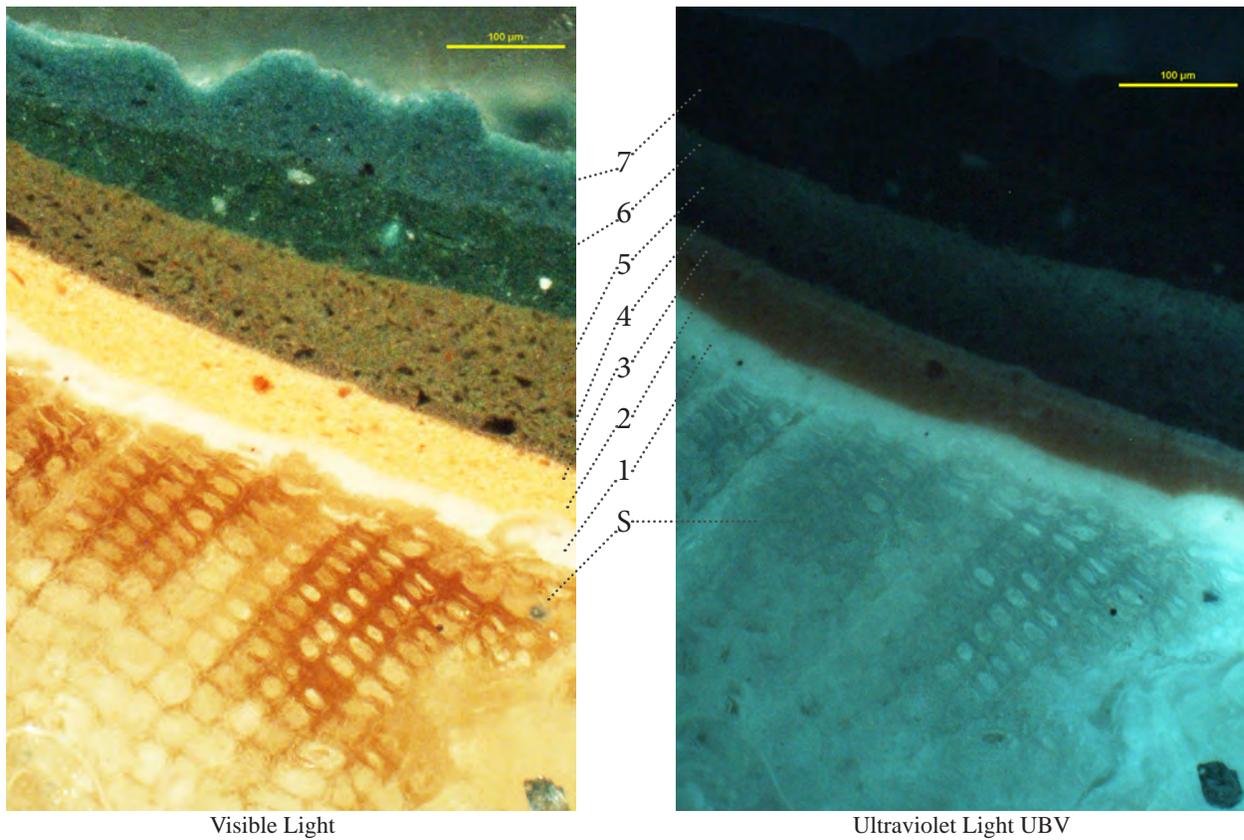
Architectural Finishes Analysis of GC7

<i>Microscopy Metadata</i>				
Location	Sampled By	Sampling Date	Analyzed By	Date
Guest Lodge JL-26. East elevation. Room 609. Window bottom sash exterior.	Araba Prah	7/5/2016	Cesar Bagues Araba Prah	11/29/2016
Microscope	Light Source	Filters	Camera	Magnification
Nikon Alphahot YS2	Visible: reflected quart halogen UV: Nikon mercury lamp	Daylight	Nikon DS Fi-1 camera NIS Elements BR software	10x
Notes				
Substrate	Wood			
Layer 1	White primer (possibly House Paint Exterior Primer as mentioned in specs)			
Layer 2	Light orange/salmon coating			
Layer 3	Light orange/salmon coating			
Layer 4	Dirt			
Layer 5	Brown green coating			
Layer 6	Dark green coating			
Layer 7	Blue green coating

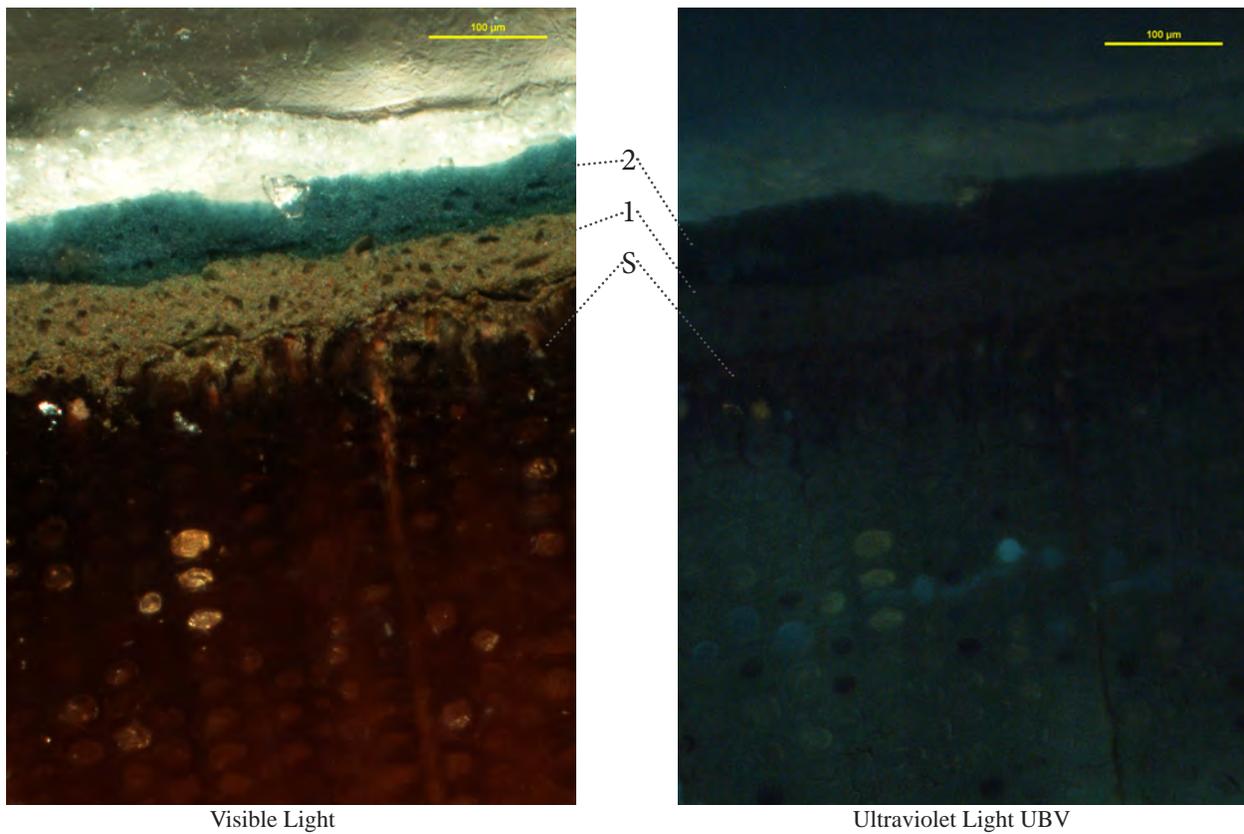
Architectural Finishes Analysis of GC8

<i>Microscopy Metadata</i>				
Location	Sampled By	Sampling Date	Analyzed By	Date
Guest Lodge JL-26. East elevation. Rafter.	Cesar Bargues	7/6/2016	Cesar Bargues Araba Prah	12/16/2016
Microscope	Light Source	Filters	Camera	Magnification
Nikon Alphahot YS2	Visible: reflected quart halogen UV: Nikon mercury lamp	Daylight	Nikon DS Fi-1 camera NIS Elements BR software	10x
Notes				
Substrate	Wood			
Layer 1	Brown green coating			
Layer 2	Blue green coating

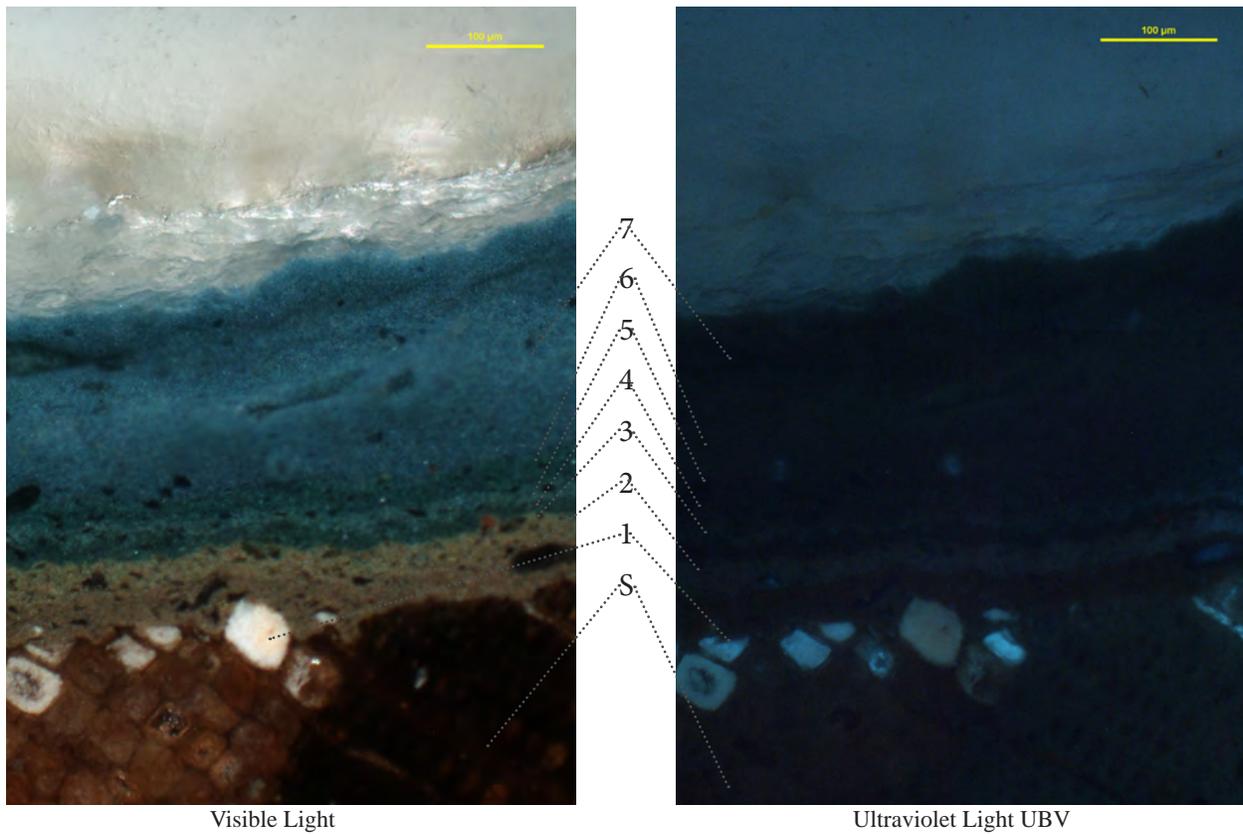
Architectural Finishes Analysis of GC9

<i>Microscopy Metadata</i>				
Location	Sampled By	Sampling Date	Analyzed By	Date
Guest Lodge JL-26. East elevation. Room 609. Canopy upright.	Nicole M. Deplet	7/7/2016	Cesar BARGUES Araba Prah	12/16/2016
Microscope	Light Source	Filters	Camera	Magnification
Nikon Alphahot YS2	Visible: reflected quart halogen UV: Nikon mercury lamp	Daylight	Nikon DS Fi-1 camera NIS Elements BR software	10x
Notes				
Substrate	Wood			
Layer 1	White primer coating (residue)			
Layer 2	Brown green coating			
Layer 3	Light brown green coating			
Layer 4	Dark green coating			
Layer 5	Dark green coating			
Layer 6	Dark green coating			
Layer 7	Blue green coating

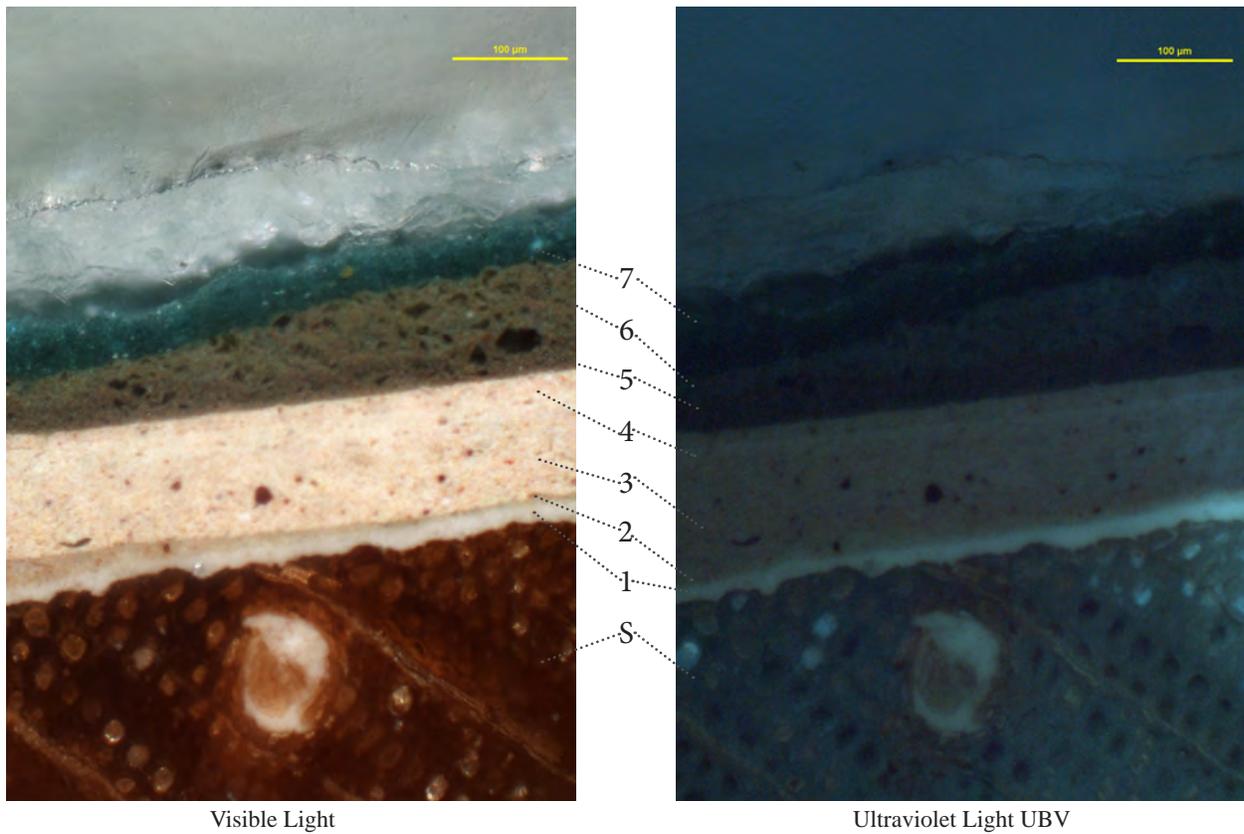
Architectural Finishes Analysis of GC10

<i>Microscopy Metadata</i>				
Location	Sampled By	Sampling Date	Analyzed By	Date
Guest Lodge JL-26. East elevation. Room 609. Window mullion.	Araba Prah	7/8/2016	Cesar BARGUES Araba Prah	12/16/2016
Microscope	Light Source	Filters	Camera	Magnification
Nikon Alphahot YS2	Visible: reflected quart halogen UV: Nikon mercury lamp	Daylight	Nikon DS Fi-1 camera NIS Elements BR software	10x
Notes				
Substrate	Wood			
Layer 1	White primer coating			
Layer 2	Beige coating			
Layer 3	Light beige coating			
Layer 4	Light beige coating			
Layer 5	Brown green coating			
Layer 6	Light brown green coating			
Layer 7	Blue green coating

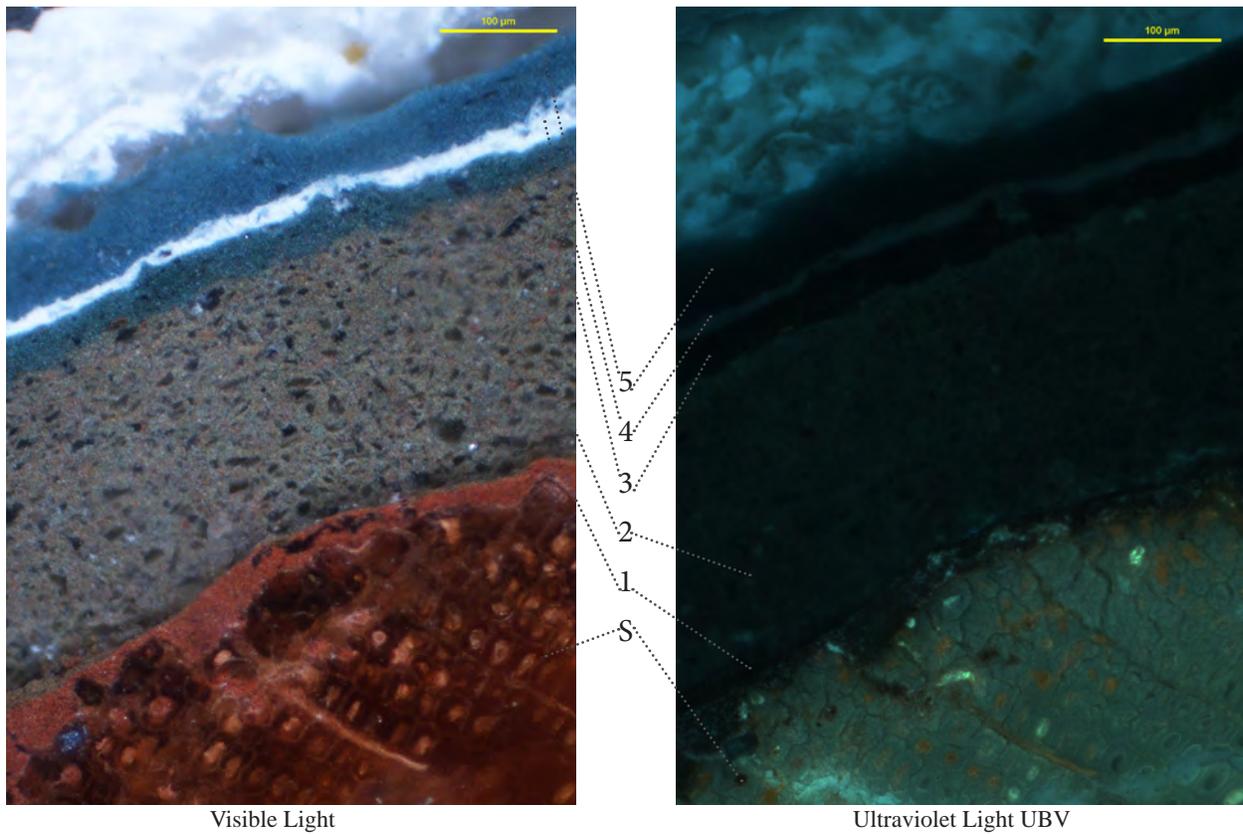
Architectural Finishes Analysis of ED1

<i>Microscopy Metadata</i>				
Location	Sampled By	Sampling Date	Analyzed By	Date
Employee Recreation Hall. Southwest Elevation. Rafter.	Nicole M. Deplet	7/14/2016	Cesar Bagues Araba Prah	11/29/2016
Microscope	Light Source	Filters	Camera	Magnification
Nikon Alphahot YS2	Visible: reflected quart halogen UV: Nikon mercury lamp	Daylight	Nikon DS Fi-1 camera NIS Elements BR software	10x
Notes				
Substrate	Wood			
Layer 1	Reddish brown coating			
Layer 2	Brown green coating			
Layer 3	Blue green coating			
Layer 4	White coating			
Layer 5	Blue green coating

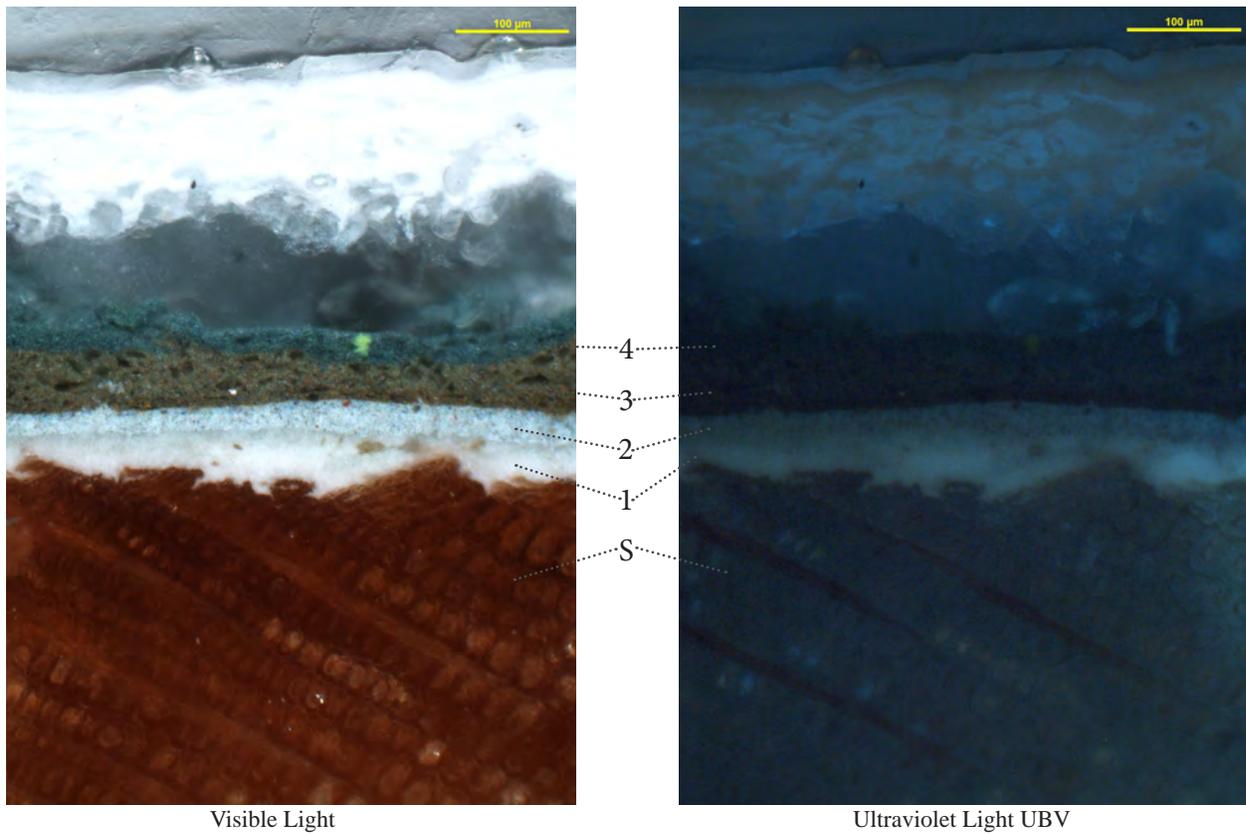
Architectural Finishes Analysis of ED2

<i>Microscopy Metadata</i>				
Location	Sampled By	Sampling Date	Analyzed By	Date
Dorm 3. Northwest elevation. Window sash exterior.	Araba Prah	7/14/2016	Cesar BARGUES Araba Prah	11/29/2016
Microscope	Light Source	Filters	Camera	Magnification
Nikon Alphahot YS2	Visible: reflected quart halogen UV: Nikon mercury lamp	Daylight	Nikon DS Fi-1 camera NIS Elements BR software	10x
Notes				
Substrate	Wood			
Layer 1	White primer coating			
Layer 2	Light blue coating			
Layer 3	Brown green coating			
Layer 4	Blue green coating

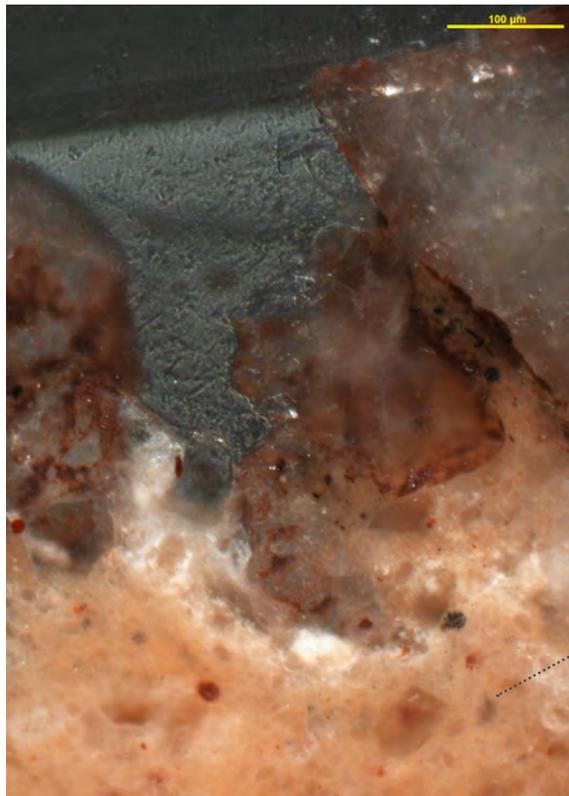
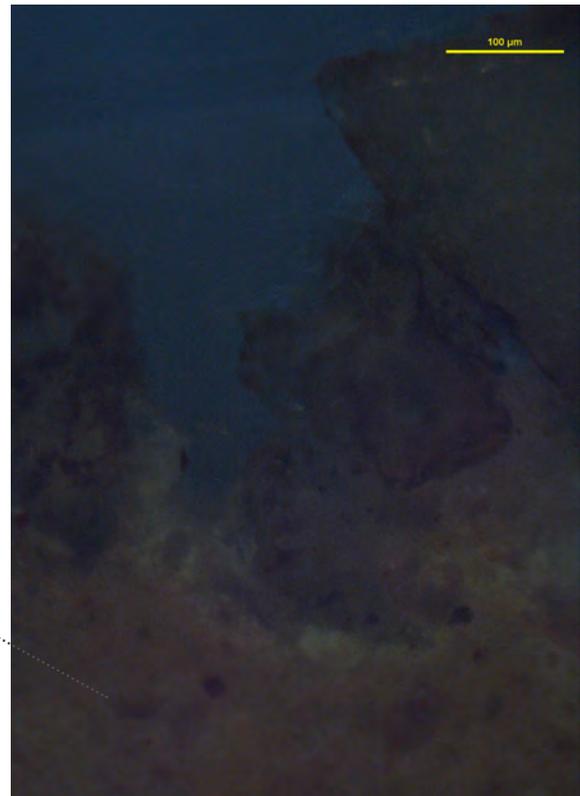
Architectural Finishes Analysis of SD1

<i>Microscopy Metadata</i>				
Location	Sampled By	Sampling Date	Analyzed By	Date
JL-45 Dorm 3. North-west elevation.	Cesar Bagues	7/4/2016	Cesar Bagues Araba Prah	12/16/2016
Microscope	Light Source	Filters	Camera	Magnification
Nikon Alphahot YS2	Visible: reflected quart halogen UV: Nikon mercury lamp	Daylight	Nikon DS Fi-1 camera NIS Elements BR software	10x
Notes				
Substrate 1	Grey bulk layer (outside of frame) with coarse mineral inclusions			
Finish	Pink grout layer with coarse mineral inclusions-John Manville Autumn Brown Shingle

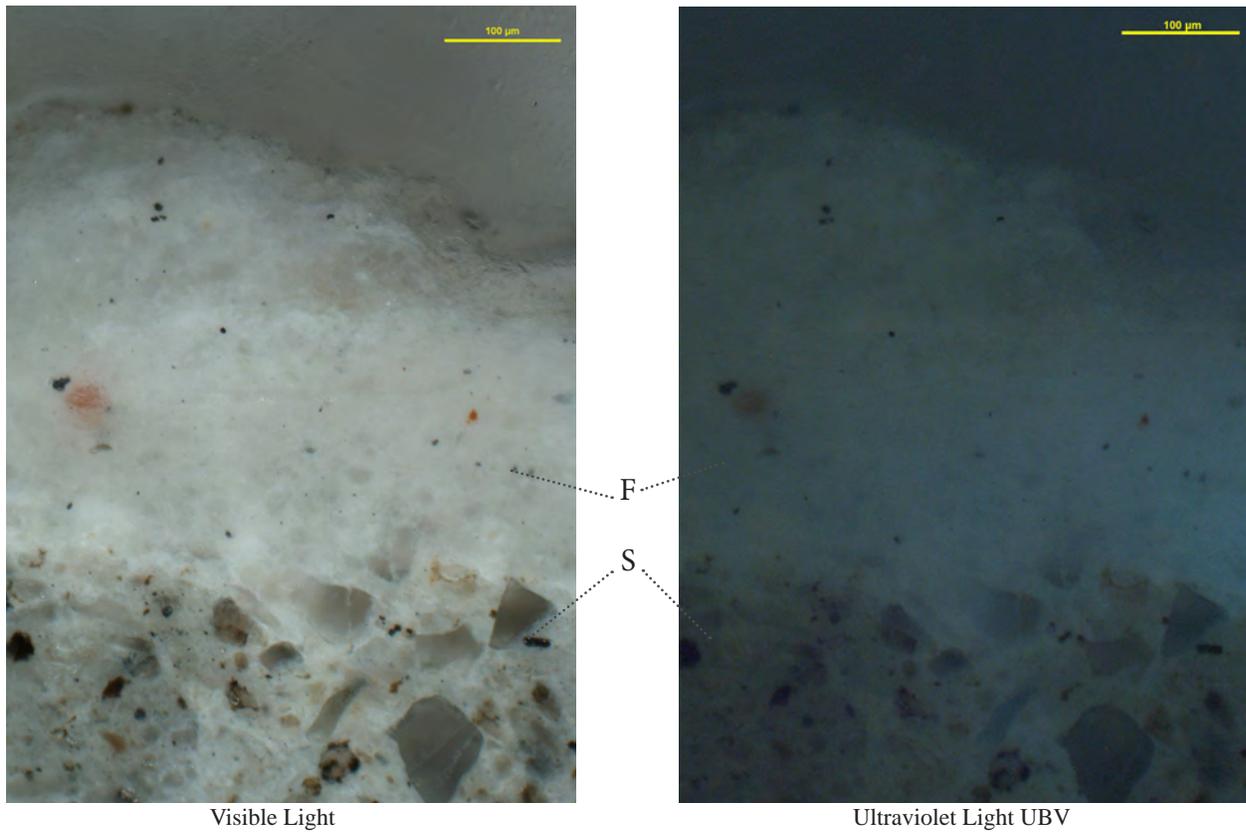
Architectural Finishes Analysis of SD2

<i>Microscopy Metadata</i>				
Location	Sampled By	Sampling Date	Analyzed By	Date
JL-43 Staff 10, 12, 14 & 16. North Elevation.	Cesar BARGUES	7/4/2016	Cesar BARGUES Araba Prah	11/29/2016
Microscope	Light Source	Filters	Camera	Magnification
Nikon Alphahot YS2	Visible: reflected quart halogen UV: Nikon mercury lamp	Daylight	Nikon DS Fi-1 camera NIS Elements BR software	10x
Notes				
Substrate	Grey bulk layer with coarse mineral inclusions			
Finish	White grout layer with coarse mineral inclusions-John Manville Silver Grey Shingles

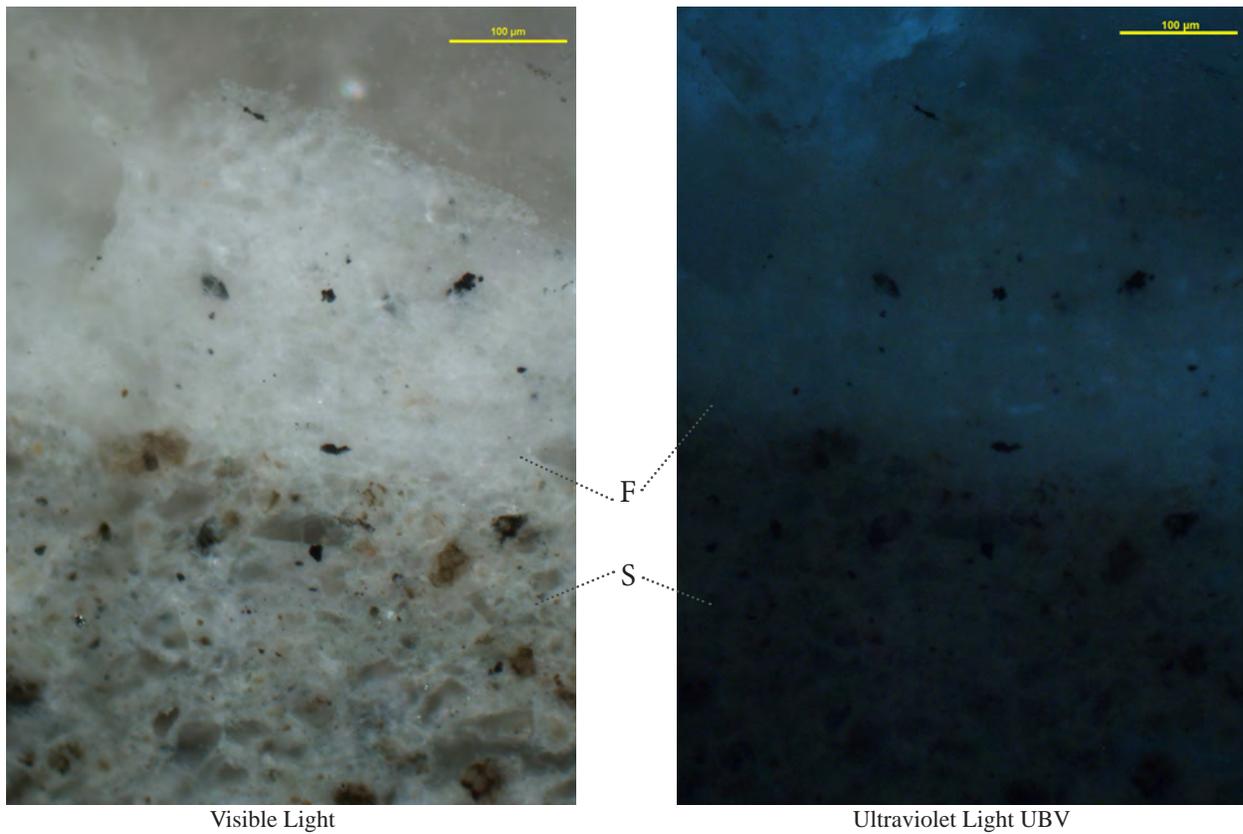
Architectural Finishes Analysis of SD3

<i>Microscopy Metadata</i>				
Location	Sampled By	Sampling Date	Analyzed By	Date
Guest Lodge JL-26. East elevation.	Cesar Bagues	7/4/2016	Cesar Bagues Araba Prah	11/29/2016
Microscope	Light Source	Filters	Camera	Magnification
Nikon Alphahot YS2	Visible: reflected quart halogen UV: Nikon mercury lamp	Daylight	Nikon DS Fi-1 camera NIS Elements BR software	10x
Notes				
Substrate	Grey bulk layer with coarse mineral inclusions			
Finish	White grout layer with coarse mineral inclusions-John Manville Weathered Grey Shingle

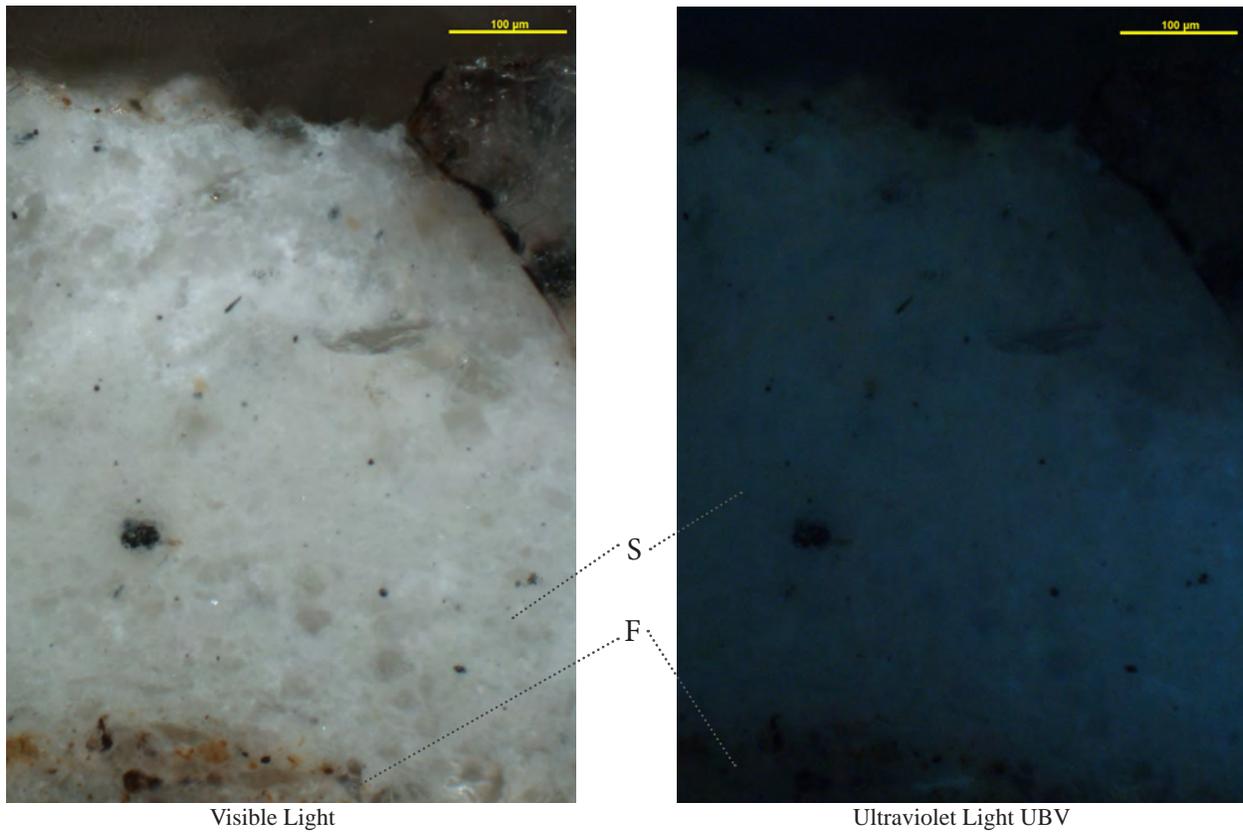
Architectural Finishes Analysis of SD4

<i>Microscopy Metadata</i>				
Location	Sampled By	Sampling Date	Analyzed By	Date
JL-47 Dorm 7.	GTLC Staff	6/30/2016	Cesar Bagues Araba Prah	11/29/2016
Microscope	Light Source	Filters	Camera	Magnification
Nikon Alphahot YS2	Visible: reflected quart halogen UV: Nikon mercury lamp	Daylight	Nikon DS Fi-1 camera NIS Elements BR software	10x
Notes				
Substrate	Grey bulk layer with coarse mineral inclusions			
Finish	White grout layer with coarse mineral inclusions-John Manville Autumn Brown Shingle

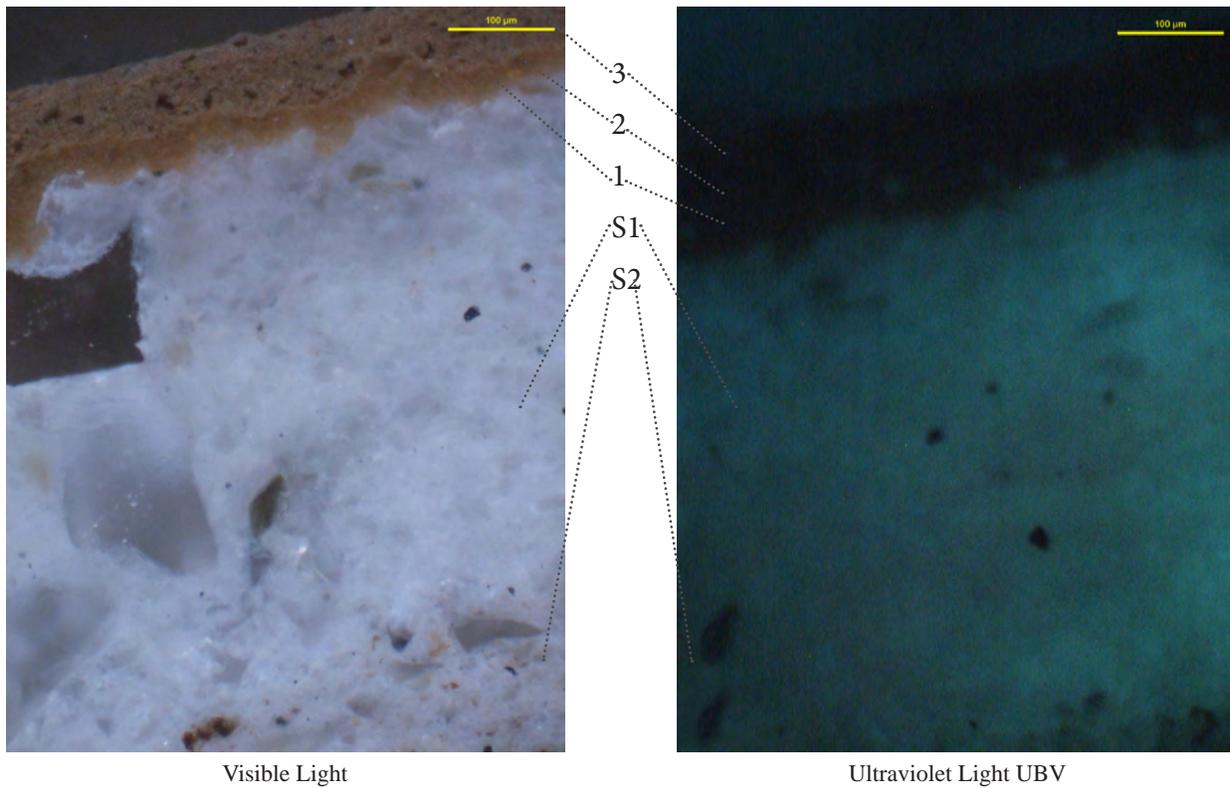
Architectural Finishes Analysis of SD5

<i>Microscopy Metadata</i>				
Location	Sampled By	Sampling Date	Analyzed By	Date
Guest Lodge JL-28	Cesar BARGUES	7/1/2016	Cesar BARGUES Araba Prah	11/29/2016
Microscope	Light Source	Filters	Camera	Magnification
Nikon Alphahot YS2	Visible: reflected quart halogen UV: Nikon mercury lamp	Daylight	Nikon DS Fi-1 camera NIS Elements BR software	10x
Notes				
Substrate 1	Grey bulk layer with coarse mineral inclusions			
Substrate 2	White grout layer with coarse mineral inclusions-John Manville Silver Grey Asbestos Shingle			
Layer 1	Light brown coating			
Layer 2	Light brown coating			
Layer 3	Light brown coating

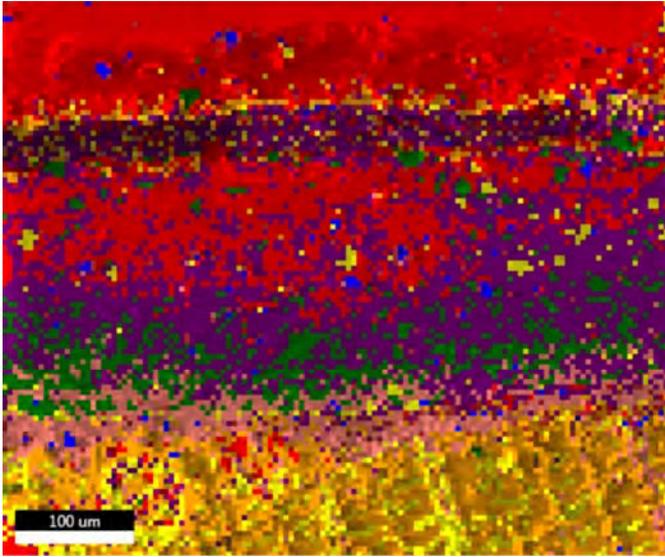
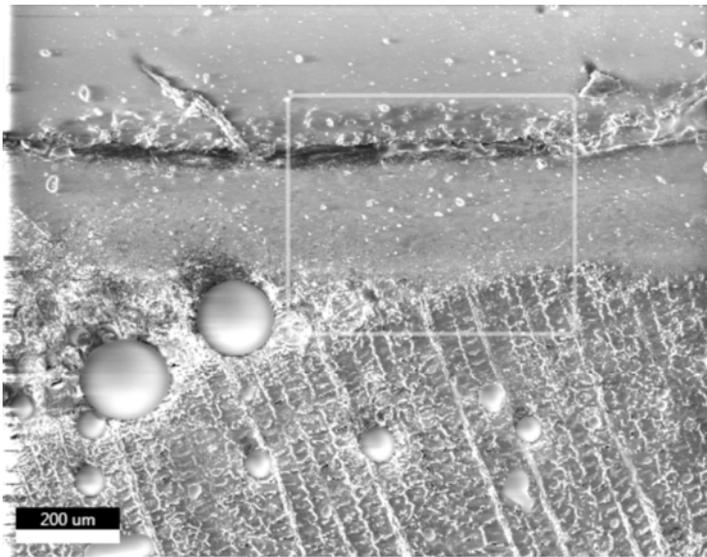
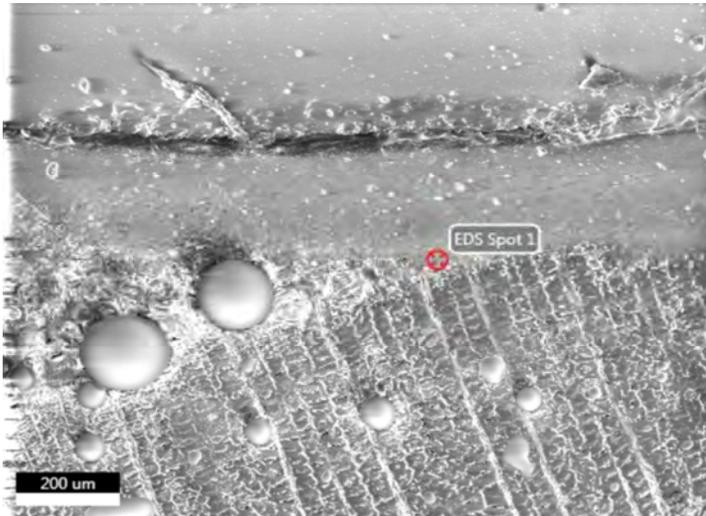
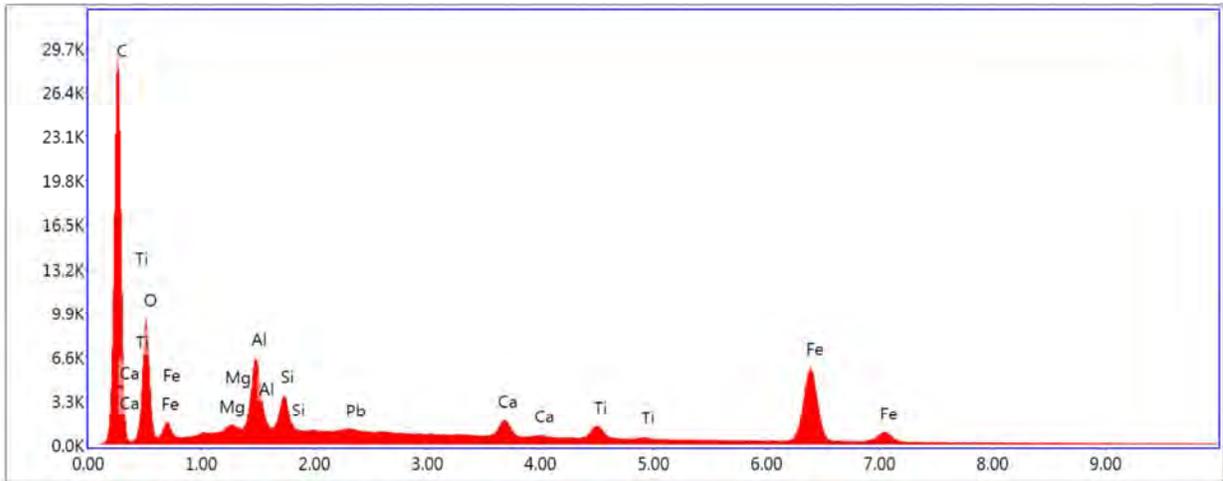
Author: prnuser
Creation: 12/21/2016
Sample Name: GC4
Area 1

In sample GC4 an orange autofluorescent material in the wood cells of the substrate may suggest that shellac was used to seal the wood surfaces before applying the red brown coating (Munsell code: 7.5 R 3/6). There is no mention of this in Underwood's specifications. Later in time, the red brown coating was covered with a brown green paint. A light brown green, brown green, and blue green finish was applied in later painting campaigns. In GC8, a sample from the east elevation, the brown stain is absent. As evidenced by the condition of the wood substrate surface, this circumstance is attributable to stripping. Nonetheless, in the dorm area, another sample (ED1) shows the same initial red brown paint, thus, confirming this is the original finish across the complex.

SEM-EDS of the brown stain, indicates presence of iron (Fe), calcium (Ca), aluminum (Al), silicon (Si), Titanium (Ti), and minor traces of magnesium (Mg) and lead (Pb). These chemical elements suggest that the red brown coating was primarily based on an iron oxide pigment.

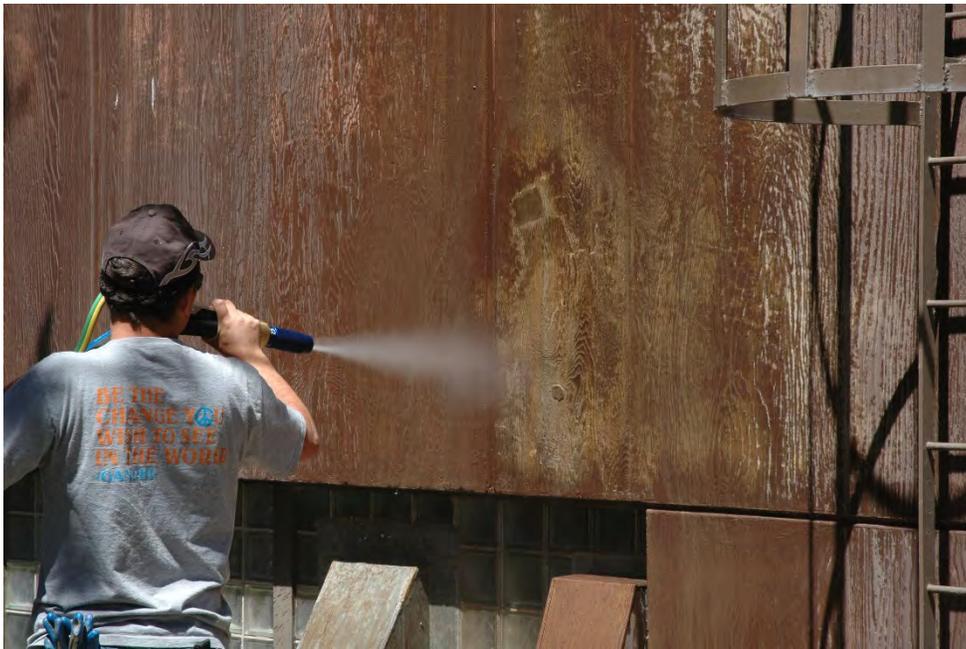
Fig. 62. Contractor performing the removal with EcoQuip® EQm

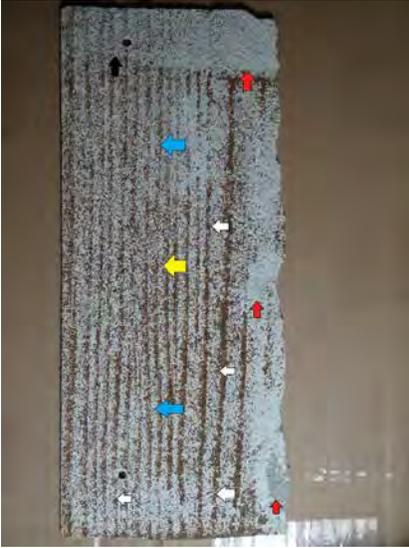
Fig. 64. This photo shows the area where a chemical stripper was used (blue arrows). A total of 4 application procedures were required to obtain the final finish. The yellow arrow shows the slightly cloudy area where acetone was used to further cleaning an area where the chemical stripper was used. The acetone seemed to have no effect on the final results other than giving a cloudy finish to an otherwise clean appearance.

After a visual assessment, it appears that the sodium bicarbonate is gentler with the substrate. However, although it would seem to be a possible solution, the volume of soda required and the amount of time needed to accomplish the results you may desire are more than likely cost prohibitive. Also, this material is hazardous for the vegetation. Total fallout asbestos residue as a result of using microblasting techniques was not assessed. Total, negative air containment would be required initially to perform a mock up for blasting at least until a negative exposure assessment is obtained, if possible. Further testing to assess the potential hazards and fine-tune the methodology needs to be done.
