**GEORGE NAKASHIMA
ARTS BUILDING AND CLOISTER
CONSERVATION & MANAGEMENT PLAN**

Project Director
Frank G. Matero

Prepared by
Cesar Bargues Ballester

Penn Praxis/The Architectural Conservation Laboratory
School of Design
University of Pennsylvania
January 30, 2017

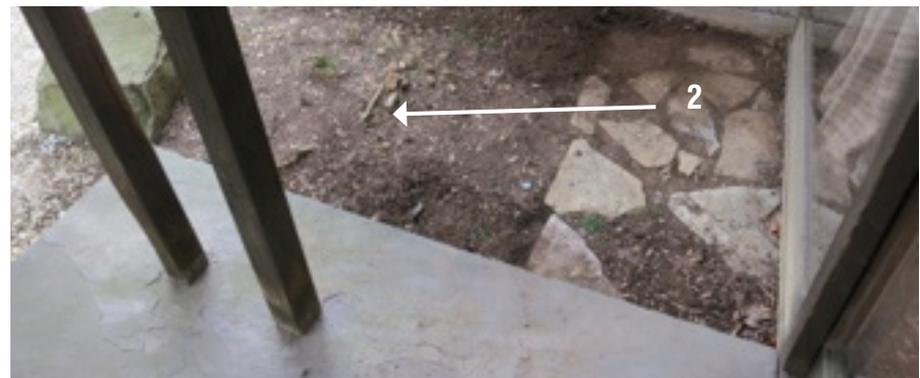
South Patio and Pond Planting, Historic (1967) and Current Conditions (2016):

1. Planned vegetation that conveys original design intent, now mature.
2. Formerly planted vegetation that conveys design intent that is currently missing.

On the other hand, the missing deciduous tree and small evergreen shrub constitute voids that violate the design intent of the Pond garden. The dominance of the Eastern red cedar and the absence of the formerly larger and more dominant deciduous tree has altered the design intent.

While it would not be advisable to remove or otherwise damage the Eastern red cedar at present (and indeed all attempts should be made to maintain its health), if in the future the red cedar were to die, original design intent through the planting of a large deciduous tree and a small red cedar in their historic relationship could be restored.

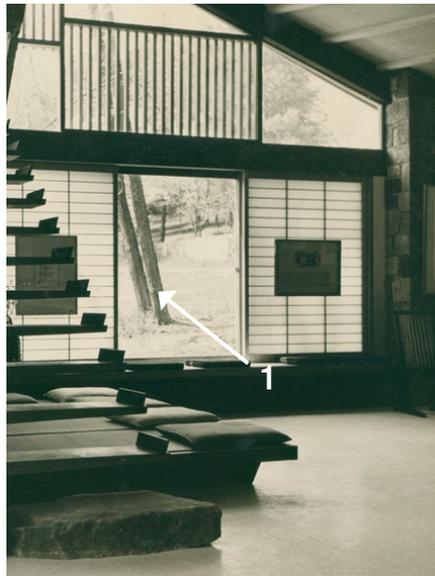
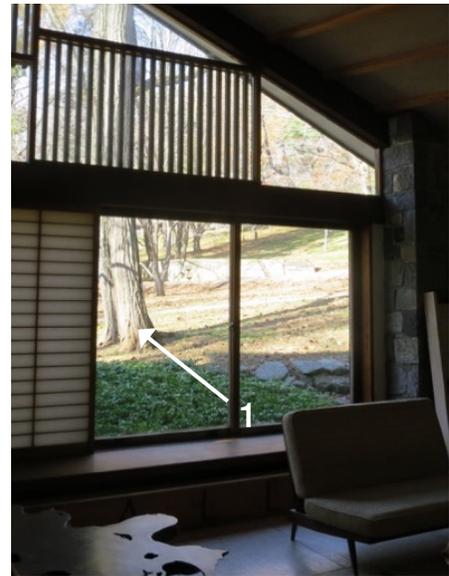
West-side Lawn, Historic and Current Conditions:

Black locust trees visible from inside the Arts Building, contributing to the Arts Building landscape (1). These twinned trees are continuing to grow well.

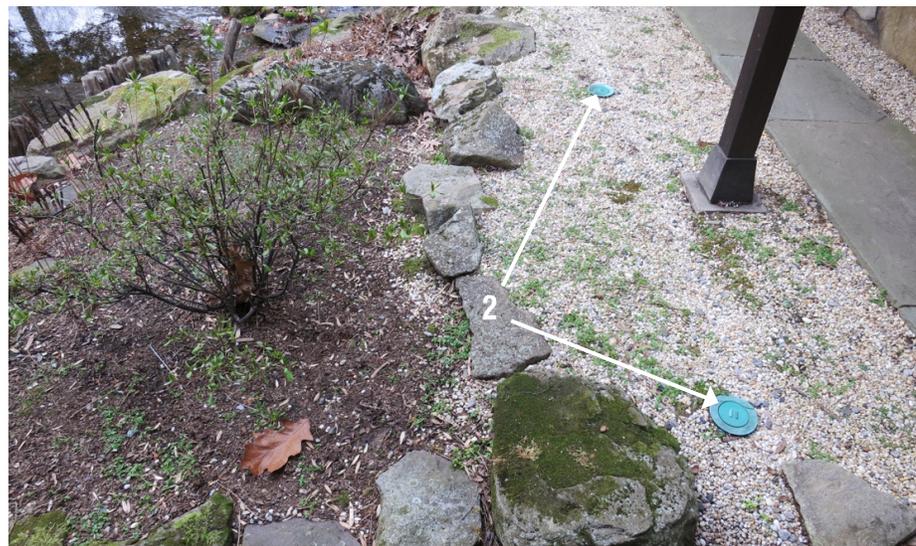
Gravel and planting areas around perimeter of Arts Building and Cloister are dotted with instances of the subterranean termite control system (2), which are not part of the original design intent and are non-contributing.

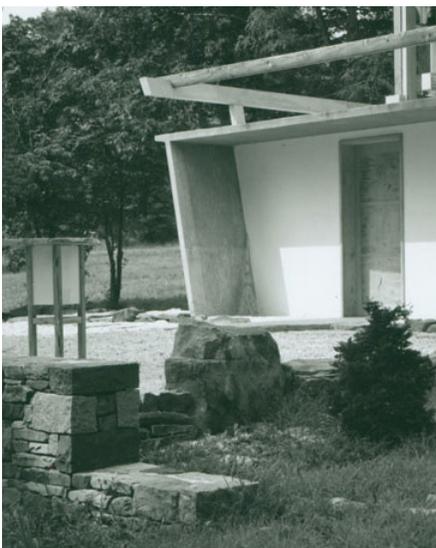
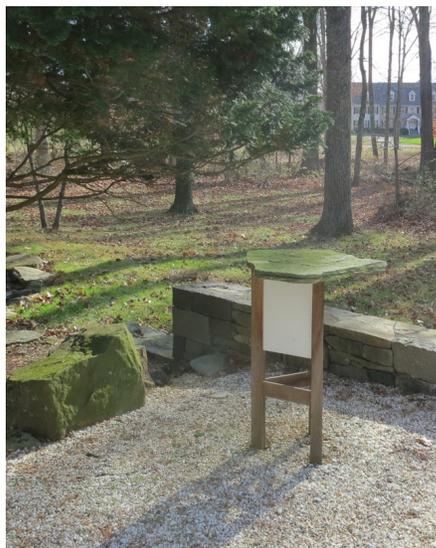
Wooden Lantern, Historic (1967) and Current Conditions (2016)

The wooden lantern is of a design that appears in several other locations on the George Nakashima Woodworker's Complex property, and is an important contributing element of the Arts Building landscape. The lantern on the South Patio was recently remade, following George Nakashima's original design, by craftsmen in the wood shop.

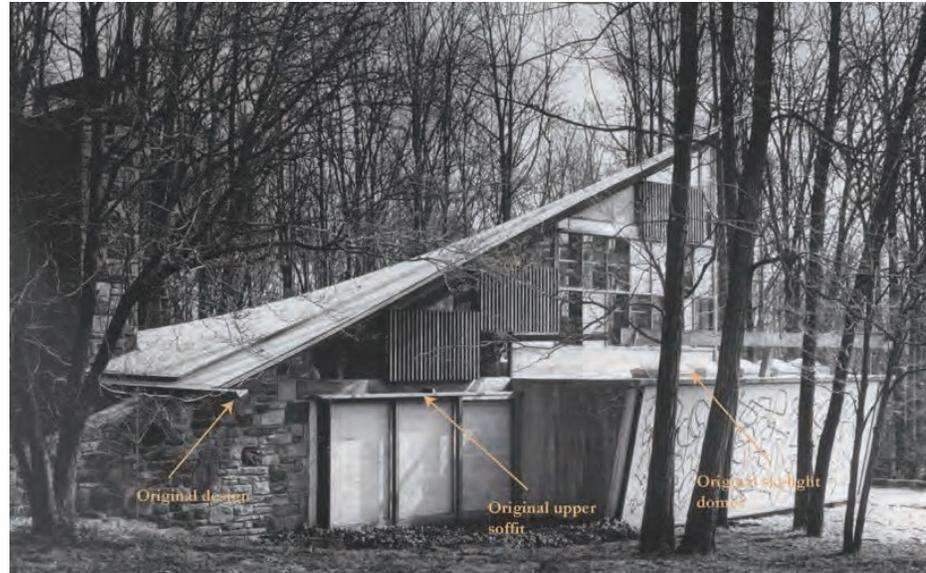
Fig. 5.1. View of the west elevation from the north. Note the original gutters, the original head in the sliding window, and the skylight domes. The concrete floor of the terrace is exposed.

In 1994, another major alteration to the exterior was the repair of the window on the west elevation. This repair included the installation of a copper canopy designed by Mira Nakashima, which would conceal both the white eastern pine lintel and the head of the original window (see figure 5.1.).

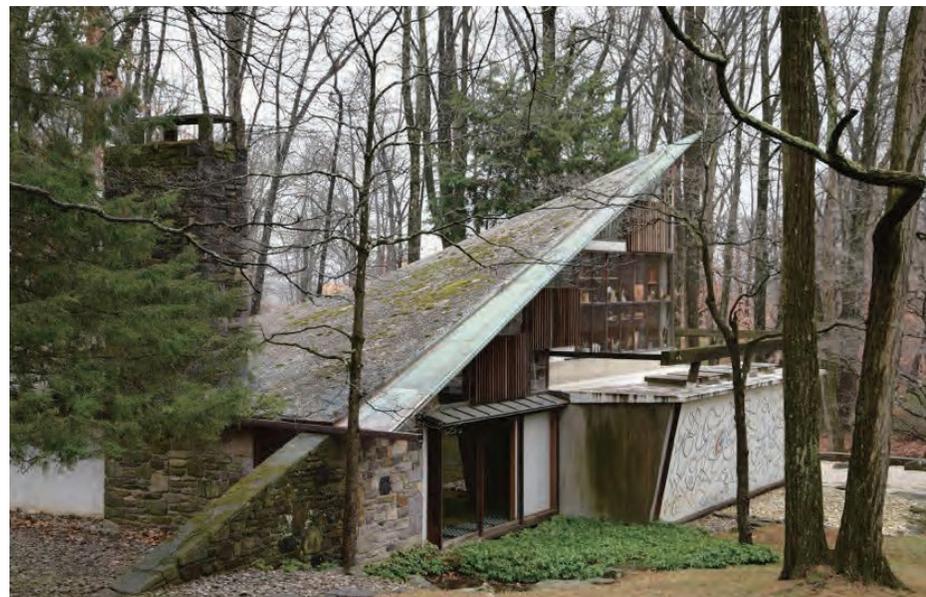
Fig. 5.2. Northwest elevation view. Date: December 2104. Note the new gutter system, the copper canopy, and the new flat skylights. The copper patina is indicative of new and old flashing campaigns. The concrete floor of the terrace exhibits a waterproofing coating painted in white. Landscape features have been changed over time.

To control leaks, the original exposed concrete terrace was waterproofed with a fiberglass membrane in a first campaign and painted white with an epoxy based coating in a second campaign. This intervention disrupted the original finish and aesthetic qualities of the exposed concrete, although it provided a watertight seal that protects the interior from moisture penetration.

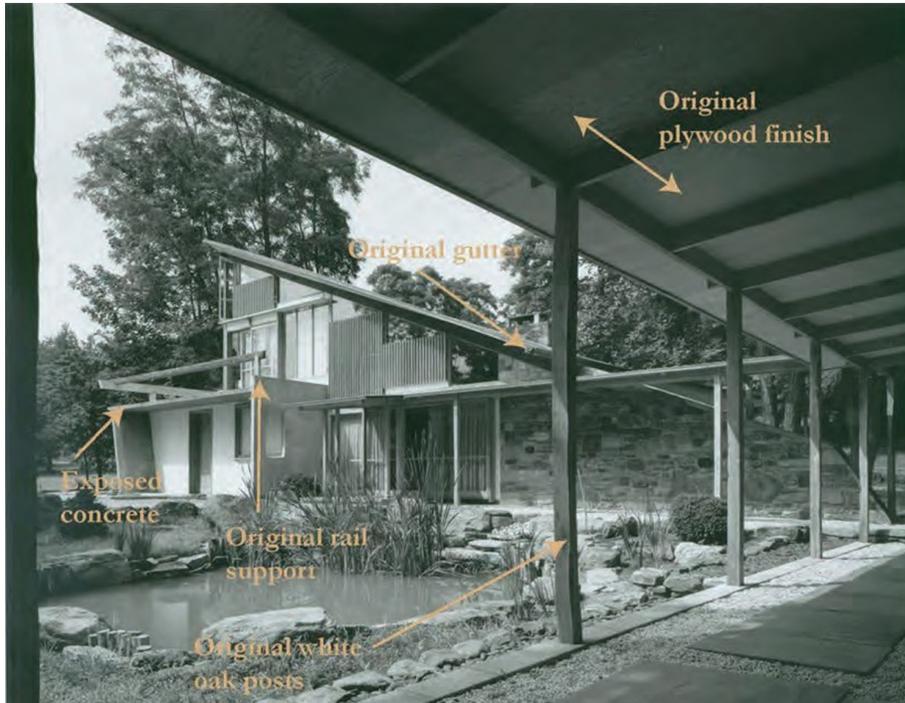
On the upper level, the wooden rail support appears to have been replaced in kind. In addition, the sliding window sill was replaced because it was rotten.³¹ Above it, the thin wall was cleaned and repaired with a similar finish. (Fig. 5.3)

Fig. 5.3. South elevation view. Date: 1965. Note the original black locust posts, plywood soffit finish, rail support, and gutter. Source: George Nakashima Woodworker Archives.

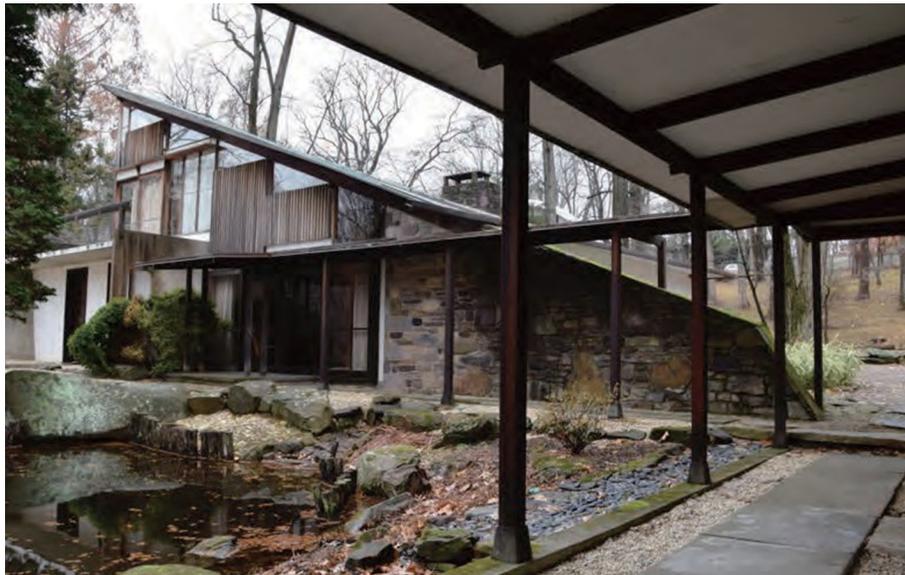
Unlike the original configuration, the new uprights rest upon ipe Japanese-inspired bases, which are a truncated square pyramid. This detail was modified presumably to discourage rot at the post base. Upper connecting joints were replicated to join new and original members.

Fig. 5.4. South elevation view. Date: December 2014. Note the new gutter system, the new ipe posts upon ipe bases, and the opaque white paint covering the plywood soffit. As shown in Fig. 5.1, the concrete floor of the terrace has been waterproofed.

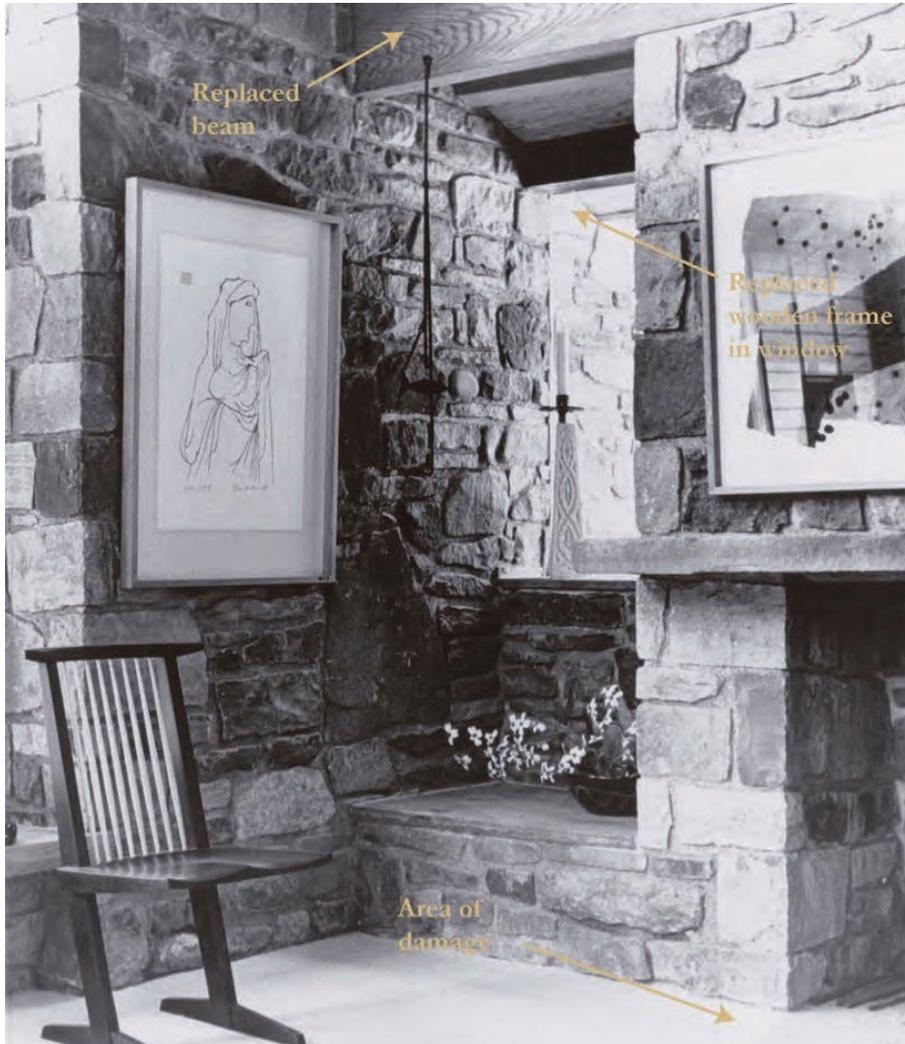
Above the fireplace, the lintel was replaced as a consequence of carpenter ant activity. Repair occurred to the adjacent window as well. Below, a 1967 photograph (fig. 5.5) partly shows the original lintel over the fireplace. As the wood was cut parallel to the grain direction and tangent to the growth rings, a wavy plain grain characterized this beam.

Fig. 5.5. Fireplace corner. Date: 1967. Author unknown. Source: George Nakashima Woodworker Archives.

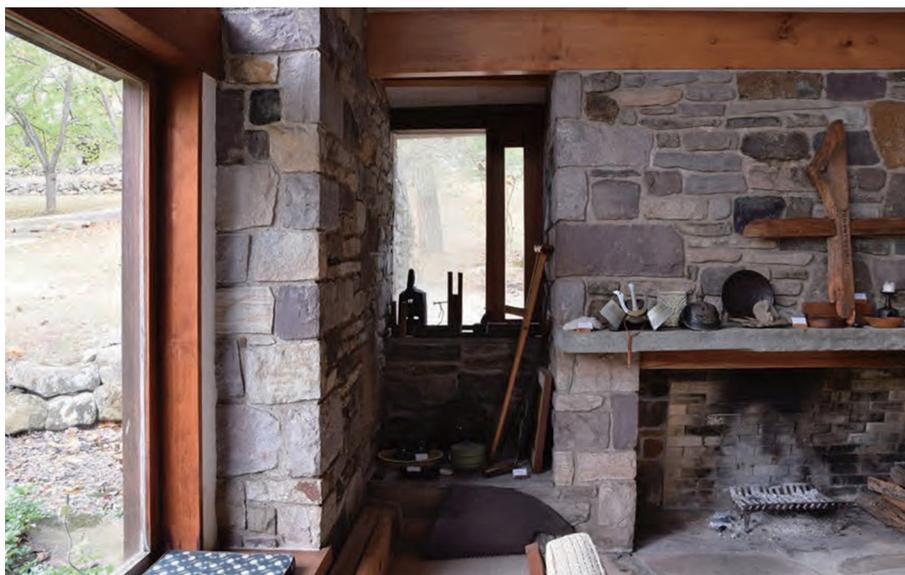
The grain figure of Nakashima's original fireplace lintel was undoubtedly selected in relation to the heavily patterned plywood ceiling, which is still visible. Although the replacement lintel reveals a sensitive repair, this visual relationship is now lost (fig. 5.6). Reportedly, the plywood deck along the north wall was replaced and repaired in kind to mend the deterioration caused by leaks. During this intervention, the skylight was also covered in the same manner as those in the exterior terrace.

Fig. 5.6. Current state of the fireplace corner. Date: November 2014.

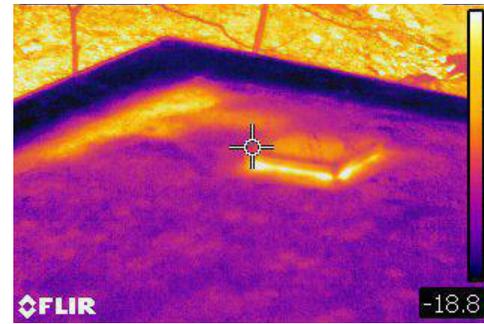
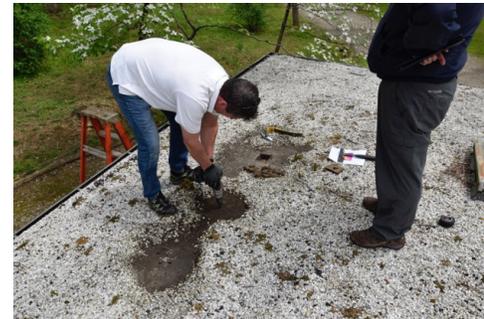
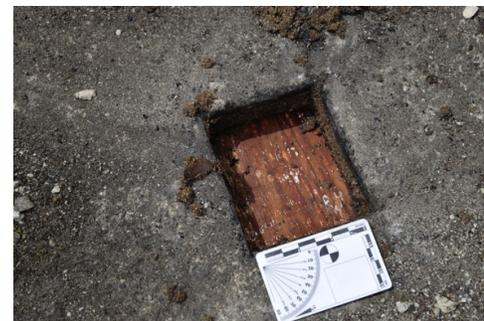
The investigation of the building envelope with an IRT Camera revealed a thermal anomaly on the north end of the hyperbolic paraboloid roof. Roof probes, approximately each two feet square, demonstrated the presence of moisture entrapped below the asphalt underlayment. The fiberboard insulation is saturated and the outer face of the plywood deck was visibly wet but not deteriorated. The area of damage is about 9'x14'.

Presumably, this condition is associated with a leak detected and repaired in the summer of 2015. This leak was caused by a roof puncture close to the north side of the skylight, where the ballast layer was unevenly distributed.

From top to bottom:
A. Infrared image of the northeast end of the hyperbolic paraboloid roof. February 15th, 2016.
B. Cutting plugs to investigate the roof. May 9th, 2016.
C. Saturated fiberboard insulation and wet surface of the plywood deck.

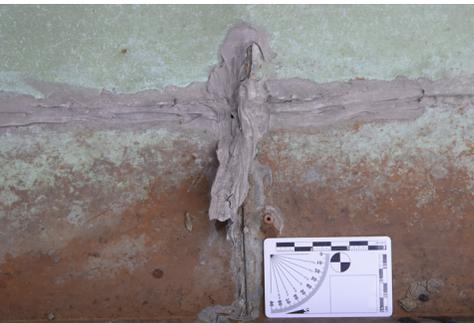
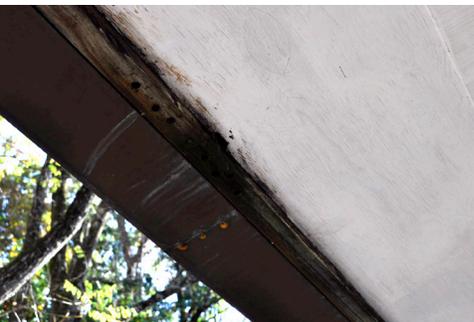
The copper gutters show crevice corrosion and galvanic corrosion in all the junctures because of direct contact between dissimilar metals: the steel nails and the copper sheet. If this type of corrosion continues, current leakage in the junctures will be expedited. Furthermore, there is noticeable damage because of impact to the gutter edges; a section has been deformed probably by fallen branches. The base exhibits damage by marble chips carried off by the snow melt and rainwater.

Above: Failing sealant and crack adjacent to a flashing juncture at the hyperbolic paraboloid roof eave on the west elevation. Below: Fascia and gutter at the hyperbolic paraboloid roof eave on the east elevation. Gray stains on the bottom of the gutter indicate water flowing between the gutter and the fascia. The fascia connection is rot, as the plywood edge. Note crevice corrosion and galvanic corrosion in the gutter juncture.

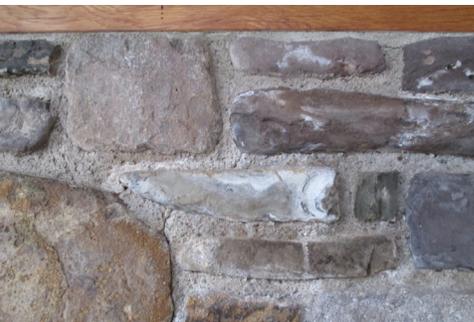
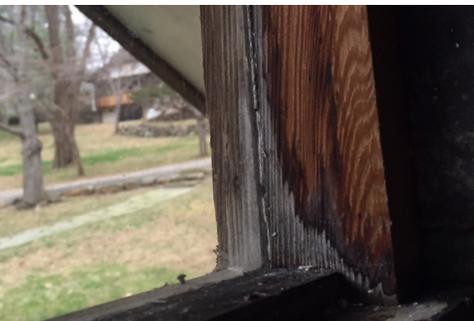
Above: Close up photograph of the "step cracking" above the mantle on the fireplace. Note efflorescence.

Below: Typical moisture stains on the wood frame

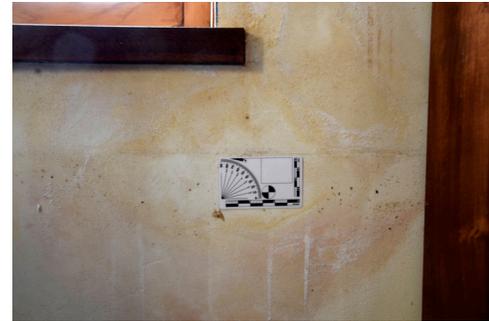
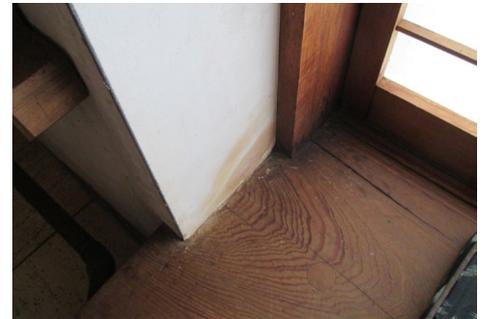
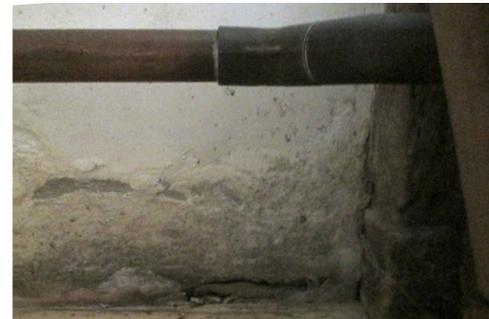
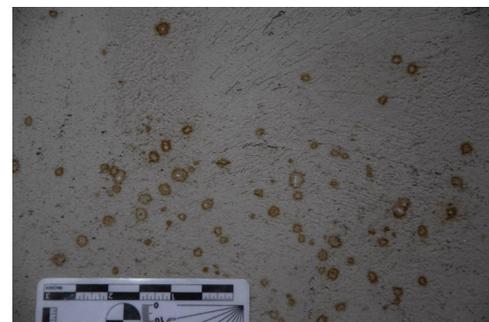
The walls plastered with Structolite™ show corrosion products in the form of small spots. The spots are typically reddish and display a whitish deposit on its center. SEM-EDS spectrum indicates the presence of aluminum (AL) and small traces of iron (FE) on the plaster. Presumably, the corrosion products could be related to the oxidation of these metallic constituents. SEM-EDS indicates also the presence of sulfur (S), calcium (Ca), and silicon (Si), typical elements present in the Plaster of Paris ($\text{CaSO}_4 \cdot 2\text{H}_2\text{O}$) and Quartz. Small traces of other chemical elements include phosphorus (P), potassium (K), magnesium (Mg), chlorine (CL), and sodium (Na).

- From top to bottom:
- A. Efflorescence and color alterations below the window sill. Source of moisture is likely water vapor that condensates on the window glass.
 - B. Moisture stain and color alteration on the left jamb of the window seat.
 - C. Disintegration and material loss visible in the stucco on the left side of the window seat.
 - D. Corrosion products on the plaster.

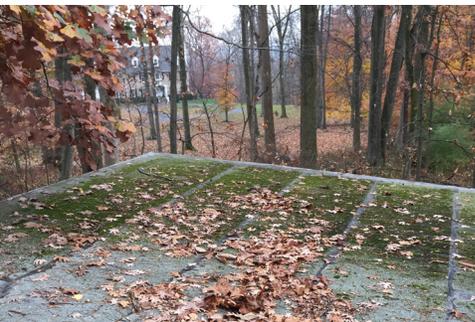
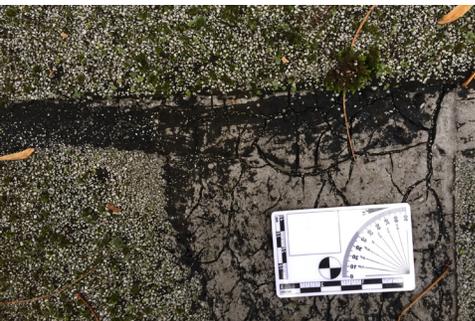
Above: View of the Cloister roof. Note moss growing on the granule surface membrane.
Below: Typical alligatoring visible on the sealants.

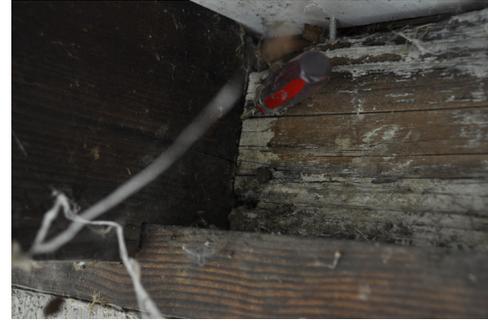
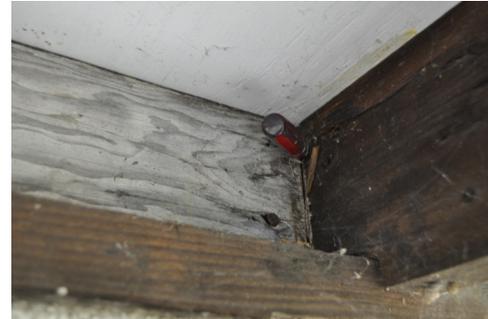
Fifth (above) and fourth (below) rafters are easily penetrated by an awl. Note horizontal checks and material loss in the first wood stop.

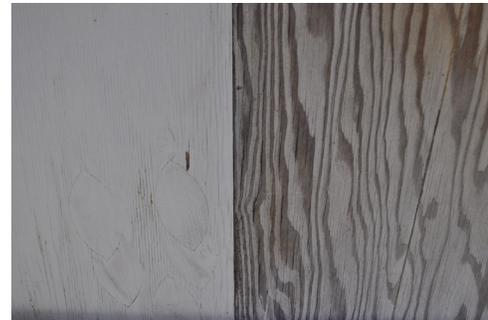
On the right, the plywood shows delamination of the outer face as well as checks. Note the contrast between the original translucent finish and the opaque white coating on the left.

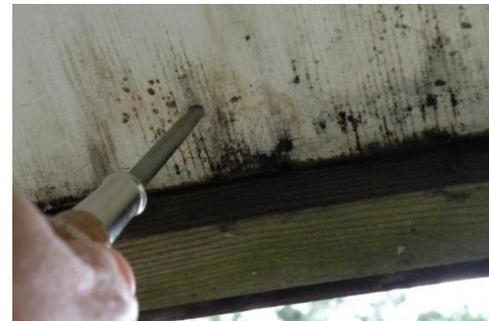
From top to bottom:
Figure 1. Sample removal location from the southwest corner post.
Figure 2. Fungal growth on the underside of the north railing.
Figure 3. Probing with an awl to determine the extent of deterioration in the plywood soffit on the Cloister.
Figure 4. Resistance drilling to identify the condition of an original porch post.

Internal decay and insect damage are often difficult to detect due to the lack of evidence on the exposed surface of the wood. Probing the wood with an awl enables rapid detection of voids in the wood just below the surface that may or may not be visible (Figure 3). It can also indicate the approximate depth of the deterioration. Visual inspection and probing provide a rapid means of identifying areas that may need further investigation or repair.

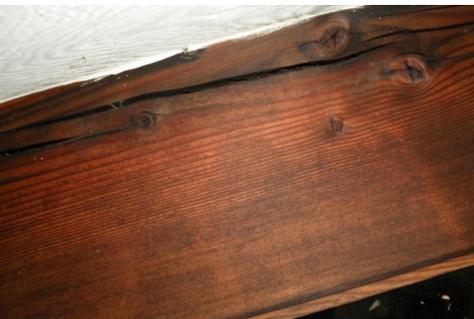
Below: Figure 5. Knots and slope of grain (indicated by the seasoning check) on the south edge beam.

characteristics such as knots and slope of grain (Figure 5). Knots and slope of grain tend to be the grade-limiting characteristics for lumber and timber in older buildings. Measurement of knots and slope of grain provides an indication of the allowable lumber grade for a given wood species. The visual grade provides essential data for structural analyses to assess the ability of the members to support current or future loading conditions and provides information critical for determining the extent of any necessary repairs. Visual grading was done on the west and south edge beams and the southwest corner post.

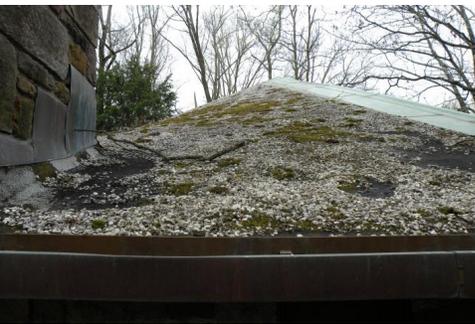
From top to bottom:
 Figure 7. Inconsistent depth of gravel.
 Figure 8. Patches of moss on the roof.
 Figure 9. Moss in-situ, with awl for scale.
 Figure 10. Moss overturned with the awl in approximately the same position as Figure 9. Note that the gravel is largely disconnected from the root

Although not constructed of wood, the condition of the roof covering directly impacts the condition and longevity of the wood elements below the roof, particularly the plywood diaphragm. An examination of the roof revealed that the gravel depth protecting the membrane was not consistent across the roof. In some areas, the gravel was missing and the membrane was exposed, leading to potential degradation due to exposure to ultraviolet light (Figure 7).

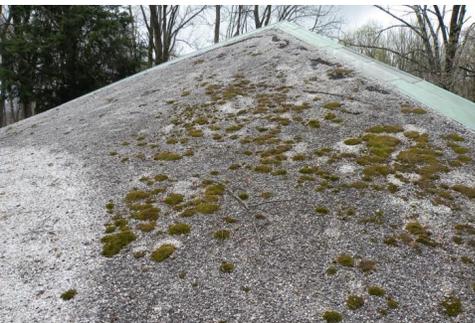
Several patches of moss were growing on the roof (Figure 8). Any biological growth on a roof is a concern due to moisture entrapment that can lead to breakdown of the membrane and roof sheathing due to root penetration, and result in leaks into the interior space. However, other than moisture entrapment, this is not the situation with the moss growing on the Arts Building roof. Several patches of moss that appear to be well-attached to the roof were found to only be loosely connected to the gravel without any attachment to the roof membrane. These patches could easily be overturned without even disrupting the gravel (Figures 9 and 10). The patches of moss should be removed periodically to prevent them from becoming established to the point where they gain roof penetration through the membrane and into the diaphragm below.

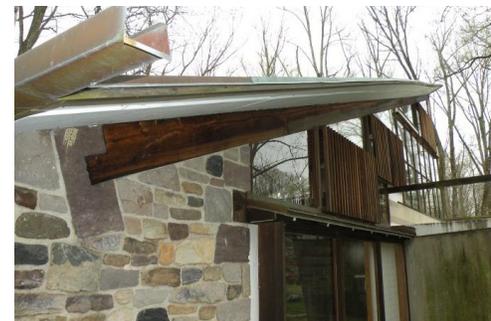
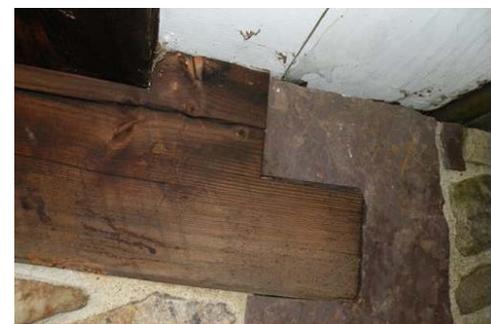
From top to bottom:
 Figure 11. Northeast corner showing the layered plywood used in the shell and the lumber used for the wall top plates.
 Figure 12. West elevation.
 Figure 13. West edge beam below the eave, as seen from below.
 Figure 14. Close up of the south edge beam at the east end. Note the notch detail into the stone is the same as the west edge beam seen in Figure 13.

The lower end of the tapered edge beams are notched into stones at the walls (Figures 13 and 14). Based on observed defects in the edge beams, there are no defects that would preclude them from being classified as Douglas-fir Select Structural, Beams and Stringers, in accordance with the Western Lumber Grading Rules (2011) published by the Western Wood Products Association. For allowable design values, the classification in the National Design Specification for Wood Construction would be Douglas fir – Larch Select Structural Beams and Stringers. The west edge beam has an unusual seasoning check (as opposed to a through-split) near the lower (north) end that is likely due to growth of the tree or milling of the beam and has not appeared to affect the performance of the beam over time.

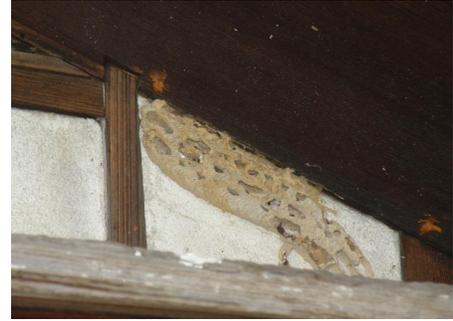
Left: Figure 15. South edge beam showing the depth of the eave that protects the edge beam.
 Right: Figure 16. Insect next on the surface of the south edge beam.

A large eave or soffit extends the roof beyond the edge beams affording some level of protection from the effects of precipitation and, to a lesser degree, ultraviolet light (Figure 15). There is evidence of minor deterioration of some minor wooden elements by insects or insect nests were observed on the Arts Building, including on the south edge beam (Figure 16).

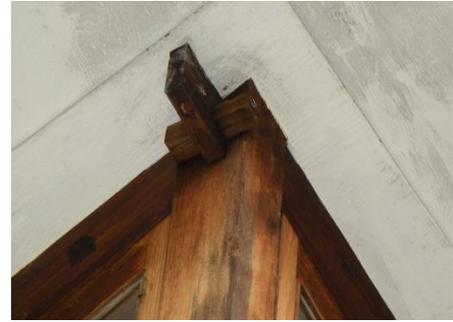
Left: Figure 17. Southwest corner post where the south and west edge beams connect.
 Right: Figure 18. Close-up of the connection between the south and west edge beams and the corner post.

the wood assessment, heavy rain made inspection of the top of the corner post and the connections to the edge beams unsafe to access without use of equipment such as a boom lift. Visual inspection of the connection from below did not reveal any sign of deterioration that would compromise the connection (Figure 18); however, the lack of redundancy in the roof supports suggests that the connection and wood condition be assessed to ensure that the structural integrity of the members has not been compromised.

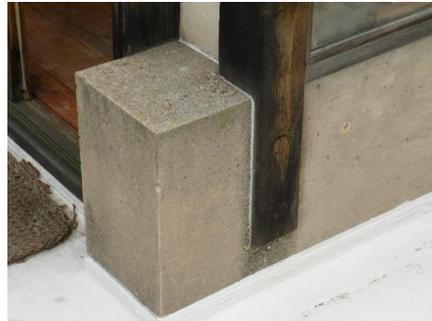
Left: Figure 19. Base of corner post.
 Right: Figure 20. North wooden railing of the terrace.

The base of the corner post is secured in poured concrete but the west face is exposed (Figure 19). Resistance drilling through the west face near the base of the post revealed no internal voids. Additional resistance drilling near the casement

window also revealed no internal voids. This post is in excellent condition.

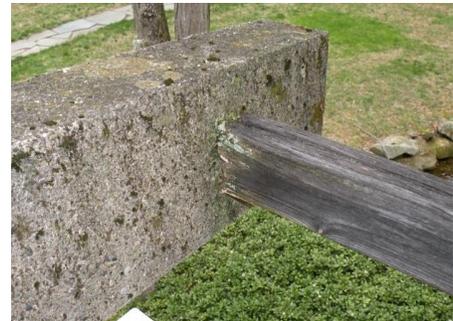
Left: Figure 21. North railing at the west wall of the Arts Building.
 Right: Figure 22. North railing at the interior face of the concrete railing showing biological deterioration on the side and upper surfaces.

Although there is deterioration where the railing is in contact with the concrete, the good condition noted along the length of the railing and at the west wall of the building is likely due to the use of black locust, a naturally durable wood species. Although black locust is naturally durable, it can succumb to wood decay if moisture is trapped for prolonged periods of time at connections, penetrations through other materials or members, and at the base of columns where water is not adequately drained.

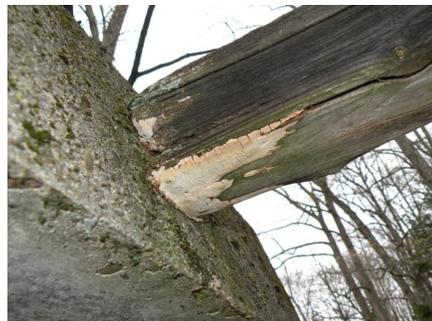
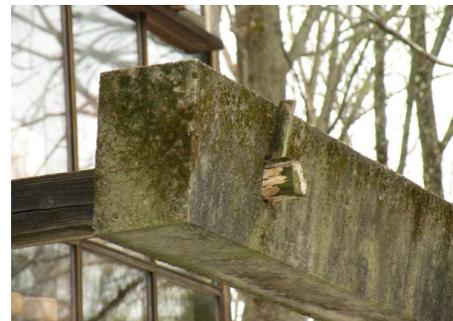
Left: Figure 23. North railing at the interior of the concrete railing, view from below showing biological deterioration on the lower surface.
 Right: Figure 24. North railing at the exterior face of the concrete railing showing deterioration. Note the use of a wooden tusk to lock the two railings.

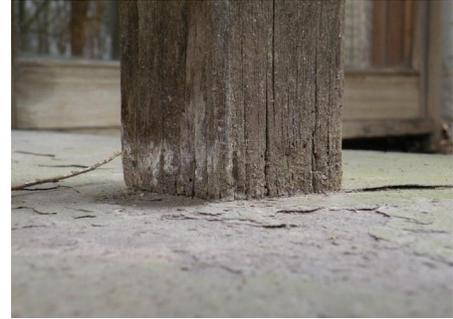
Right, above: Figure 30. Base of an original post at the landing outside the sliding doors on the south elevation. This post is in good condition.

A covered walkway on the south elevation of the Arts Building connects to the Cloister. The walkway is supported by nominal 4-inch by 4-inch wooden posts (Figure 29). Most of the original posts supporting the walkway and the porch of the Cloister have been replaced, reportedly with Ipe (*Tabebuia spp.* aka *Handroanthus spp.*). Four original black locust posts, in place at the landing with the sliding doors into the Arts Building, have experienced various degrees of minor deterioration at the base. These posts are better protected from the elements (weather) than the walkway posts and are, generally, in good condition with only minor deterioration at the base (Figures 30 and 31).

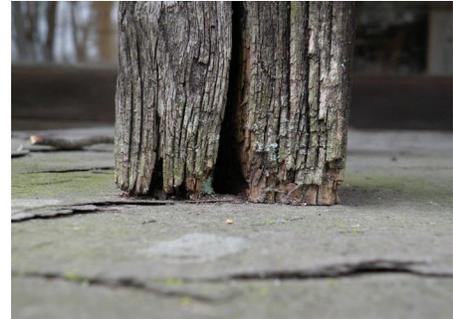
Right, below: Figure 31. Base of the southeast original post at the landing outside the sliding doors on the south elevation. This post is in fair condition at the base, but in good condition 8 inches above the base.

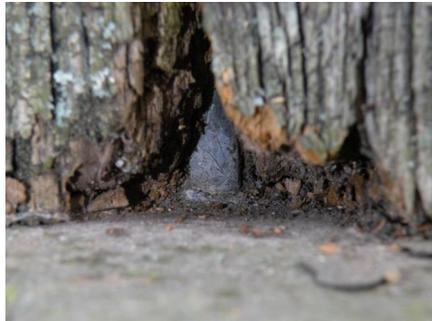
Left: Figure 32. Close up of the base of an original post at the landing outside the sliding doors on the south elevation. This post has deterioration at the base. Note the metal pin that holds the post to the landing.

One original post has more extensive deterioration at the base and is suitable for a hidden repair to prevent further deterioration of the wood (Figure 32). The post does not need to be replaced. The deterioration at the base of this post is likely similar to the deterioration that was present in the walkway posts that led to their replacement. The posts (at least the southeast landing post) are attached to the

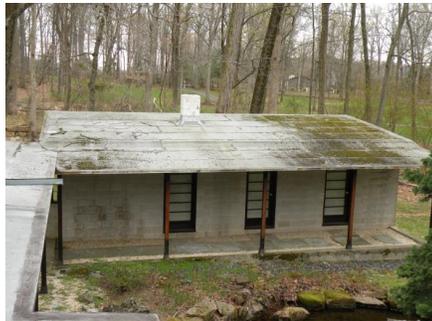
Left: Figure 34. Cloister showing biological growth on the roof, west elevation.

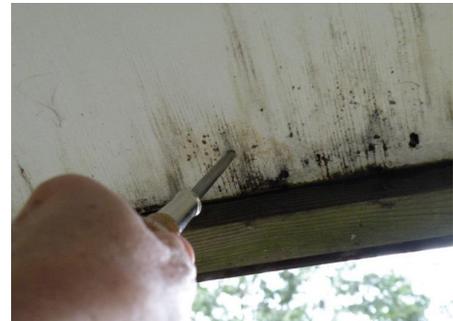
Right: Figure 35. Plywood soffit of the Cloister, easily penetrated by an awl.

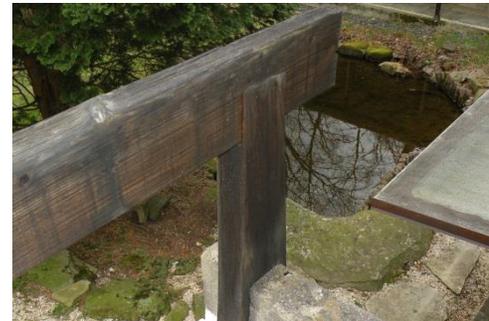
The railing on the south side of the terrace is made of Douglas-fir (Figure 25). The ends of the railing use different connection details to attach the railing to the terrace (Figures 26 and 27). The railing is weathered and has biological growth on the surface, but the growth is not decay. The weathered appearance is the result of long-term exposure to precipitation, ultraviolet light, and wind-blown debris (Figure 28). While the biological growth (moss and lichens) are not deteriorating the wood directly, their presence provides for a favorable environment for wood decay fungi by trapping moisture at the surface. As such, the biological growth could be removed periodically (not using pressure methods). The weathered appearance is often a desirable look for exposed exterior woodwork and does not need to be treated along its length, other than to remove the biological growth. If there is concern about deterioration at the connections, remedial preservatives, such as borate rods, could be inserted to retard the action of wood decay fungi or insect attack.

From top to bottom:
Figure 25. South railing on the terrace.
Figure 26. East end of the south railing. Note connection details between the notched railing and the vertical post and the base of the vertical post embedded in the concrete toe-kick on the terrace.
Figure 27. West end of the south railing.
Figure 28. Weathered surface color and texture of the upper surface of the south railing on the terrace.

- The south railing on the terrace is weathered and has biological growth on the surface but is in good condition. The biological growth could be removed periodically and remedial preservatives, such as borate rods, could be inserted at the connections to retard the action of wood decay fungi or insect attack.

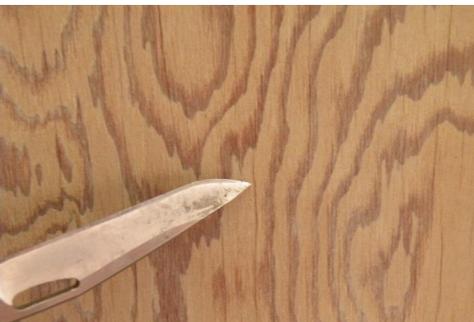
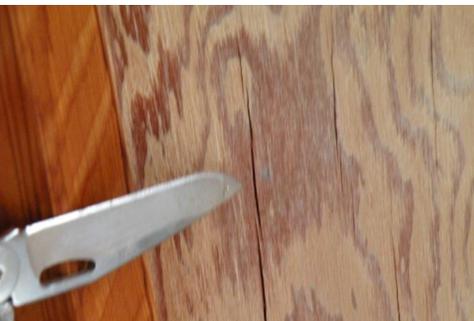
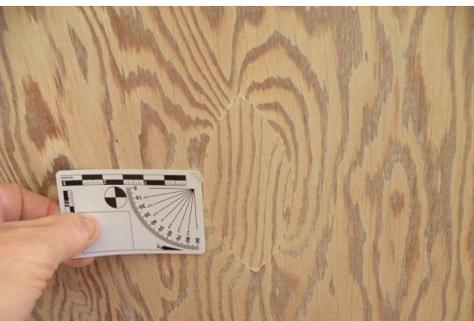
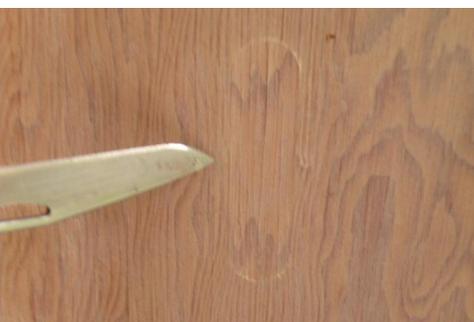
From top to bottom:
Figure 38. Narrow micro-check in surface veneer of the ceiling plywood.
Figure 39. Larger micro-check in the surface veneer of the ceiling plywood.
Figure 40. Boat patch in the surface veneer of the ceiling plywood.
Figure 41. Router patch in the surface veneer of the ceiling plywood.

The underside of the plywood visible from the interior of the Arts Building appears to be free of defects and blemishes. However, close examination of the veneer shows that micro-checks of various widths and lengths are present, as well as patches that replaced defects during the manufacturing process (Figures 38 through 41). The micro-checks are the result of either lathe checks that were present in the veneer after it was rotary cut from the log or due to drying after installation. In either case, the micro-checks are of no consequence for either structural performance or general appearance of the interior space. The patches are placed in the veneer to replace defects such as knots during the manufacturing process. Two types of patches were observed. Most common were boat patches (football-shaped) 4.5 inches long and 2 inches wide. Less common were router patches (with parallel sides and rounded ends) 2 inches long and 1 inch wide. Both patch types are difficult to see on the plywood ceiling without close examination due to the precision of installing the patches to try and match the grain pattern and the whitewash coating that masks the patches. Baldcypress ribs extend between the east and west walls (Figure 42). The ribs are spaced 24 inches on center and, as mentioned earlier, cover the end joints of the plywood. The ribs are not continuous, but are connected with a splice

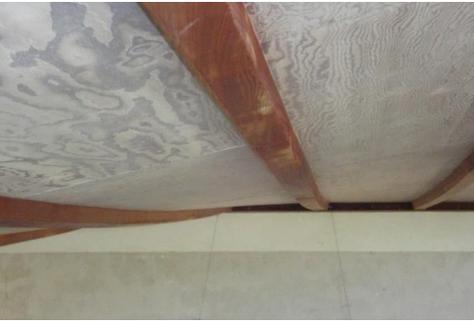
Cesar Bagues Ballester. The scan shows several nail locations and the joint at the first plywood layer (arrow Figure 3). We can't be certain which layers (2 or 3) the nails belong to without performing a removal.

From top to bottom:
 Figure 1. Underside view of the hyperbolic paraboloid roof.
 Figure 2. Plywood layout.
 Figure 3. Infrared scan.
 Figure 4. Cracked rib.

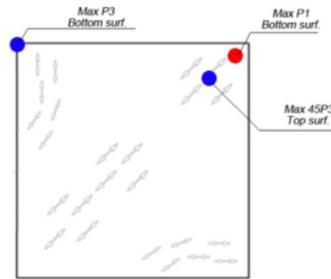
Figure 15. Maximum stress location for balanced snow load.

- The balanced load reaches 93% of capacity as shown in Figure 15

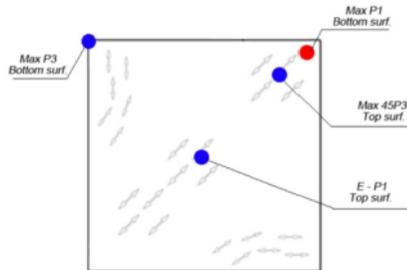
Figure 16. Unbalanced load combination 5

- For unbalanced loads, the load combination due to wind produced the maximum stress which is 99% of capacity (Figure 16).=

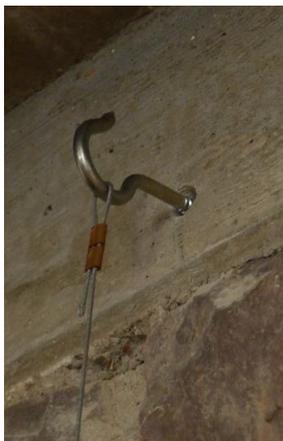
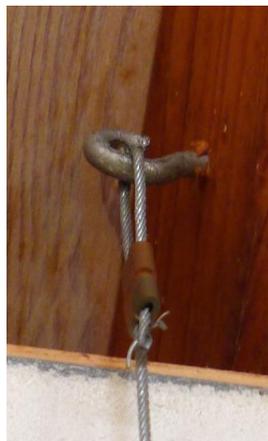
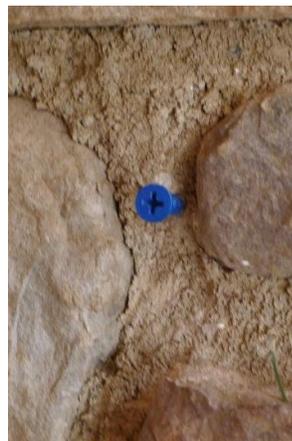
Hook hanging system showing holes drilled into concrete and wood. Screw anchor in masonry wall (January 2017)

Ensure that the installation of collection displays do not leave the fabric of the gallery with a progressively increasing collection of drilled holes and minor alterations that affect its visual appearance and integrity and that new installations conform to Nakashima's preferences, reuse of existing fittings and the overall approach to hanging should be maintained.
