**PENN PRAXIS/THE ARCHITECTURAL CONSERVATION LABORATORY**

**GEORGE NAKASHIMA  
ARTS BUILDING AND CLOISTER  
CONSERVATION & MANAGEMENT PLAN**

**INTERIM REPORT**

January 30, 2016

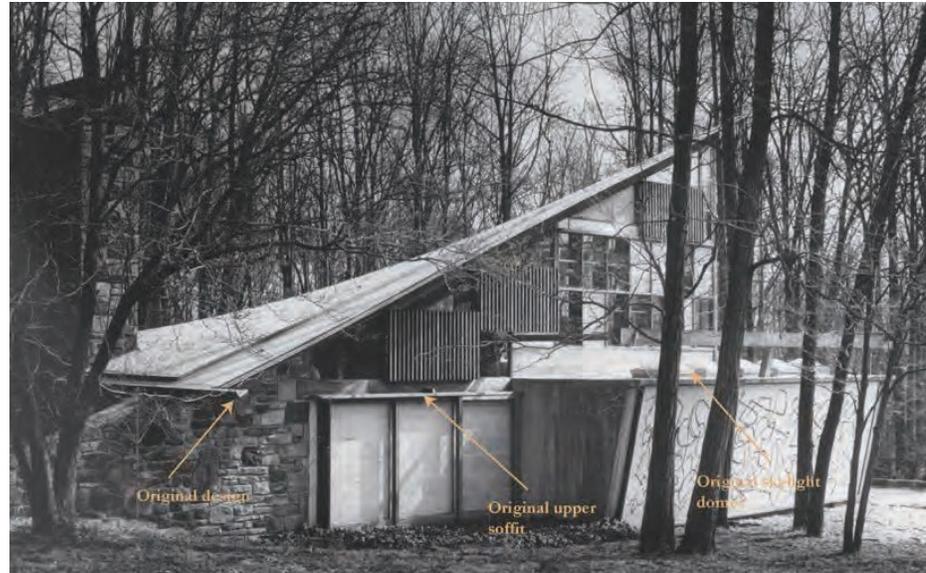
In 1994, another major alteration to the exterior was the repair of the seat window on the northwest elevation. This repair included the installation of a copper canopy designed by Mira Nakashima Yarnall, which would conceal the head of the window as envisioned by George Nakashima. The original building solution was a cypress head interlocked in the oak beam (Fig. 5.1)

Fig. 5.1. Northwest elevation view. Notice the original gutters, the original head in the sliding window, and the skylight domes. The concrete floor of the terrace is exposed. Source: George Nakashima Woodworker Archives

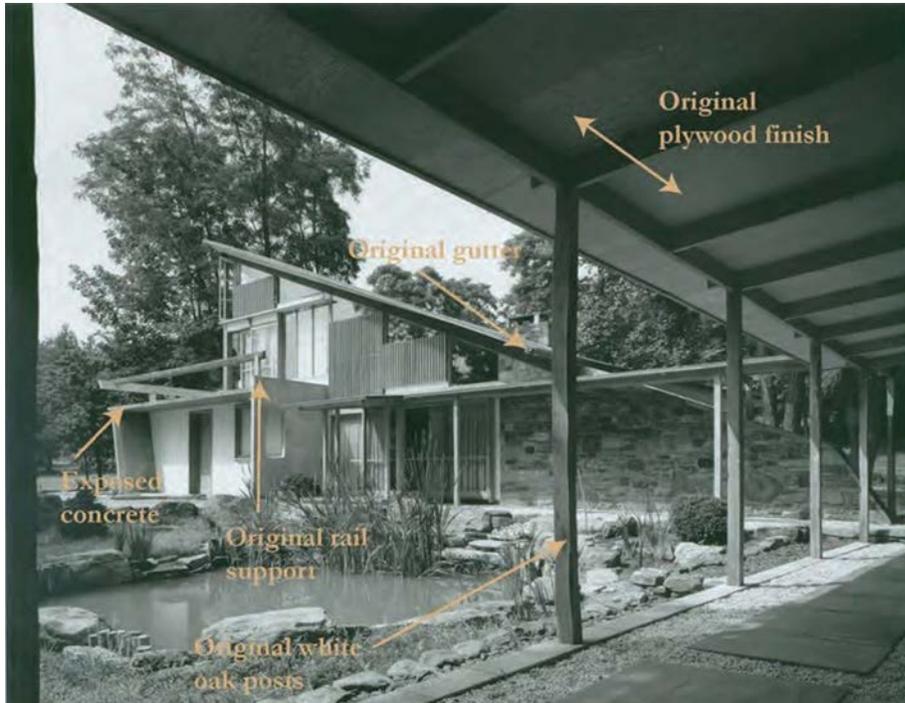
In the south elevation, the white oak load-bearing post of the engawa and the Cloister porch were replaced. The intervention also altered the original finish of the plywood soffit in a large area of the porch.

In the 2000s, the original load-bearing posts were replaced by ipe posts, which are machine made. Unlike the original posts, the new ones rest upon ipe Japanese-inspired bases, which are a truncated square pyramid. This detail was modified presumably to discourage rot at the post base. Upper connecting joints were replicated to join new and original members.

Fig. 5.3. South elevation view. Date: 1965. Notice the original white oak posts, plywood soffit finish, rail support, and gutter. Source: George Nakashima Woodworker Archives.

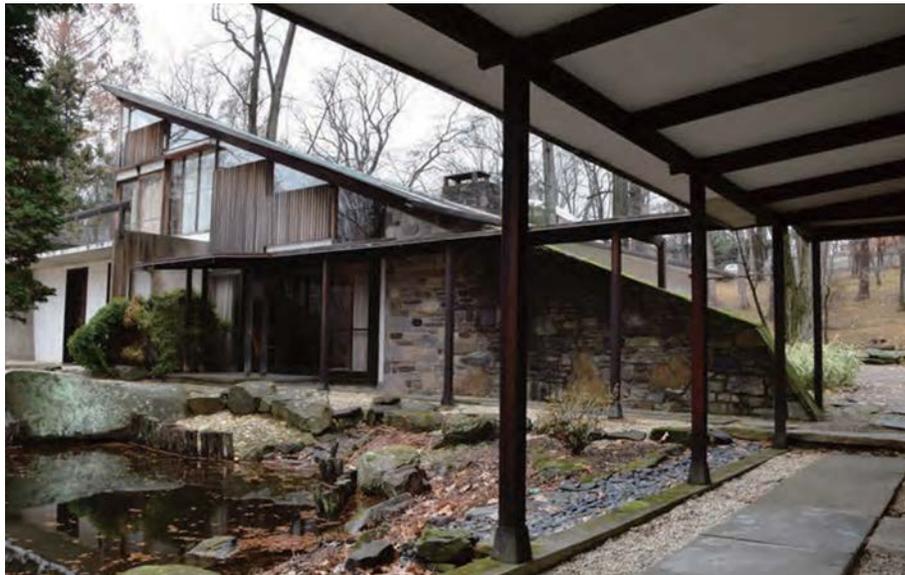
To control leaks, the original exposed concrete terrace was waterproofed with an impervious membrane in a first campaign and painted white with an epoxy based coating in a second campaign. This intervention disrupted the original finish and aesthetic qualities of the exposed concrete, although providing a watertight seal that protects the interior from moisture penetration.

Fig. 5.4. South elevation view. Date: December 2014. Notice the new gutter system, the new ipe posts upon ipe bases, and the opaque white paint covering the plywood soffit. As shown in Fig. 5.1, the concrete floor of the terrace has been waterproofed.

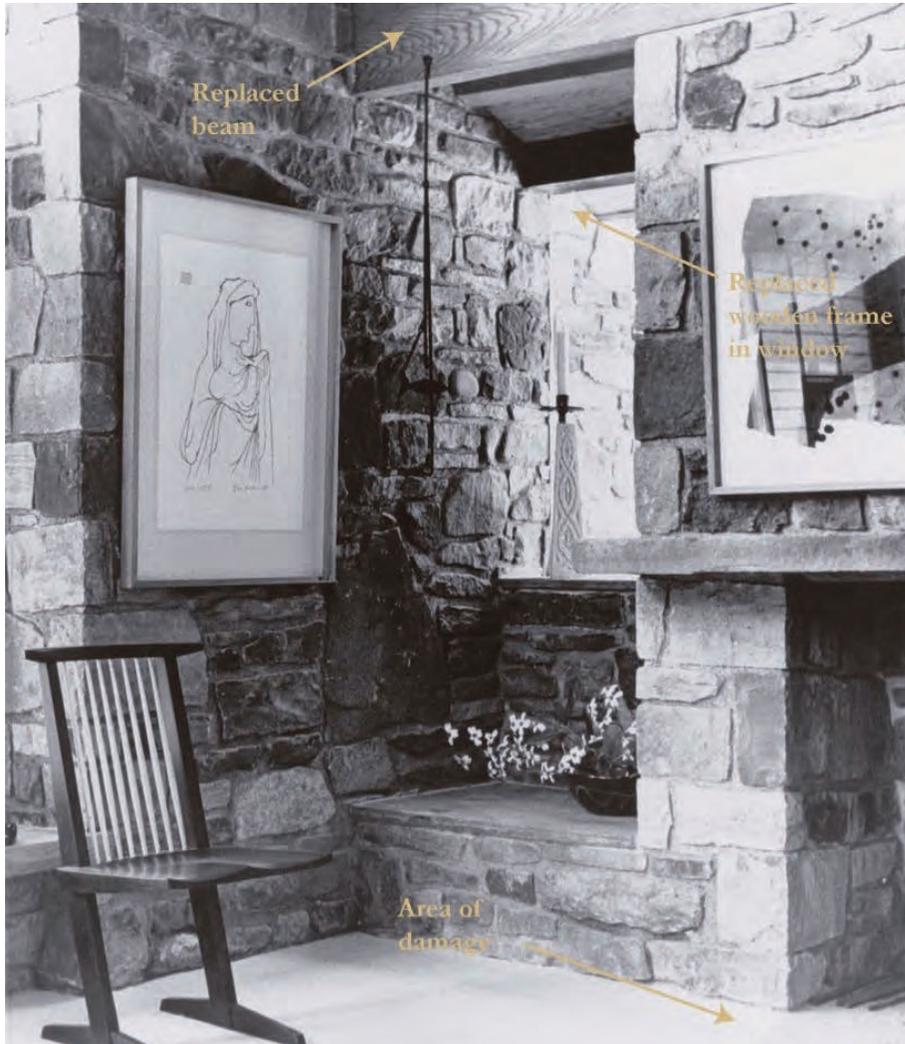
Above the fireplace, the lintel was replaced as a consequence of carpenter activity. Repair occurred to the adjacent window as well. Below, a 1967 photograph (fig. 5.5) partly shows the original white oak beam over the fireplace. As the wood was cut parallel to the grain direction and tangent to the growth rings, a wavy plain grain characterized this beam. Other photographs supplement the information and show the six plugs that concealed the bolt heads. Unfortunately, there is no image of the previous window, although clearly the fixed pane of glass directly terminated into the stone masonry wall. A direct examination reveals that the stones were cut to house the glass.

The grain figure of Nakashima's original fireplace lintel was undoubtedly selected in relation to the heavily patterned exposed plywood ceiling, which is still visible. Although the replacement lintel reveals a sensitive repair, this visual relationship is now lost (fig. 5.6). Likewise, the northern corner was replaced and repaired in kind to mend the deterioration caused by leaks. During this intervention, the skylight was also covered in the same manner as those in the exterior terrace.

Fig. 5.5. Fireplace corner. Date: 1967. Author unknown. Source: George Nakashima Woodworker Archives.

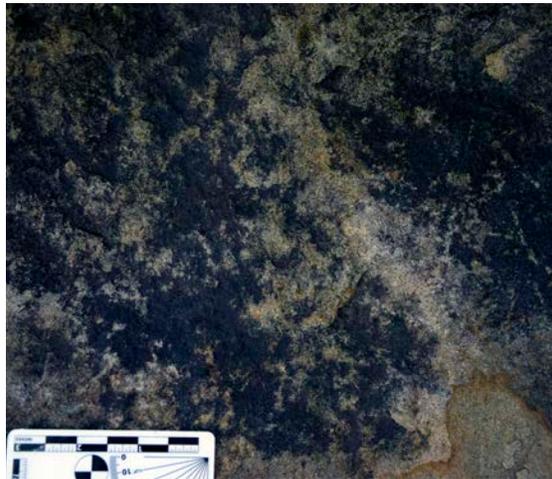
#### *Soiling*

Deposit of a very thin layer of particles giving a dirty appearance to the stone surface. It may be a direct effect of earlier biological colonization with algae.

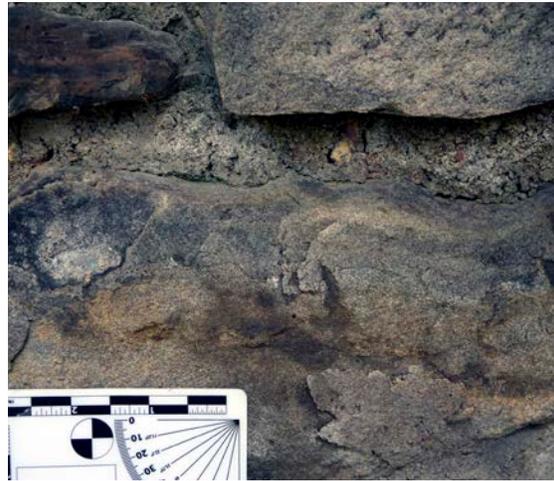
#### *Flaking*

Scaling in thin flat or curved scales. The detachment is located near to the stone surface.

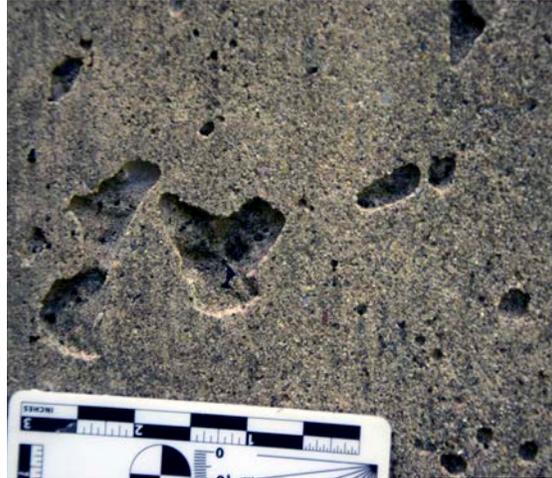
*Bugholes*

Small regular or irregular cavities as a result of entrapped bubbles during the placing process. Overall, they do not exceed 5/8 inch in diameter.

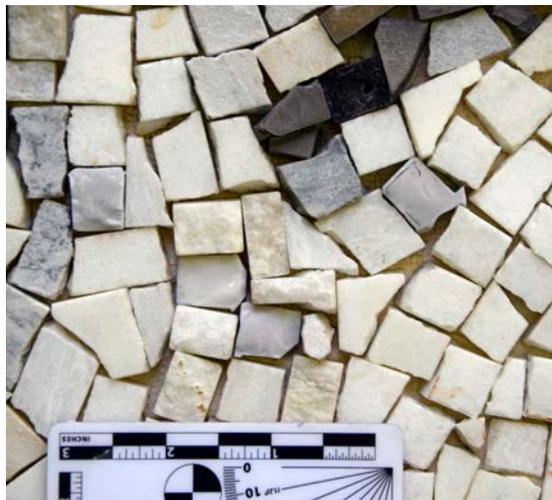
#### *Granular Disintegration*

Eroded and detached surface of tesserae.

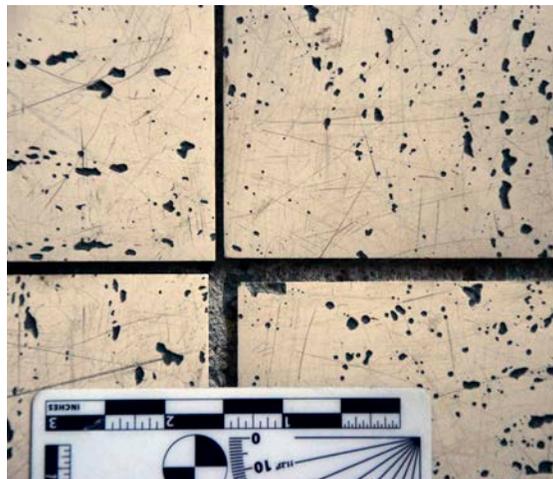
#### *Tile shrinkage*

The flooring present a contraction in comparison to their original dimension due to sunlight exposure.
