# APPENDIX A

## FIGURES

- 1.0 Figures: Executive Summary
- 2.0 Figures: Description of Structures
- 5.0 Figures: Description and Investigations of the Fort Exterior
- 6.0 Figures: Description and Investigations of the Upper Building
- 7.0 Figures: Description and Investigations of the Lower Building

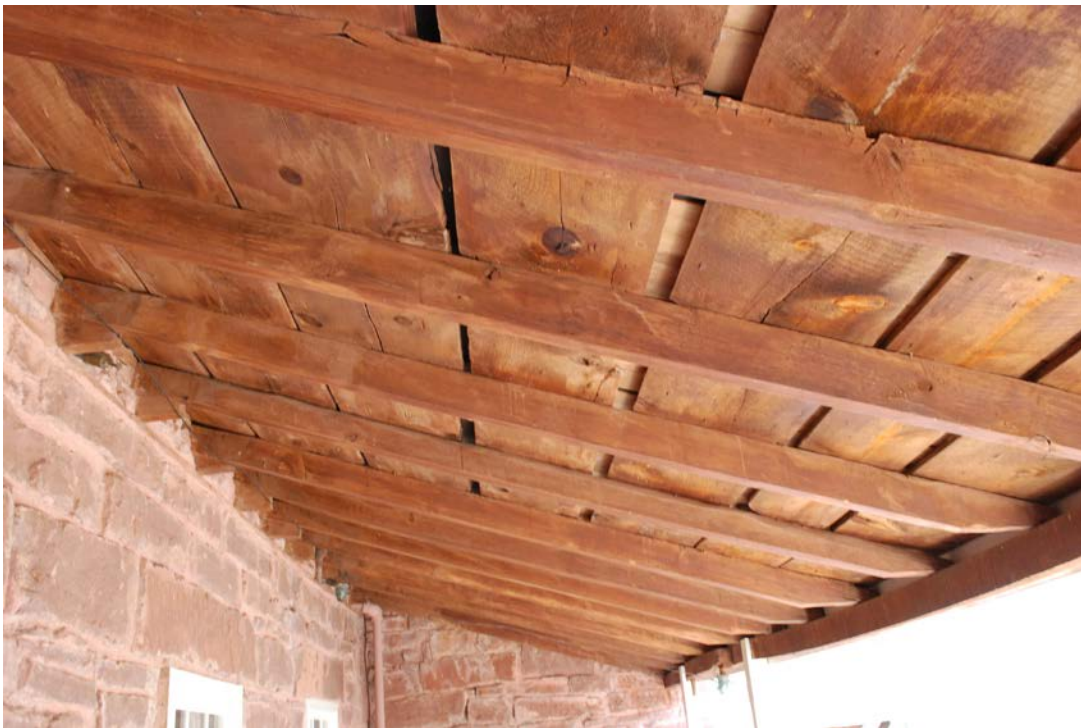
Figure 5.18. The Architectural Conservation Laboratory, “Rafters of lower (south) balcony, detail of the wood sheathing supporting the roof shakes” (July 12, 2012).

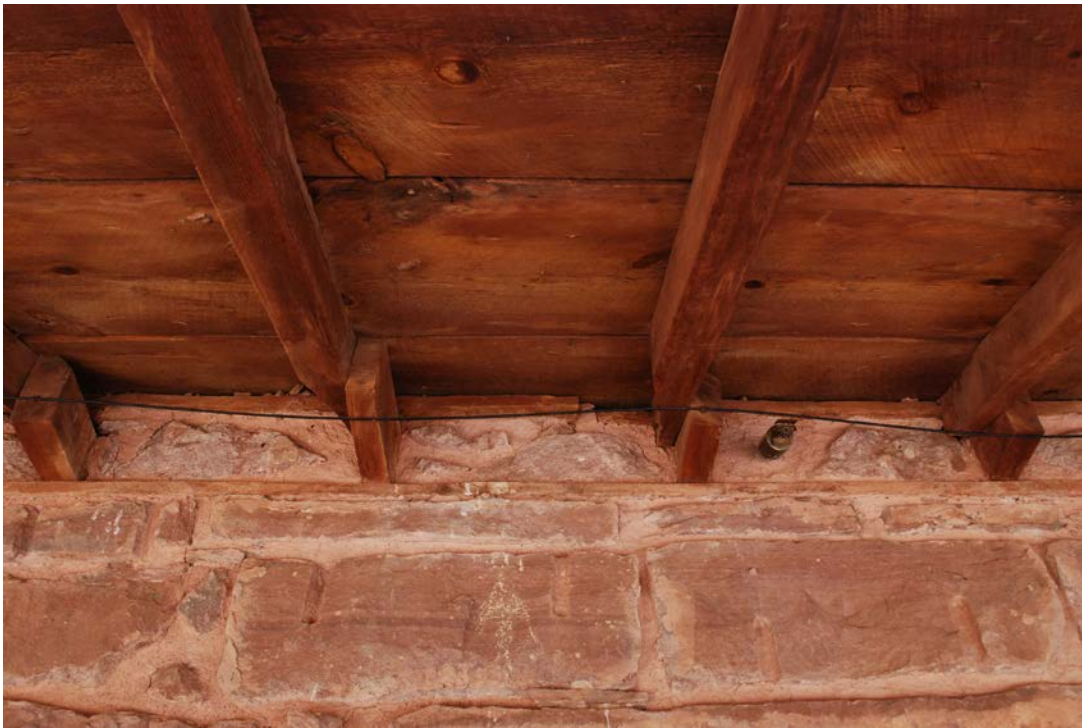
Figure 5.19. The Architectural Conservation Laboratory, “Rafters of lower (south) balcony; detail of wood coursing supporting the rafters in the masonry” (July 12, 2012).

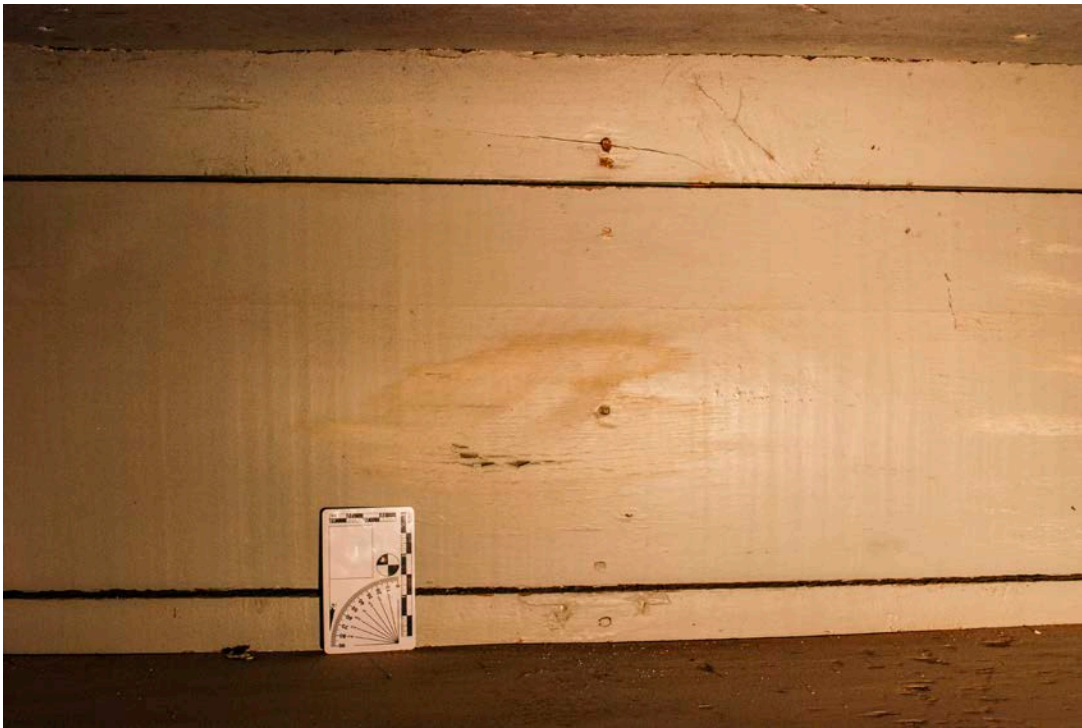
Figure 6.1. The Architectural Conservation Laboratory, “Detail of backboards showing center nailer, saw marks and wider width boards” (July 12, 2012).

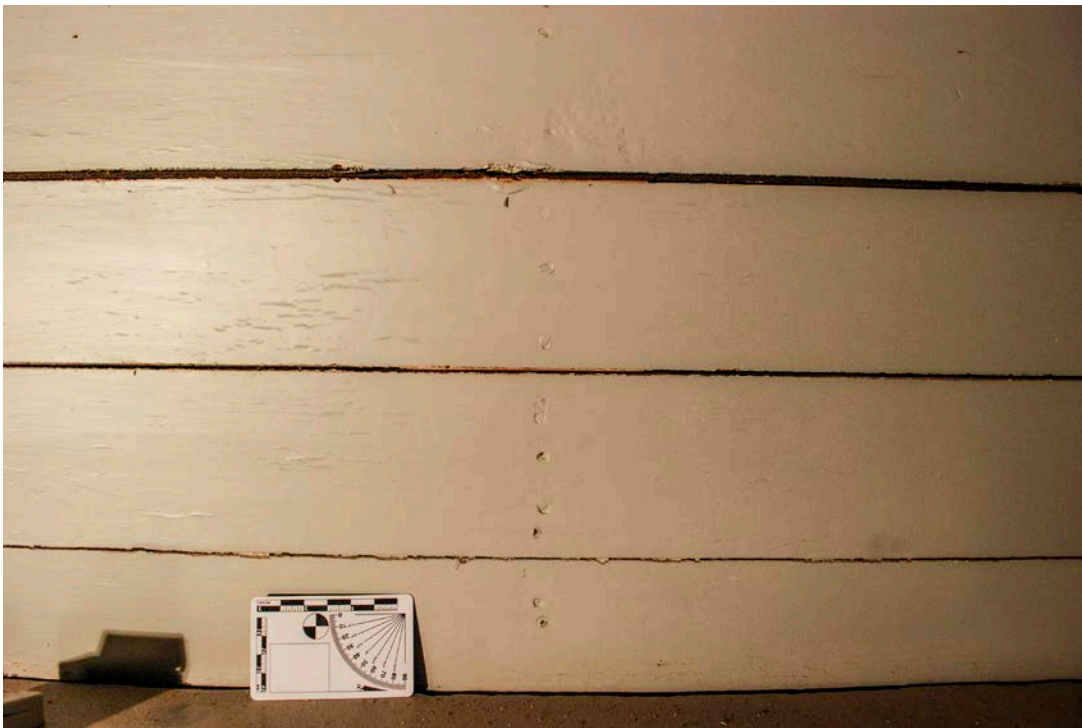
Figure 6.2. The Architectural Conservation Laboratory, “Backboards in right upper cupboard showing thin width of center nailer” (July 12, 2012).

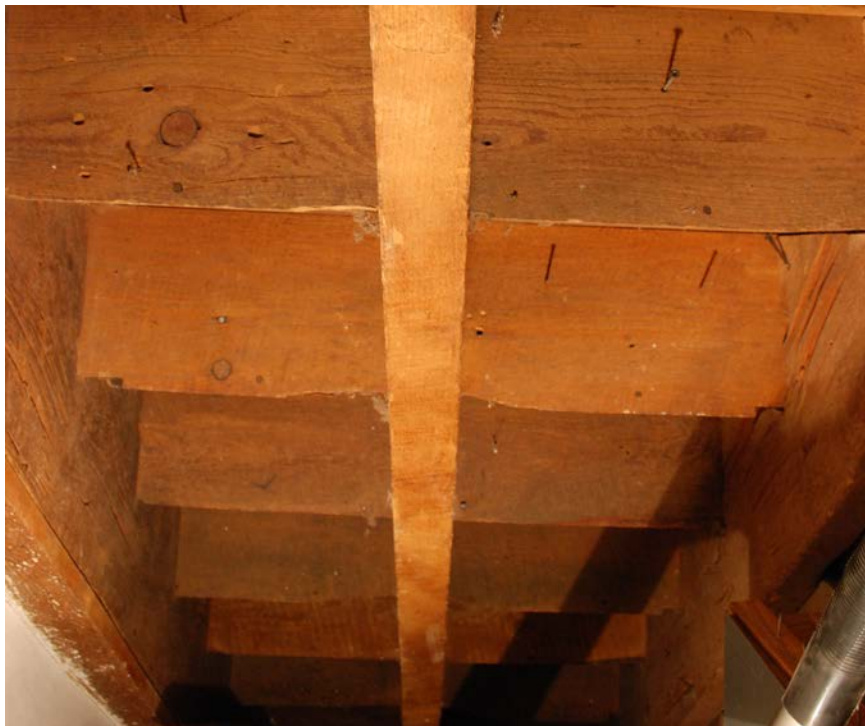
Figure 6.6. The Architectural Conservation Laboratory, “Added center stringer on the stairs, from closet below staircase” (July 12, 2012).

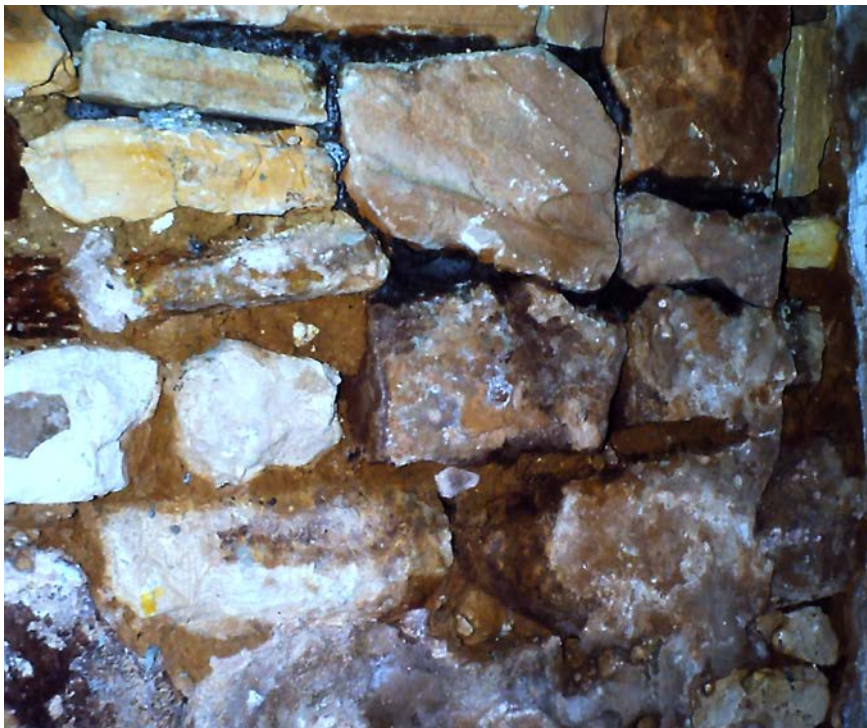
Figure 6.8. Dale Scheier, “Reconstruction of parlor” (June 10, 1980), Pipe Spring slide archive, fig. SL0881.

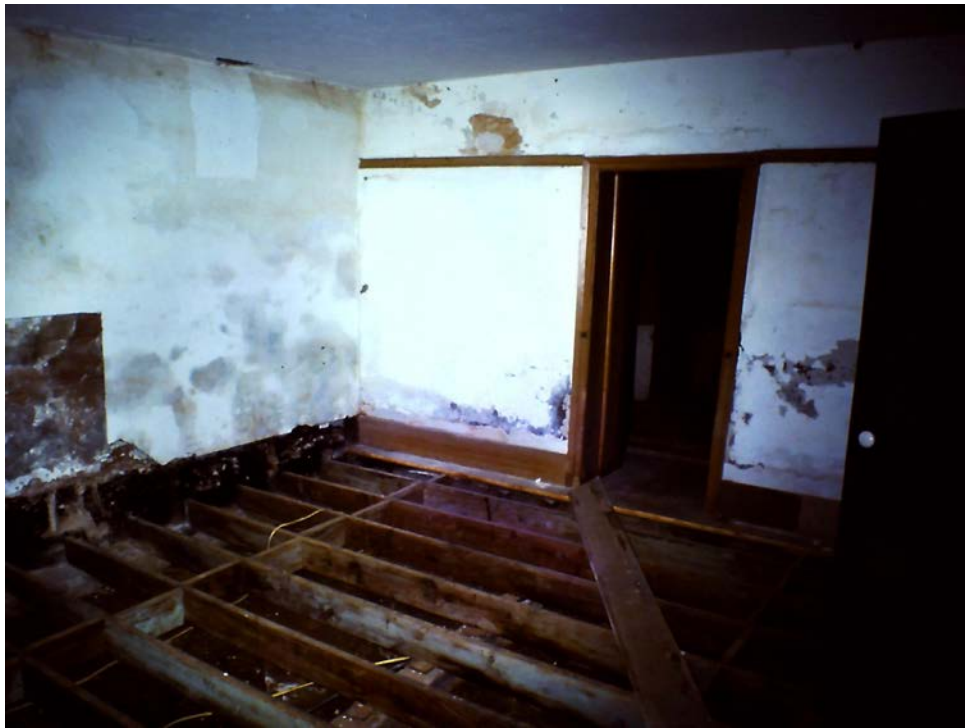
Figure 6.9. Dale Scheier, “Parlor prior to reconstruction” (January 10, 1979), Pipe Spring slide archive, fig. SL0880.

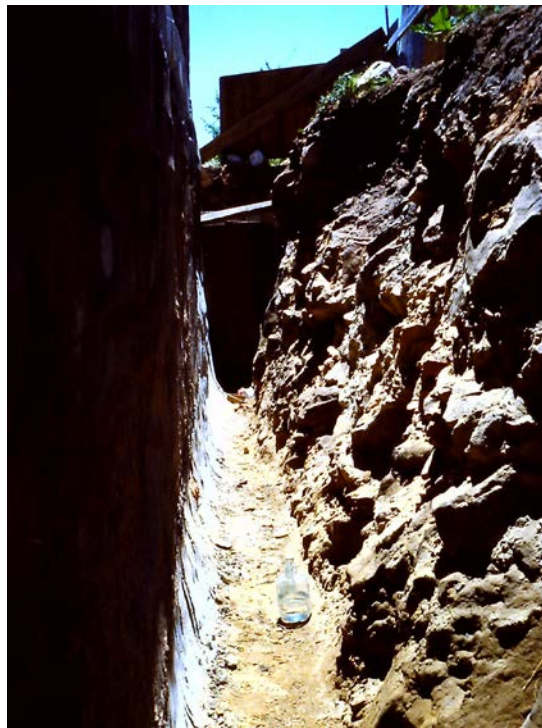
Figure 6.10. “Excavation of drainage trench” (June 1980), Pipe Spring slide archive, fig. SL0669.

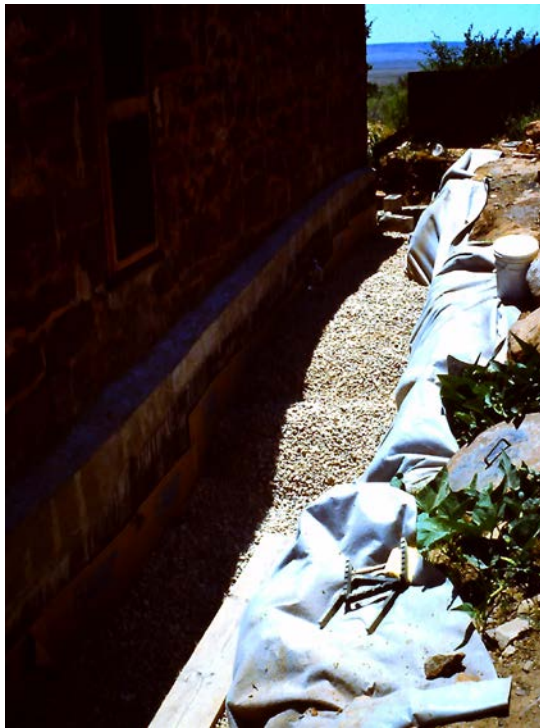
Figure 6.11. Dale Scheier, "Excavation of drainage trench" (June 29, 1980), Pipe Spring slide archive, fig. SL0642.

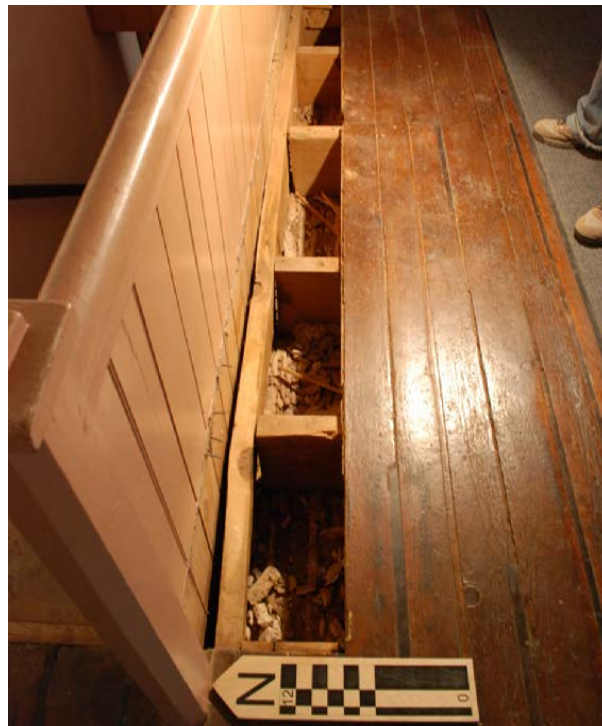
Figure 6.14. The Architectural Conservation Laboratory, "Lifted floorboard adjacent to staircase in the meeting room" (July 10, 2012).

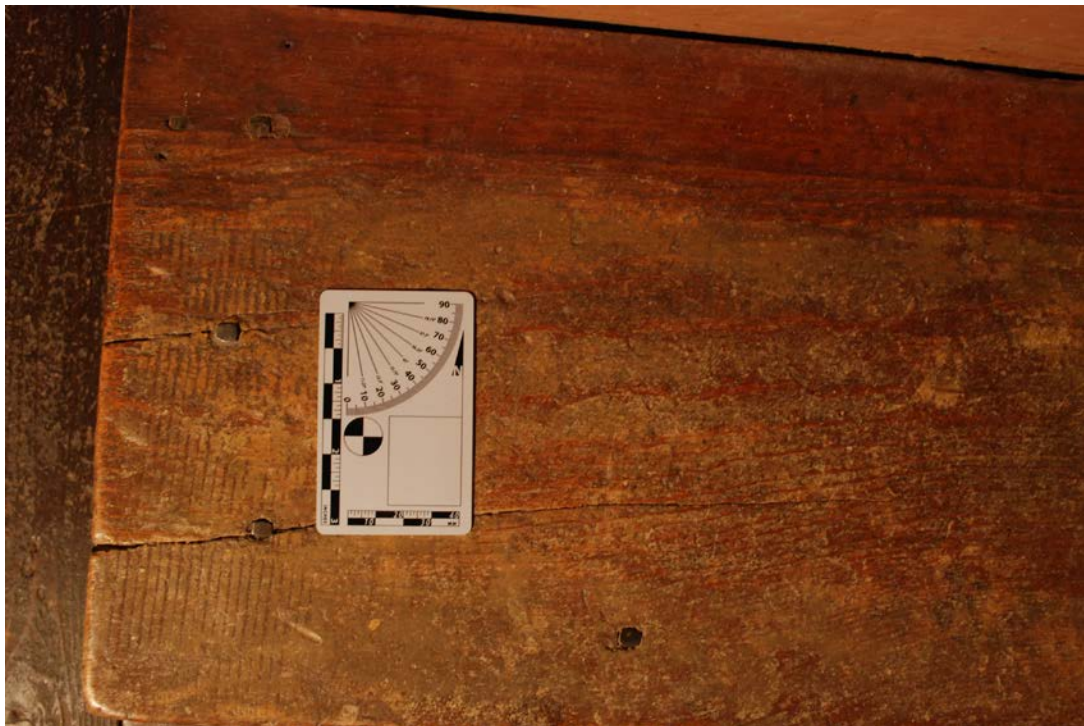
Figure 6.18. The Architectural Conservation Laboratory, “Stair tread in kitchen; evidence of tarring and glue, and square cut nails” (July 12, 2012).

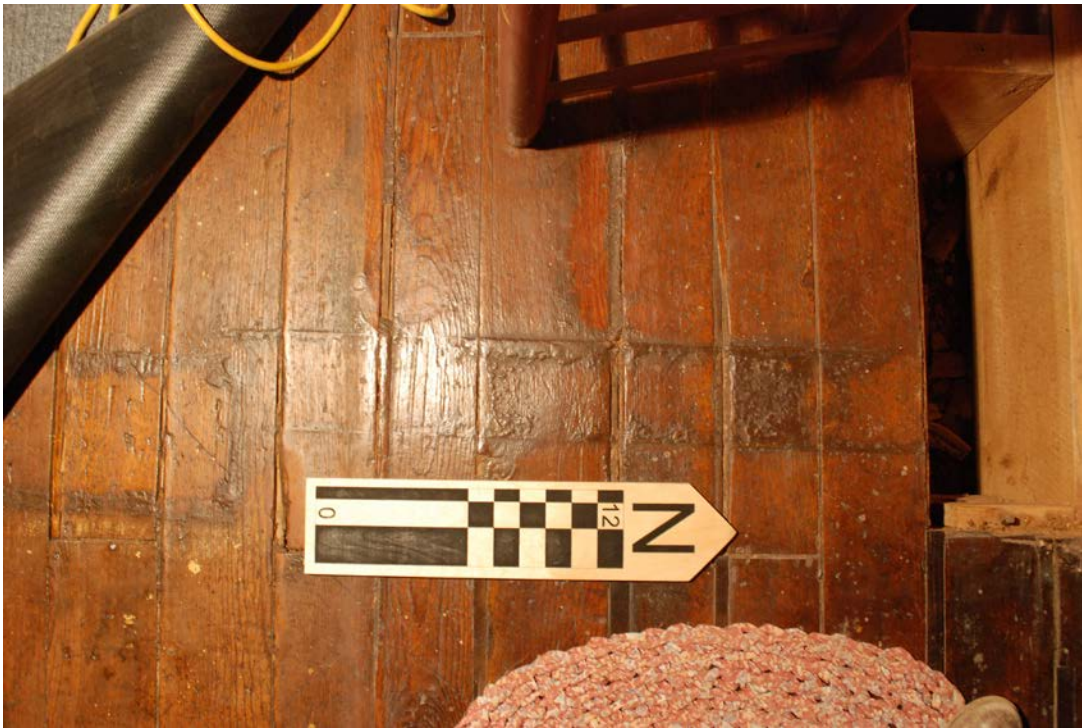
Figure 6.19. The Architectural Conservation Laboratory, “Residue on floorboards showing threshold of removed partition wall in meeting room” (July 10, 2012).

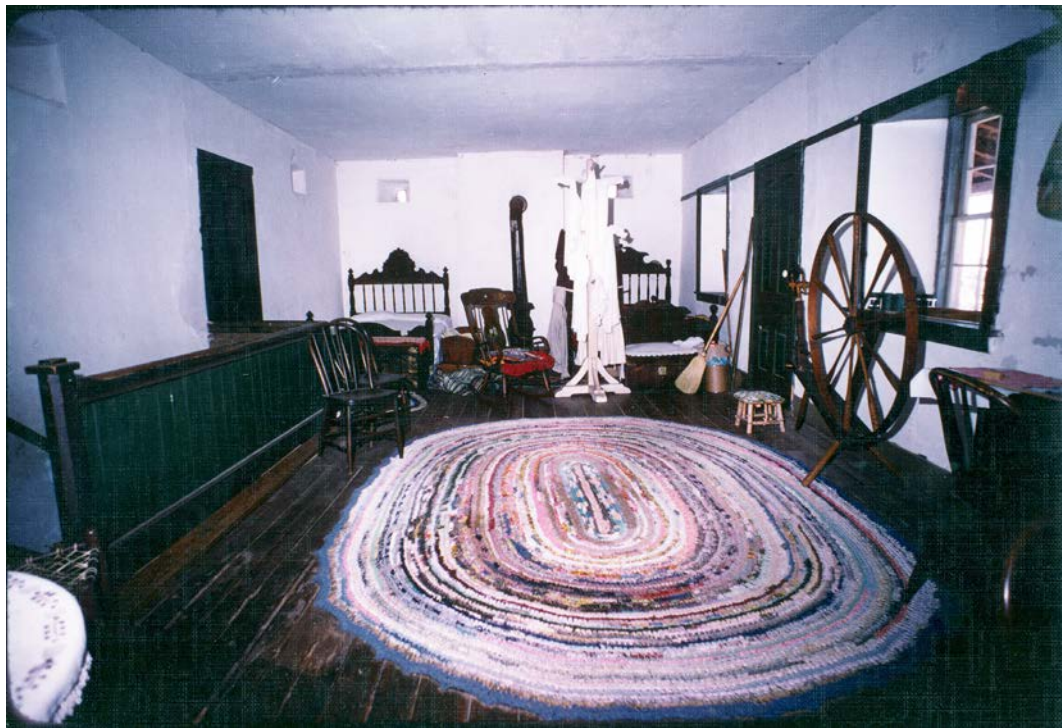
Figure 6.22. The meeting room following the removal of the partition wall prior to replastering of the ceiling and walls. (post-1959)

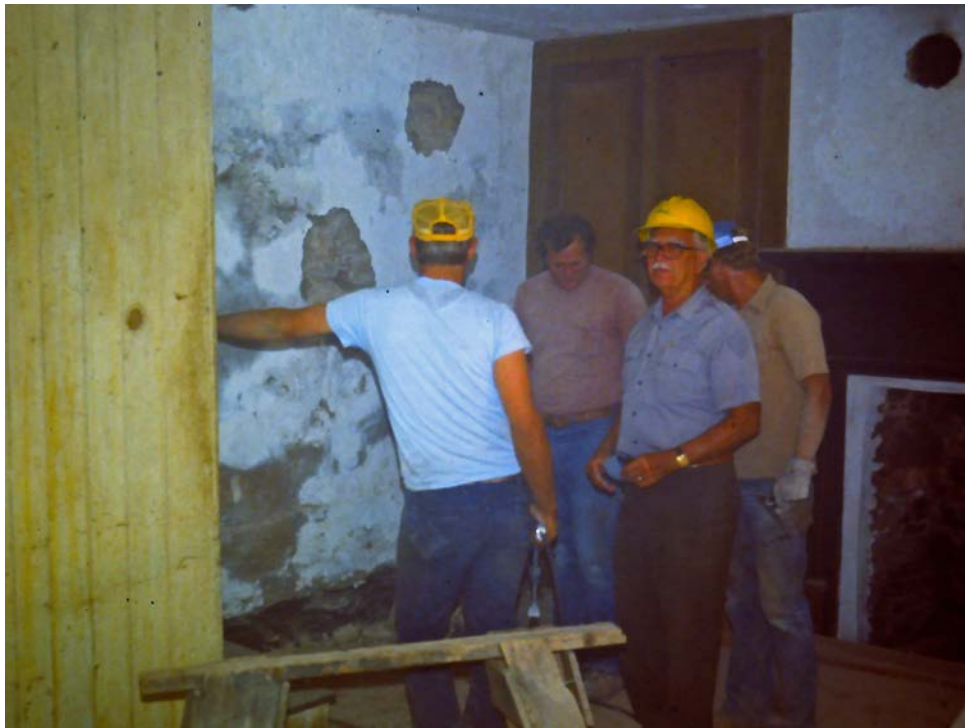
Figure 6.23. Dale Scheier, "Reconstruction of kitchen wall" (June 10, 1980), Pipe Spring slide archive, fig. SL0865.

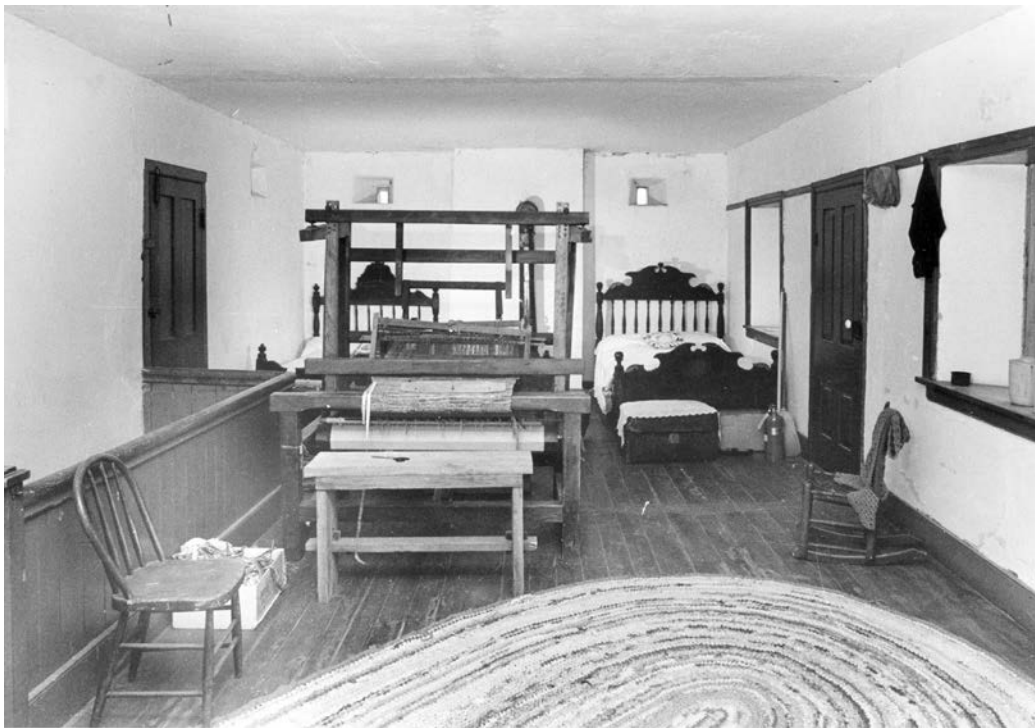
Figure 6.24. The meeting room following the removal of the partition wall with the wall's positioning visible in both the floor and ceiling. (post-1959)

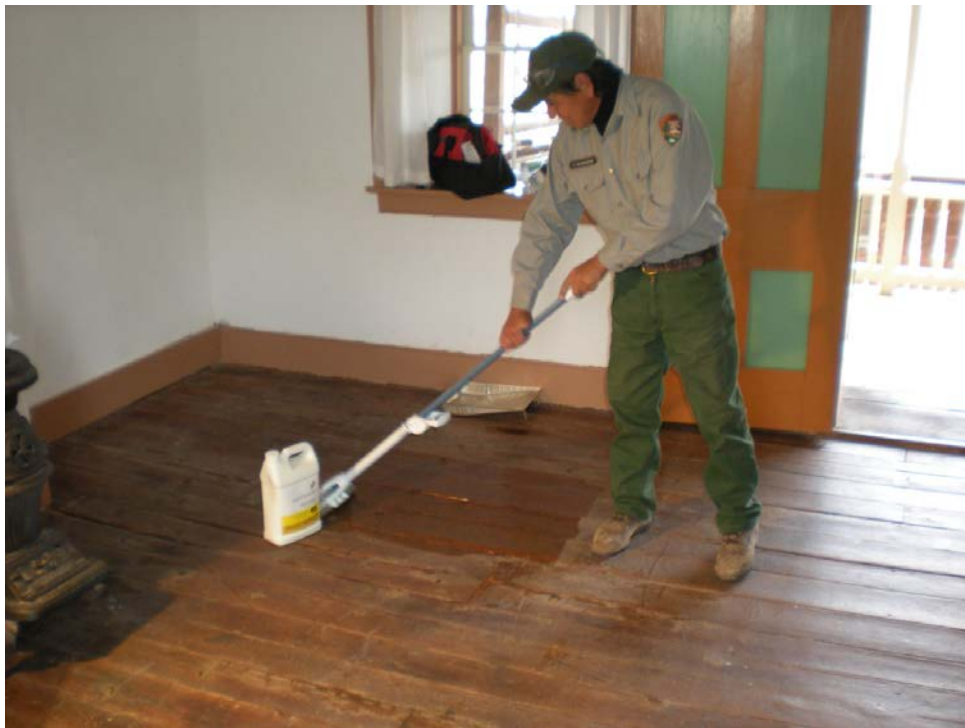
Figure 6.26. "Removing wax with paint thinner" (March 03, 2009).

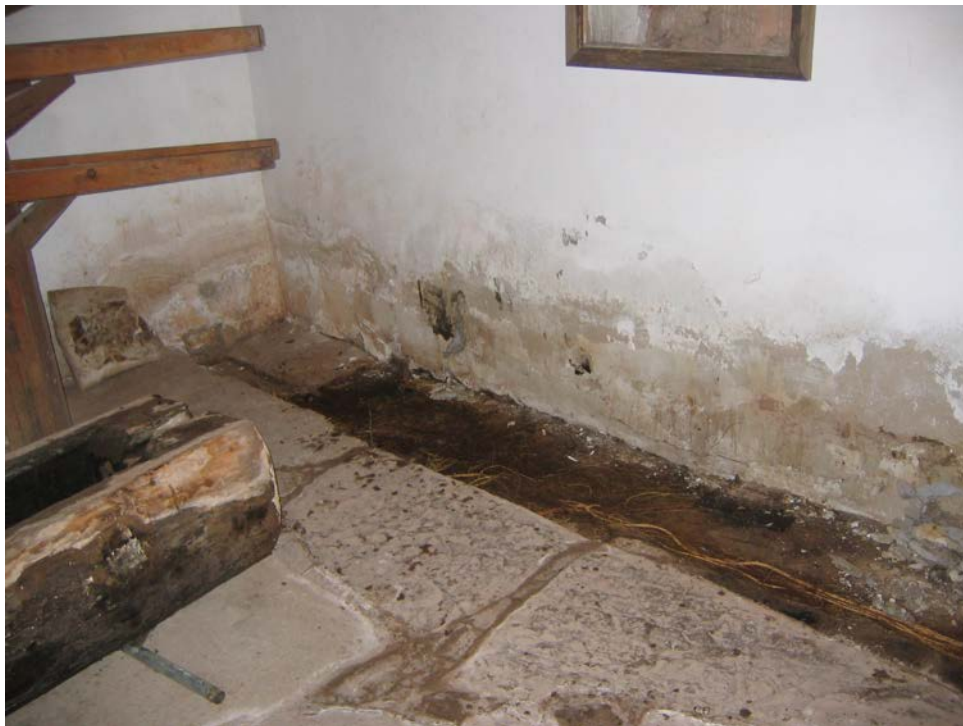
Figure 7.2. Pipe Spring National Monument, Southwest corner of spring room with trough removed (February 23, 2006).

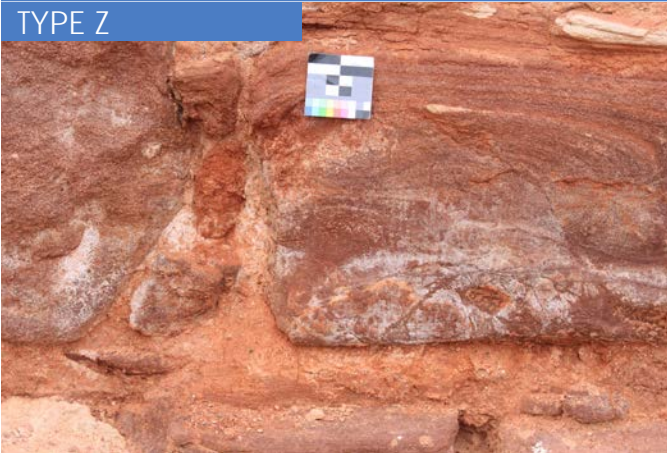
## TYPE Z

A fine textured, red clay based mortar, with minimal aggregate. This mortar is located towards the lower portions of the east wall of Winsor Castle.

NOTE: Onsite, it was believed that this mortar was a separate "type", but upon further investigation, it appears that this mortar is a badly deteriorated form of Mortar Type C (left) and Mortar Type B (right).

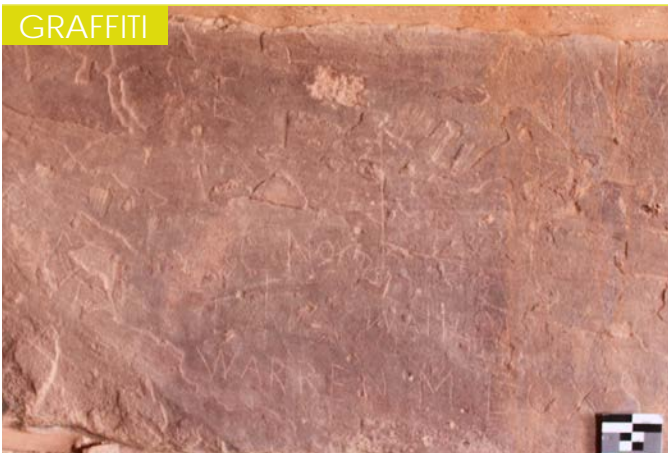
## GRAFFITI

Graffiti appears as images or lettering scratched, painted or marked on the stone surfaces.

These markings appear on Winsor Castle as well as the East and West Cabins—most frequently on the stones surrounding the fireplaces, courtyard, and doors ranging from the early to mid-twentieth century. Some of the markings are historically significant while others are acts of vandalism.

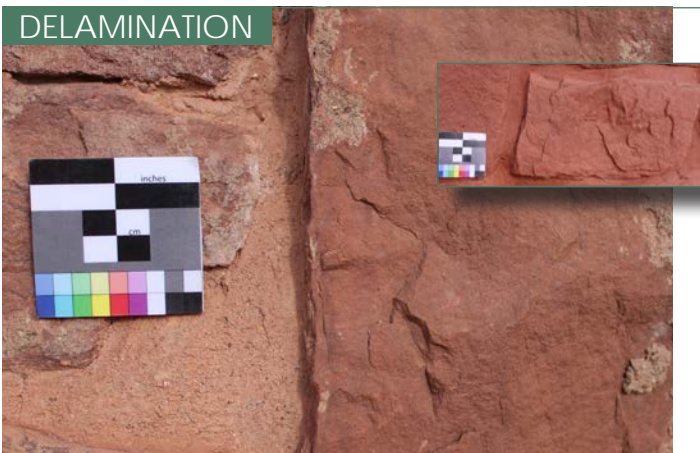
## DELAMINATION

Planar detachment of the stone related to its bedding orientation.

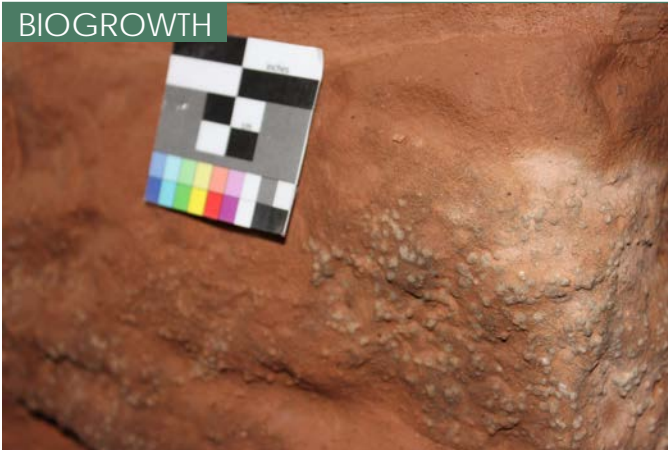
## BIOGROWTH

Colonization of micro-organisms such as bacteria, cyanobacteria, algae, fungi and lichen (symbioses of the latter three), generally visible as green, brown or black surface discoloration.

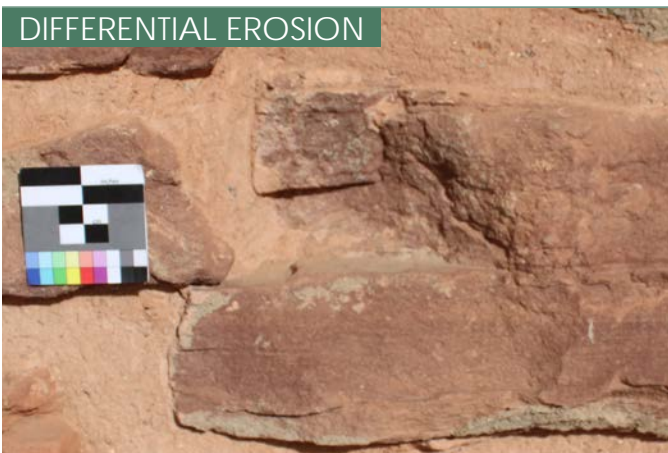
## DIFFERENTIAL EROSION

Uneven surface loss of stone resulting from weathering.

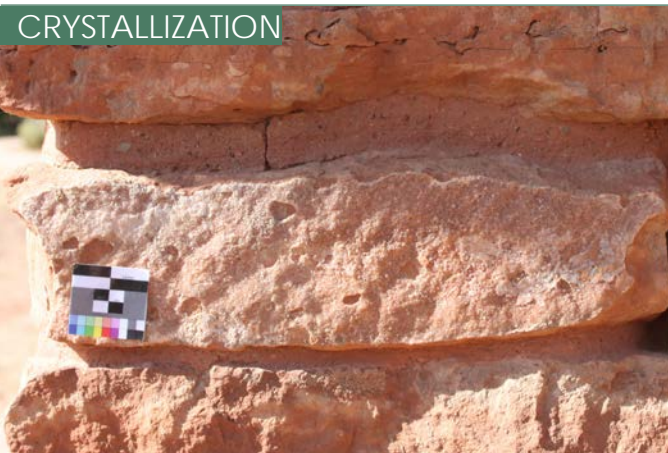
## CRYSTALLIZATION

A surface of stone that has become hardened due to the precipitation of solid crystals. Stones containing this featured are rare, and are visible on the East and West Cabins.

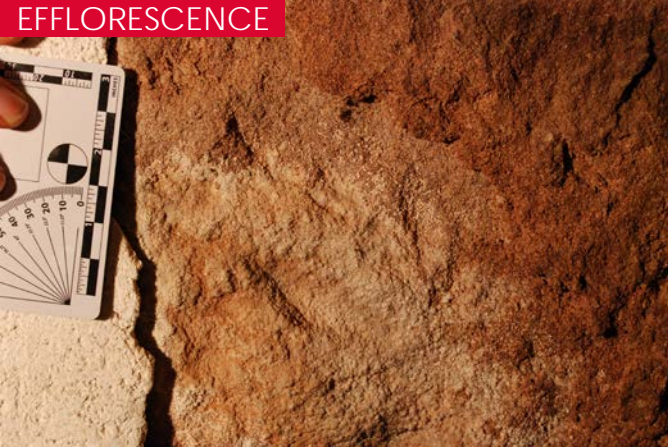
## EFFLORESCENCE

Generally white, powdery or whisker-like crystals of water-soluble salts.

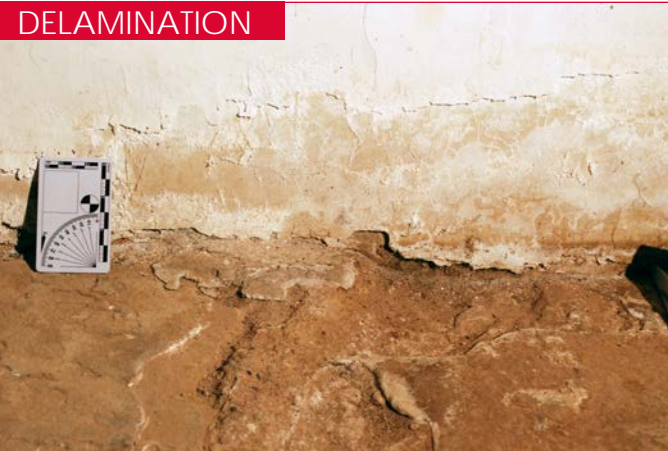
## DELAMINATION

The physical separation of the stone or plaster surface into one or several layers.

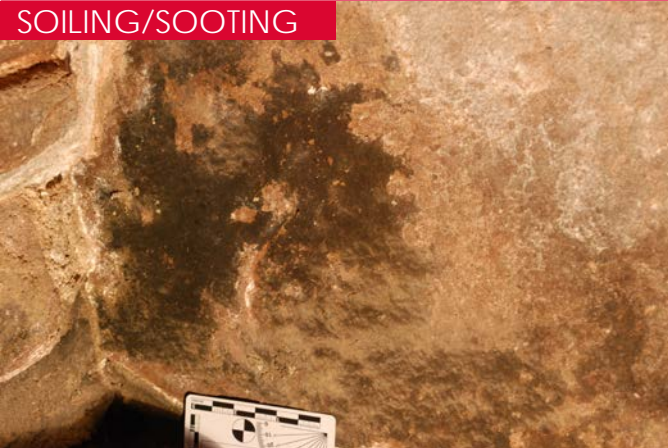
## SOILING/SOOTING

Deposit of a very thin layer of exogenous particles (eg. soot) giving a dirty appearance to the stone surface.

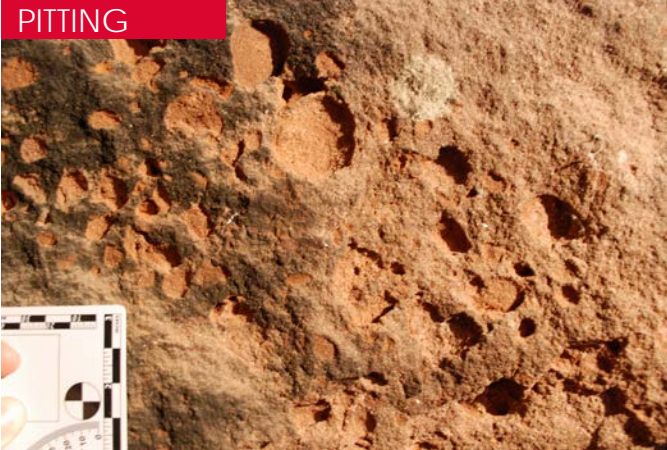
## PITTING

The formation of small pits, generally not connected, on a stone surface.

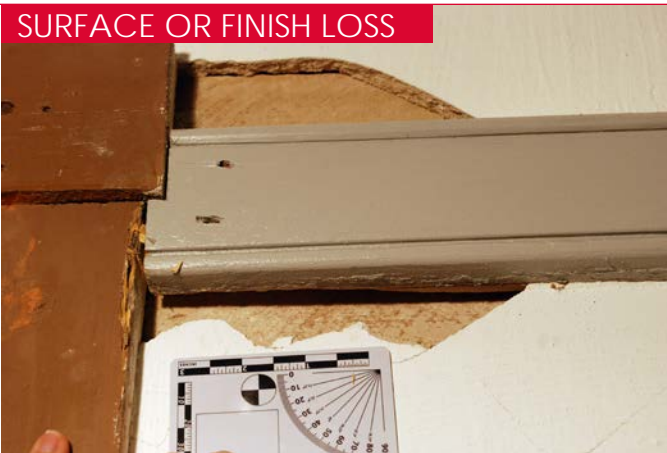
## SURFACE OR FINISH LOSS

Localized loss of material resulting in exposed substrate.

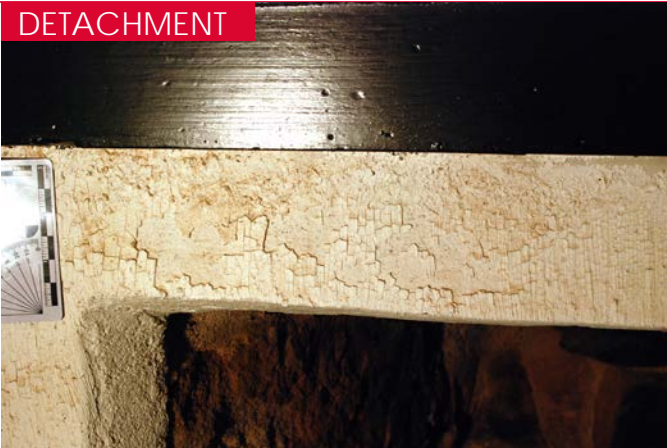
## DETACHMENT

Blistering and flaking of plaster and surface finishes potentially leading to loss.

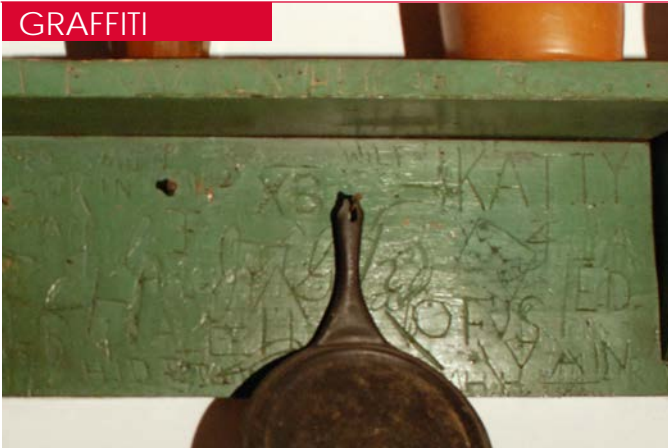
## GRAFFITI

Engraving, scratching, or cutting into a wood or stone feature.

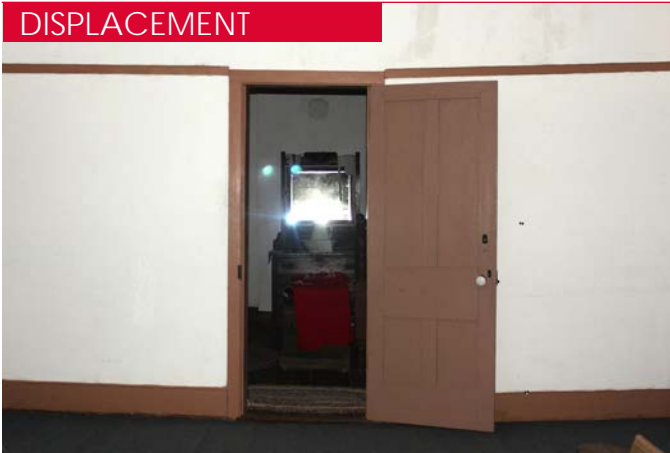
## DISPLACEMENT

In- and/or out-of-plane movement of structural components, including interior and exterior walls and floors.
