THE PENNSYLVANIA BLUE PROJECT

Documentation and Conditions Survey of the Exterior Marble Masonry

THE SECOND BANK OF THE UNITED STATES
INDEPENDENCE NATIONAL HISTORICAL PARK
PHILADELPHIA, PENNSYLVANIA

The Architectural Conservation Laboratory and Research Center
051 Duhring Wing
University of Pennsylvania

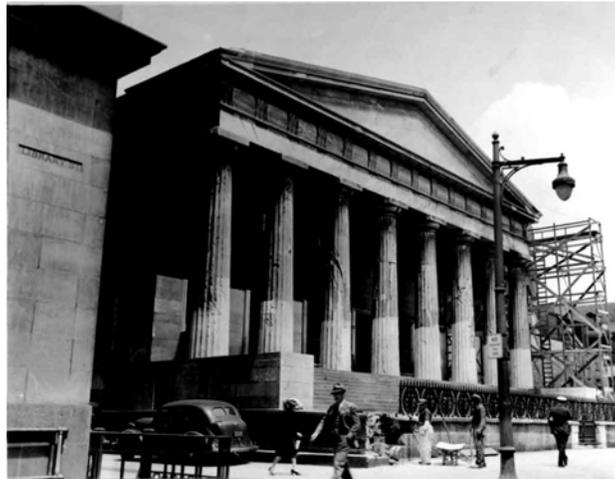
records were found describing the reagents, tools, or methods used.¹⁶ Photographs show that the columns and the ashlar of the south façade were cleaned from the bottom up, with the northern elevation being done at about the same time in a similar pattern.(Fig. 4) The east and west façades were cleaned in sections starting at the southern and northern ends working towards the middle.¹⁷ Later reports were more complete with a 1961 report by Grant Simon recommending thirteen different methods for preserving the marble; however, no indications have been found that his cleaning recommendations were followed. Simon wanted the marble cleaned with water and brushes. More difficult areas were to be washed by hand with brushes supplemented with steam pressure at less than 100 psi. He recommended that the most difficult areas be cleaned with the previously mentioned steam pressure and by hand, supplemented with sand. After restoration, the exterior would be cleaned with water, and where necessary, scrubbed with fiber brushes on an annual basis. He discouraged the use of water repellents, detergents, or chemical solutions. Only water was to be allowed.

Figure 4: South façade, in process of being cleaned, 1942.

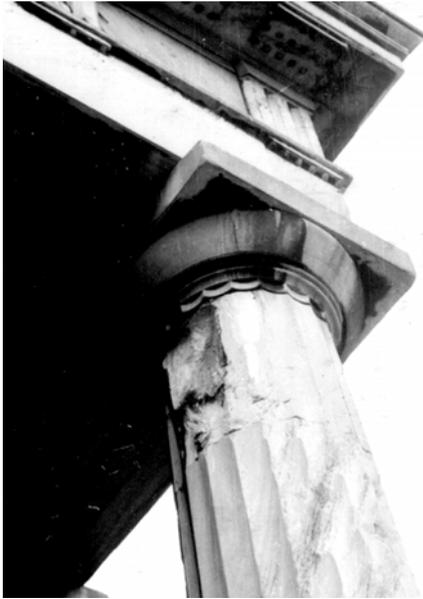
Some care was taken to report deteriorating exterior stone from 1964 to 1965. On 21 January 1964, a fragment of marble fell off the top of the column on the east end of the north façade.²⁰ (Fig. 6) In July 1964, Architect Joe Petrak reported that a large area of spalling on the shaft of the northwest column was clamped in place and needed "extensive repairing or partial replacement."²¹ In

Figure 6: North portico, column 1, dimensional loss. 1964. Note fresh loss of upper area in 1961 photograph (Fig. 5).

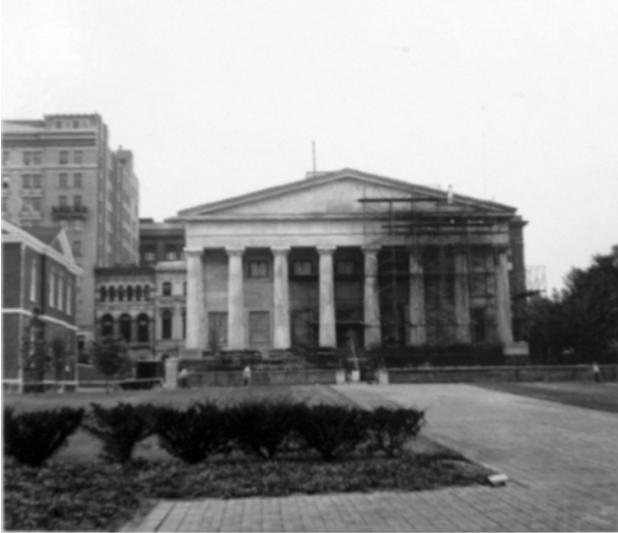
Penny Batchelor reported that the fluoride solutions were applied with soft bristle brushes and rinsed with clear water.²⁴ Photographs taken in July and August of 1964 indicate the cleaning patterns for only the north and south façades. (Fig.7) For the north façade, the scaffolding was first erected on the eastern side of the portico. The workers started cleaning at the apex of the raking cornice and then proceeded down to the columns and ashlar stones. The scaffolding was first set up on the west side of the south façade beyond the sides of its porticoes. The pediment was cleaned from top to bottom, and then the columns and the ashlar were treated in the same manner.²⁵

Figure 7: South portico in process of being cleaned. 1964.

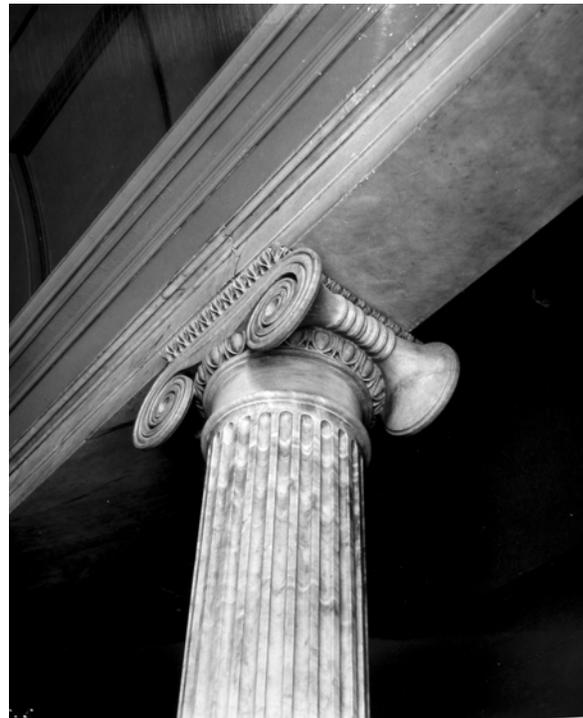
Figure 8: Interior column capitol cleaned with a poultice. 1974.

A photograph taken on 2 May 1974, documented an original column capitol had been cleaned with a poultice.³³ (Fig. 8)

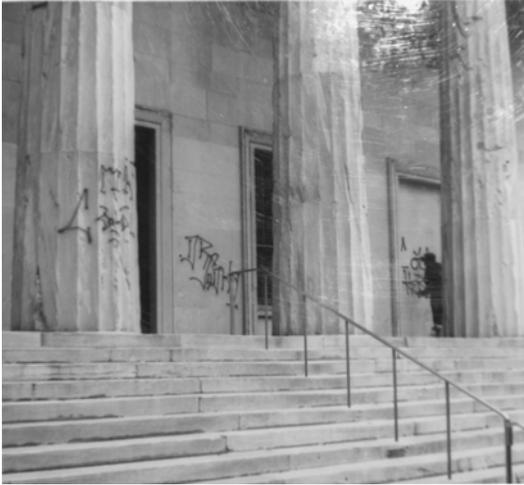
Figure 9: Worker cleaning spray paint vandalism. 1971.

Some marble deterioration was carefully recorded during the 1970's. In April 1971, a worker was photographed painting an unidentified cleaner onto spray paint graffiti on the north façade.³⁴ (Fig. 9) A color slide taken in September 1975 shows yellow patches on the N-2 column, indicating old epoxy repairs.³⁵ In 1975, Penny Batchelor noticed that a "rather sizable" piece of marble was on the verge of spalling off from the column next to the west of the north façade [Column 1]. "The piece is below waist level facing

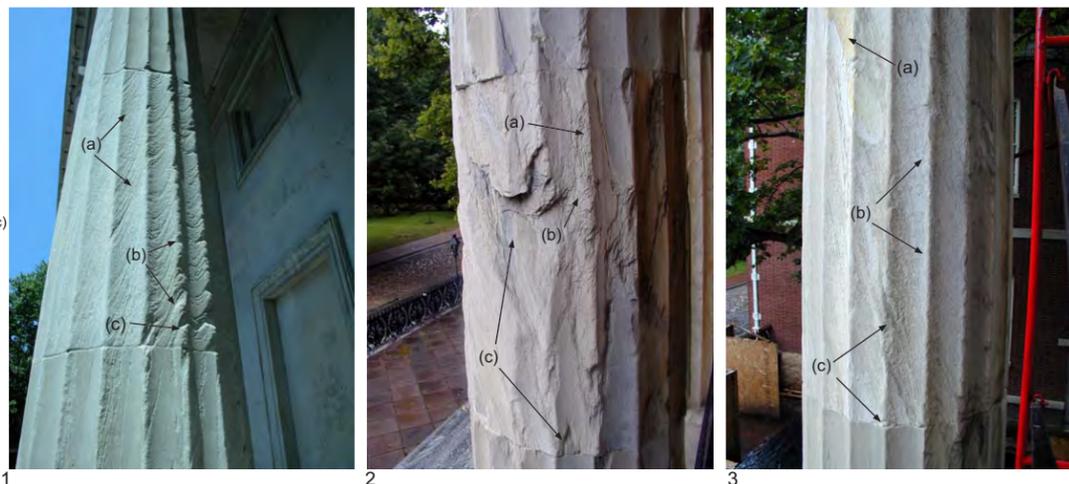
- 1: Column 3 flutes 14-18 (drum 3). An example of (a) stone redressing (b) differential erosion, and (c) incipient spalling.
- 2: Column 3 flutes 17-18 (drum 2). An example of (a) contour scaling, (b) differential erosion, and (c) significant dimensional loss.
- 3: Column 1 flutes 16-21. An example of (a) a mineral inclusion, (b) stone redressing, and (c) dimensional loss.

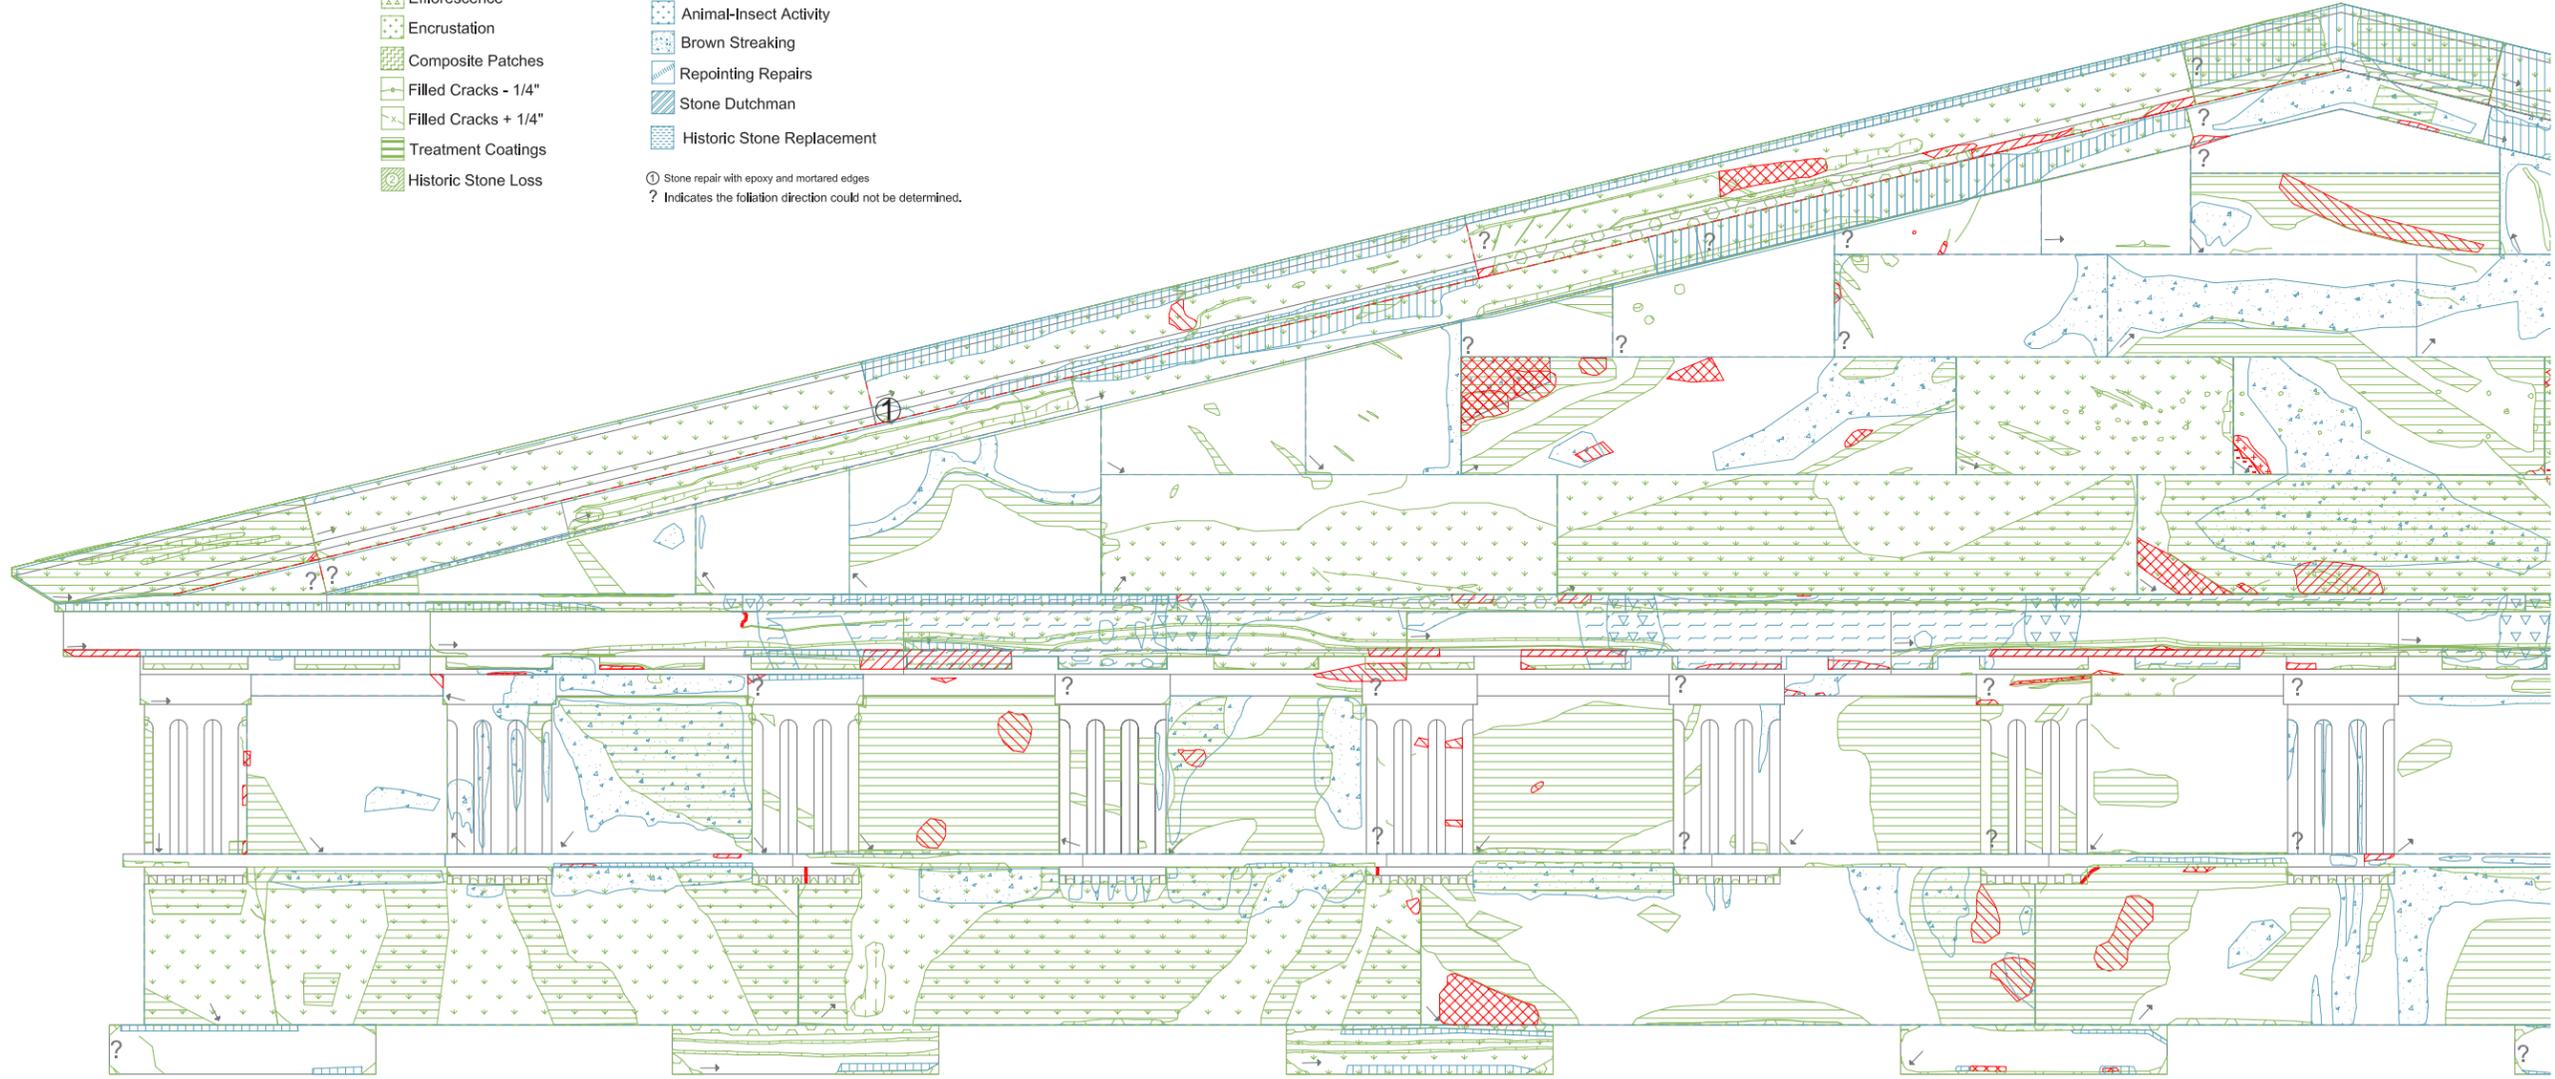
C1 NORTH PORTICO PEDIMENT - East Half
SCALE 1/4" = 1' 0"

1. Entire raking cornice has metallic staining from the roof

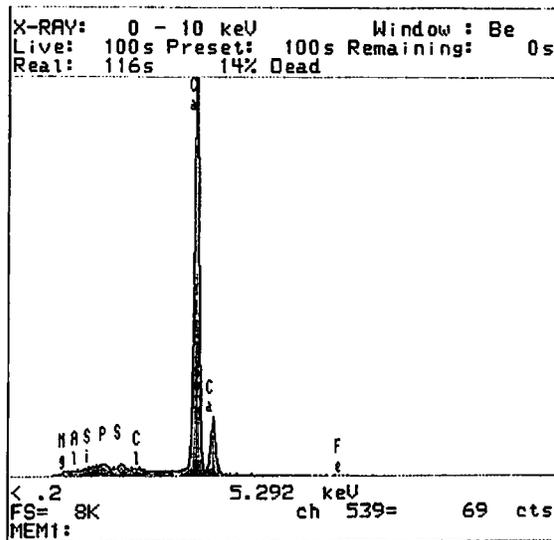
XRD, marble surface without coating

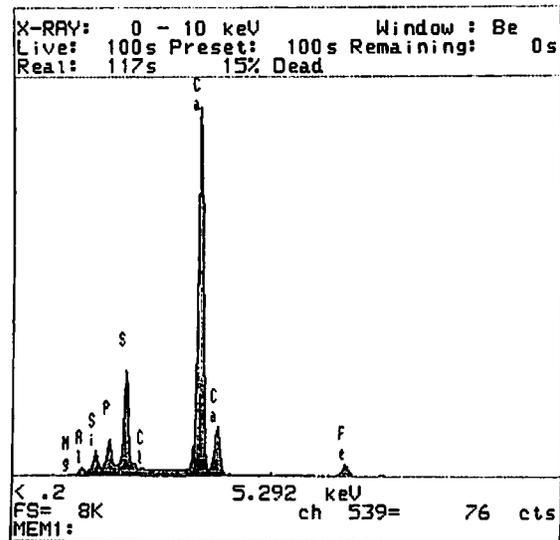
XRD, marble surface with coating

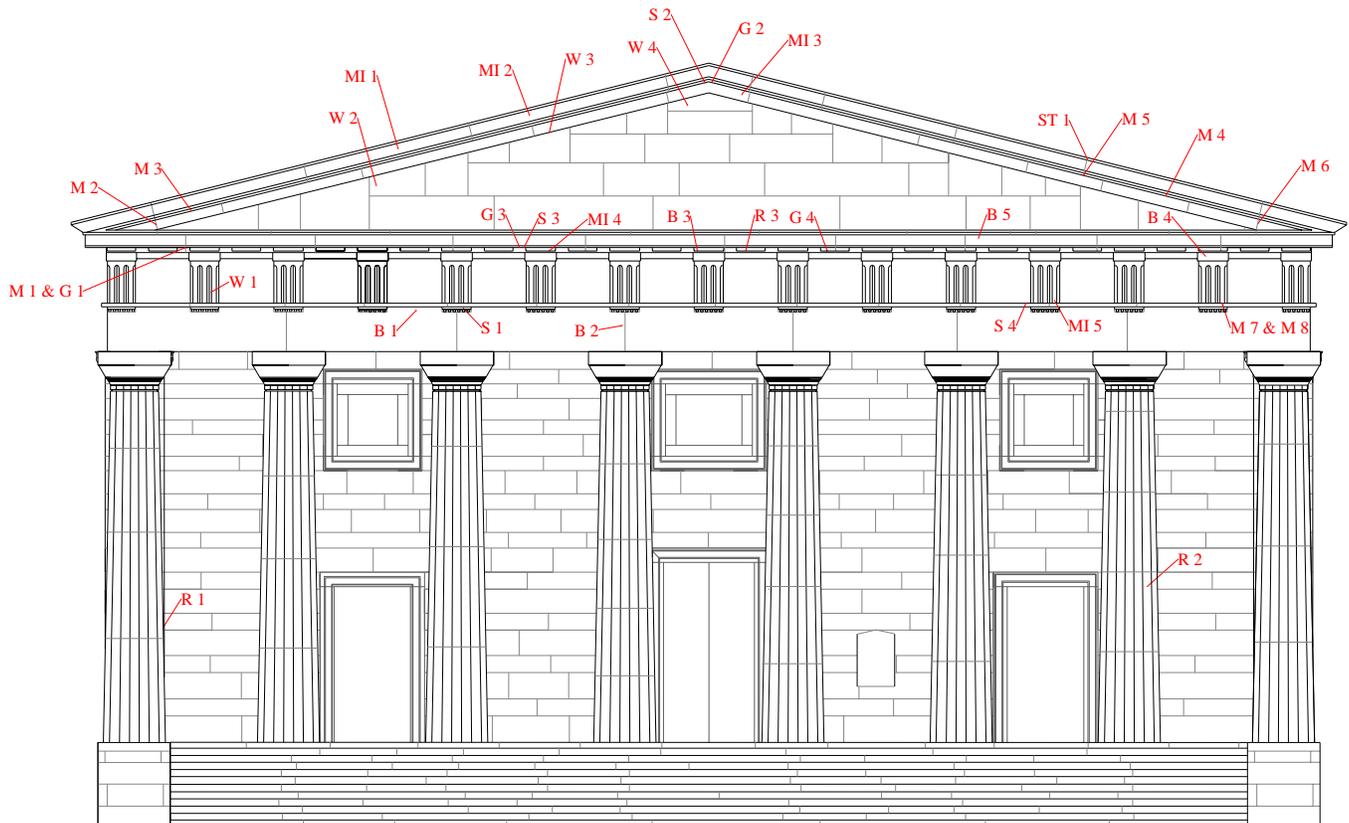
Locations and identification numbers of samples taken from the north façade in 1999.

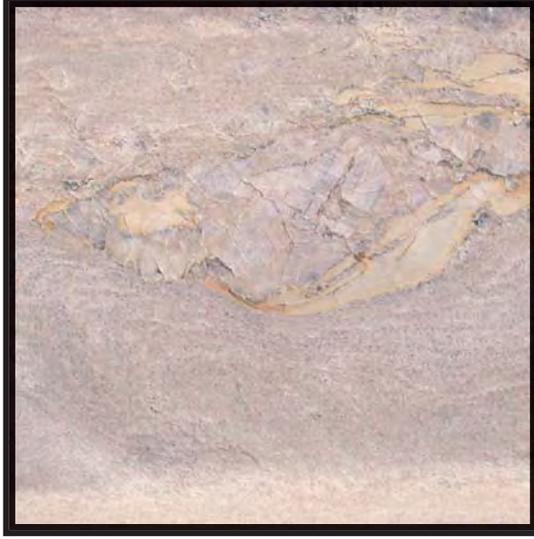
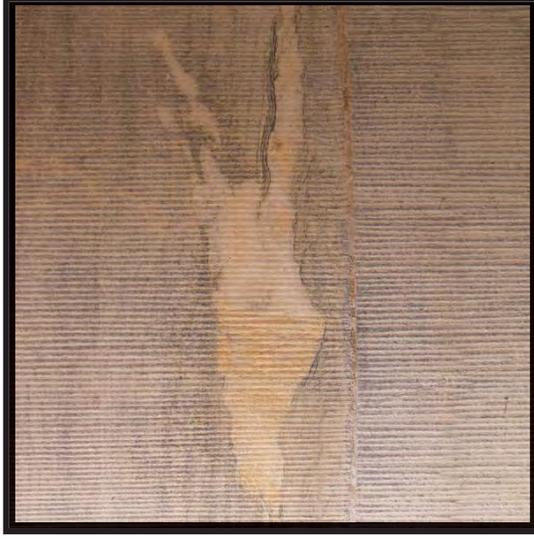
(a) Raised in relief

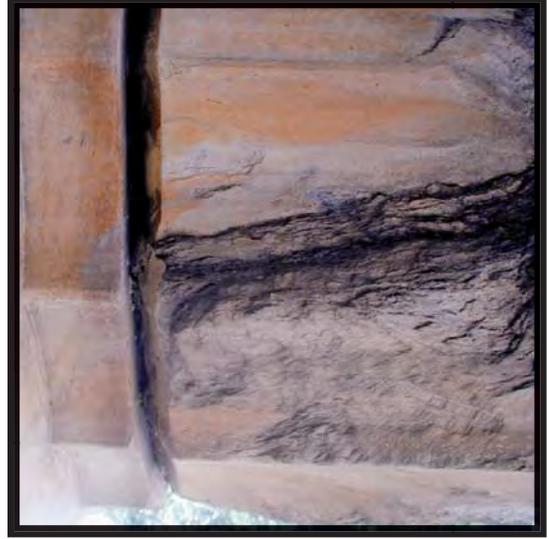
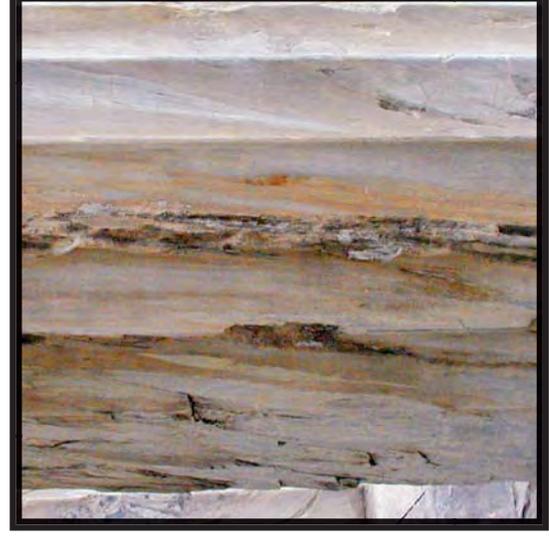
(b) Weathered out

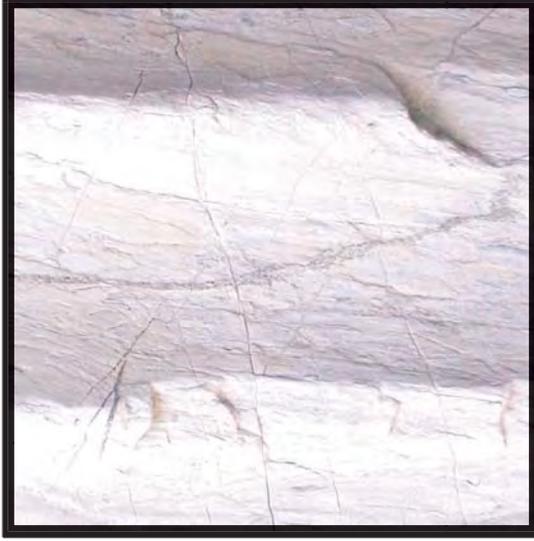
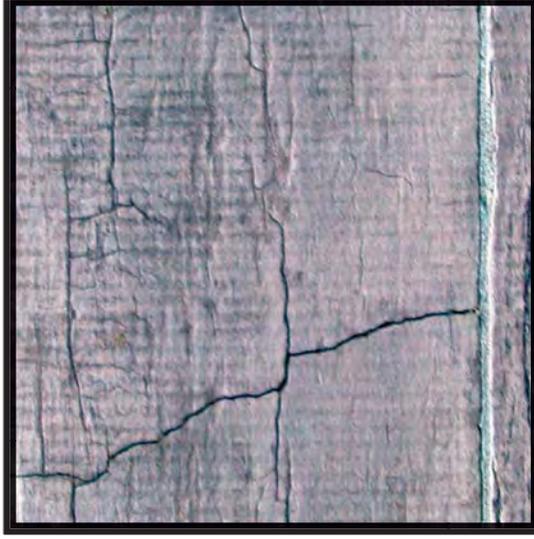
A patterned network of fine intersecting cracks occurring on the surface of the stone, often in association with mineral inclusion-rich areas.

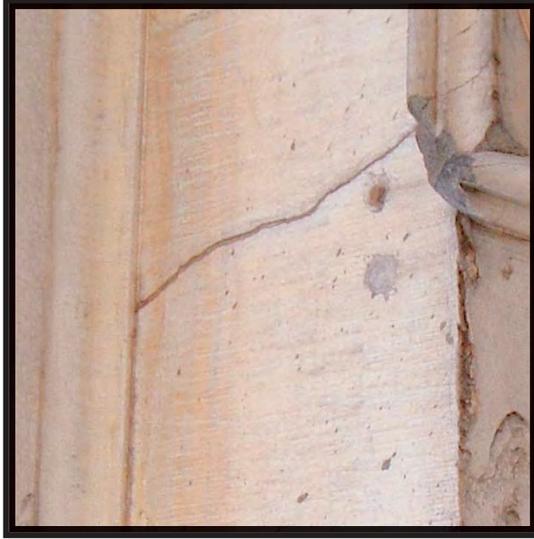
Cracks that are 1/16-1/8 inch (1.6-3.2 mm) wide, of varying orientation and depth. These can be either (a) structural or (b) those that occur along foliation planes.

(a) Structural crack

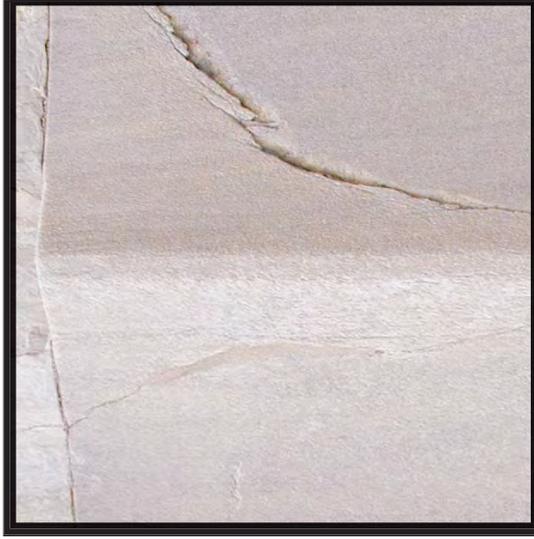
(b) Foliation crack

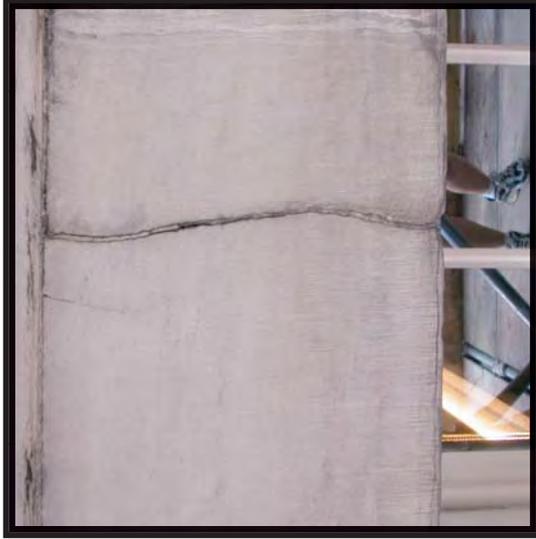
Cracks greater than 1/8 inch (3.2 mm) wide, of varying orientation and depth. Usually associated with (a) deformation / displacement and/or (b) incipient spalling.

(a) deformation or displacement

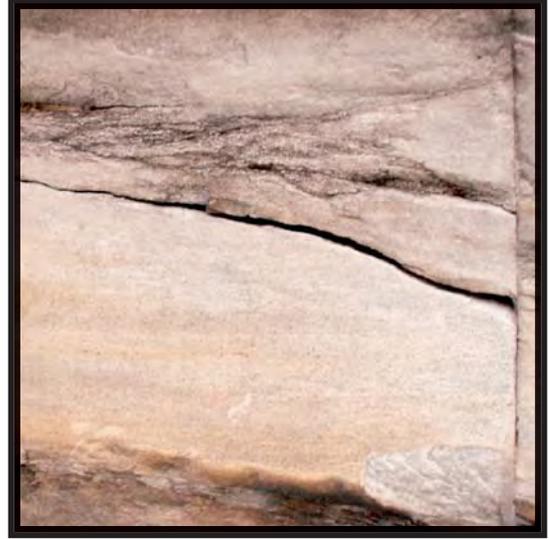
(b) incipient spall

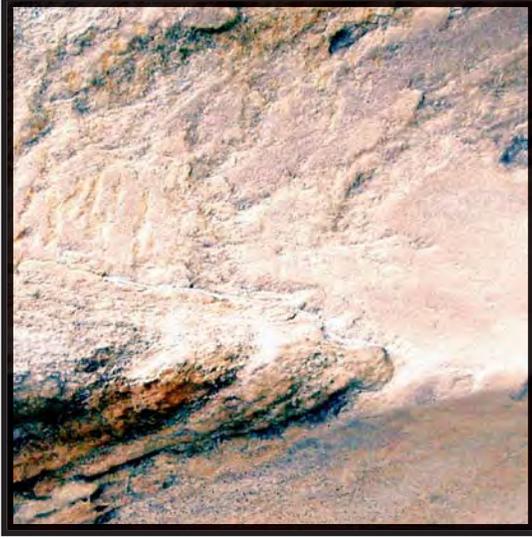
(a) Coarse texture

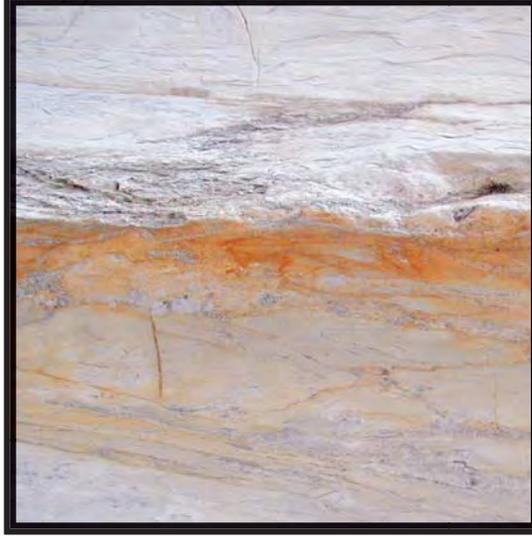
(b) Localized loss

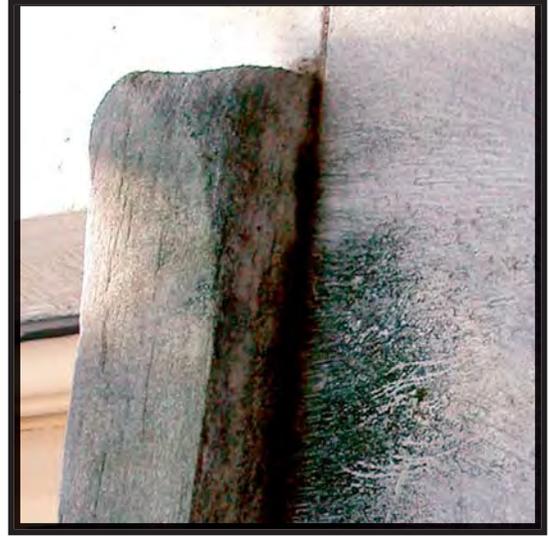
(c) Reduction of surface details

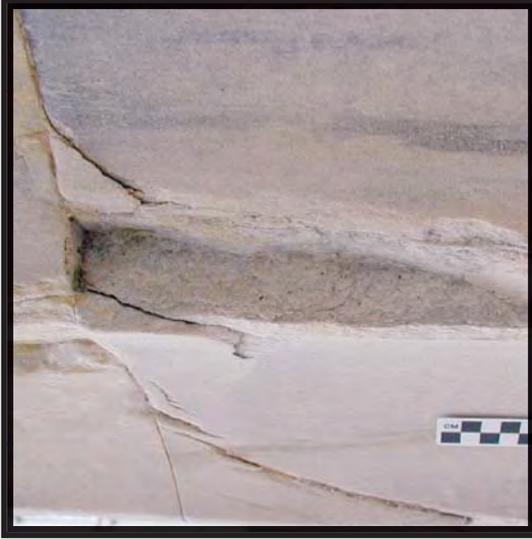
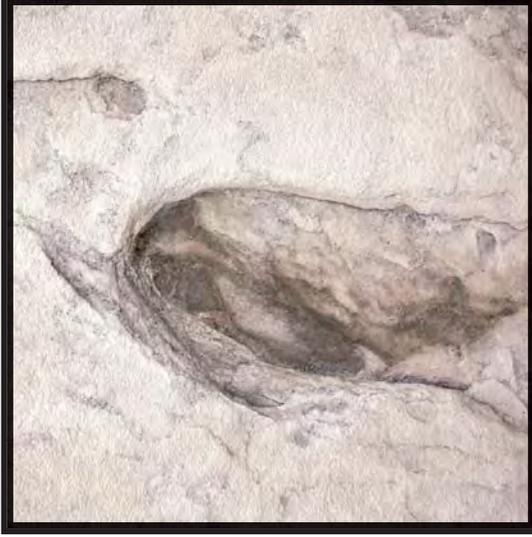
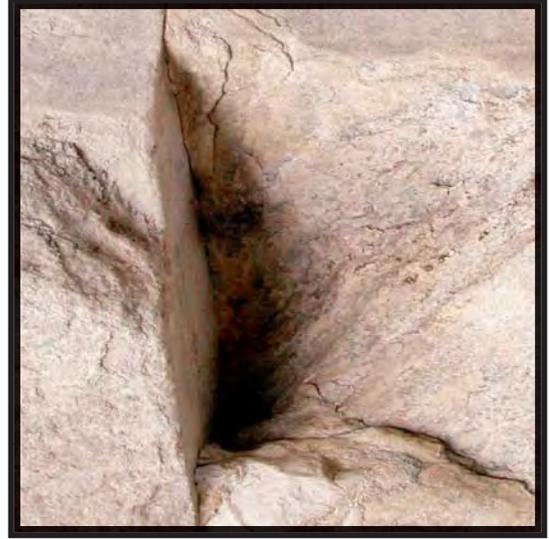
Dimensional loss

Localized stone loss greater than 2 square inches in area and at least ½ inch in depth as measured in plane with the surrounding stone surface. This may or may not be in association with spalling.

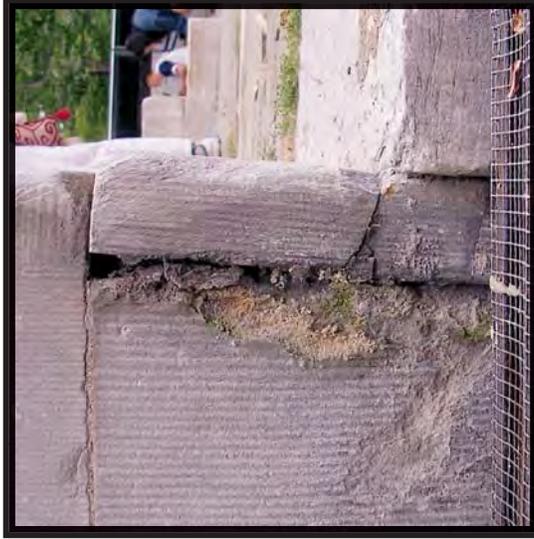
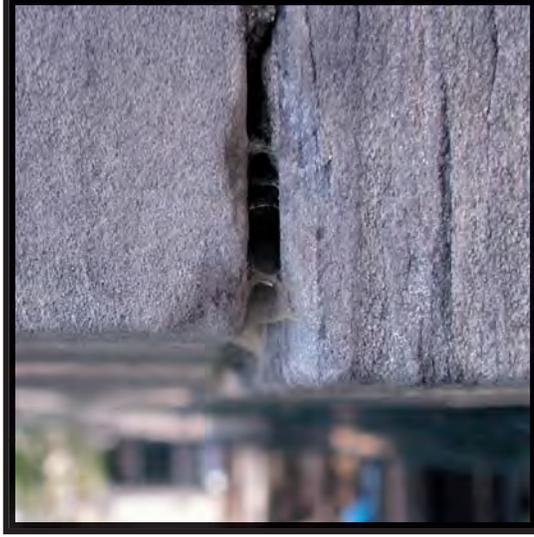
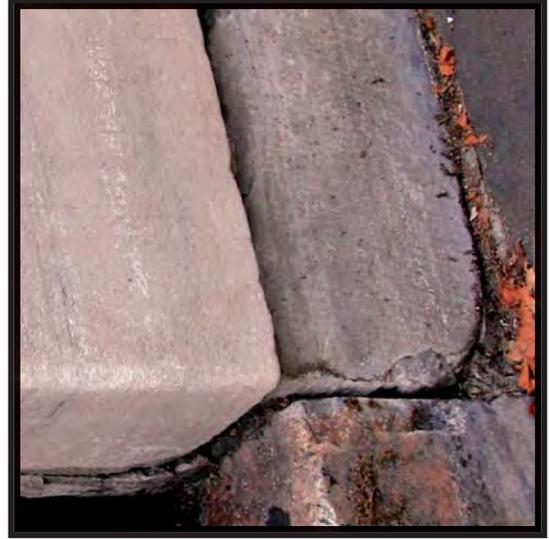
Movement and cracking or separation of one or more stones resulting in the shifting of stone surfaces more than 1/2 inch out of plane. Relative planar shifts recorded as (+) or (-).

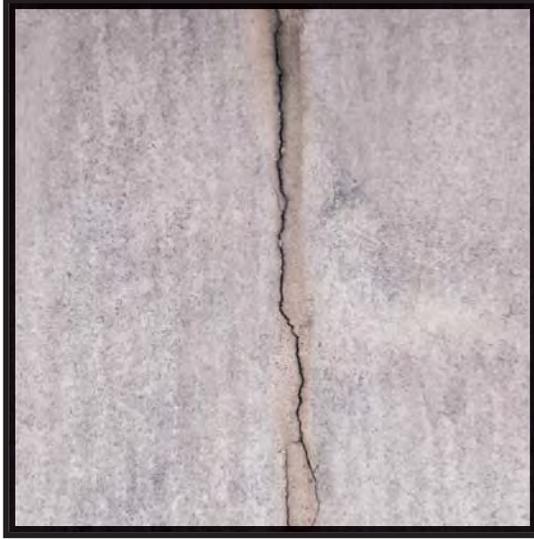
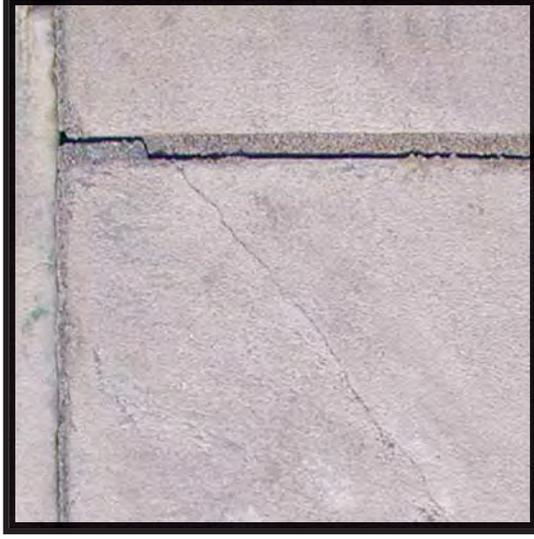
Deteriorated mortar joint

Stone joints where the mortar is still present but eroded back 1/2 inch or more in depth, or noticeably cracked, or separated from the stone.

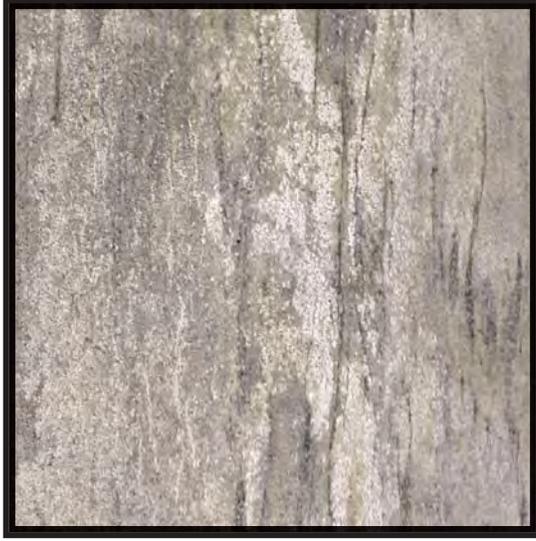
Efflorescence

White crystalline, water-soluble deposits on the surface or within the pores of the stone indicating the presence of damaging salts.

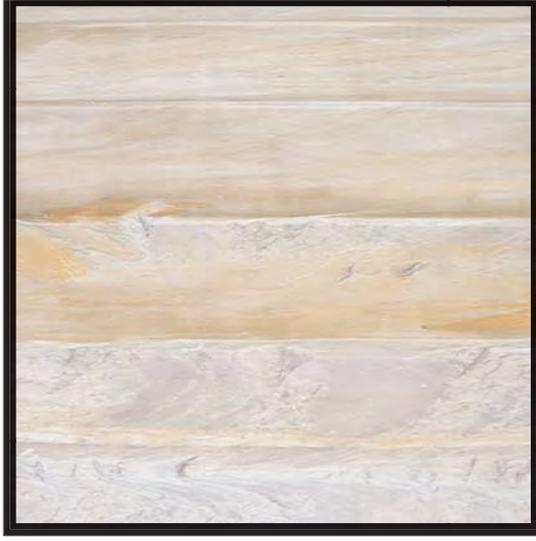
Localized discoloration resulting from the weathering of either (a) intrinsic (mineralogical) or (b) extrinsic (copper or iron accessories) sources, usually black/brown (iron) or blue/green (copper) in color.

(a) intrinsic staining

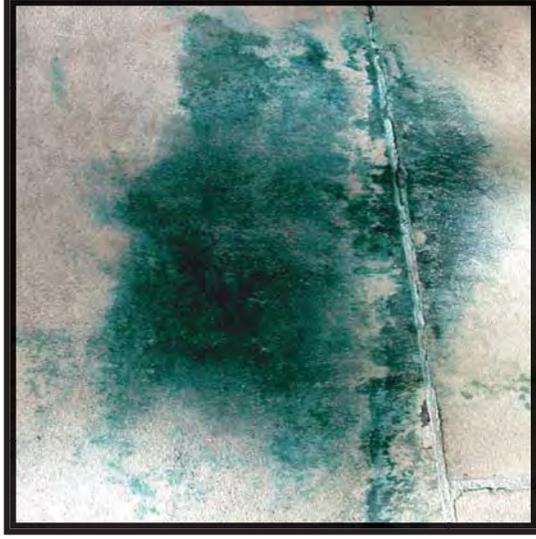
(b) extrinsic staining

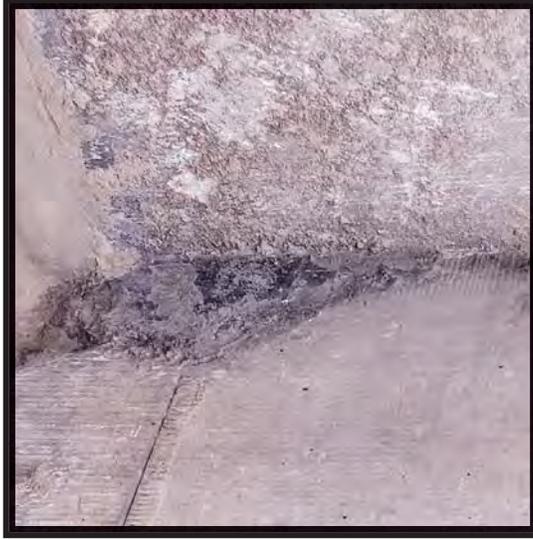
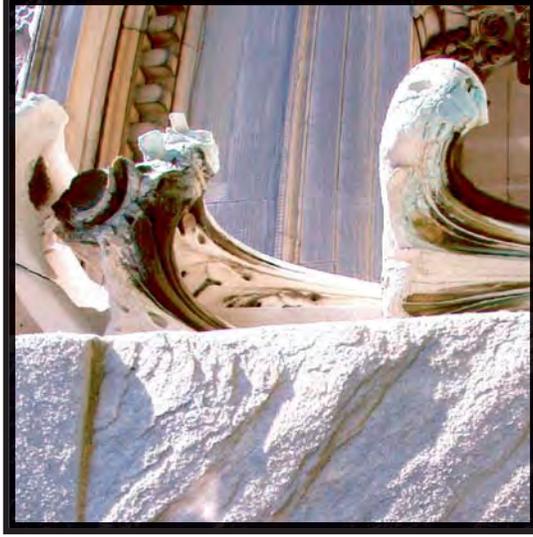
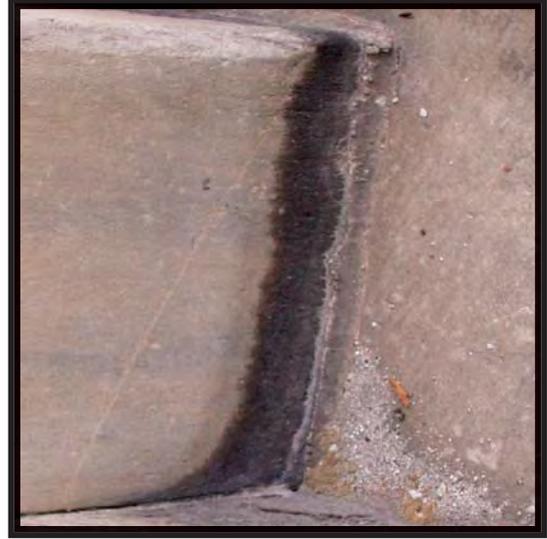
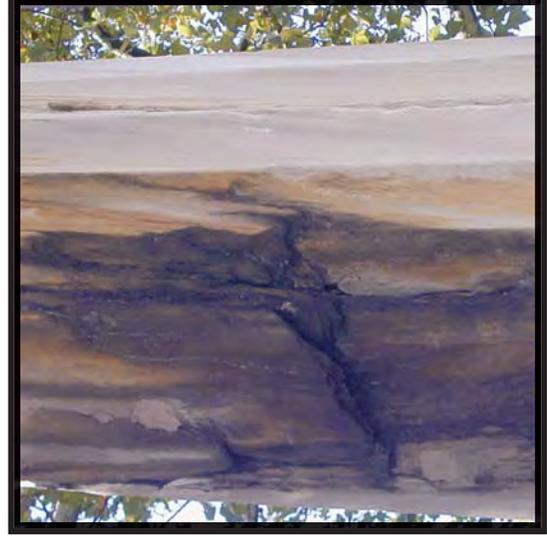
Formation of gray to black smooth deposits or framboidal crusts in protected areas that are noticeably more concentrated than the prevailing soiling patterns.

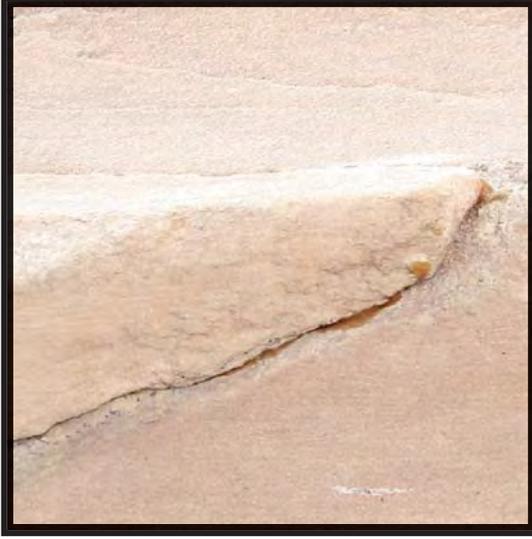
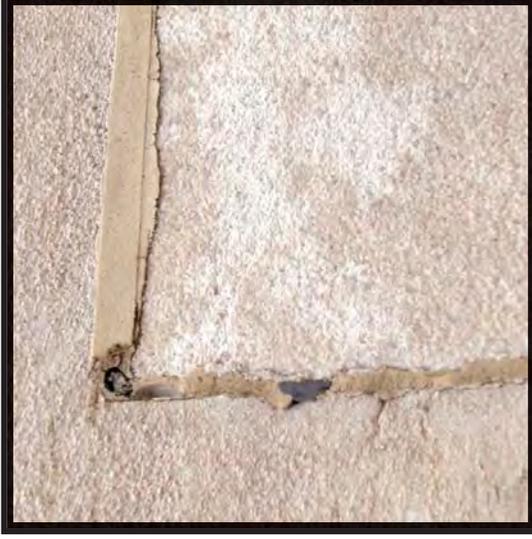
Sealant repair

Presence of elastomeric sealants used as a masonry repair or pointing material.

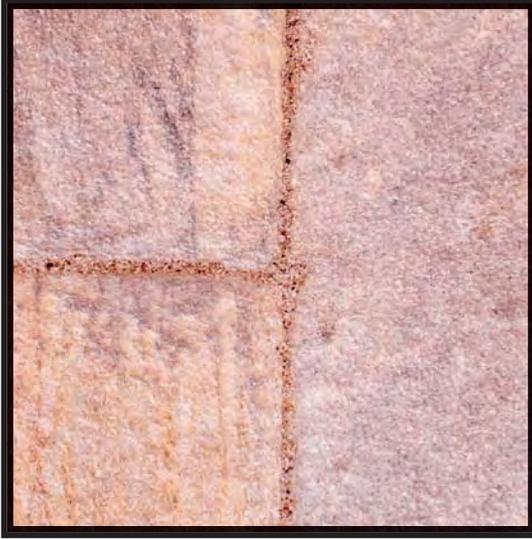
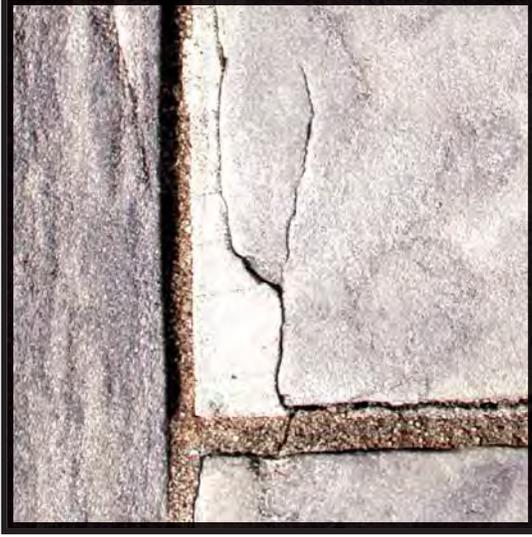
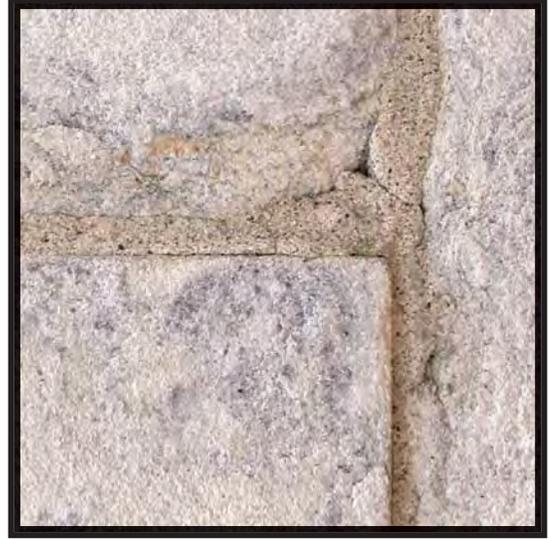
All non-original mortars used for repointing joints, usually gray or white in color and often in association with joint recutting.

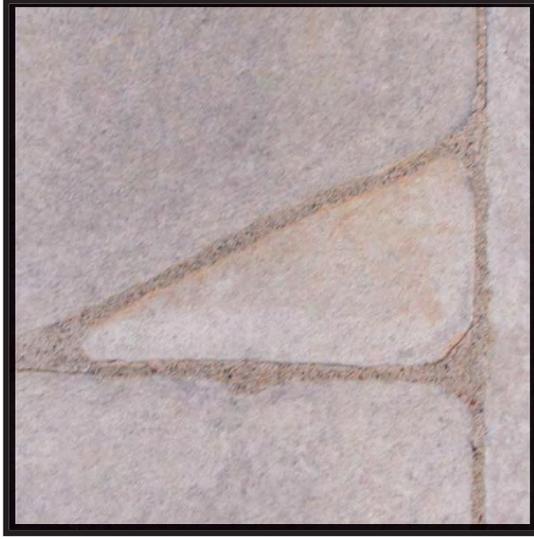
(a) dutchman with mortar

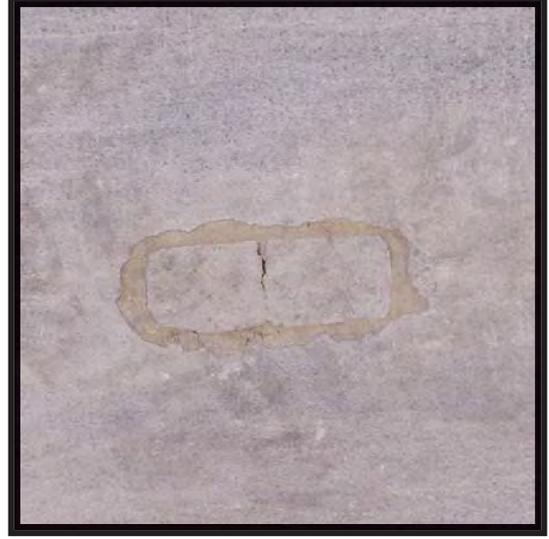
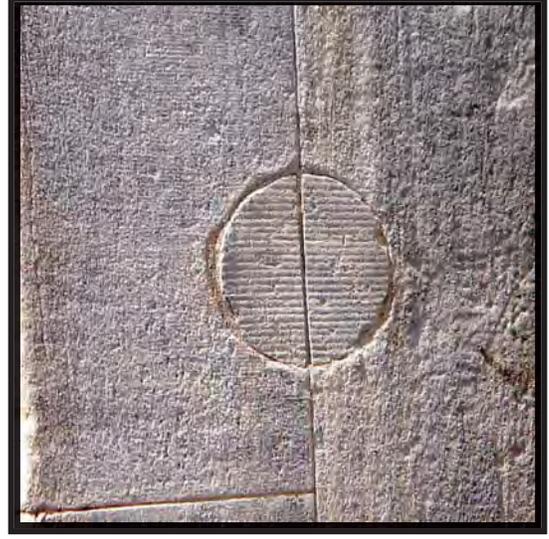
(a) dutchman with mortar

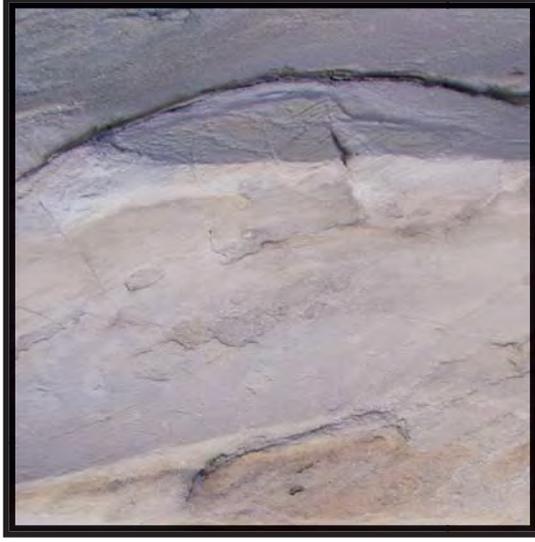
Repairs to cracks executed at any time (a) less than 1/4 inch in width.

(a) Less than 1/4 inch

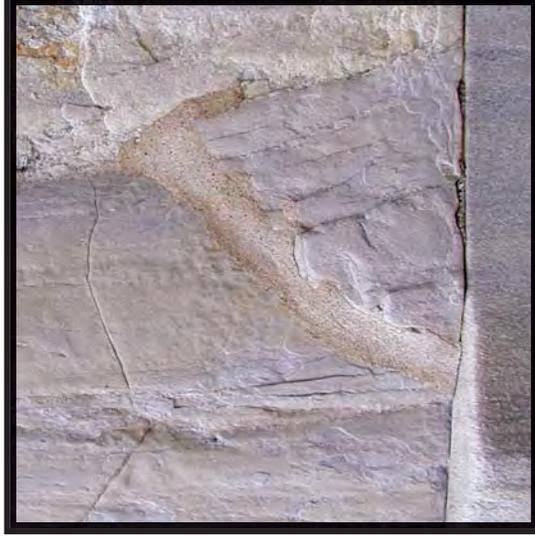
Repairs to cracks executed at any time (b) greater than 1/4 inch in width.

(b) Greater than 1/4 inch

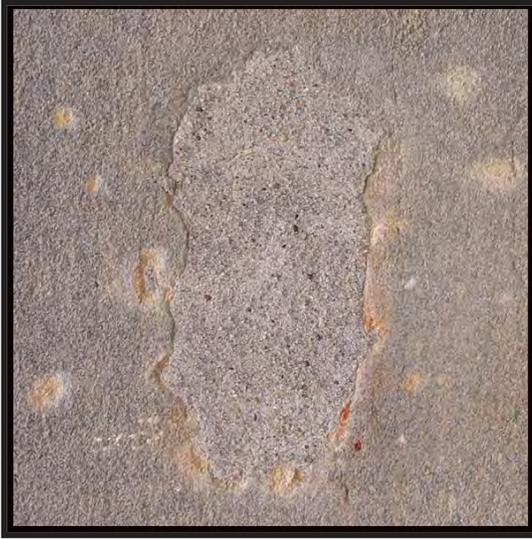
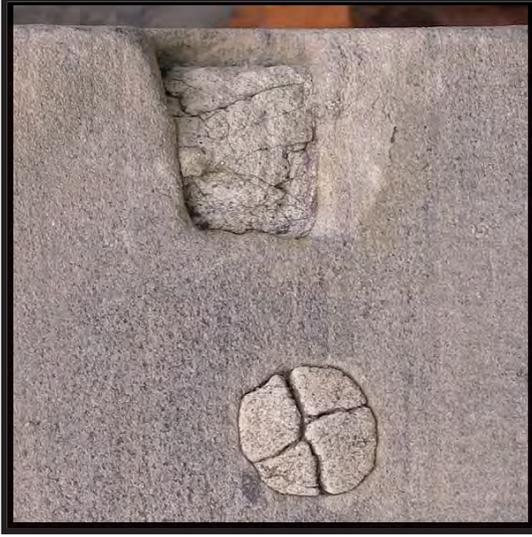
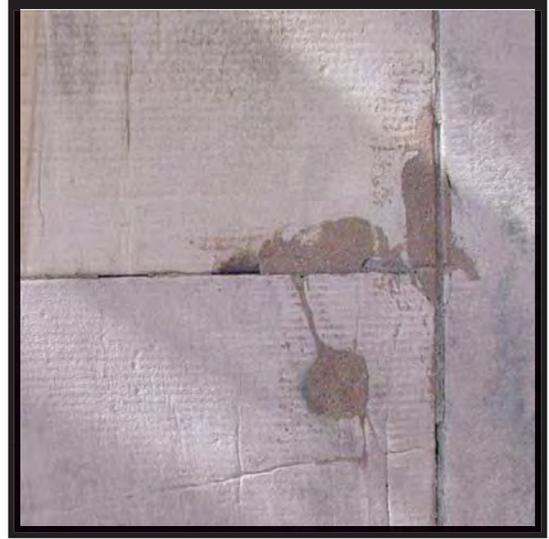
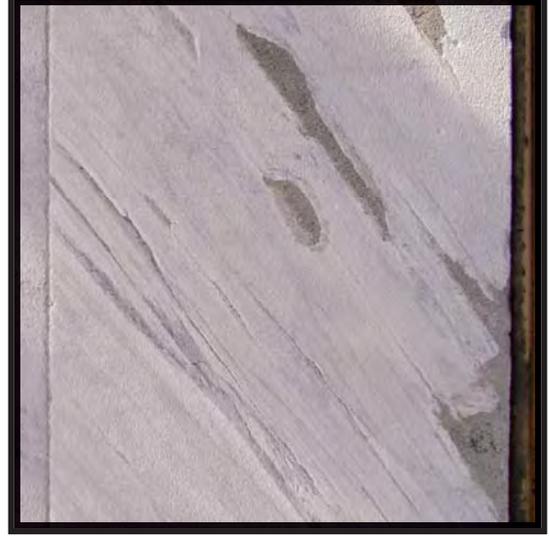
Composite Repairs

A mortar or resin based system, used as a surface repair greater than 3/4 inch in width for spalls and overall losses, including those along joints, but not for cracks.

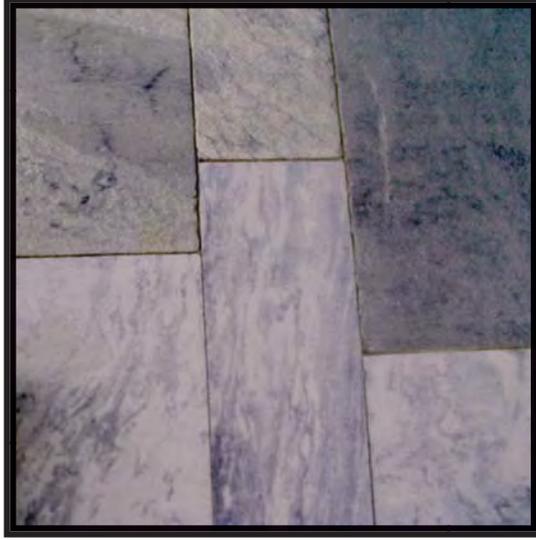
1976

Stone Replacement

Physical and/or archival evidence that complete stones or sections of the building, terraces, or perimeter walls have been replaced. Include date if known.

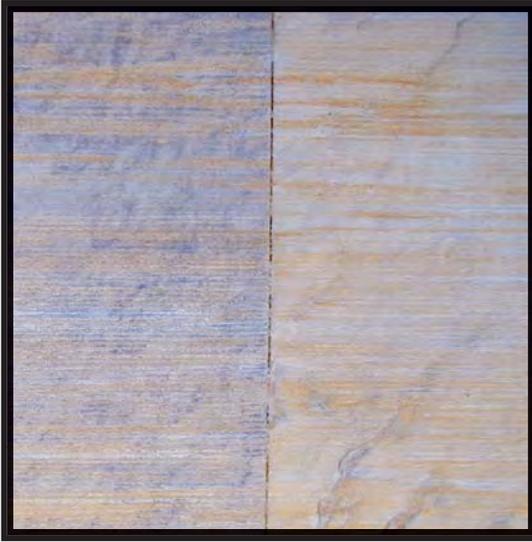
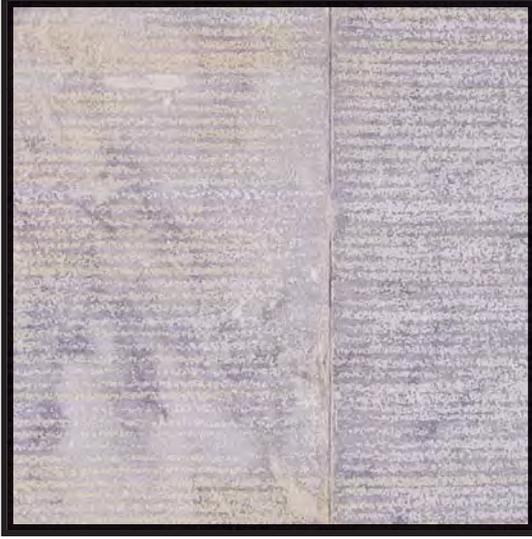
The past application of a coating on the stone surface, generally off-white or pale yellow in color.

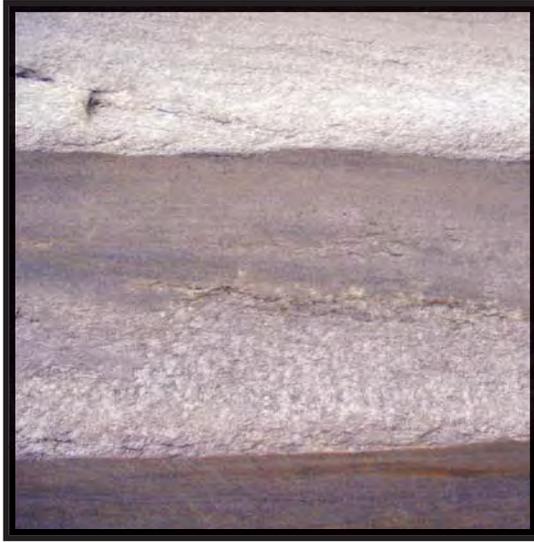
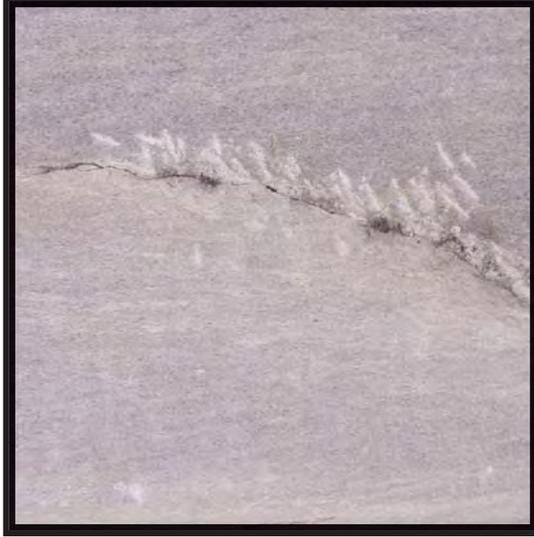
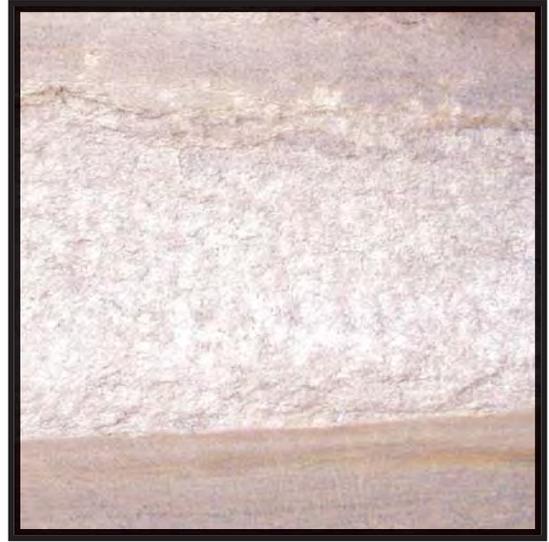
Tooling marks that indicate the selective redressing of stone to address advanced surface deterioration.

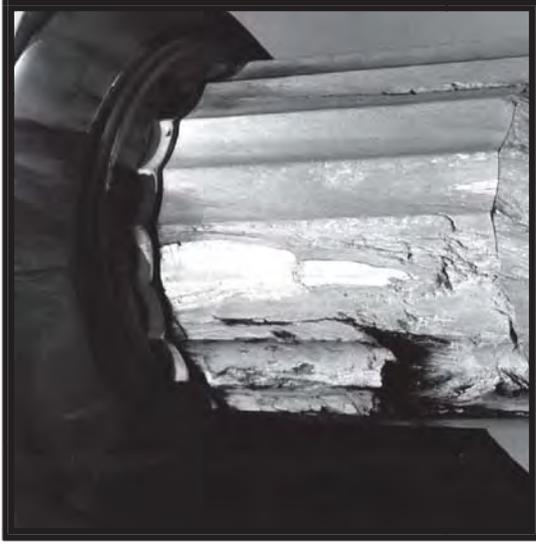
1961

Historic conditions

Historic photographs that provide a time-based comparison of stone loss, weathering, and soiling patterns.
