University of Pennsylvania Architectural Laboratory and Research Center

Marine Garden  
Locator Map  
Condition Survey

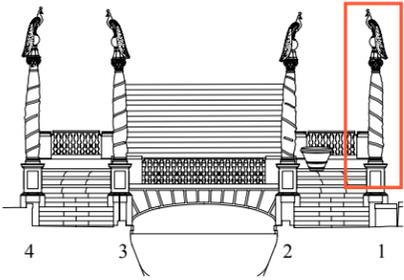
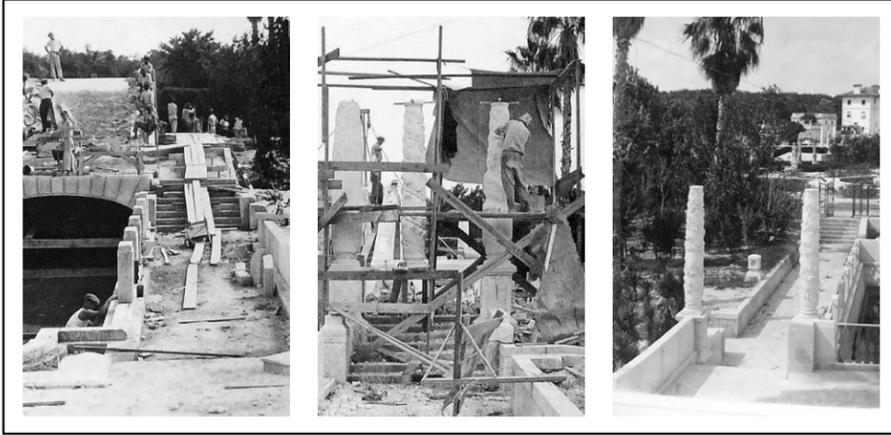
Historic images of peacock columns 1 and 2 during construction.

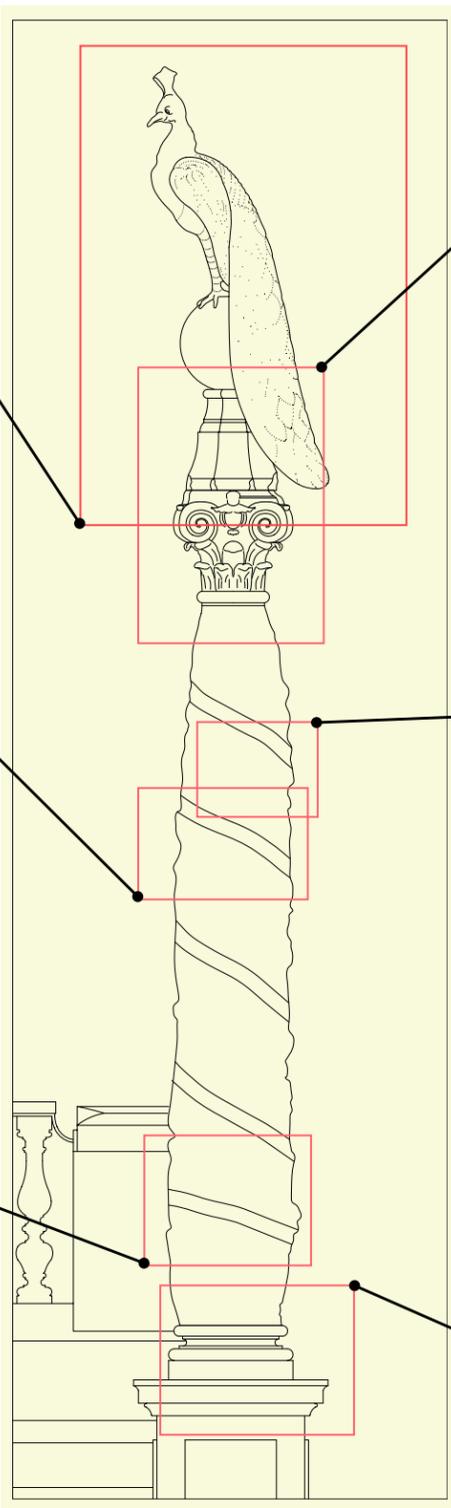
Although this sculpted peacock is largely original, the sphere on which the bird is standing is a cast reproduction. The base on which the sphere rests is cracked and suggests that the top sculpture was carved separately and is probably keyed to the column with a pin and socket joint.

The original column shaft decoration contained a wound garland of stylistic leaves and fruit suspended from a vine. Previous replacement of the leaves appears unnatural and heavy in comparison to the original.

Mortar repairs on the upper third of the column do not recreate the texture and color of the original carved stone. However, an effort was made to recreate some of the garland details by attaching cast leaves and direct modelling the spiraled vine.

Patching at the bottom of the column appears to have been carried out in two campaigns. All mortar repairs are poorly executed.

The entire base of the column has been mortar repaired.

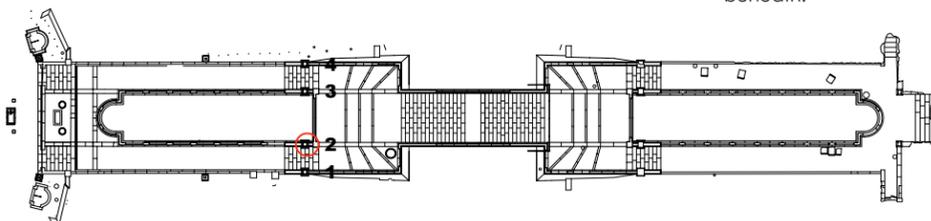
Extensive cementitious repairs are evident on the juncture of top of the capital and the base for the peacock sculpture. The repair conceals where the sculpture was completely separated from the column. The execution of this patch is poor.

Although there is evidence of major repairs on all of the peacock sculptures, the Column 2 peacock appears to be a complete replacement casting. Seams along the tail are evident and the beak of the bird is oversized in comparison to those of the other columns. The chest, thighs, and feet all appear heavy and ungraceful. In addition the texture, color, and general appearance of the original stone has not reproduced in the replacement.

With mortar repairs to all of the columns, there is evidence of multiple layers where the columns may have been repaired more than once, or a finish coat was added in an attempt to integrate the patch into the original form. For column 3 the top coat has begun to deteriorate, exposing the earlier patching material beneath.

As in other cases, the column base has been completely repaired.

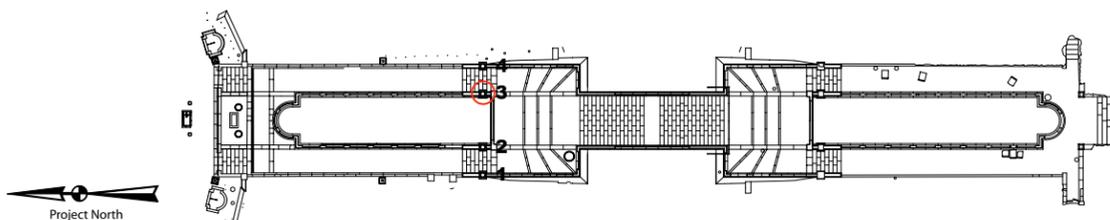
Like all of the other columns, severe failure and repair is evident at the bottom of the column where the shaft meets the base. The patching effort here is extremely poor in execution with no attempt to visually match the original stone.

The Column 3 peacock sculpture appears to be the best preserved of the four figures. Although the head and portions of the feet are clearly replaced with mortar, the large sphere on which the bird sits is original stone. The form supporting the sphere is also completely replaced. Although the tail of the peacock on Column 3 appears to be of original stone, the underside has been repaired.

In two locations on Column 3, mortar patches have been applied and tooled to approximate the original stone carving. This type of patterning is not found in any other location on the four columns.

A large patch at the bottom of the shaft of the column clearly shows the visual inconsistency between the original carved stone and the applied mortar repairs.

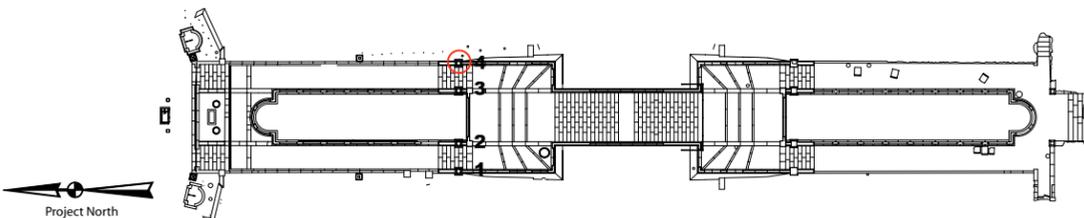
The patching at the juncture of the shaft of the column and the base is very poorly executed with little attempt to recreate the sharpness of the original. In addition, the proportion of moulding are inaccurate.
