3.3 Conditions Survey: Fort and Cabins

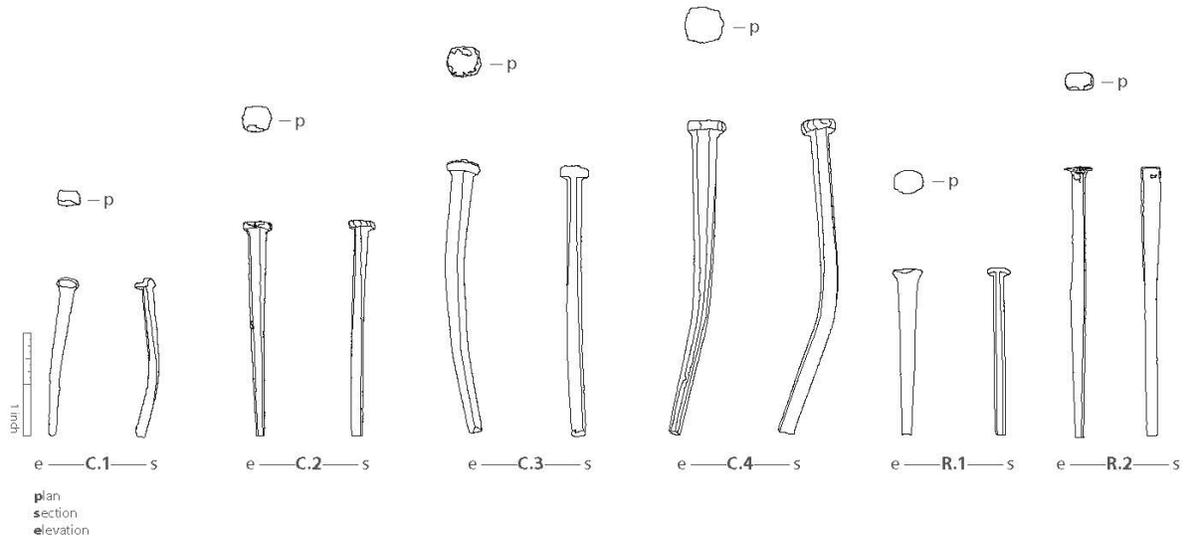
and shape of the head and size and shape of the shaft. Of the thirteen cut nails sampled, six categories were identified.

CUT NAILS			
Type	Length (inches)	Period	Use
C.1	1.5	Original	103: fireplace molding, beveled backband on door casings
C.2	2	Early Installation (pre-1900)	102: stair risers; 202: baseboards
C.3	2.5-2.63	Early Installation (pre-1900)	102: stair treads; 104: door casings
C.4	3	Early Installation (pre-1900)	104: door casings; 202: altered floorboard; 204: baseboards
R.1	1.5	Unknown	102: beadboard door; 103: Dutchman repair
R.2	2.5	Unknown	204: baseboards

Although the typologies are based solely on length and identifiable features, further evidence of their periods of use and function emerge from their location within the Fort buildings. Comparisons of types are made across elements of the same period, which have been established by the molding profile analysis (below), historic documentation, and onsite investigations. The samples corroborate the periods of construction and show that certain nail

types were used only in original features while other types were also used in early alterations. Reproduction nails do not appear to be restricted to moldings and casings fabricated during the restoration period. These reproduction nails were likely used in minor repair work, such as reattaching loose or temporarily removed moldings, as well as Dutchman repairs (i.e., partial replacement) of the woodwork.

An examination of the nail locations supports the installation dates of various features and suggests that certain alterations were likely contemporary. Type C.1 nails are found within the parlor fireplace surround and applied beveled backband to the door casing on the partition wall—both believed to be original features with no alterations (although these moldings may have been removed for repair with the original nails used in the reattachment). More sampling would be necessary to confirm whether this specific type was used exclusively in original moldings. It is possible that they were not used in any of the early alterations, since their use is generally limited to more delicate or ornamental moldings. No cut finishing nails were observed in the lower building.

The remaining sampled nails—types C.2, C.3, and C.4—were found in features altered at the end of the nineteenth century. These nails, all similar in their characteristics but of variable overall size, were used extensively in the meeting room stair risers, treads, and surrounding baseboards and adjacent floorboard. The doorway between the spring and cheese rooms—probably installed at the same period as the upper building staircase—contains door casings fastened with the larger nail types. These historic cut nails were not identified in any known restoration elements.

Because reproduction nails are found intermixed with cut nails in historic elements, their presence does not definitively indicate areas of restoration or heavy repair of a feature. These

nail types, R.1 and R.2, appear to be less frequently used and, consequently, a specific period of use cannot be ascertained. First use of these nails has been approximated to the later Fort restorations, although no specific date has been established for any of the three samples. The extensive use of wire nails during the earliest restorations reduces the likelihood of these nail types being incorporated into work done prior to 1930. Their appearance possibly coincides with the 1959 restoration, or even later work. Sampled from a Dutchman repair, a historic baseboard, and the kitchen beadboard, there also seems to be no apparent consistency to their locations within the Fort buildings.

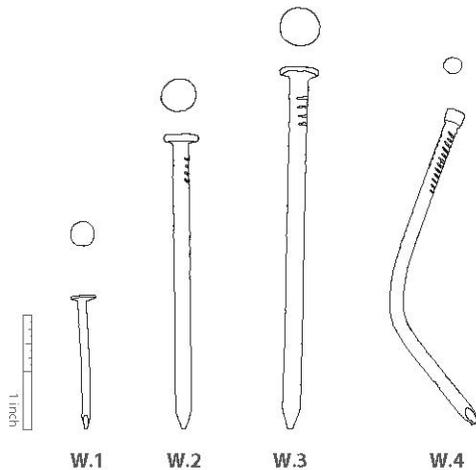
WIRE NAILS			
Type	Length (inches)	Period	Use
W.1	1	Early Restoration (1930)	204: lath
W.2	2.5	Early Restoration (1929/1930)	204: floor; 205: baseboards, floor
W.3	3	Early Restoration (1929/1930)	204: baseboards; 205: floor
W.4	3	Early Restoration (Post-1923)	204: baseboard

Wire nails, found in both the upper and lower buildings, were used in restoration campaigns and localized repair work of historic and replacement material. The change from cut

to wire nails occurred when the site became a national monument and NPS commenced a full restoration program. At this time, cut nails were no longer used (although extant nails were reused), and the large-scale renovations within the lower building's upper floor were completed using wire nails. These earlier projects—dating to 1929 and 1930—included the doubling of the floorboards in this upper space and the erection of the two partition walls, which created three equally sized rooms. Three of the sampled wire nail types are found in these early renovations. Type W.1 was removed from the wood lath of the partition wall between the southeast bedroom and middle room, and dates to the wall's 1930 installation. No other lath nails were sampled, but circular sawn lath and wire nails were observed in the northwest bedroom, which is the only other plaster and lath wall system aside from the two lower building's 1929 partition walls. Nail types W.2 and W.3 are similar in their head and shaft characteristics but differ slightly in size. Both types were used extensively in the 1929 floor installation, but were also used, likely immediately following the floor installation and/or wall construction, to resecure historic baseboards and fasten new moldings to the walls. The last type sampled, W.4, was removed from a southeast bedroom baseboard with extensive nailing and is possibly a later addition used to strengthen the connection to adjoining baseboards.
