# BAR BC DUDE RANCH

## CONDITION ASSESSMENT AND REPORT

University of Pennsylvania  
Architectural Conservation Laboratory

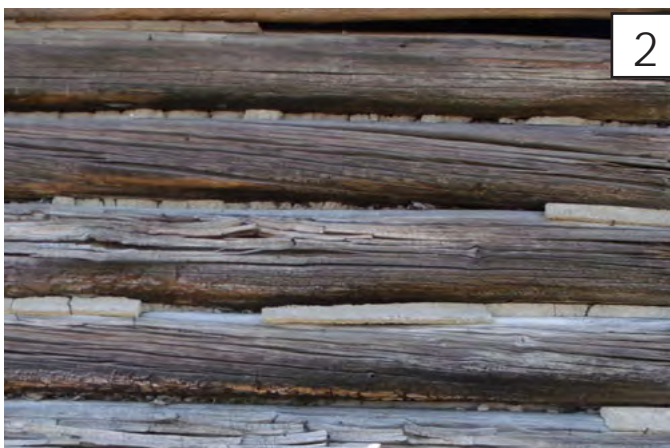
2 between 25 and 10% of total chinking material is present in the log joints.

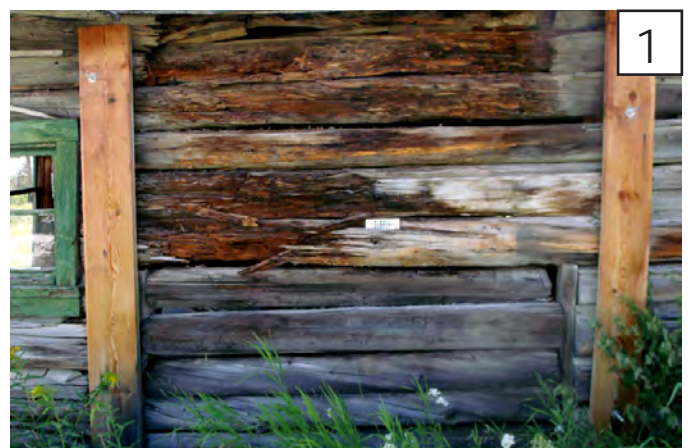
1 10% or less of total chinking material still is present in the log joints.

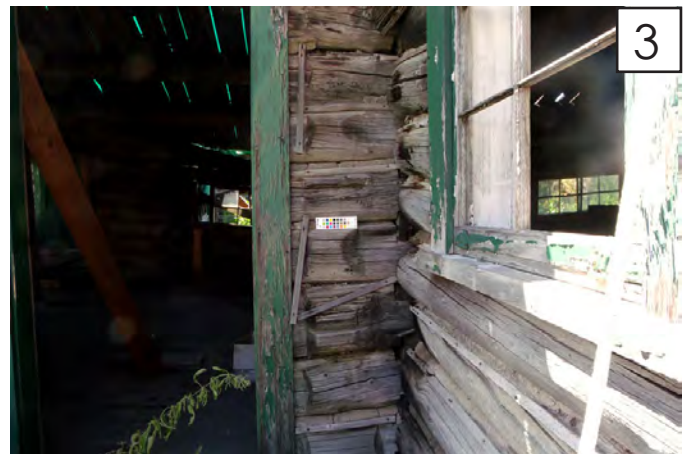
3 corners have separation in the log joints, the construction may exhibit slight displacement.

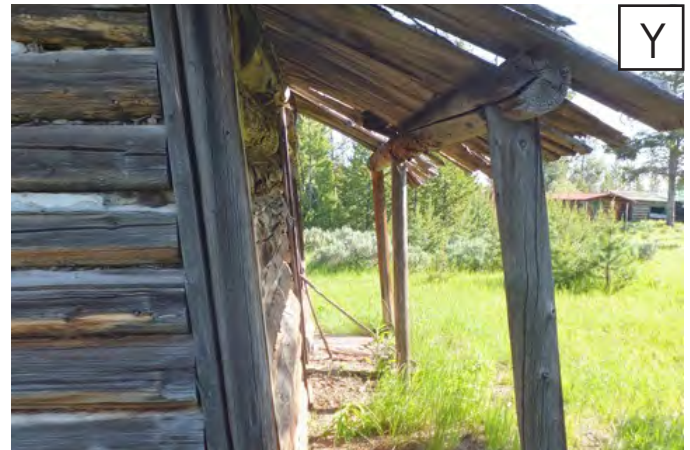
A leaning wall.

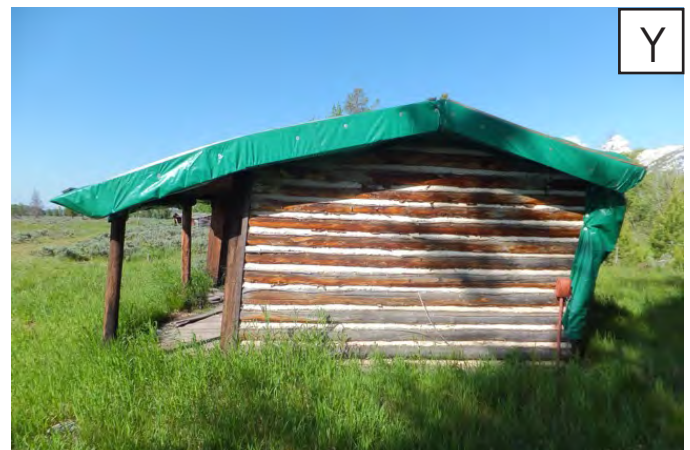
A racked wall.

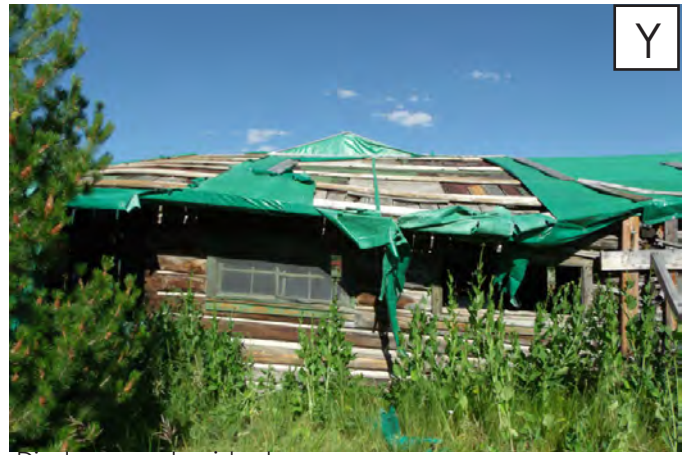
Y

Displacement evident.

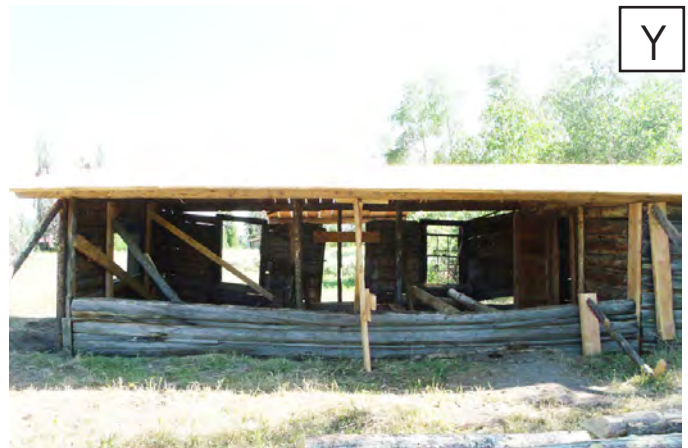
Y

Deformation evident in the remaining lower portion of this wall.

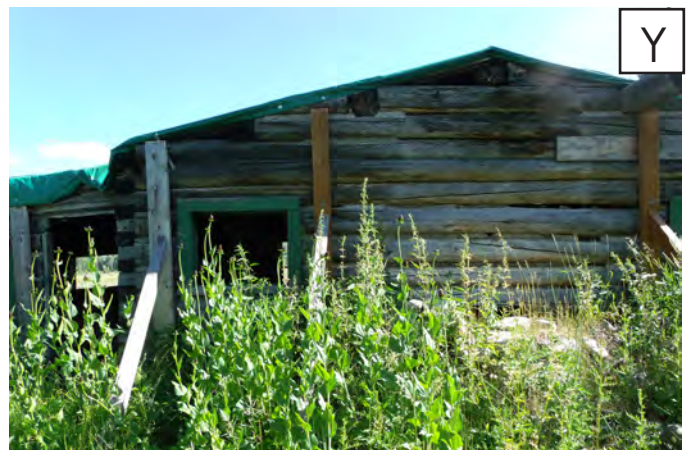
Vegetation present.

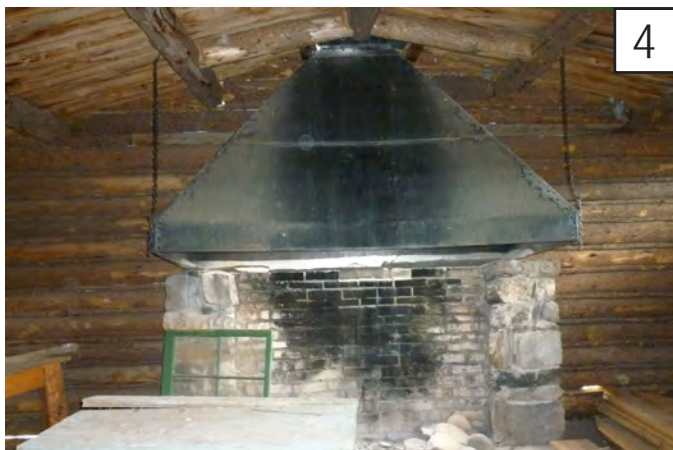
4 chimney condition exhibits some slight cracking or mortar loss but no major damage.

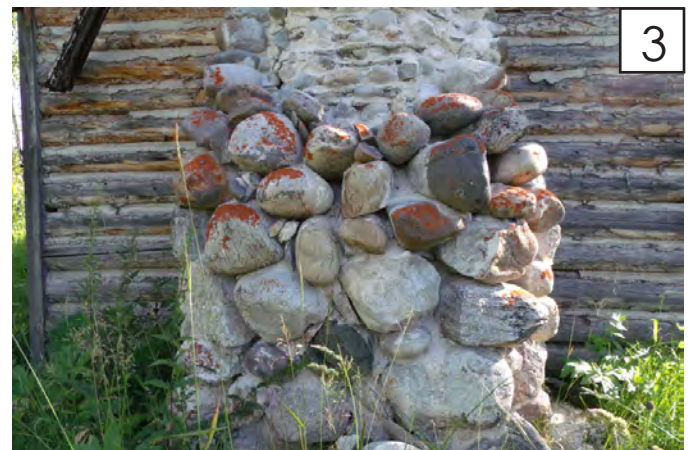
3 chimney condition exhibits major loss that does not affect structural integrity.

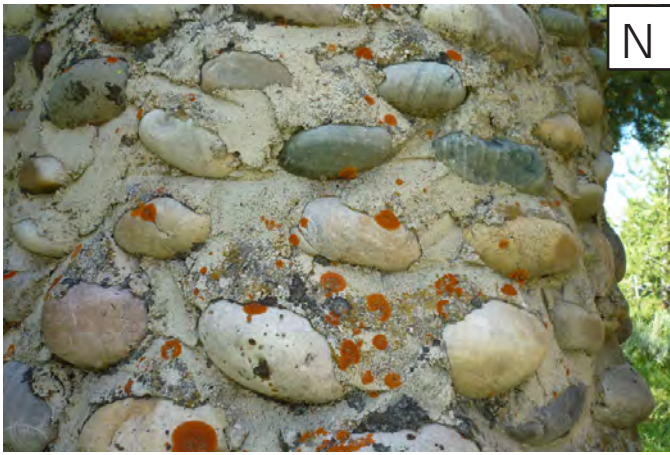
No cracking.

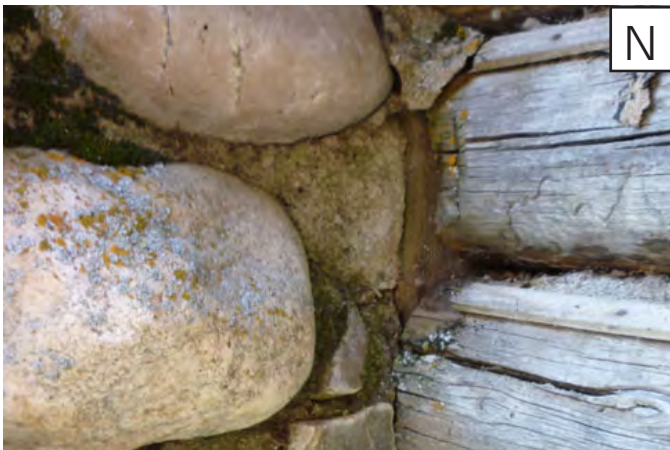
No separation.

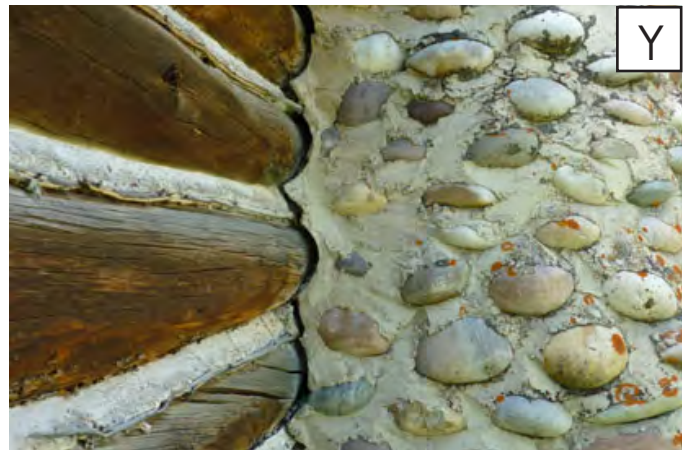
Separation.

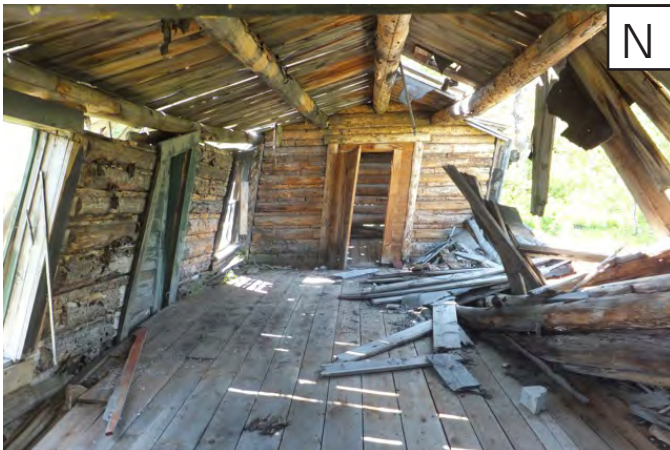
No interior stabilization.

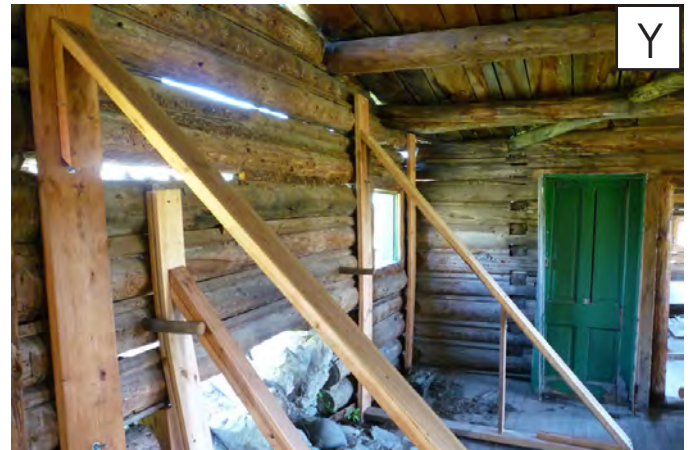
Interior stabilization present.

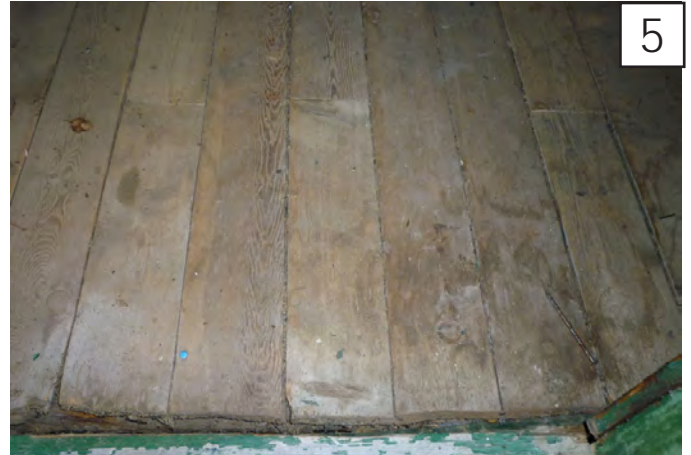
5 condition floor boards are straight and show no signs of damage or deterioration.

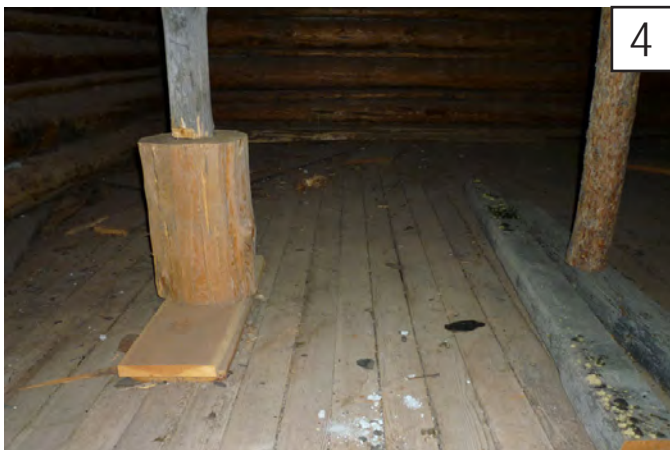
4 floor boards may show signs of wear and minimal deterioration.

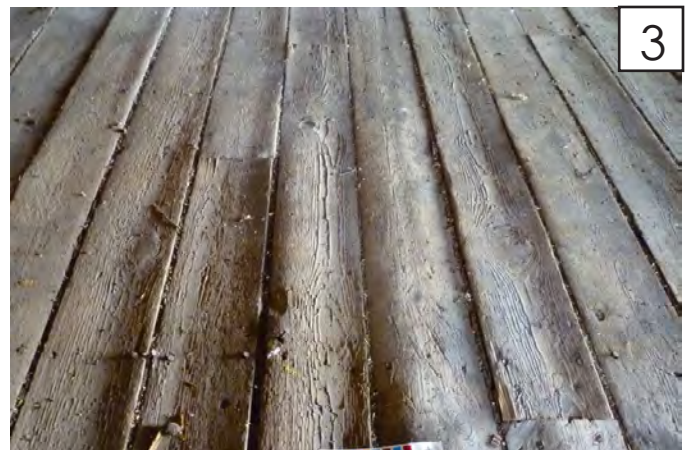
3 floor boards may be warped and moderately deteriorated.
